Space Station Control Moment Gyroscope Lessons Learned

Abstract

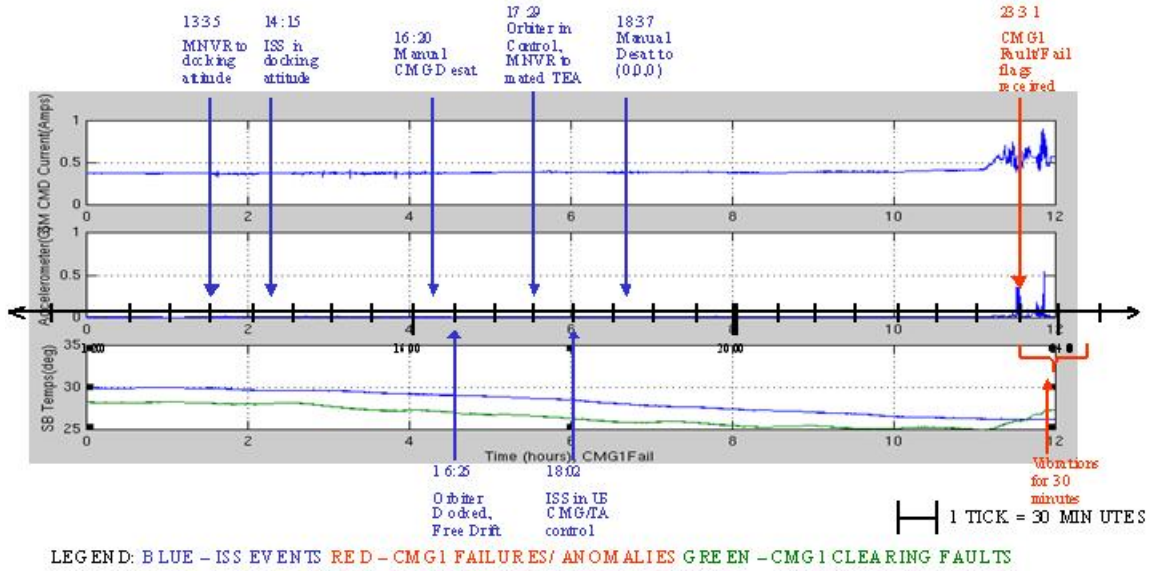
Figure 5. First Indication of Anomalous Behavior GMT 158/2002/12:00-24:00

At the end of May 2002; the ISS was in a high solar beta X-POP period. The ISS attitude was transitioned from X-POP to LVLH on June 7th, several hours prior to shuttle docking. In order to accomplish this re-orientation and docking, large gimbal rates within design requirements were imparted to the CMG due to desaturations. Approximately 6 hours after the docking at ~23:00 on GMT Day 158, 2002, CMG1's Spin Motor Command Current (SMCC), the indicator of the combined bearing torques, started increasing over a 14-minute period. This increase in SMCC was later concluded to be the start of the failure. The increase in SMCC was caused by an increase in the Hall Resolver side bearing torque. This was confirmed by the increase in bearing temperature that indicated the Hall Resolver side bearing may be in distress. During the course of the next 15 hours, CMG1 showed signs of good and bad bearing performance, with the ultimate failure occurring at 14:57 on GMT Day 159, 2002. Several hours after docking, the flight control team noted a flag that indicated the accelerometer on CMG1 had measured 0.5 Gs. The rise in SMCC and associated Hall Resolver temperature was repeated twice during the next 16 hours. Then, following a 30-minute period with no ground communication, telemetry showed that the CMG1 SMCC was at its maximum value, 1.6 Amps, and the wheel-speed was decreasing. After several seconds of maximum current and wheel-speed reduction, Fault Detection and Isolation software declared the CMG failed and automatically shut down the Spin Motor. Normal shut down would result in the flywheel speed decelerating to 0 rad/s in approximately 12 hours. However, during this event, the flywheel stopped 72 minutes after Spin Motor shutdown because of the bearing failed condition. During this run-down period, the Hall Resolver bearing temperature exceeded the maximum telemetry value of 93°C (199.4°F) while the Spin Motor bearing temperature reached only ~30°C (86°F), indicating major distress in the Hall Resolver bearing. Data was retrieved from the on-board data recorders to fill in the missing telemetry for analysis purposes. The timeline of events is given with SMCC and spin bearing temperatures shown in Figure 5, Figure 6 and Figure 7. The CMG1 was later returned to L-3 for disassembly and formal failure investigation.

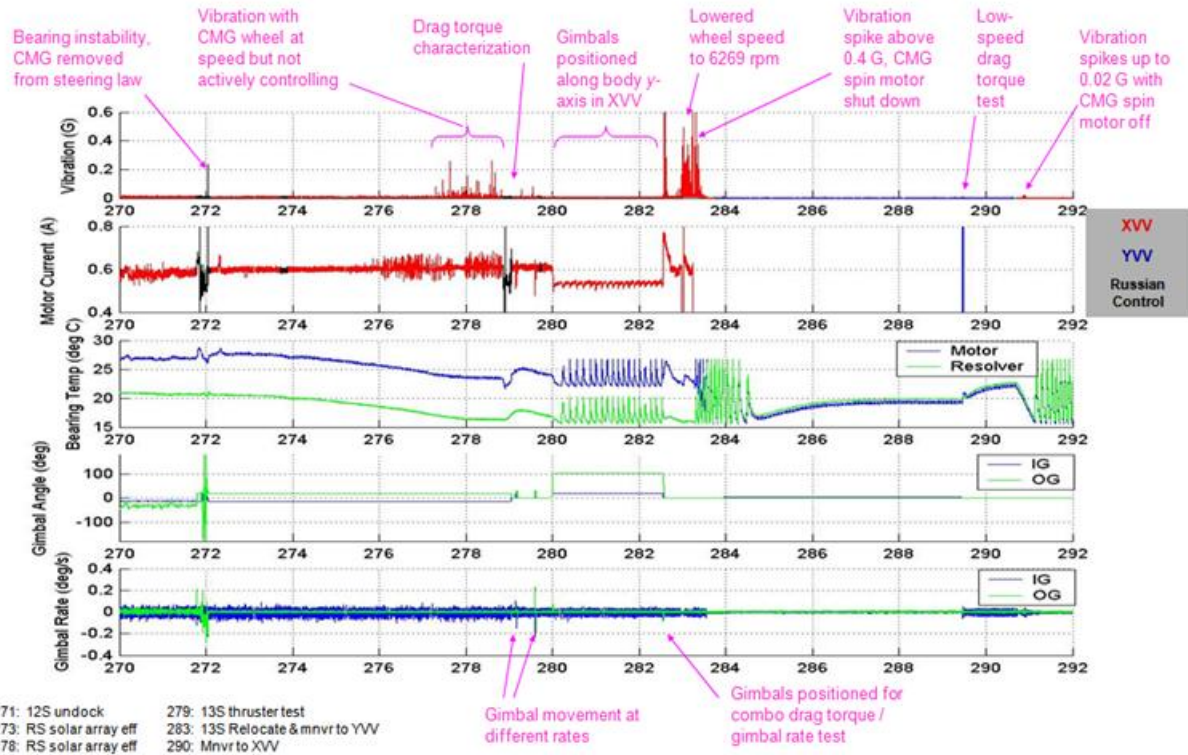
Figure 8. CMG3 Time Line to Shutdown

CMG3 operated continuously at 691 rad/s (6600 rpm) from its activation on February 12, 2001 until the unbalance sensor level reached the criteria (0.2 g) for removal from the active steering law on Day 272, September 29, 2006. This occurred as the CMGs were being pre-positioned for Momentum Management startup in the XVV flight attitude. CMG3 was kept out of the steering law pending further analysis. Several times the unbalance sensor levels reached 0.2 g while the CMG was operational but not used to actively control the ISS. On Day 283, October 10, 2006, the unit was shut down because the unbalance sensor reached the shut down criteria of 0.4 g. Figure 8 shows the performance signatures and events that preceded the shut down of CMG3. CMG3 was returned to L-3 Communications Corporation Space & Navigation (L-3 S&N) on March 11, 2008 for disassembly and a failure investigation.

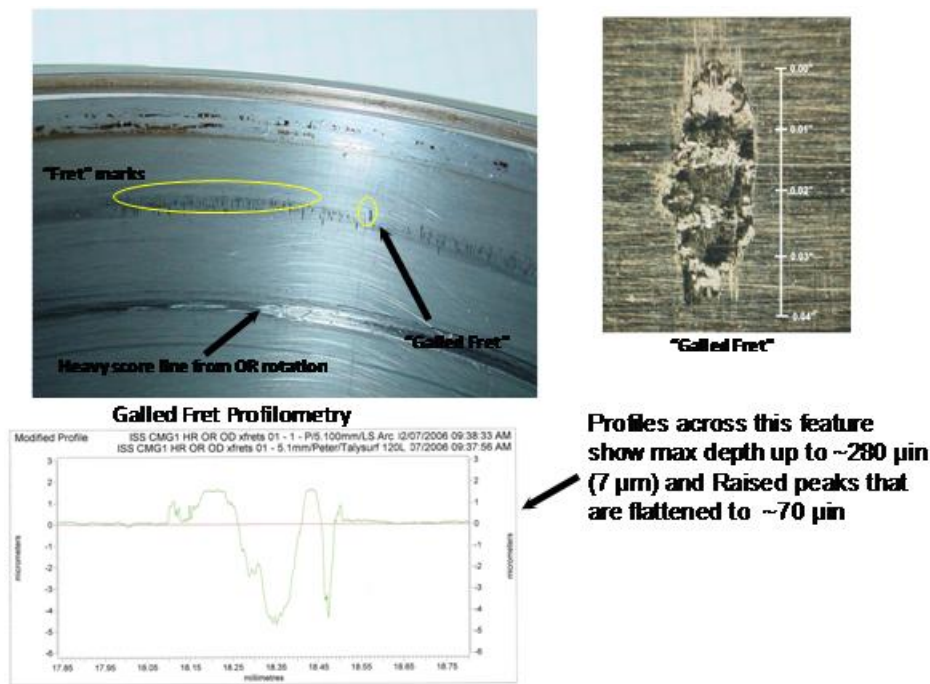
Figure 9. HR Side Bearing Housing Steel Sleeve

1. Some "fretting" type marks were observed on the steel sleeve of the SM bearing cartridge steel sleeve. The fretting marks were 180 degrees apart from the area on inboard section to the area on the outboard section, an indication of bore misalignment. If these conditions occurred before the failure, either during on earth acceptance testing or during operation, this misalignment would have affected the preload system. In addition, a particular mark coined a "galled fret" was observed on the CMG1 HR steel sleeve. This galled fret may have specifically been the one that prevented the outer race to slide properly which would compromise preload and initiate ball skidding.

1. Change the sleeve material to a harder dissimilar metal than the bearing outer race to prevent fretting and galling
2. Add Rheolube grease to the bearing/steel sleeve interface to improve long term lubrication, reduce wear/galling/fretting, and improve sliding
3. Change the preload nut material from A286 to harder 52100 to prevent wear/record grooving
4. Add flats to the Belleville preload spring to reduce contact stresses and prevent wear/record grooving of the preload nut
5. Improve the inner gimbal cover/inner gimbal interface to reduce gimbal distortion and maintain bearing bore alignment
6. Improve the cleaning process of bearing housing sleeves to minimize/eliminate hard particles that may have contributed to the repetitive marks in the bearing raceway and that may have lodged between the outer race and steel sleeve resulting in locked outer races

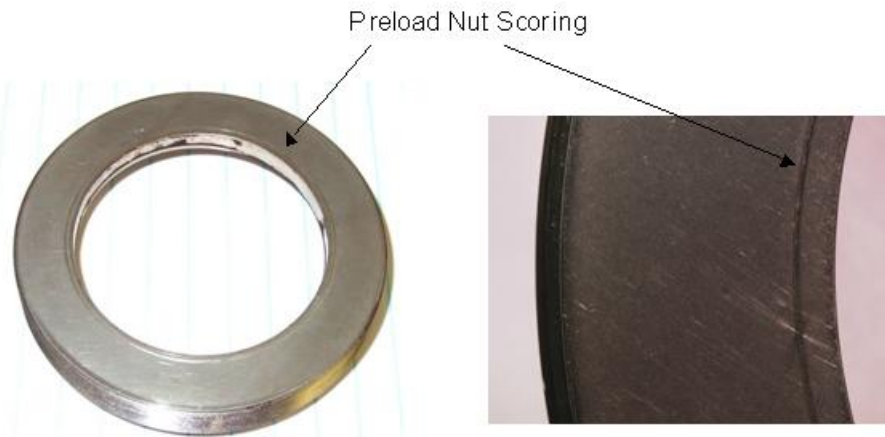
Figure 10. Pre-Load “Record Grooving”

2. Some scoring (record grooving) on both the Spin Motor and Hall Resolver side preload nuts has been observed. This condition inhibited the spring action to react properly during the load and release cycle during axial motion of the flywheel. Preload was reduced to cause ball skid.

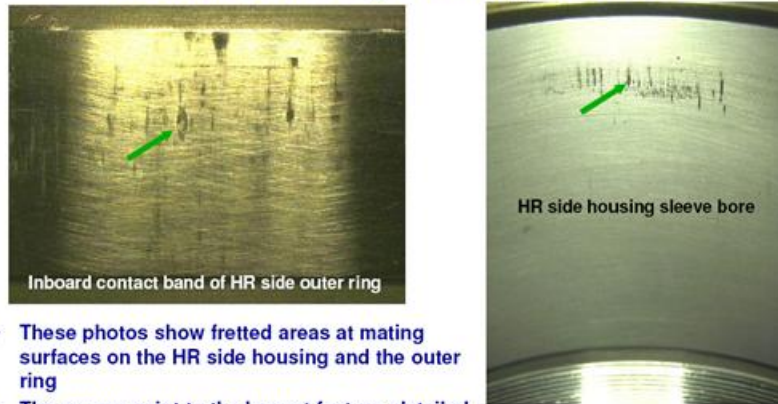
HR Side Outer Ring / Housing Interface

1. Similar “fretting” type marks were observed on the steel sleeve of the bearing cartridge steel sleeves (Figure 11). The fretting marks were near 180 degrees apart from the area on inboard section to the area on the outboard section, an indication of bearing bore misalignment. If these conditions occurred before the failure, either during on earth acceptance testing or during operation, this misalignment would have affected the preload system.

- These photos show fretted areas at mating surfaces on the HR side housing and the outer ring
- The arrows point to the largest feature, detailed on the next chart
- There were generally fewer frets here than on CMG1 and ADP
- There was some evidence of wear marks 180 degrees apart from these on the outboard end of the bore, but this was not as distinct as in CMG1 and qual unit

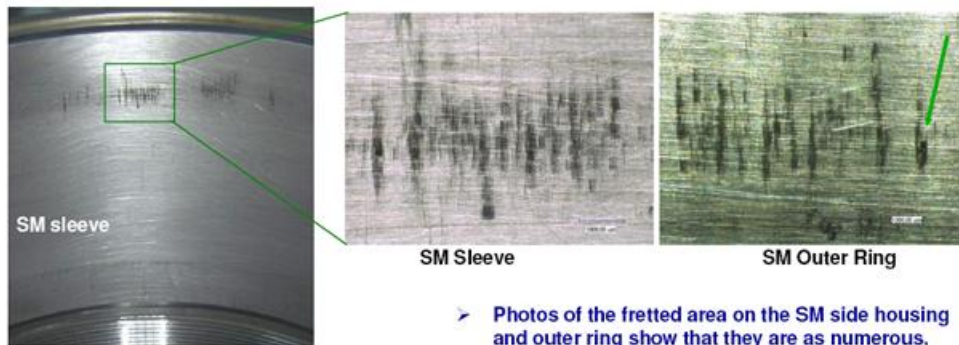
SM Side Outer Ring / Housing Interface

- Photos of the fretted area on the SM side housing and outer ring show that they are as numerous, but not as severe as on the HR side housing
- The profile shown here was scanned across the corresponding surface of the outer ring inboard contact band
- This profile confirms that the wear is not as severe, but it shows a persistent mildly abrasive contact

Figure 11. Typical Cartridge Fretting

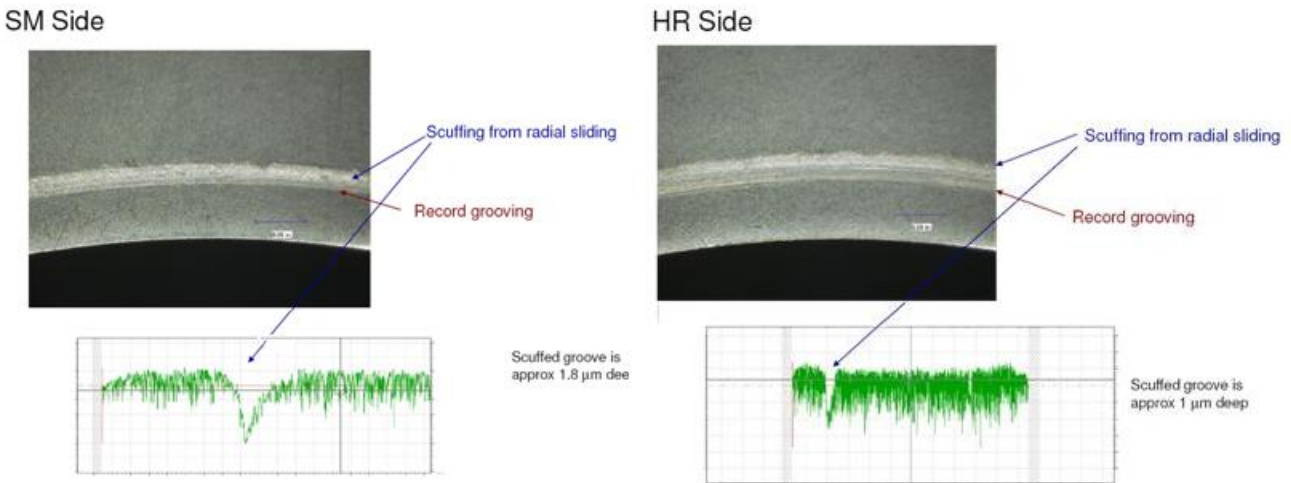
Figure 12. Typical Preload Nut Record Grooving

- Some scoring (record grooving) on both the Spin Motor and Hall Resolver side preload nuts has been observed (Figure 12). This condition inhibited the spring action to react properly during the load and release cycle during axial motion of the flywheel. Preload was reduced to cause low preload and ball skid.
