Space Station Control Moment Gyroscope Lessons Learned

Abstract

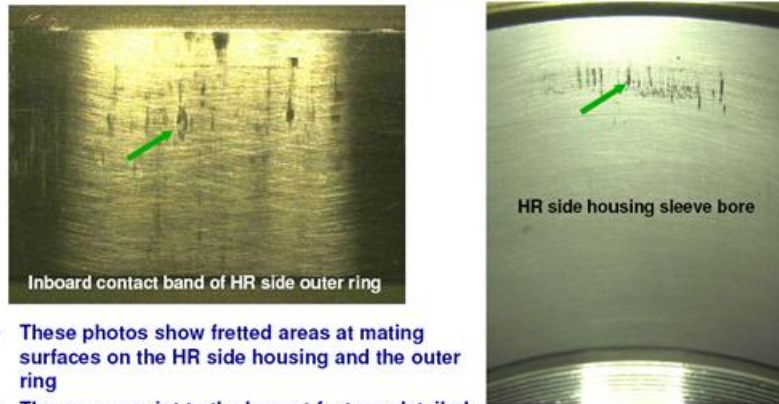
HR Side Outer Ring / Housing Interface

1. Similar “fretting” type marks were observed on the steel sleeve of the bearing cartridge steel sleeves (Figure 11). The fretting marks were near 180 degrees apart from the area on inboard section to the area on the outboard section, an indication of bearing bore misalignment. If these conditions occurred before the failure, either during on earth acceptance testing or during operation, this misalignment would have affected the preload system.

- These photos show fretted areas at mating surfaces on the HR side housing and the outer ring
- The arrows point to the largest feature, detailed on the next chart
- There were generally fewer frets here than on CMG1 and ADP
- There was some evidence of wear marks 180 degrees apart from these on the outboard end of the bore, but this was not as distinct as in CMG1 and qual unit

1. Change the sleeve material to a harder dissimilar metal than the bearing outer race to prevent fretting and galling
2. Add Rheolube grease to the bearing/steel sleeve interface to improve long term lubrication, reduce wear/galling/fretting, and improve sliding
3. Change the preload nut material from A286 to harder 52100 to prevent wear/record grooving
4. Add flats to the Belleville preload spring to reduce contact stresses and prevent wear/record grooving of the preload nut
5. Improve the inner gimbal cover/inner gimbal interface to reduce gimbal distortion and maintain bearing bore alignment
6. Improve the cleaning process of bearing housing sleeves to minimize/eliminate hard particles that may have contributed to the repetitive marks in the bearing raceway and that may have lodged between the outer race and steel sleeve resulting in locked outer races

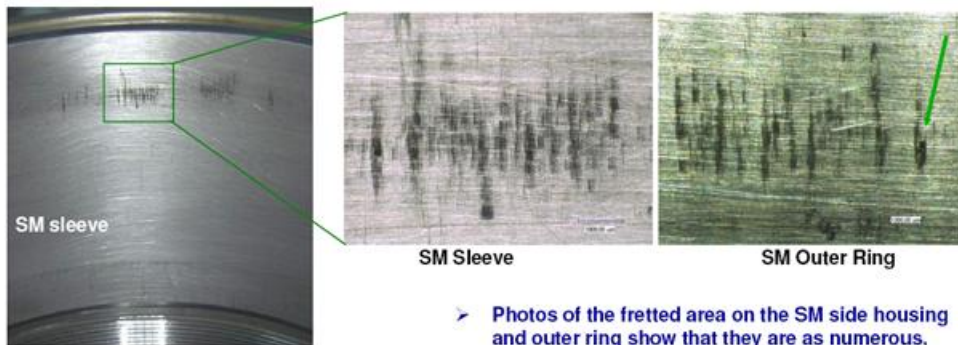
SM Side Outer Ring / Housing Interface

- Photos of the fretted area on the SM side housing and outer ring show that they are as numerous, but not as severe as on the HR side housing
- The profile shown here was scanned across the corresponding surface of the outer ring inboard contact band
- This profile confirms that the wear is not as severe, but it shows a persistent mildly abrasive contact
