# International Space Station Powered Bolt Nut Anomaly and Failure Analysis Summary

Daniel E. Sievers\* and Harry K. Warden\*

## Abstract

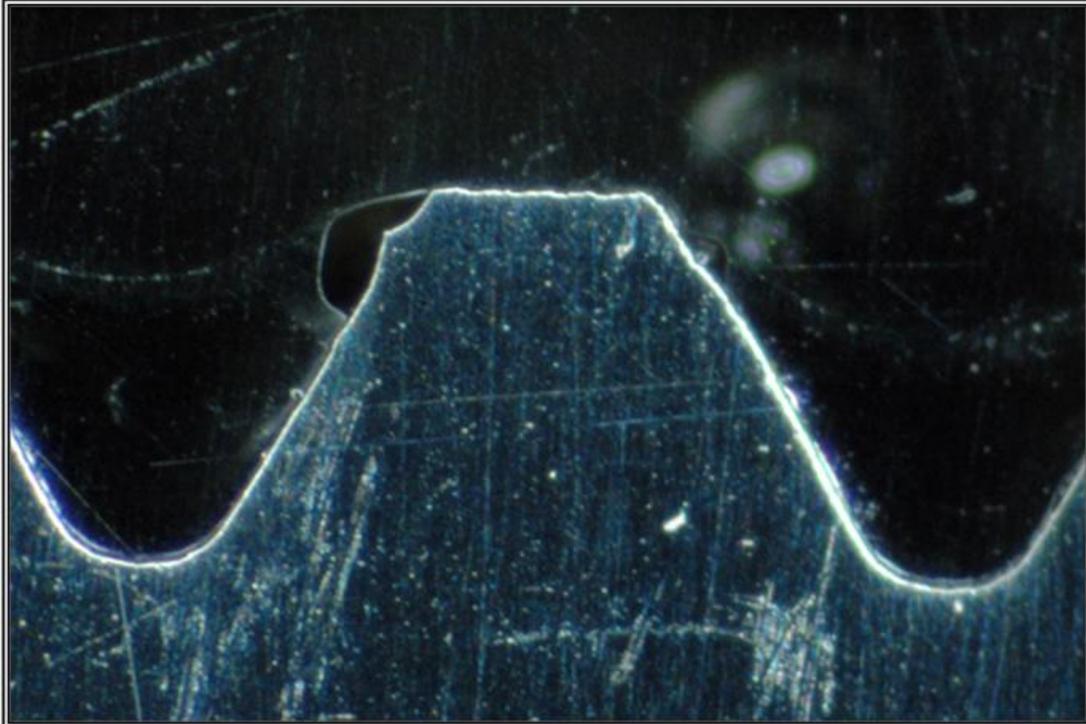
The machinist must ensure adequate and uniform lapping over all the internal threads with a hand tool specially made for the PBN thread dimensions to ensure burrs are removed and the required 0.41  $\mu\text{m}$  (16  $\mu\text{in}$ ) finish is obtained. The lapping process for the 2009 PBNs consists of machining a bolt to proper dimensions and covering it with lapping compound. When choosing a hand tool to lap the nuts and remove burrs left from machining, the hand tool material must be softer than the nut base material. This is to ensure the burrs will be removed and the base metal will not be damaged by galling with the hand tool. The best way to ensure an adequate finish is to fully engage the softer material tool with lapping compound multiple times to wear down any burrs left from machining. This process was implemented for the 2009 PBNs to smooth out burrs and meet required finishing while opening the nut pitch diameter before the application of lubricant. Figure 2 is a surface finish error (burr) that occurred due to inadequate machining and lapping of the 2007 PBNs. This error may seem minuscule, but when requiring the Powered Bolt to autonomously attach two pressurized elements of the ISS together, a small burr will quickly break through the thin dry film lubricant and cause galling of the Powered Bolt Assembly. The PBNs fabricated in 2007 were polished with a lathe and polishing sponge. The lathe and sponge method is unable to polish in the grooves of the PBN threads; therefore this method will not meet the thread call out and finish of the specified PBN drawing. This process not only leaves room for potential burrs but also does not evenly open the thread pitch. Using a lathe and sponge technique could also damage the threads of the nut if the machinist calculates dimensions wrong or a sizable previously made burr gets caught on the lathe. The PBNs fabricated in 2009 were correctly dimensioned and lapped to open the pitch diameter in order to meet the PBN drawing specifications.

**Figure 2: Surface Finish error, burr; 500x magnification**

- When lapping a surface, a method that is capable of obtaining the desired surface finish in every thread, groove, etc, must be determined and controlled. In this case, manual thread lapping with a “softer” tool and lapping compound, lapped multiple times worked well to wear down any burrs left from machining.
- Polishing with a lathe and sponge method was eliminated.
- Use of a go/no-go gauge before lubrication to check for correct thread dimensions was implemented.

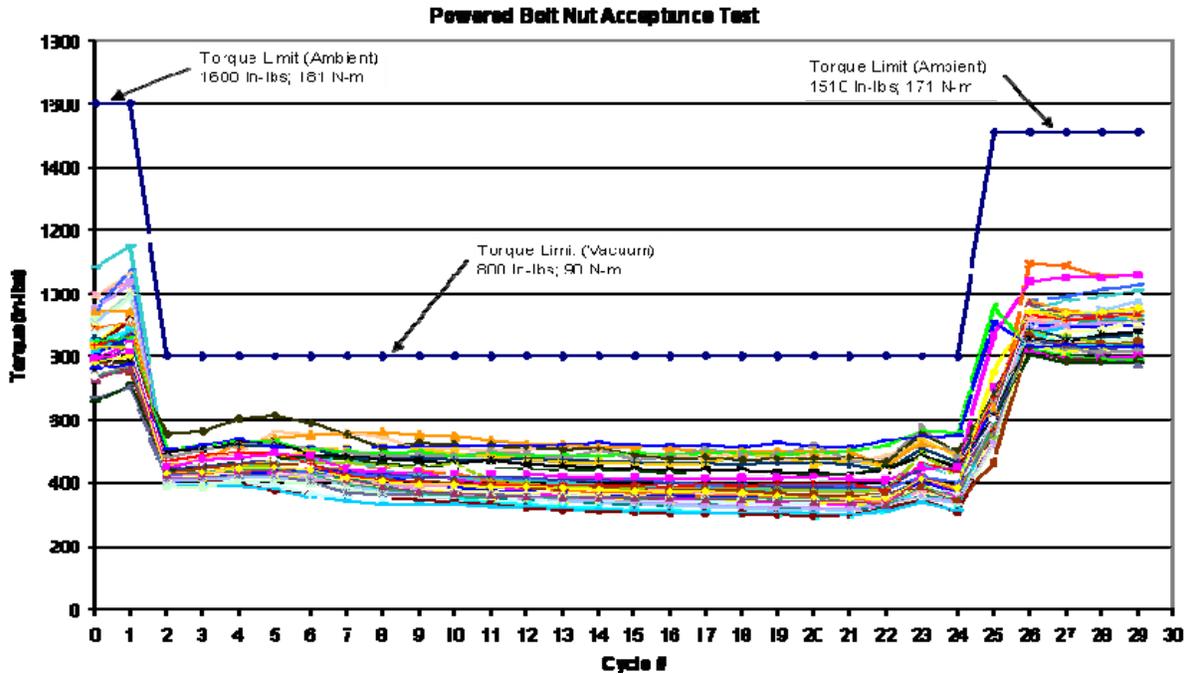
Figure 4: Acceptance test data from passed PBN lot of 2009

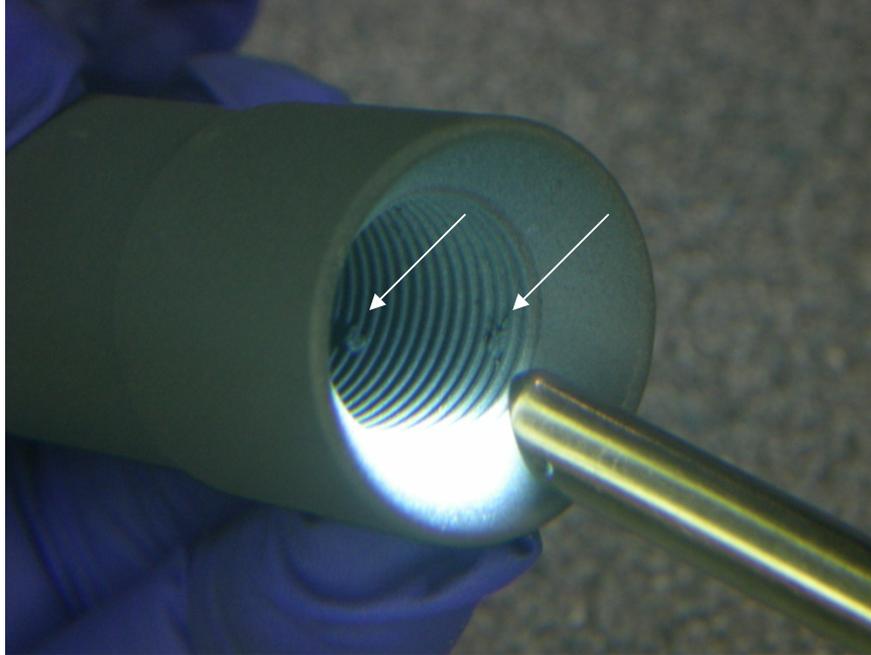
Dry film lubricant, which is applied to internal threads using common practices, has an unpredictable thickness. Thickness is almost impossible and usually too expensive to measure in an indestructible manner. If the lubricant is too thick, this will cause high torque limits during acceptance testing leading to failure of the nuts. Thickness of the PBN lubricant was also a reason for failure for some of the previously built PBNs. A way to defer from dry film lubricant being too thick is to use a thread cutting tap. On previously built PBNs, a roll forming tap or a specially manufactured forming tap was used. Both the roll forming tap and specially manufactured forming tap were not sufficient enough to cut through the cured ceramic base coat of the lubricant; this problem will be similar for most ceramic-based dry film lubricants. During this process, the roll forming tap became stuck in the nut barrel on various PBNs and had to be cycled multiple times into the nut. Much force had to be applied to the tap to smooth and cut out lubricant. This process increases the risk of damaging the lubricant or the threads of the PBN. A thread cutting tap should only be used on the fully cured ceramic base coat of the lubricant. Dry film lubricants may be applied in multiple coats and a thread cutting tap should not be used on the top coat. The thread cutting tap will strip the top coat off the base coat and the lubrication properties of the top coat and the lubrication system will be lost.

**Figure 5: Agglomerations of base coat ceramic of Dry Film Lubricant**

When deciding on a thread cutting tap, the end thickness of the lube must be taken into consideration. Adding the end thickness of the lubricant and subtracting the top coat not yet applied to the nut pitch diameter will ensure the thread cutting tap only clears out the unneeded base coat of the lubricant and leaves an even and smooth base coat on the threads. Figure 5 is an agglomeration of ceramic particles after curing of the lubricant and before using the thread cutting tap. Another benefit of using a thread cutting tap is cutting out debris which may come loose later during acceptance testing. This loose debris gets caught between the threads and causes torque spike anomalies in acceptance test data. This debris can also lead to false failures. Spraying the top coat of lubricant over a loose base coat will cause a loss of both top coat and base coat as debris during testing. Losing the top coat and base coat in areas will cause the lubrication system to function improperly, leading to higher torque readings and possibly galling. For each PBN, the thread cutting tap was used only one time to mitigate cutting into too much lubricant or causing damage to the lubricant. Using a thread cutting tap on dry film lubricant is not an easy process and difficult to do by hand. The PBNs were placed in a vice while a hand tool was used to gain

cutting torque in order to cut through the cured ceramic base coat. After the correct thickness of the base coat was obtained through proper tapping of the nut, the top coat of the lubricant system was applied. The variables stated earlier in this section are now controlled to ensure a consistent uniform lubrication throughout production.

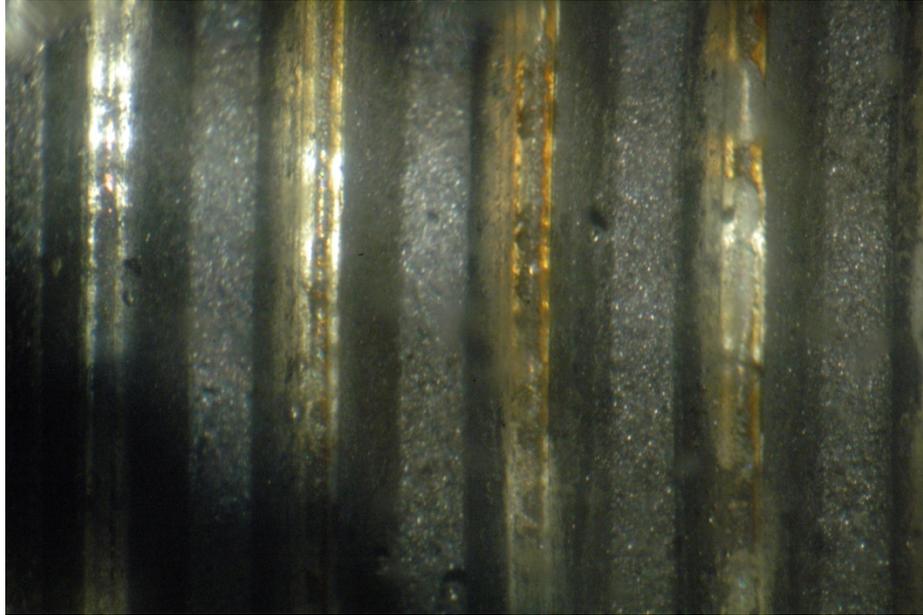
If dry film lubricants are applied in a liquid form, the substrate must be heated to ensure proper evaporation of the carrier liquids (commonly known as flashing). If proper flash is not reached, the carrier liquid will migrate with the lubricating particles and pool at its potential energy equilibrium. This pooling will cause uneven lubrication. A result of uneven lubrication can be seen in the case of the Powered Bolt Nuts acceptance test failures. The coefficient of friction was not met during these tests and high torque limits were reached, leading to failure. The dry film lubricant used in this process, Vitro-lube NPI-1220C, is a resin bonded ceramic coating, therefore if the lubricant is not properly flashed, an amber coloration can be seen in resin rich areas (Figure 6). This specific dry film lubricant was chosen because of its thermal vacuum stability and because of its ability to perform reliably under the high load rates of the Powered Bolt assembly; 1.03 MPa of contact stress. Vitro-lube NPI-1220C was also selected due to its superior wear life as compared to other dry film lubricants. This specific dry film lubricant is made up of two parts; a ceramic base coat and a resin top coat. Some dry film lubricants are not resin bonded and the resin rich areas in Figure 6 will not be seen. Areas of high ceramic content can also be seen if Vitro-lube NPI-1220C is not flashed properly; these areas form where the majority of the ceramic base coat pool during lubricant application. Ceramic pooling of a failed PBN can be seen in Figure 7. This result of improper flashing of dry film lubricant can be used as a guide for non-resin bonded lubricants. When using a non-resin bonded lubricant the surface characteristics will be different between base metal and dry film lubricant.

**Figure 6: Amber coloration of resin binder; 50x magnification**

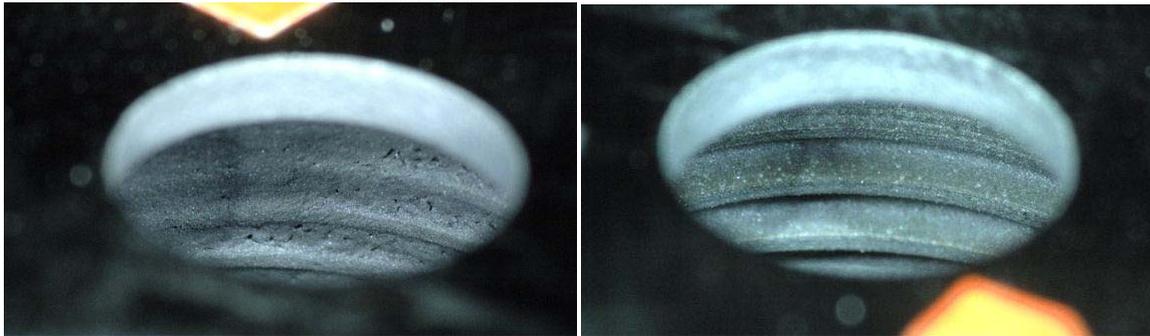
Oxidation protection given to the substrate ceramic by the phenolic resin was a main factor in choosing resin bonded dry film lubricant for the powered bolt nuts. In the case of PBNs, Molybdenum disulfide ( $\text{MoS}_2$ ) will not oxidize to Molybdenum trioxide ( $\text{MoO}_3$ ), a poor lubricating material, in air due to the use of the top coat resin. A downfall to using  $\text{MoS}_2$  over other dry film lubricants is it will fail due to high coefficients of friction when testing in high humid atmospheres under high loads.  $\text{MoS}_2$  will oxidize to  $\text{MoO}_3$  in high humid atmospheres under high loads. Most non resin-bonded dry film lubricants will slowly oxidize in air environments, such as storage warehouses, leading to early failures of the lubricant.

**Figure 7: Two 180° views of a failed PBN; 50x magnification**

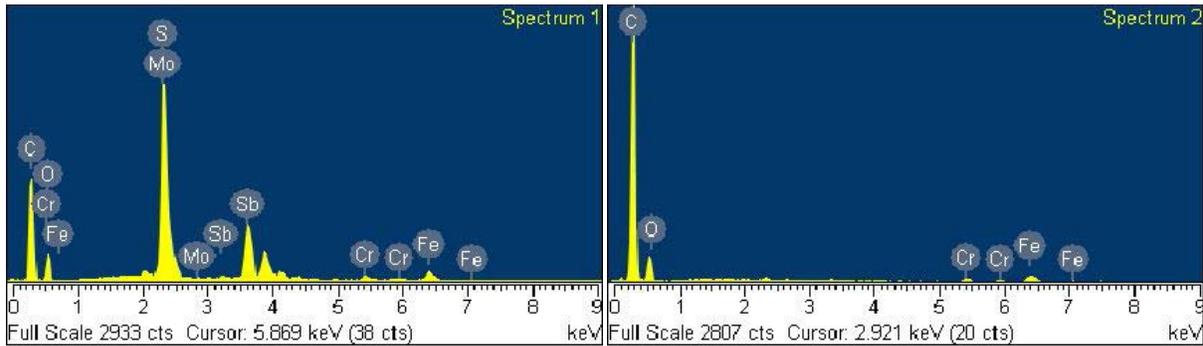
A way of analyzing lubricant for composition is using an Energy Dispersive Spectrometer (EDS). This equipment will show if lubricant is missing from the threads. The EDS indicated that the ceramic base coat was applied to the threads before the resin top coat. Figure 8 shows EDS images of a PBN which failed acceptance testing. Spectrum 1 is of a non-amber colored area and Spectrum 2 is of an amber colored area. The chemistry shows the absence of the Molybdenum disulfide and Antimony which make up the ceramic base coat of Vitro-lube NPI-1220C. This absence of ceramic base coat is a direct cause of not preheating the PBNs before lubrication.

**Figure 8: Differences in coating chemistry of PBN**

Depending on a substrate's thickness and material type, the temperature of the substrate itself may differ in order to properly flash the carrier liquid. The flash temperature will also differ for lubricants depending on the carrier liquid used. The 2009 batch of PBNs was preheated in an oven/furnace for a specified amount of time at a temperature predetermined based on the PBNs material thickness and the carrier liquid (in this case isopropyl alcohol). A thermocouple was attached to the internal threads of the PBN while in the oven to evaluate the surface temperature where the flashing of the lubricant would take place. During production, the PBNs were taken out of the oven and prepared for lubrication; wheeled to station, set-up properly, etc... Depending on the technician, some of the PBNs would not be lubricated for 10 minutes, losing their flash temperature. It was realized that the PBNs needed to retain flash temperatures during production. To retain this temperature, mitigating risk of improper lubrication, a 3-minute time limit was placed on the PBNs to be out of the oven before being lubricated. Some dry film lubricants, for example Vitro-lube NPI-1220C, are applied in multiple coatings. To ensure proper flashing throughout all coatings, mechanisms must have an out of oven time limit placed upon them to retain their flash temperature during lubrication. This added preheat process to the lubrication method of the PBNs ensured proper flashing of the dry film lubricant leading to even lubrication of the nut threads and less production variation. At completion of the lubrication process, the PBNs exhibited dark spots throughout the nut. Further analysis of these dark spots showed it to be excess top coat. This excess top coat was deemed acceptable because it was not thick enough to cause mating problems and the excess top coat will not cause a lack of lubrication of the system. During acceptance testing this excess top coat will be burnished into the ceramic base coat as is the rest of the top coat.

- To maintain consistent lubrication thickness a thread cutting technique was implemented over a thread rolling tap. Consideration of final lubricant dimensions is a key aspect of choosing a cutting tap.
- A preheating process was implemented to obtain proper flash temperature. Due to the migrating capabilities of dry film lubricants that are applied on to substrates as liquids, it is beneficial to preheat all mechanisms to defer and risk of lubricant pooling or lack of lubricant in less energy potential areas.
- Imposing an out of oven time limit during the lubrication process to keep the mechanisms at flash temperature.
