Failure Analysis at the Kennedy Space Center

Victoria L. Salazar and M. Clara Wright*

National Aeronautics and Space Administration, Kennedy Space Center, FL, 32899

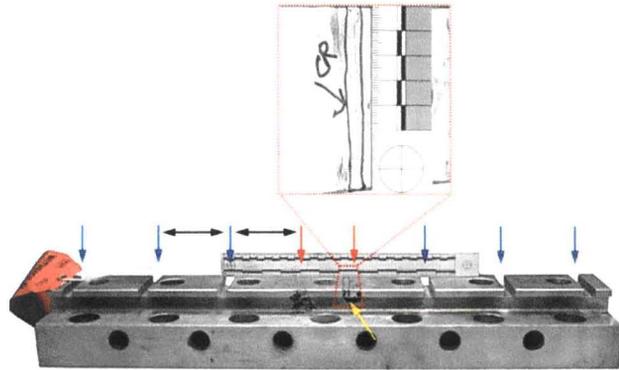
International Space Station (ISS) materials and processes engineering personnel submitted a payload canister rail from the Rotation Handling Fixture when a crack was observed on the top of the rail during installation. The Rotation Handling Fixture is used to lift the modules of the ISS into a vacuum chamber in order to perform leak checks. The drawing specified that the rail be composed of AISI 4140 steel (UNS G41400). Fig. 1 shows the payload canister rail, as received. The blue arrows indicate the six notches that are cut into the top of the rail in order to fit a thrust block assembly used to secure the payload to the rail. The yellow arrow indicates the location of the crack (inset). Two apparent weld repairs were observed in the locations indicated by the red arrows. The distance between the weld repair regions and their closest notches was approximately equal to the distance between adjacent notches, which is equal to 10 cm. The rail was sectioned longitudinally in order to remove the top ledge from the base of the rail so that examination of the underside of the ledge could be performed. Four cracked regions were observed on the underside of the ledge near the weld repair regions.

Figure 1. Payload canister rail, as received, with an inset image of the crack on the top of the rail. Scales are in cm increments.

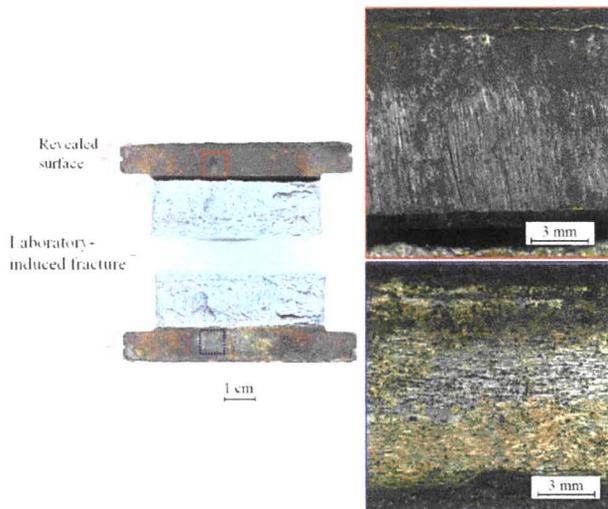
The crack was opened using an Instron tensile tester in a three-point bend loading configuration in order to examine the fracture surface. Corrosion product covered the majority of the revealed surfaces, as shown in Fig. 2. The corrosion product was removed in order to reveal the features on the surface. The surfaces were flat and only had a small region of fracture around the edge of the surface that was approximately 1 to 2 mm wide.

Figure 2. Stereomicroscope images of the revealed service fracture.

Analysis of the fracture surface via scanning electron microscope (SEM) revealed tool marks on both of the surfaces. Examination of the fracture region around the edge of both of the surfaces revealed dimples formed by microvoid coalescence (MVC), characteristic of ductile stress overload. Analysis of the bulk metal surface with qualitative/semi-quantitative energy dispersive spectroscopy via the SEM (SEM/EDS) confirmed the presence of nickel plating on one of the revealed surfaces.

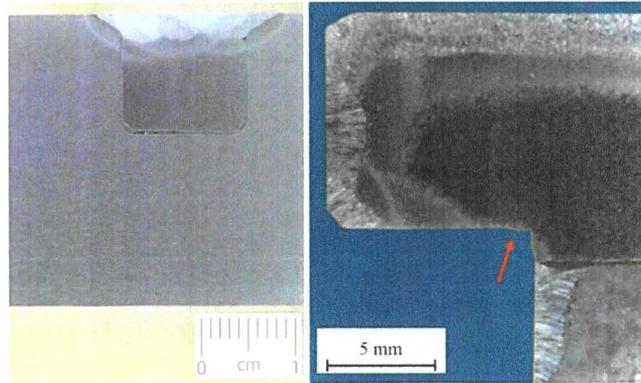
Metallographic specimens were prepared from cross sections of the unfractured weld repair region. Initial observation of the metallographic specimens after etching indicated that a piece of different material was welded into a notch cut in the base material and that the weld had penetrated less than 3 mm, as shown in Fig. 3. The size of the notch correlated with the size of the machined notches that were located in six positions on the rail in order to install the thrust block. On the underside of the rail ledge, the weld did not fuse the fill piece with the base metal.

Metallographic specimens were also prepared from cross-sections of the fractured weld region. Macroscopic examination of the metallographic specimens indicated that cold-work lines parallel to the fracture surface were present on the fill material, which would indicate that the bar was cut from a larger plate of material and the material was inserted such that the transverse cross-section was sustaining the load. Metallographic analysis of the samples confirmed the stereomicroscope and SEM findings that plating was present on the bulk metal surface and the fracture surface was limited to a small region on the edge of the specimen. The weld used to hold the piece of fill materials in the notch also had significant porosity.

The payload canister rail failed due to improper fabrication techniques. The rail had two cut notches that were not in accordance with the drawing, and thereby were filled with a low-strength, 1000-series steel. The grinding marks on the fill material surface indicate that the cut piece of materials was ground in order to fit into the miscut notch. The weld around the steel bar that was used to fill the slot did not have adequate penetration to fuse the fill material with the bulk rail metal. The lack of fusion was the most pronounced on the underside of the rail and acted as crack initiation points. The rail subsequently failed due to stress overload.

Figure 3. Cross-sections of the weld repair region showing a piece of metal inserted into the rail (left) with an incomplete weld around the edge (right, arrow).

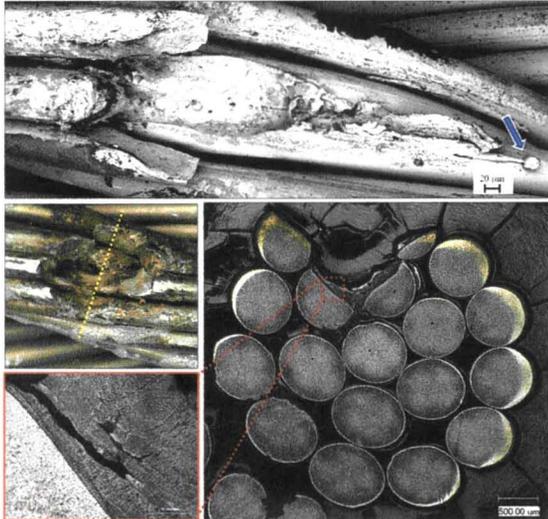
Several areas of damage were observed on the surface of the wire rope that were apparent localized melted and fused wires.

Figure 4. SEM image (top) and cross-section (bottom) of the wire rope.

Orange corrosion product was observed on the wire rope in the areas of the melting damage. The one pull test sample that did not fail at the swage fitting failed at one of the areas of apparent melting damage. SEM examination of one of these areas of damage observed via stereomicroscope revealed a melted bead of metal that formed during a localized heating event, as shown in Fig. 4 (blue arrow).

One of the areas of apparent melting and resolidification was cross sectioned and prepared for metallographic examination, as shown in Fig. 4 (yellow line). Observation of the cross-section indicated that five of the nineteen wires in the strand were damaged. The area of interest had a typical weld-like dendritic microstructure, confirming that the material had been melted and resolidified, as illustrated in Fig. 4 (red inset image). The base metal consisted of extremely fine austenitic grains in the transverse direction. The etchant preferentially reacted with the melted and resolidified metal, indicating that it is more prone to chemical attack than the original wire rope material, as confirmed

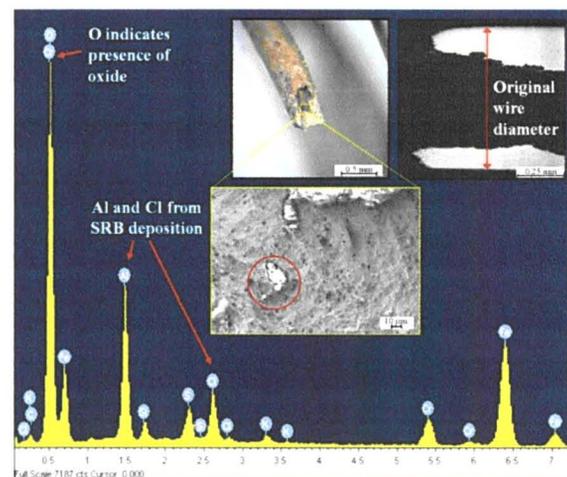
Visual and stereomicroscopic inspection of the fractured wires in one of the ropes revealed pitting of the interior of several of the wires, as shown in the top left image in Fig. 5. Approximately one quarter of the wires in one strand had reduced cross-sectional areas due to the pitting. SEM observation of these wire indicated that the pitting was not limited to the exterior of the wires, and in some cases, the corrosion process preferentially attacked the interior of the wires, leading to a wormhole-like appearance.

The pitted wire sample was analyzed using EDS via the SEM. Spherical deposits containing aluminum and chlorine were observed within the pit, as shown in Fig. 5 (circled), which are typical of solid rocket booster (SRB) combustion product deposit. The corrosion product consisted primarily of oxygen, iron, and chromium with minor amounts of both chlorine and sulfur. The corrosion was likely due to chloride-induced pitting of the stainless steel wire from the chlorine-containing SRB deposition and from the marine environment.

One of the pitted wires was mounted and metallographically prepared to observe the longitudinal cross-section of the wire. Approximately two-thirds of the interior portion of the cross-section was pitted, as shown in the top right image in Fig. 5. The grain structure of the wire was extremely elongated due to cold-working. The

Figure 5. The pits observed via stereomicroscope (top left) were determined via SEM (bottom image) and EDS (spectrum) to contain SRB deposition (circled). The cross-section of the wire was reduced due to pitting (top right).

grain boundary attack caused the wormhole-like pitting of the interior of the wire since the corrosion mechanism acted longitudinally with the grain structure. In other words, the directionality of the grains due to cold working influenced the directionality of the pitting process, leading to wormhole-like pitting of the wire.

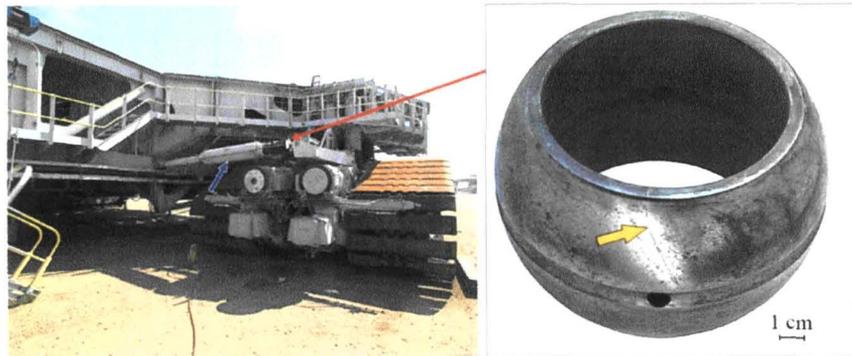
Figure 6. Image of the CT in the storage field (left) showing the steering cylinder (blue arrow) and the location of the cracked bearing (red arrow). The crack was observed on the surface of the spherical bearing (right, yellow arrow).

The bearing was photographed as-received to document the location of the crack on the bearing, as shown in Fig. 6. A lubrication groove was located around the circumference of the spherical bearing. The bearing was submitted for nondestructive evaluation (NDE) by liquid penetrant and magnetic particle examination in order to extent of the cracking. The crack tip was located just below the lubrication groove. A witness mark was observed on the interior surface of the spherical bearing, directly across from the location of the crack. The witness mark was more pronounced on the lower portion of the spherical bearing, indicating that uneven pressure was applied to the spherical bearing.

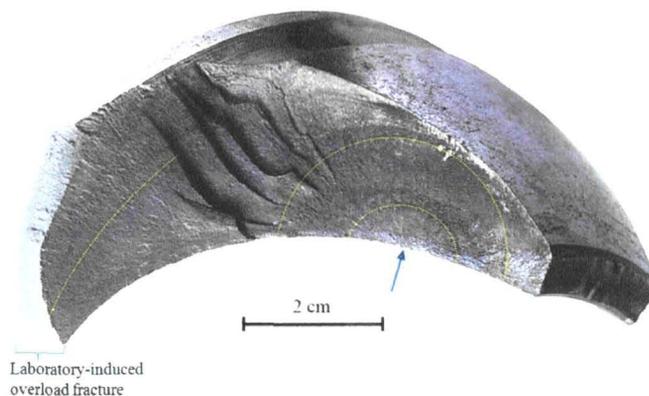
Figure 7. The revealed fracture surface displayed crack arrest marks (yellow lines).

indicate that the failure was progressive, as shown in Fig. 7. The blue arrow indicates the location of the origin, which was located on the weak axis of the spherical bearing.

The lubricant analysis indicated severe degradation due to age and contamination with environmental particles. Also, macroscopic indications of misalignment were found on the interior wall of the spherical bearing. The bearing failed in a progressive manner, likely the result of misalignment, with periods of fast crack growth corresponding to cycles of large applied loads. The misalignment could be caused by the failure of the grease to properly transfer the load, leading to the bearing binding in its race.

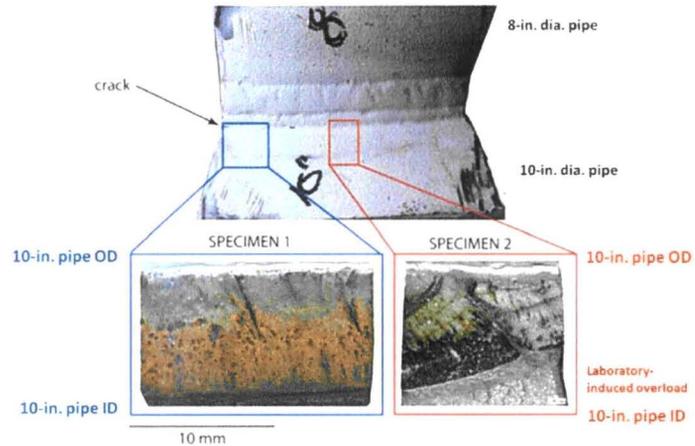
After initial photodocumentation, a sectioning plan was formulated to create cross-sectional samples for stereomicroscopy, metallography, fractography, and chemical analysis. During sectioning of Specimen 1 shown in Fig. 9, the through-crack was exposed to reveal corrosion product on the fracture surface. Specimen 2, which was opened during analysis creating a laboratory-induced overload region, revealed that the crack surface extended to the inner diameter (ID) of the 10-in. pipe and tapered off, as illustrated in Fig. 9, bottom right. No paint was

observed on the fracture surface, indicating that the crack had initiated after painting and had propagated to its full extent before the coupon was taken, with enough time to allow corrosion product to form.

Figure 9. Removed coupon, as received (top), showing the location of the two samples that were opened for fractographic analysis (bottom images).

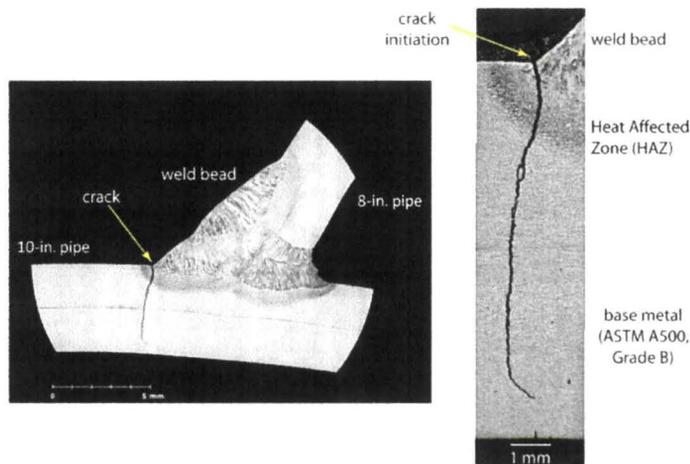
Figure 10. Micrographs of the cross-section of the weld showing the crack at the toe of the weld.

the left image of Fig. 10. The crack propagated mostly perpendicular to the weld near through-thickness and deviated at a 45° angle 1mm from the ID of the 10-in. pipe, as shown in the right image of Fig. 10. The cross section exhibited acceptable microstructures for the heat-affected zone (HAZ), weld metal, and base metal as expected for a plain carbon steel fillet weld. Microstructure and crack morphology indicated that this failure was neither due to hydrogen-induced cracking nor other types of materials-related fracture.

The crack profile and fractography indicated that the joint failed due to stress overload. The lack of paint on the fracture surface indicated that the crack occurred after painting. Heavier oxidation on the fracture near the 10-in. pipe ID, rather than the origin at the OD, indicates that moisture had wicked into the fracture and settled over time.

Weld features and geometry appeared nominal. No weld discontinuities or defects were observed. Fracture initiated at a transition near the toe of the weld, a region of stress concentration, and propagated inward through the base metal rather than following the weld HAZ. Microstructure, hardness, and fracture features did not indicate a hydrogen-induced failure mechanism. No other failure mechanisms related to the material were observed.

Loading configuration of this joint design should be evaluated to determine if the joint was overloaded, with the weld toe considered to be a significant point of stress concentration. Future assembly operations should eliminate the possibility of stress overload during fit-up and existing cracks should be repaired.
