STS-131
KSC S&MA

LC-39A High Pressure Gas Storage Facility (HPGF) Net Damage	Presenter R. Margasahayam	
	Date 03/08/2010	Page 1

STS-130 Ice Detection Camera FOD concern

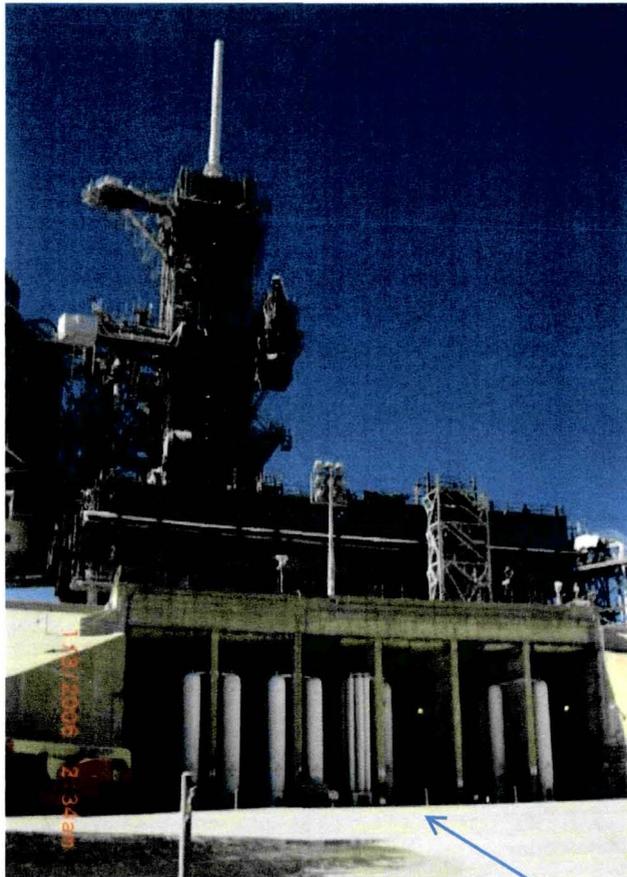
**HIGH PRESSURE GAS FACILITY –
EAST SIDE PAD 39A WITH SIX TUBE
BANK CELLS**

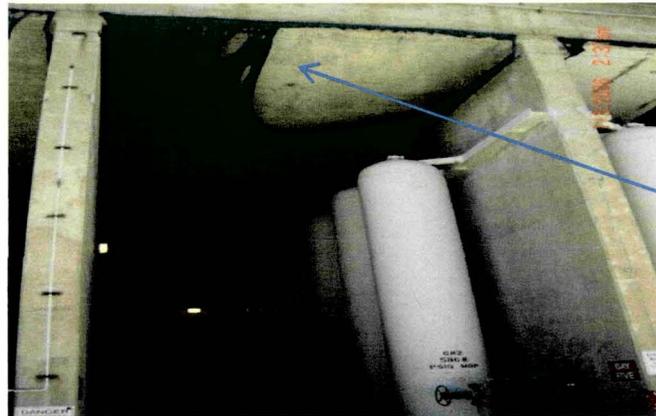
- During STS-130 launch High Pressure Gas Facility (HPGF) netting was damaged due to plume pressures and heat radiation
- Damage involved heat shrinkage and tearing of the netting during Space Shuttle lift-off; possible FOD concern
- Consequence: Marginal

- HPGF netting was placed for the first time during STS-130 launch for 'extra' safety (area was already controlled properly)
- Netting was intended to protect personnel working below from falling debris in the form of spalled concrete from the roof
- Most probable cause of damage is attributed to lift-off plume pressures acting on sail-type netting coupled with radiant heat
- Net damage most likely lasted for 3-5 seconds at lift-off (T+0 seconds) and as the vehicle cleared the tower at T+6 seconds
- Net damage was observed in all six (6) cells of the High Pressure Gas Storage Facility

**TUBE TANK WITH TORN,
DEFORMED NETTING**

- Corrective action: netting for STS-131 and subsequent launches will not be installed
 - Post-launch inspection and repairs have mitigated the problem; no large concrete pieces observed per EG&G

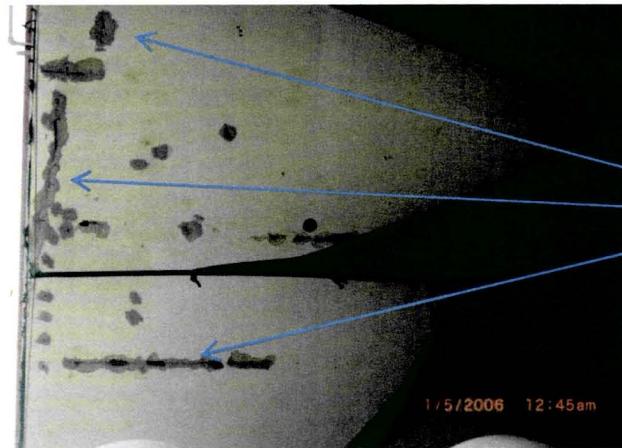
- Risks due to concrete spalling from roof and SRB/SSME exhaust contacting ground support equipment were reviewed
 - Corrosion-induced concrete spalling is limited to 2"x2" only; occurs at random and not during lift-off

**ROOF CONCRETE
SPALLING - TYPICAL**
