Overview of Avionics and Electrical Ground Support Equipment

Sean C. Clarke

49th AIAA Aerospace Sciences Meeting

Orion Pad Abort 1 Flight Test

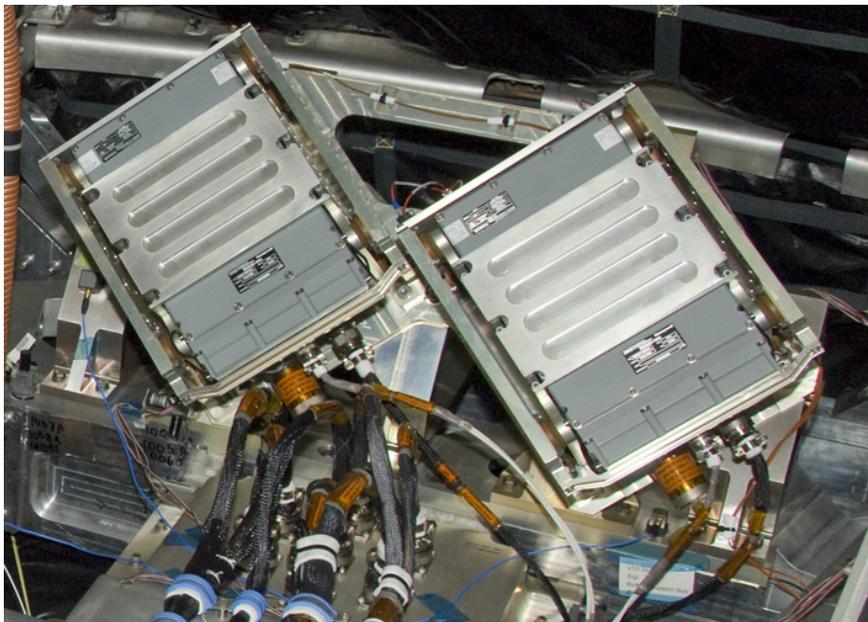
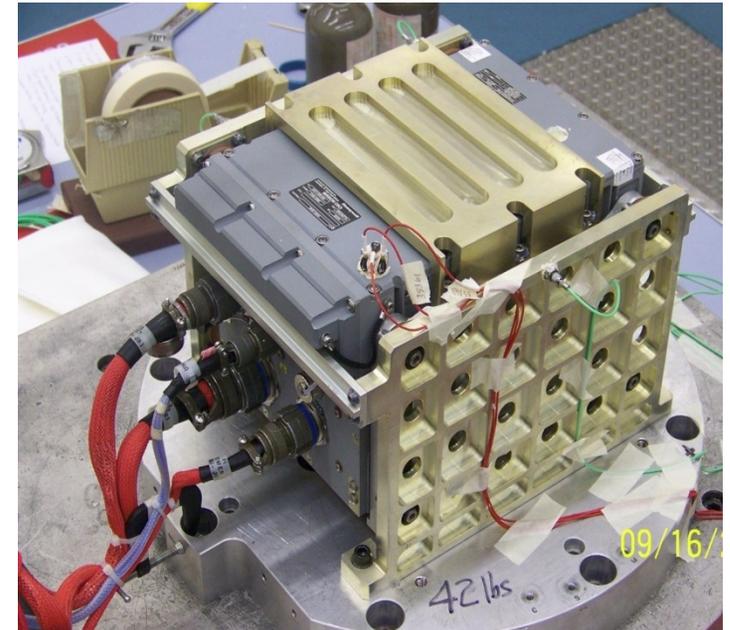
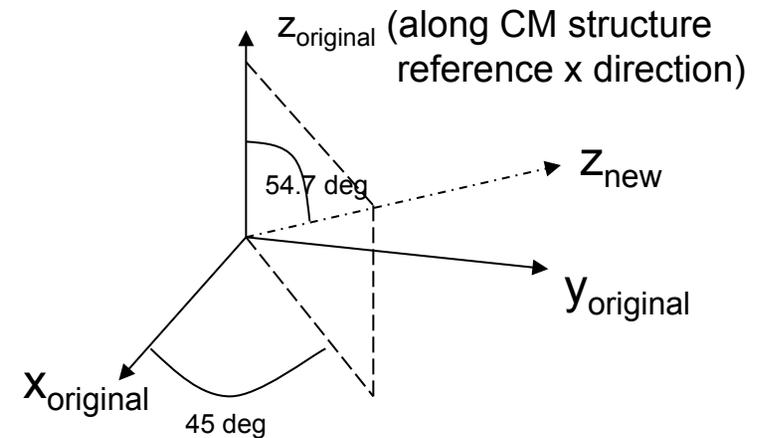
Flight SIGI

- PA-1 large angle of attack knowledge error; attributed to design of PA-1 orientation
 - Environmental testing resulted in vertical velocity and altitude errors which affected angle of attack
 - Tests at high steady g in vertical channel plus random vibration saturated sensors
- Solution: Mount SIGI with diagonal axis vertical. Instead of 19 g on a single vertical channel, 11 g will be sensed by all 3 channel

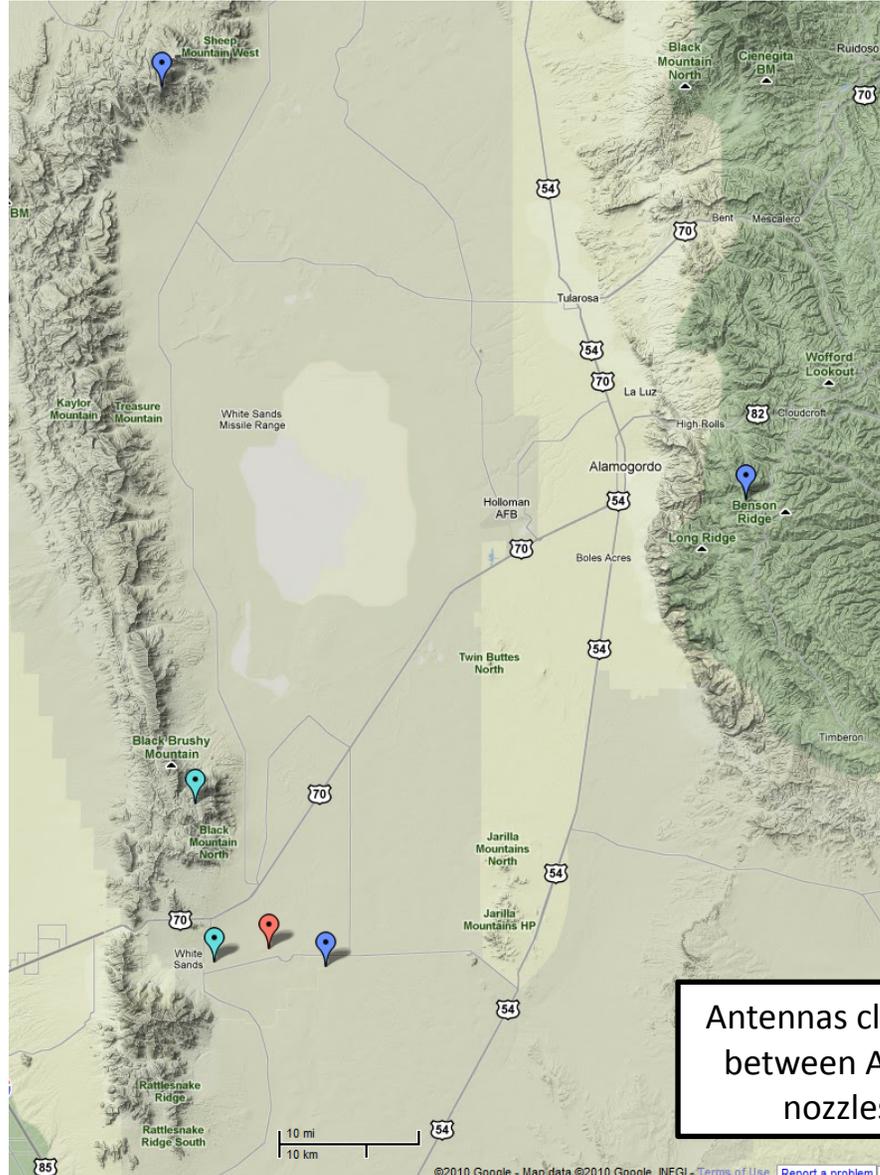
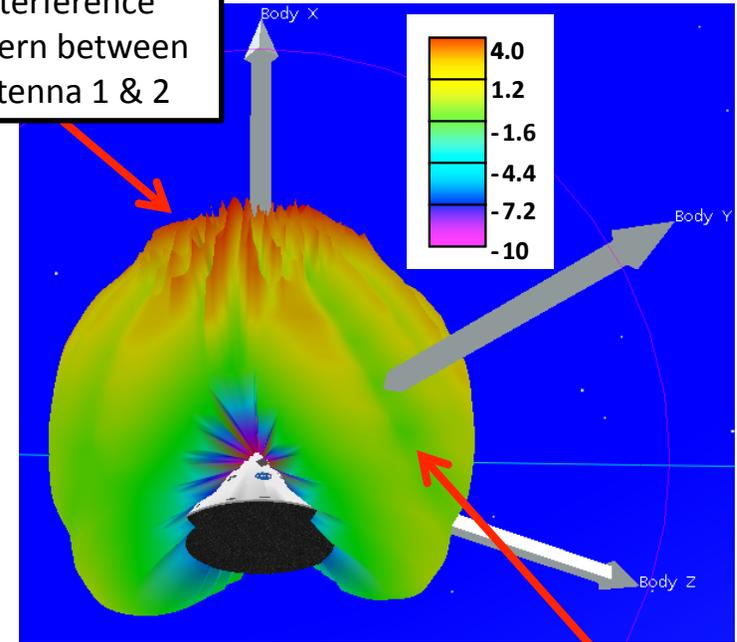
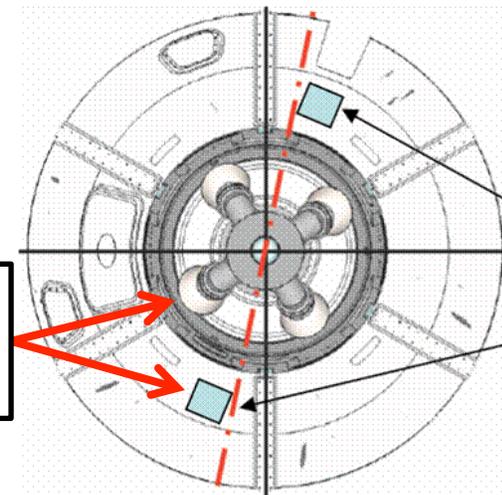
Antenna Analysis

Interference pattern between Antenna 1 & 2

Abort plume assumed to be opaque

Antennas clocked between Abort nozzles

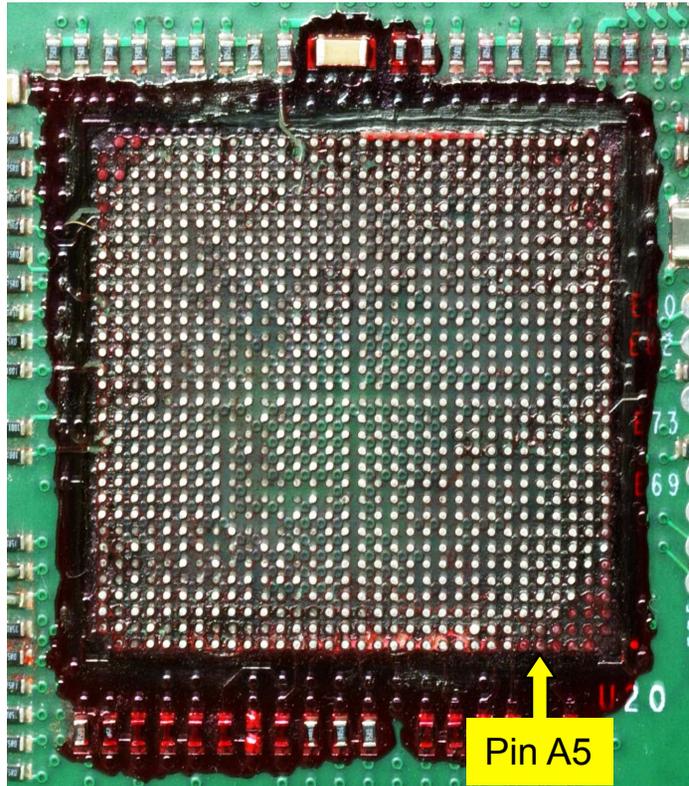
U20 – CCA side

U20 Pin A5
Device side

U20 Pin A5
CCA side

- FT-VMC BGA Black pad Issue (Risk #3941)
 - Black pad evidence on high vibration failed test unit (unmodified rugged chassis) in development testing
 - Black pad phenomenon occurs when the ball grid array on a device soldered to the printed wire board fractures or has debonded (open pads)
 - The root issue is anomalies in the inter-metallic bonds during the manufacturing process. This leads to a weakened joint and potential premature failure at these points
 - Industry phenomenon
 - Second test shows no black pad
 - Part is Altera Stratix 3 FPGA
- Conclusion: accepted risk for PA1

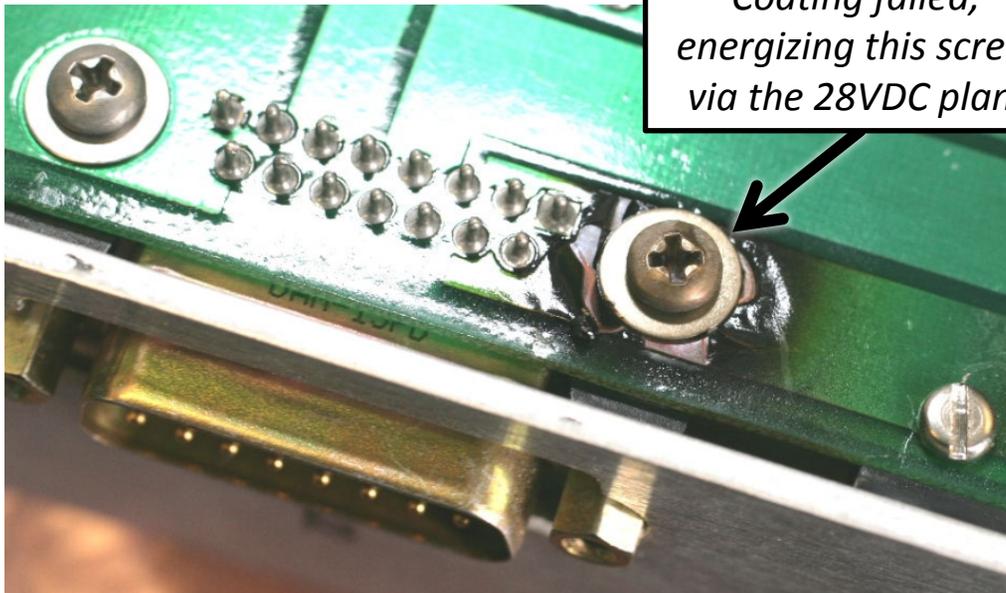
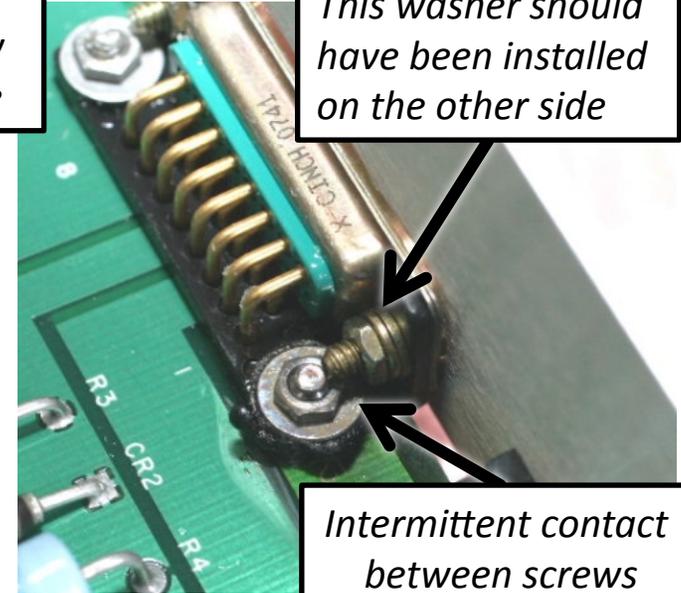
- Vehicle Interface Unit 'Voter Card' shorted intermittently.
 - At T-18d, routine checks found that the CM skin had become energized by the VIV ground reference.
 - Upon investigation, root cause found to be jack screw not installed according to drawing and a failure of the PCB conformal coating.
 - Replaced failed board with spare. Inspected remaining 8 boards for similar failures, replaced all post-flight.

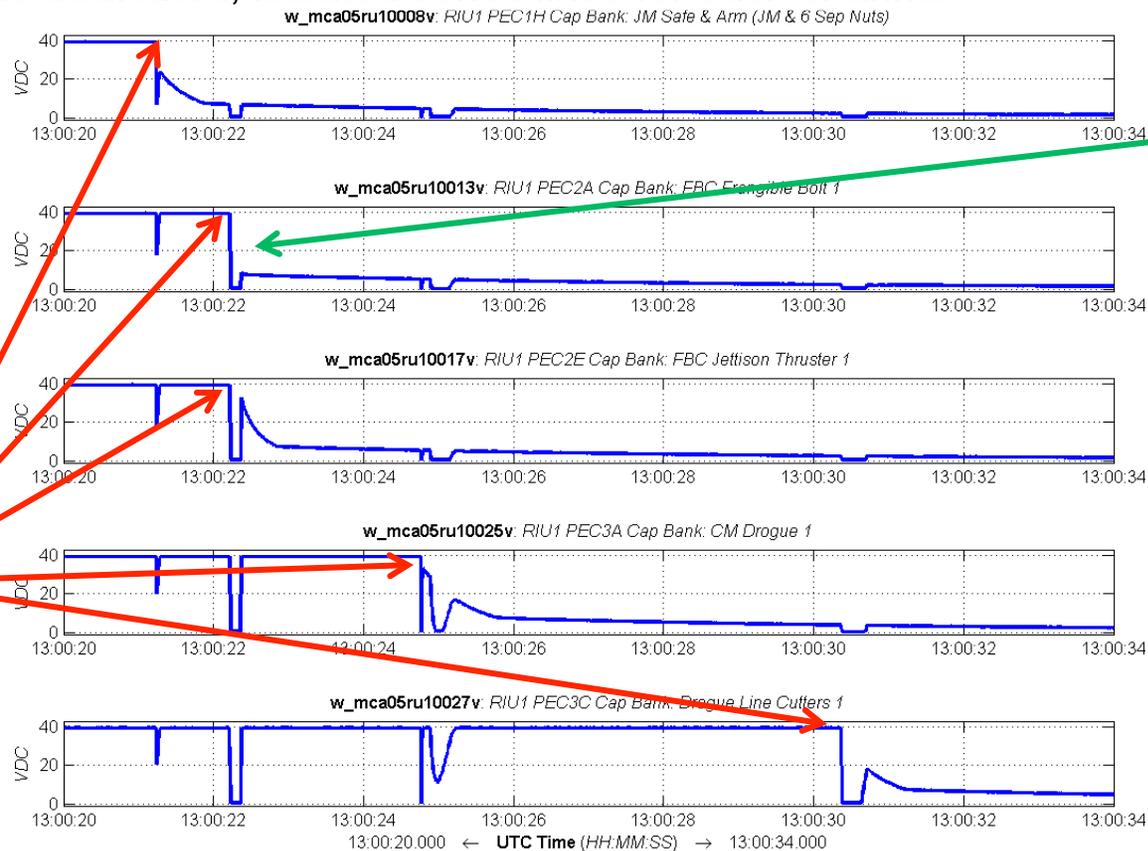
- Due to PEC and MDAU design, erroneous telemetry can be recorded during ordnance firing events. When a channel is fired, PwrSpplly indicates 0V and all channels firing
- Similar signature observed in EDL during validation testing with live NSIs
- This does not affect the performance of the PECs themselves, all ordnance did fire as designed (verified by post-flight continuity test)
- Had there been an anomaly, the lack of telemetry would impede troubleshooting
- Solution: provide dedicated, isolated sense lines for each channel

Actual firing events

Missing Data

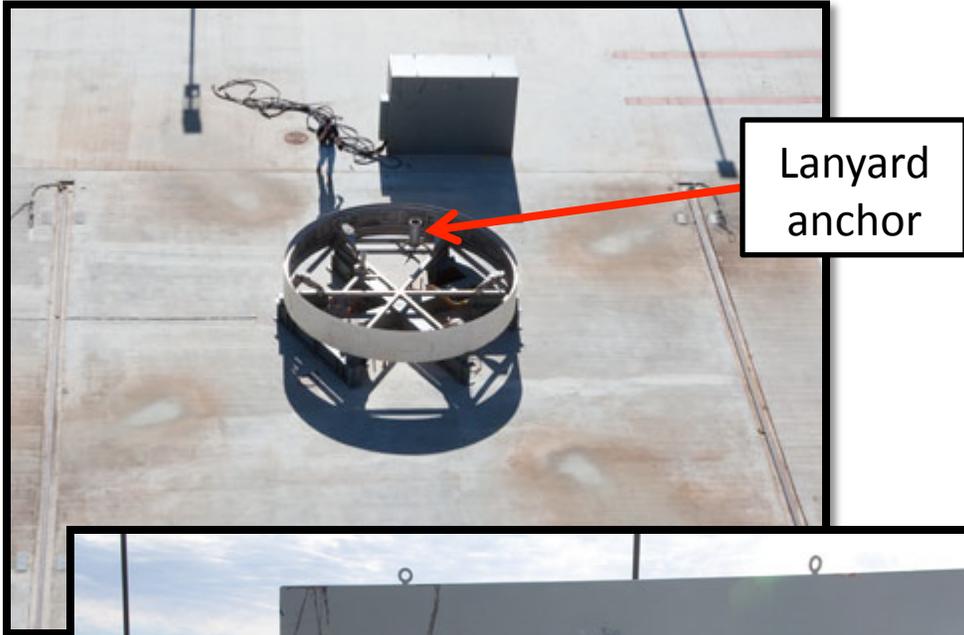
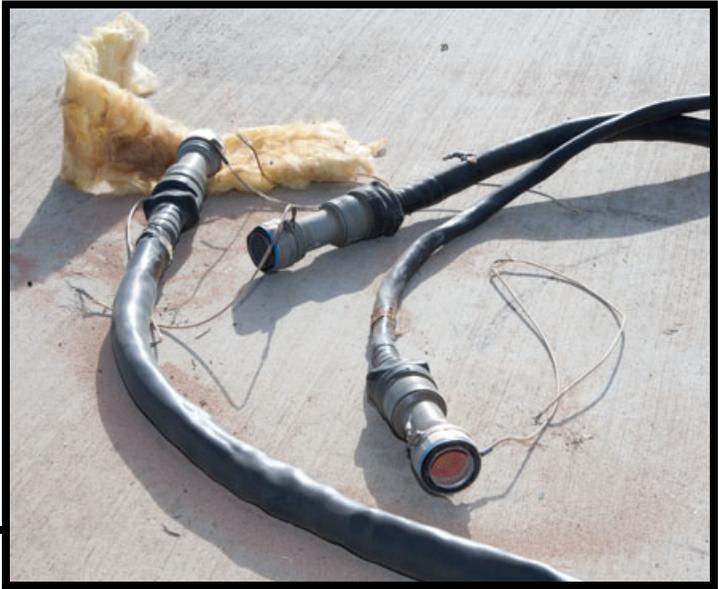
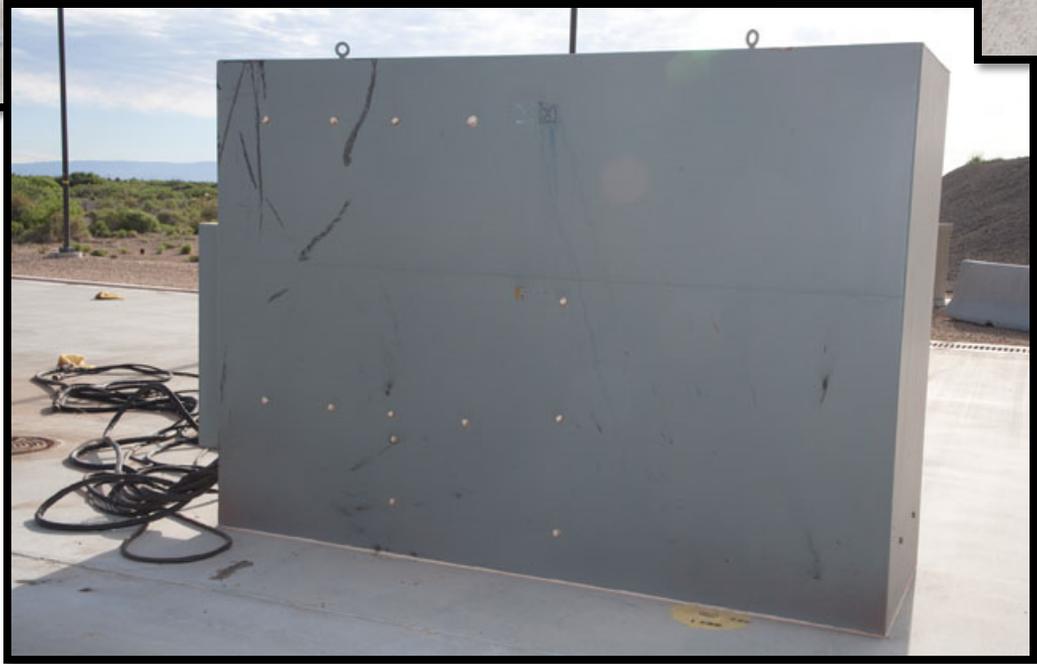
T-0 Cable Failure Post Launch

- Abort motor blast competed with vehicle motion to demate umbilical connectors from the Crew Module.
- Lanyards failed, although may have been after connectors demated.

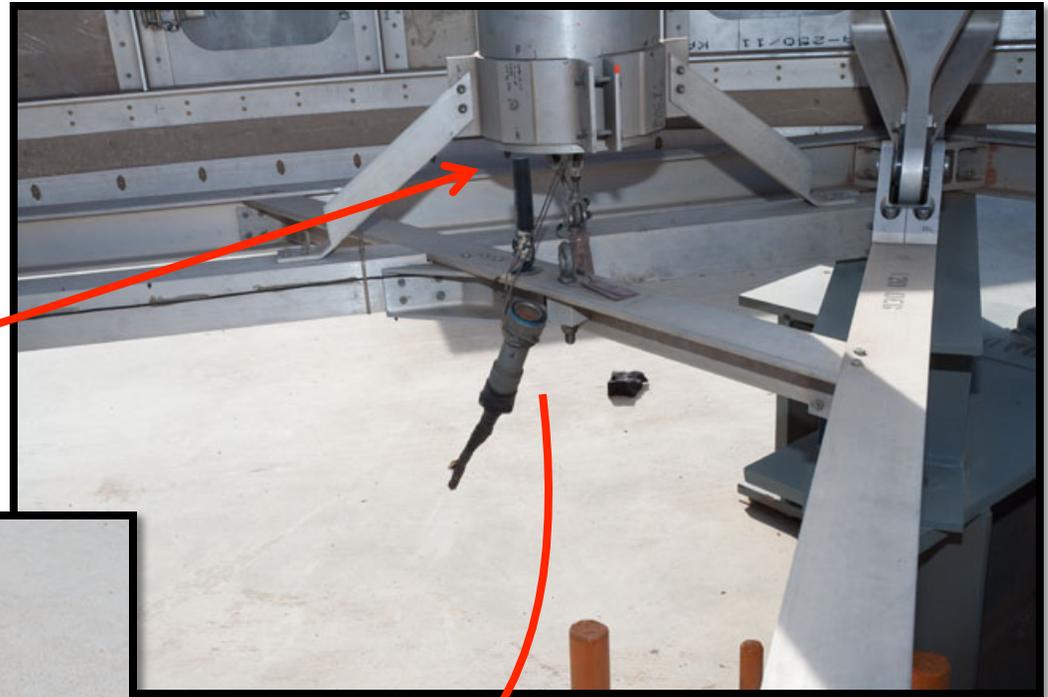
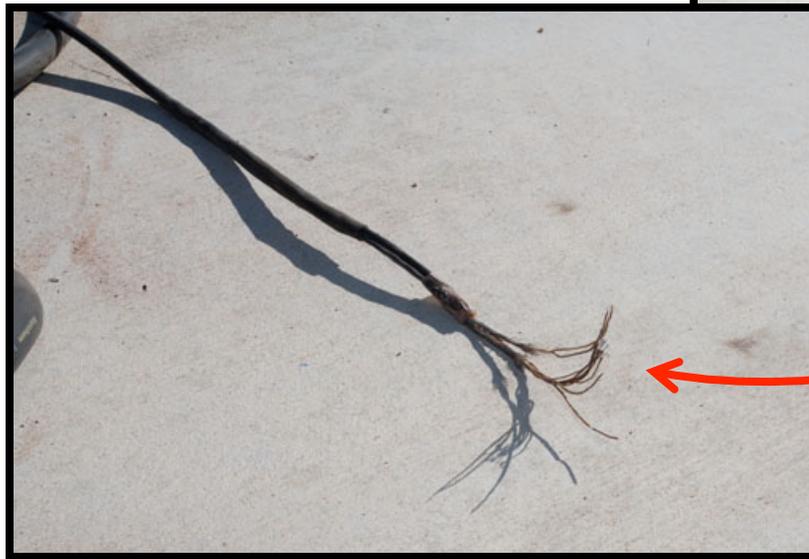
Lanyard anchor

Blast forces depinned the smallest connector
