Metallographic Preparation of Space Shuttle Reaction Control System Thruster Electron Beam Welds for Electron Backscatter Diffraction

A Space Shuttle Reaction Control System (RCS) thruster failed during a firing test at the NASA White Sands Test Facility (WSTF), Las Cruces, New Mexico. The firing test was being conducted to investigate a previous electrical malfunction. A number of cracks were found associated with the fuel closure plate/injector assembly (Fig 1). The firing test failure generated a flight constraint to the launch of STS-133. A team comprised of several NASA centers and other research institutes was assembled to investigate and determine the root cause of the failure. The JSC Materials Evaluation Laboratory was asked to compare and characterize the outboard circumferential electron beam (EB) weld between the fuel closure plate (Titanium 6Al-4V) and the injector (Niobium C-103 alloy) of four different RCS thrusters, including the failed RCS thruster.

Background

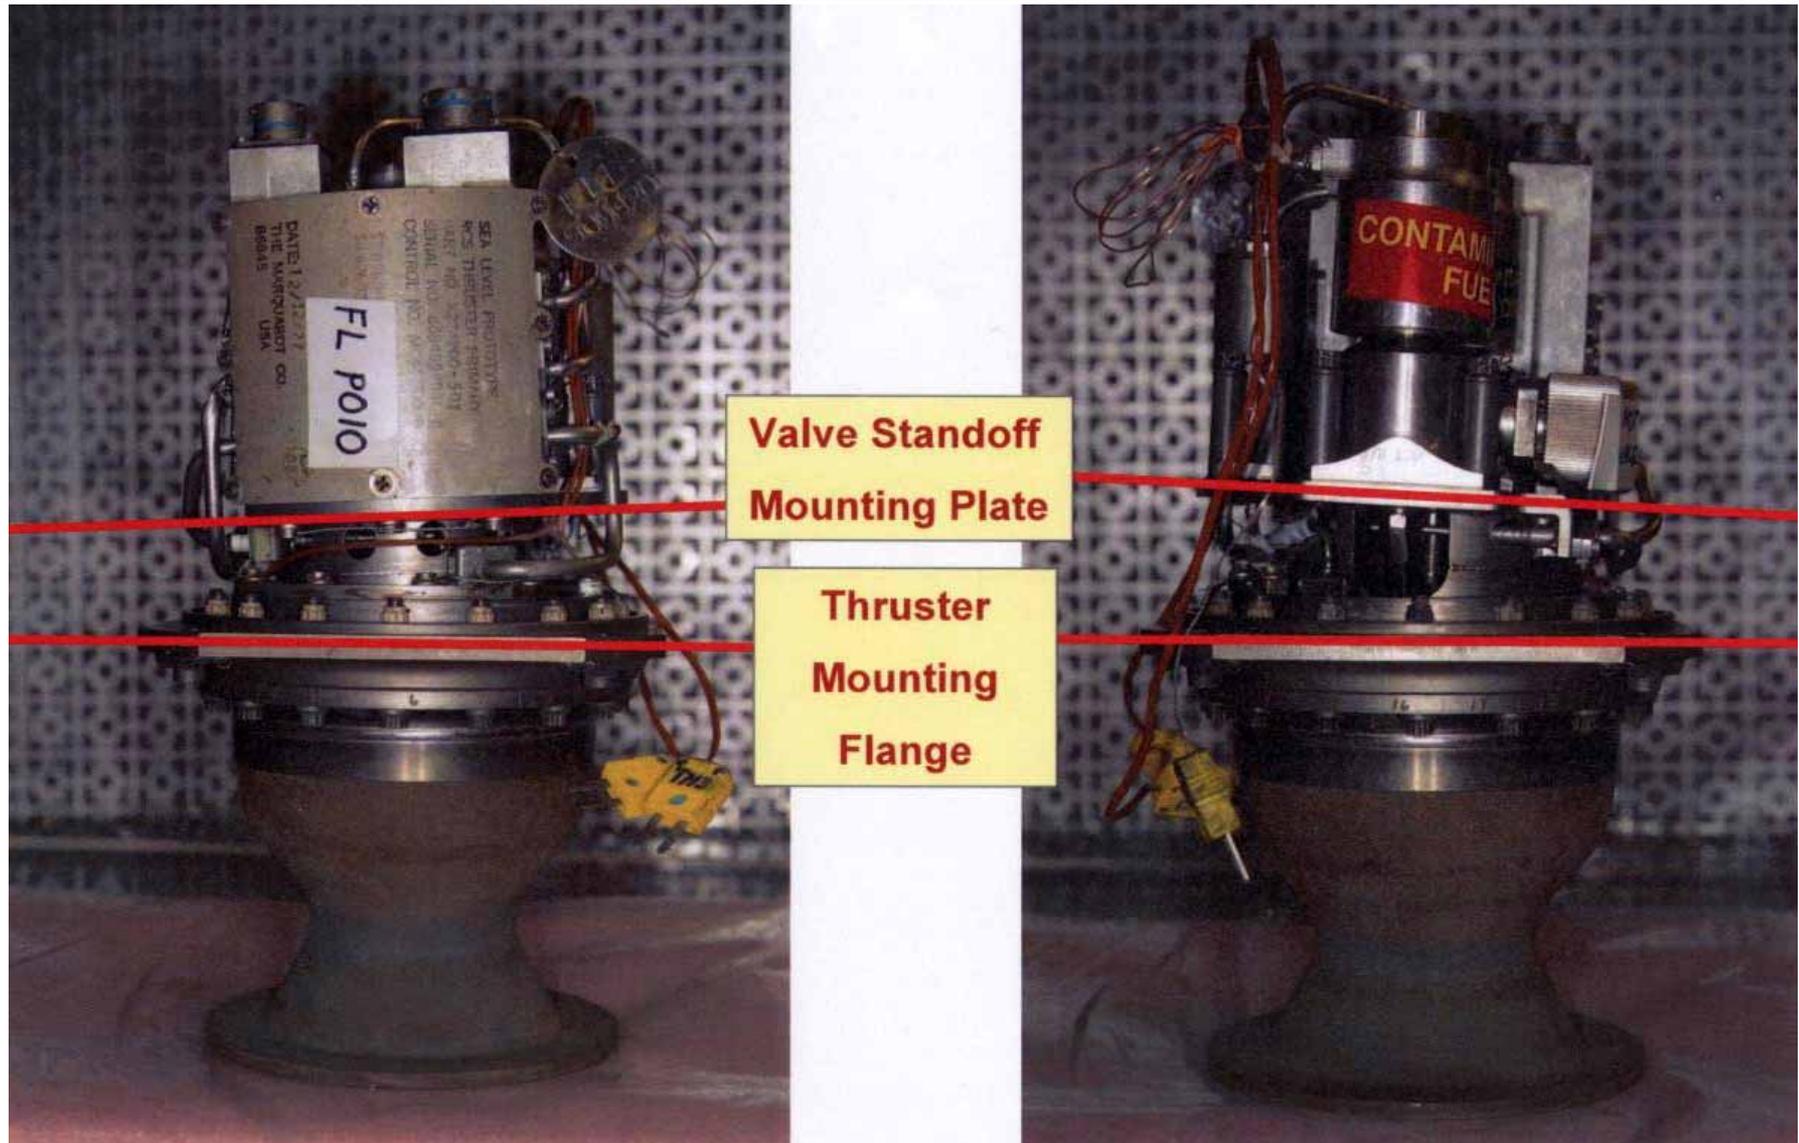
Misalignment of Flange/Plate

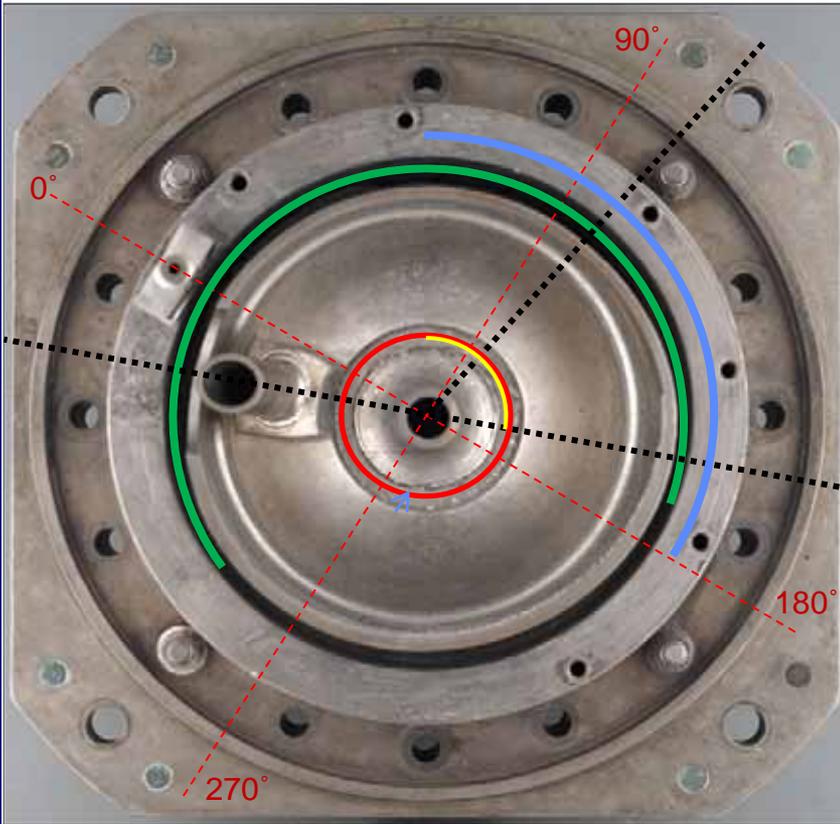
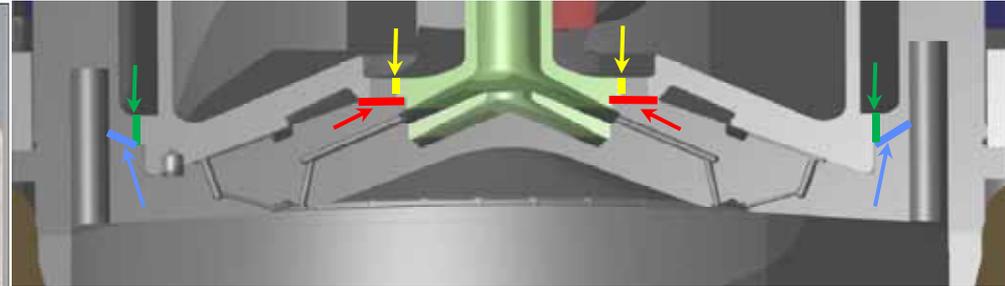
'45 Degree' Acoustic Cavity Cracks
(60 -180° CW)
-

Inboard Fracture between Fuel/OX Passages
(0 - 360°)
-

Ox Tube EB Weld Crack
(45 – 160° CW)
-

Outboard Fuel Closure EB Weld Fracture
(300 - 160° CW)
-

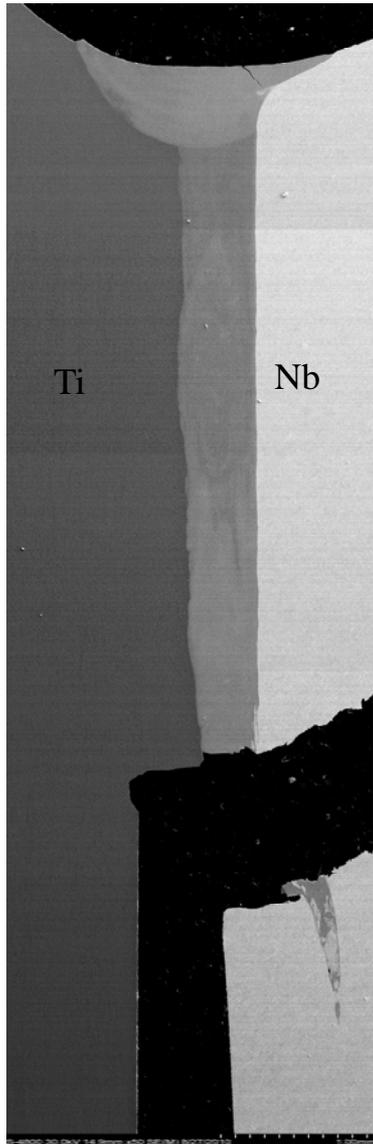
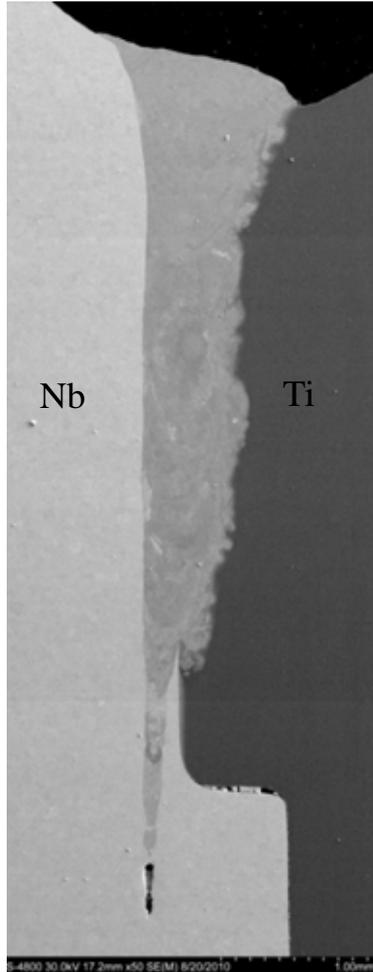
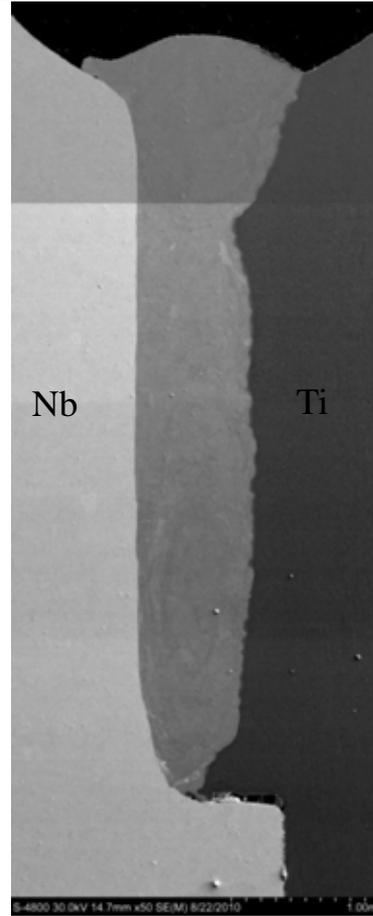
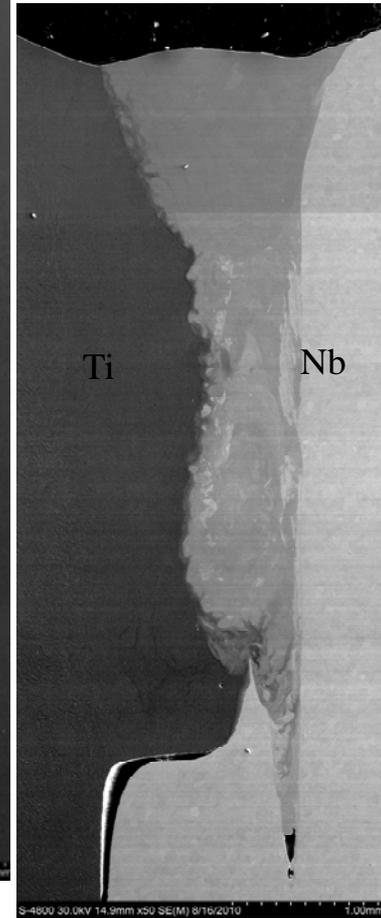
Correlative Scanning Electron Micrographs Outboard Fuel Closure Welds

- **No anomalous material condition associated with weld insufficiency was observed in the material surrounding the “Green Crack”**
 - **No pre-existing flaws were found in the fuel closure plate-to-injector welds of any of the four thrusters evaluated (SN 10, 120, 132, 172)**
 - **Adequate fusion took place during original EB welding process**
 - **Microstructure and microhardness (both of the parent materials and fuel closure plate) are consistent with specifications/expectations**
- **No evidence of fatigue, intergranular cracking (ICG) or other sub-critical mechanisms found**

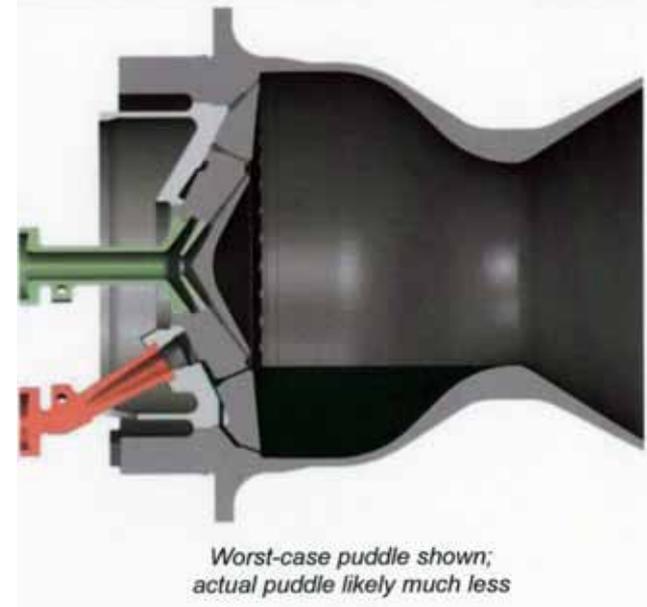
Failure Scenario

- **Liquid Ox Collection**
 - Leaking Ox valve
 - Thruster orientation and gravity field allows puddle formation
 - Sufficient time with leak rate for puddling
- **Liquid OX Flows thru injector and boundary layer cooling holes into fuel injector manifold**
 - Sufficient puddle depth to go through holes
- **Sufficient OX in fuel manifold to produce detonation capable of causing injector damage**
- **Single firing to produce explosion**

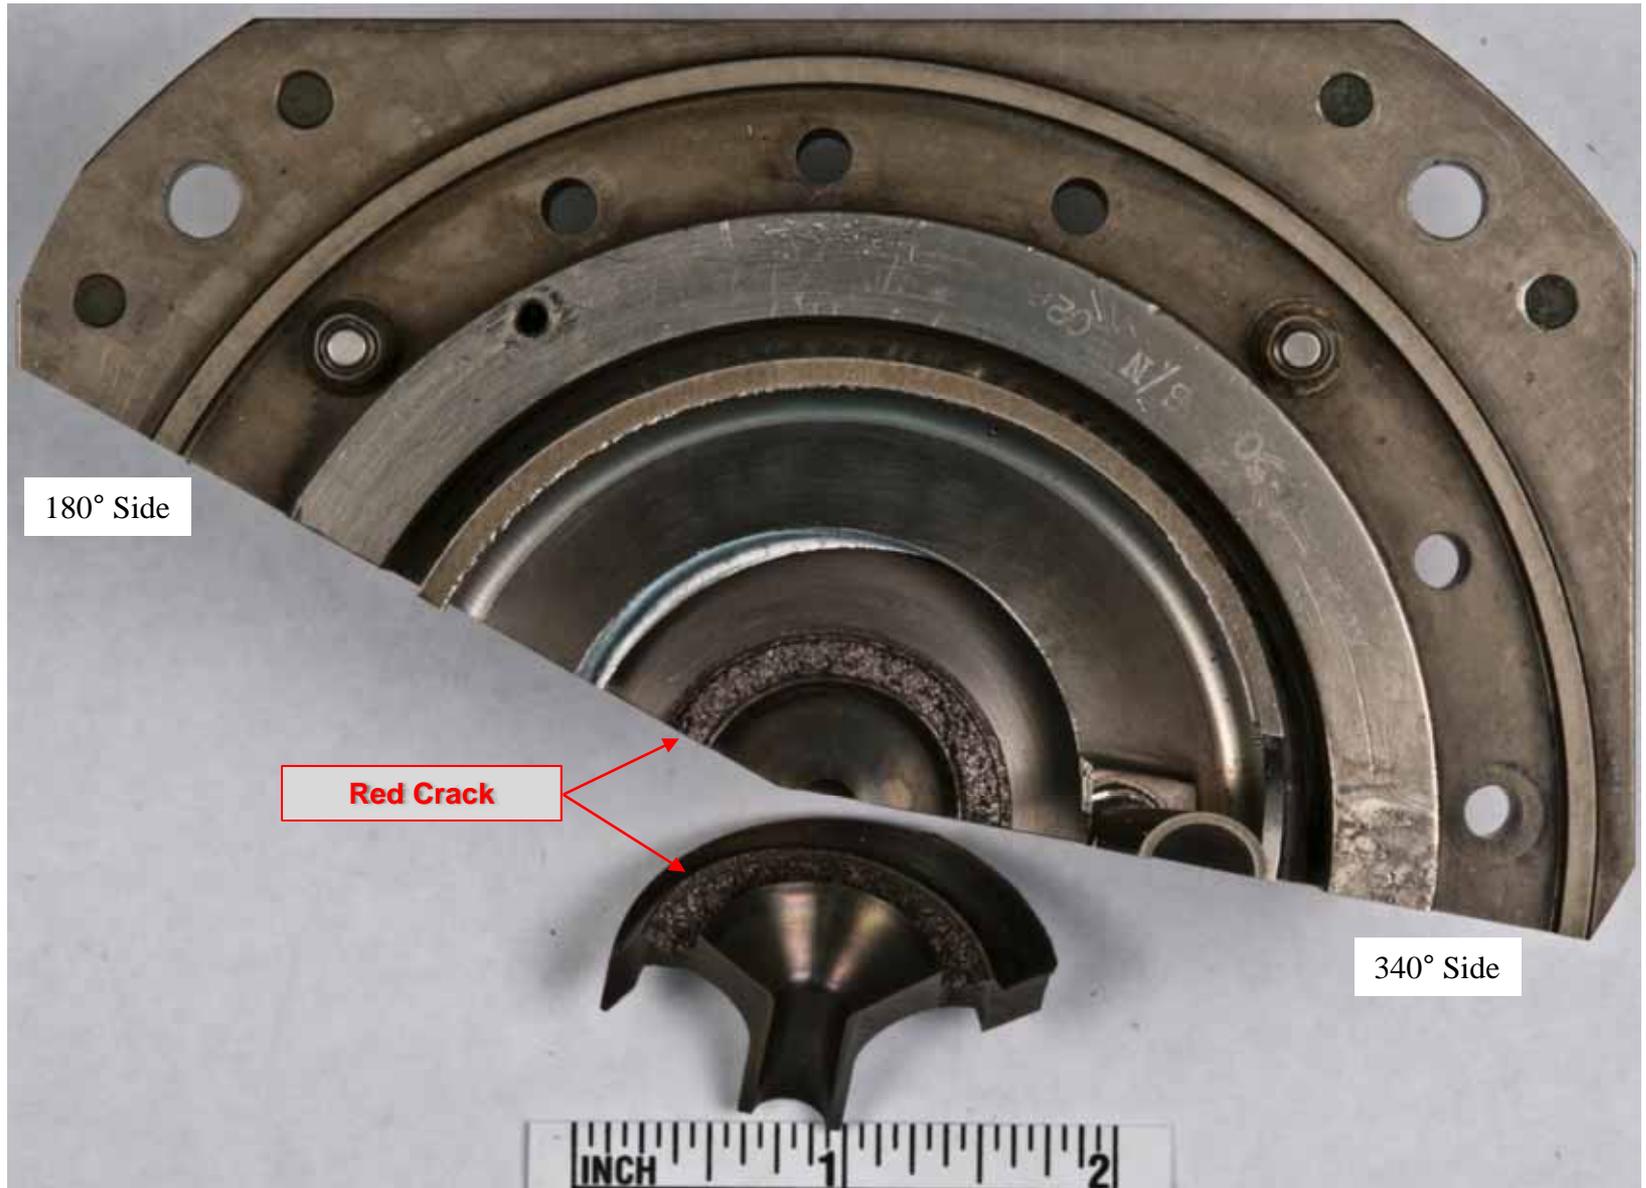
S/N: 10 Red Crack Exposed by End Milling (180° to 340° Side)

- **No thumbnails evident**
 - No conventional fatigue observed
 - No intergranular cracking observed
 - No unexplained discoloration
- **Continuous shear band evident along inboard and outboard welds**
 - Shear dimples evident along bands
 - No significant interruptions in shear bands
- **Fracture surface across niobium**
 - Mostly cleavage-like facets
 - Occasional shear dimples between facets
