# **SHUTTLE PROPULSION SYSTEM MAJOR EVENTS AND THE FINAL 22 FLIGHTS**

James W. Owen, NASA, Marshall Space Flight Center

Numerous lessons have been documented from the Space Shuttle Propulsion elements. Major events include loss of the Solid Rocket Boosters (SRB's) on STS-4 and shutdown of a Space Shuttle Main Engine (SSME) during ascent on STS-51F. On STS-112 only half the pyrotechnics fired during release of the vehicle from the launch pad, a testament for redundancy. STS-91 exhibited freezing of a main combustion chamber pressure measurement and on STS-93 nozzle tube ruptures necessitated a low liquid level oxygen cut off of the main engines. A number of on pad aborts were experienced during the early program resulting in delays. And the two accidents, STS-51L and STS-107, had unique heritage in history from early program decisions and vehicle configuration. Following STS-51L significant resources were invested in developing fundamental physical understanding of solid rocket motor environments and material system behavior. And following STS-107, the risk of ascent debris was better characterized and controlled. Situational awareness during all mission phases improved, and the m

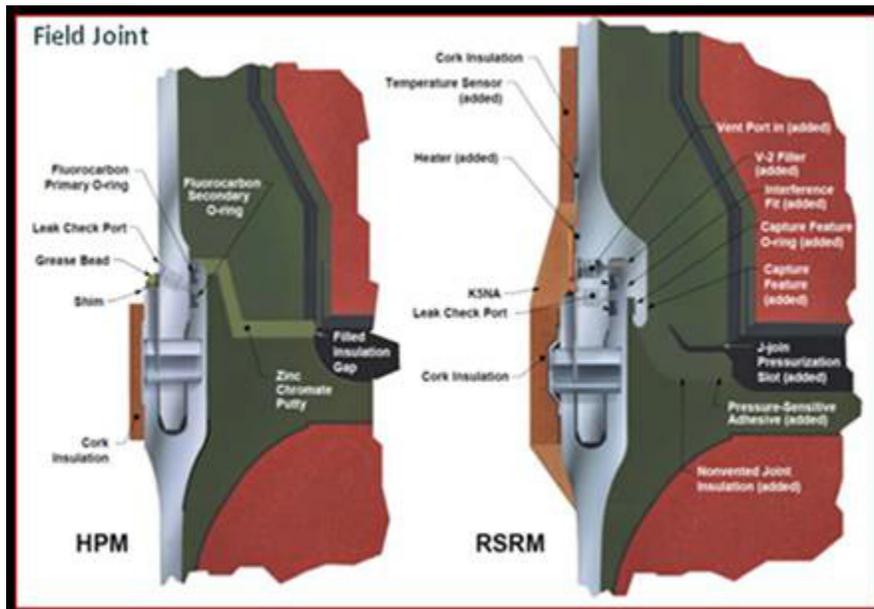
Figure 7. Solid Rocket Motor Field Joint Redesign

STS 51-L Loss of Crew and Vehicle: The failure of the solid rocket motor field joint sealing system during launch of Challenger on January 28, 1986 has been well documented, and investigated by the Rogers Commission. The combination of a design which allowed the joint to open during motor pressurization coupled with extremely cold temperature on the day of launch resulted in hot gas leakage leading to structural failure of the vehicle and loss of the crew. The investigation revealed prior warnings of problems with the field joints, and an increasing acceptance of risk as flights proceeded. Redesign following the accident corrected the design's shortcomings, and produced a design that has multiple layers of protection. These improvements include a capture feature that greatly reduces gap opening, an innovative seal within the segment insulation called a j-leg, joint heaters, and improved assembly procedures. The redesign flew successfully throughout the remainder of the program, with no indications of sealing problems. A number of cultural, managerial, and decision making process improvements were implemented, and the government/industry team performed exceedingly well during the remainder of the program.

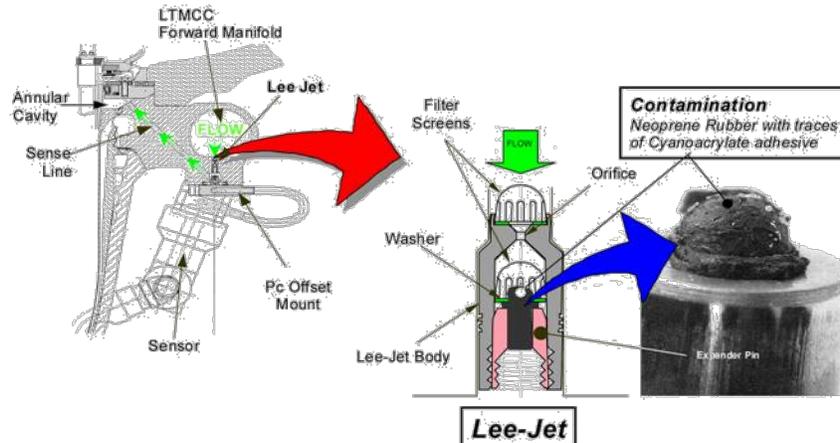
Figure 8. Contaminated Chamber Pressure port

STS-91 SSME Chamber Pressure Channel A Failure: On 06/02/1998, during Discovery's ascent, the Main Combustion Chamber (MCC) Chamber Pressure Channel A sensor ceased to respond on main engine one. During throttle down, channel A exceeded the 200 PSID limit (the sensor did not follow the engine power level). Main Engine one was controlled by Channel B for the remainder of ascent. No engine problems were experienced and Discovery continued to a nominal orbit insertion. The channel A sensor, however, remained qualified for redline monitoring by the controller, since it was with reasonable limits. If the engine had experienced a real problem that drove the engine to a chamber pressure redline, sensor B (the good one) would have called for an over-speed shutdown which would have been ignored by the controller because sensor A (the bad one) remained qualified for redline monitoring. Hence redline protection had been lost. Contamination was found (post flight) to have plugged the chamber pressure port (a material from a leak check performed during engine manufacture). Control of foreign object debris is essential.

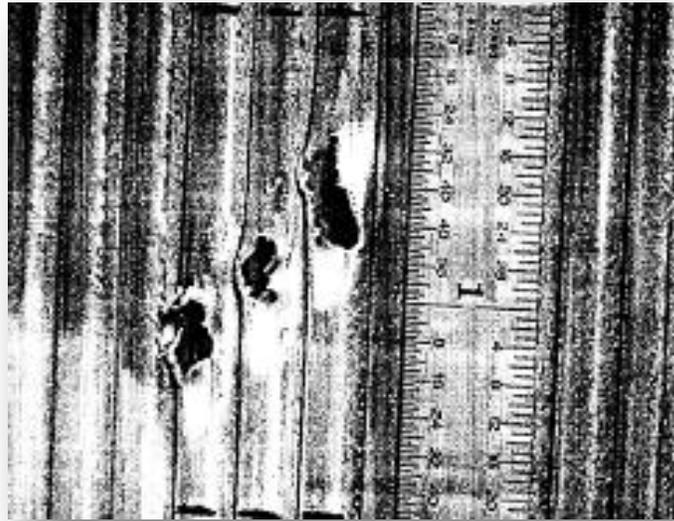
Figure 9. Punctured nozzle coolant tubes from STS-93

STS-93 Orbiter wiring and Space Shuttle Main Engine (SSME) nozzle tubes punctured during ascent flight: Two serious in-flight anomalies occurred during ascent flight on STS-93. One main engine controller primary circuit, and one back-up circuit, on separate engines dropped offline when an Orbiter AC power bus experienced a short circuit 6 seconds after liftoff. The redundant controller circuits (one on each engine) worked throughout ascent, but redundancy had been lost on two engines. This flight observation initiated a system level inspection of all Orbiter wiring. Clearly redundancy management had been key to mission success. Additionally, on STS-93, a nozzle fuel leak on one engine resulted in a premature main engine shut down (low level liquid oxygen cutoff) due to an SSME liquid oxygen pin being ejected from an injector post in the main combustion chamber. The pin penetrated 3 nozzle coolant lines causing a hydrogen leak from the nozzle. The loss of fuel caused the main engine controller to increase power level (an increase in turbine power requires an increase in oxidizer flow) which depleted oxygen prematurely. Acceptable orbit insertion, or orbital velocity, was provided by the Orbiter Maneuvering System, post main engine shutdown. Corrective action called for elimination of pins used in the main

combustion chamber liquid oxygen posts. Redline protection was essential in achieving mission success.

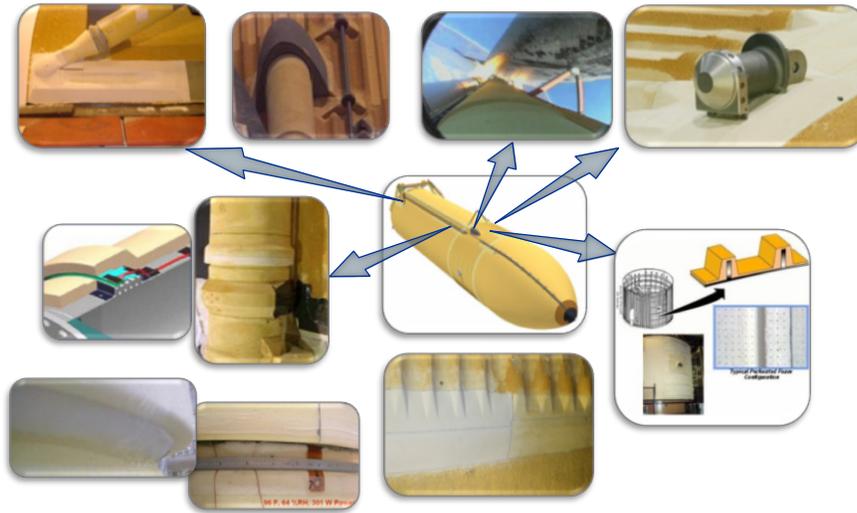
Figure 10. STS-114 External Tank Redesigns resulting in Reduced Ascent Debris Risk

STS 107 Loss of Crew and Vehicle: The loss of crew and vehicle during entry of Columbia on February 1, 2003 was a result of debris damaging the Orbiter wing during ascent. This accident was well documented by the Columbia Accident Investigation Board report. Prior warnings of debris damage had been evident throughout the history of the program, but had usually been treated as a maintenance and refurbishment item. Following STS-107 corrective actions were implemented to remove sources of foam debris where possible, improve process controls, and preclude ice formation in selected components as well. The debris risk mitigation efforts continued as the flight program continued. Generally the effect of debris mitigation efforts during the final 22 flights resulted in a two order of magnitude reduction in possible impact energy. The program also implemented on orbit inspection to assess the Orbiter heat shield prior to entry, and developed a thermal protection system repair capability if needed during orbit.

The resulting redesigns and operational procedures enabled successful management of risk during the remainder of the flight program.

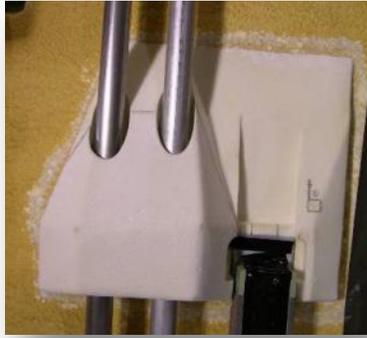
Figure 11. Liquid Hydrogen Tank Ice Frost Ramps

External Tank (ET) Liquid Hydrogen Tank (LH2) Ice Frost Ramps: A unique opportunity arose following STS-114, when an External Tank (ET-120) was returned to the manufacturing facility after undergoing two cryogenic cycles on the launch pad. Detailed inspection of a flight tank following partial operation had never been done before. Dissection data of the thermal protection foam material from ET-120 (post cryogenic cycling) revealed significant foam cracking and delaminations within the liquid hydrogen tank ice frost ramps and protuberance air load ramps (PAL). The PAL ramps were subsequently removed. Subsurface cracking and delaminations in the ice frost ramps, were believed to be linked to stresses induced by thick foam. Reducing foam thickness was thought to be a solution. However, reshaping the ramps revealed conflicting thermal and debris requirements and did not address root cause. Subsurface cracks and delaminations were later found to be caused by cryogenically induced liquid air intruding into "built-in" leak paths and reservoirs. Once the failure mode was fully understood, a redesign was initiated which met thermal and debris requirements. Additionally, identification of the correct failure mode enabled updated risk assessments showing greatly reduced ascent debris risk from these ramps. The lesson to remember is that failure modes and effects must be fully understood and characterized. The ability to get direct inspection of actual hardware after service is invaluable.

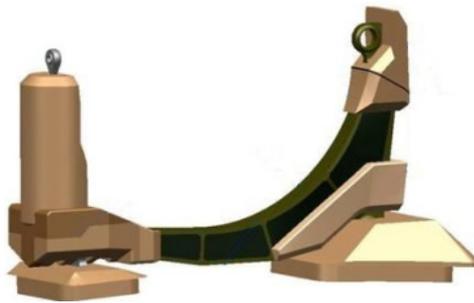
Figure 12. Liquid Oxygen Feedline Titanium Bracket

Redesign of the Liquid Oxygen Feed-line Bracket: A significant change implemented during the final 22 flights was the redesign of the feedline support brackets (from aluminum to titanium) greatly reducing the risk from ice debris, and eliminating a failure mode discovered at the bracket to feedline interface. The material change greatly simplified the foam closeout on the bracket, and dramatically reduced ice formation on the bracket. The initial redesign included a gap at the bracket to feed-line interface, susceptible to ice formation. Ice growth at these interfaces could bridge the gaps between the bracket and feedline, and subsequent articulation of the joints could cause the foam to crack. This could have resulted in ice and foam debris. Flight video data from STS-118 revealed the potential debris risk (from an aluminum bracket with a similar gap), and a slip joint was successfully added to the redesign, eliminating the gap (and ice). This design was extremely successful, flying on twelve of the final twenty-two flights.

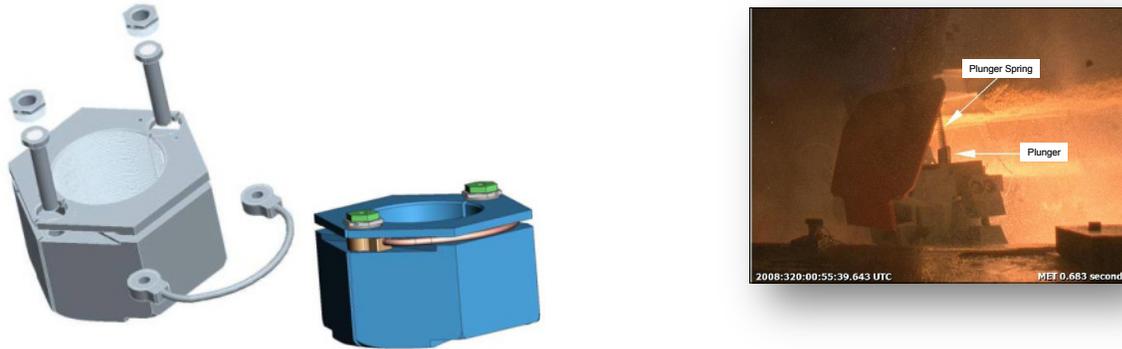
Figure 13. Pyrotechnic cross over and plunger/spring released during lift-off

Solid Rocket Booster (SRB) Pyrotechnic Cross-over Redesign and Debris Containment Plunger Failure: During launch of STS 126 video showed the SRB hold-down post (HDP) plunger spring, and plunger, extending during liftoff from the debris containment system. Concurrent with this launch a design change had been implemented to reduce the occurrence of a condition called “stud hang-up” a recurring

anomaly during the program. A pyrotechnic crossover feature had been added to the SRB frangible nut, part of the system which released the Shuttle from the pad. The change enabled nearly simultaneous firing of two pyrotechnic charges in the nut. The crossover successfully mitigated the potential for stud hang up, but an unintended consequence was discovered. The decreased pyrotechnic skew time (the time between the two charges firing) increased the velocity of the debris containment system plunger, and increased the chance of a plunger being released. A design modification (called retention blocks) was successfully implemented within the debris containment system housing to address this issue for STS-119 and subsequent missions. All changes must be evaluated for potential unintended consequences.

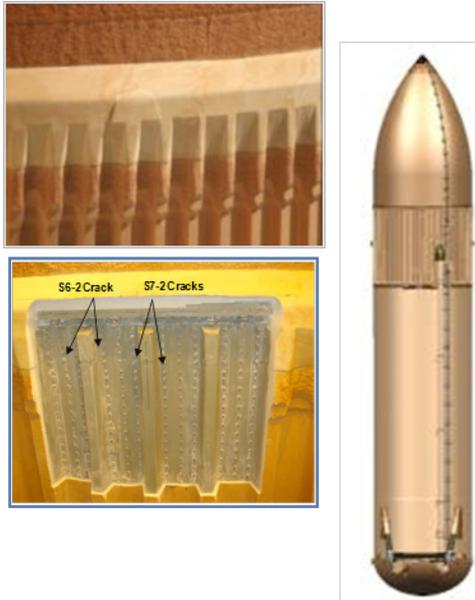
Figure 14. External Tank stringer cracks

STS-133 External Tank Cracked Stringer: During preparations for launch of STS-133 stringer cracks were observed on the External Tank intertank liquid oxygen flange during propellant loading. Subsequent cracks were identified by nondestructive evaluation following roll back to vehicle assembly building. Extensive root cause investigation was performed and identified two primary contributors, first a material with low fracture toughness (isolated to two lots of material) had been used during assembly, and second loads and resulting residual stresses had been imparted during assembly of stringers due to tolerance stack up. A corrective action was successfully implemented by reinforcing the stringer feet near the end of the stringer. The lessons include the need for adequate sub-tier vendor controls, and material acceptance inspections must assure proper configuration. Also, design and assembly tolerances must accommodate the potential for residual stresses.

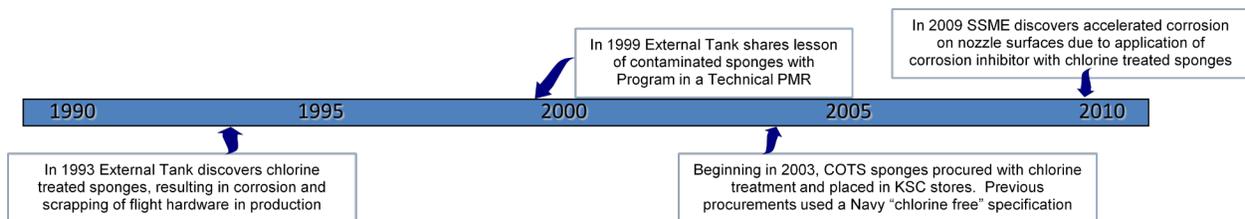
Figure 15. Timeline describing unrelated corrosion events.

STS-127 and STS-128 Nozzle Hotwall Leakage: A post-flight hotwall leakage increase on two nozzles was noted. Inspections showed presence of high levels of chloride ions which is well known corrosion accelerant. Investigation also found that the sponges used to apply corrosion inhibitor contained high levels of chloride ions. Use of these sponges was discontinued. The affected nozzles were repaired, cleaned and dry purges were implemented to protect against any future occurrence. Further investigation showed that a change in the procurement specification had allowed the sponges to become available in inventory. Interestingly, a similar condition had been identified years earlier during external tank manufacturing. A timeline is shown in Figure 15 below. Lessons are that adequate specifications are necessary for everything that touches the flight hardware and that process controls must be assured for multi-decade, multi-element programs. Implementation of effective problem reporting and corrective actions systems across a multi-element program, with multiple prime contractors and independent reporting systems, is quite a challenge.

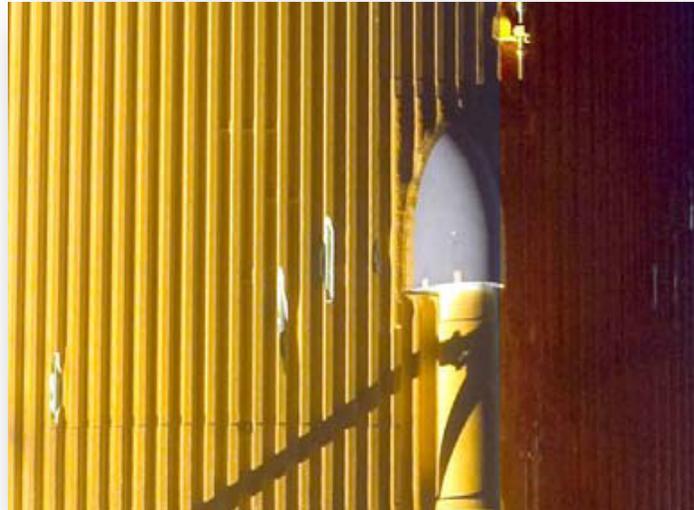
Figure 16. Example of inter tank foam losses due to poor bond adhesion

External Tank (ET) Inter Tank Foam Loss: Unexpected foam losses occurred from the ET Intertank during ascent of STS-127. Imagery indicated visible areas of shiny primer from loss sites, indicating adhesion failures. Although the root cause could not be determined, most probable cause was inadequate cleaning of the surface prior to foam application. This was the first intertank to be processed following the plant shutdown after STS-107 and also following hurricane Katrina and damage to the plant. Since all remaining intertanks had already been sprayed at the time of STS-127, corrective action

consisted of performing bond adhesion testing (sampling) on future intertanks. Since it is not over 100% of the area, the sampling could only provide confidence that the cleaning anomaly was not widespread or systemic. Unexpected events (i.e. Katrina) can lead to consequences revealed only in flight performance. Ensure that adequate controls/verifications are in place for critical processes. If you are unable to implement corrective action, anticipate recurrence in the future.
