SOLID ROCKET BOOSTER (SRB) FLIGHT SYSTEM INTEGRATION AT ITS BEST

T. David Wood
NASA MSFC Space Flight Center, Huntsville, AL

Howard S. Kanner, Donna M. Freeland and Derek T. Olson
United Space Alliance, LLC, Titusville, FL

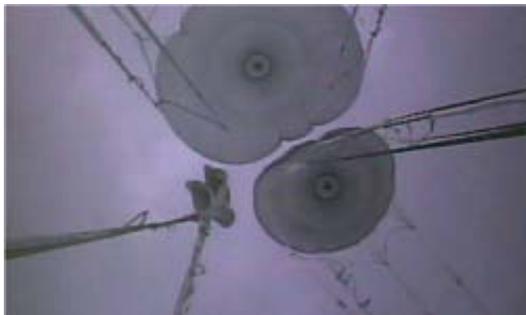
cameras, in addition to the ground-based imagery, ET Feedline Camera and Orbiter imagery, were tools that provided the Mission Management Team (MMT) valuable data to assist in evaluating the on-orbit condition of the Orbiter. In addition, the cameras provided details of in-flight anomalies, such as parachute failures (Figure 4) and material liberation that could strike the Orbiter (Figure 5).

Figure 4. STS-122 Parachute Failure Observed With Parachute Forward Skirt Dome Camera.

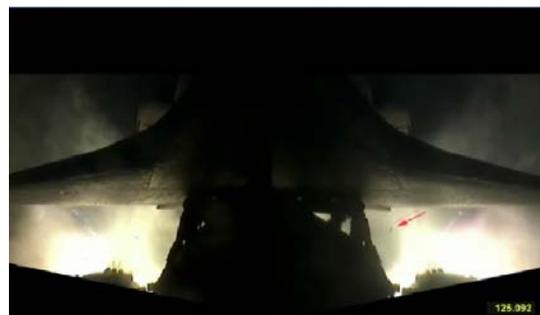
Figure 5. STS-116 In-Flight Anomaly of TPS Striking the Orbiter during SRB Separation.

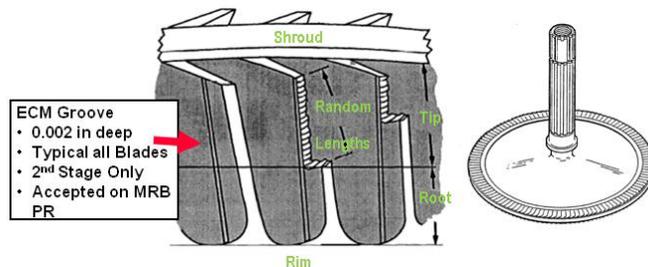
Figure 6. Auxiliary Power Unit S/N 171 Turbine Wheel

During disassembly of the SRB Auxiliary Power Unit (APU) balance assembly that flew on STS 61 (1994), portions of the turbine wheel blade tips were noted to be missing on 62, 2nd-stage blades. (Figure 6) The missing blade tips exited the turbine wheel area through the exhaust housing, fortunately causing no significant damage to any other parts. Due to the low mass of the missing blade tips, the turbine wheel balance was negligibly affected. The turbine wheel blade damage was attributed to a machining feature which accelerated the known crack growth. A review of all manufacturing paper for this unit indicated that a groove had been machined into each second stage blade of the turbine wheel. These grooves were accepted by the Original Equipment Manufacturer (OEM) on a Material Review Board (MRB) disposition in 1985. A material analysis has determined that the turbine blade damage was precipitated by this machining feature. This feature introduced a stress riser which accelerated known crack growth. This anomaly required that all of the OEM's

MRB activity be reviewed by representatives of NASA and the SRB Contractor to gain confidence in supplier dispositions in addition to insuring that no other manufacturing defects existed on flight hardware which could result in turbine wheel blade damage. All turbine wheels NDE (dye penetrant) mapping was reverified in order to restore hardware integrity. If this APU had not been recovered and assessed after flight this anomaly would not have been known and other units with similar defects could have potentially flown.

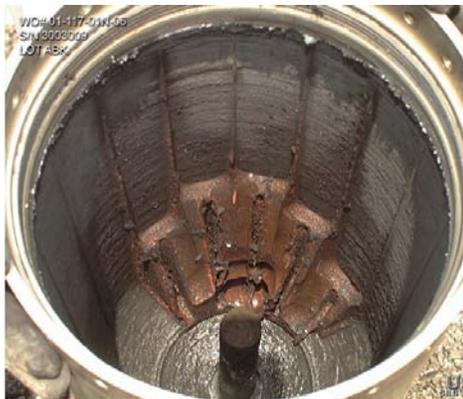
Figure 7. STS-100 Forward booster Separation Motor (BSM) Residual

During postflight disassembly inspection of STS-100 forward Booster Separation Motors (BSMs), one motor exhibited an unusual amount of residual propellant (4-5 of the original 75 pounds) (Figure 7). All other forward (7) BSMs were in nominal postflight condition. As a result of this observation, the postflight assessment process required the calling of a "Squawk" which is a means to document and assess off-nominal observations. The Squawk was subsequently elevated to an Anomaly, and a formal investigation team (Anomaly Resolution Team) was formed to determine the cause and corrective action of the incident. The combined team included members from Design Engineering, Materials & Processes, Quality Engineering and the BSM sub-vendor, among other subject matter experts on the design and handling of the BSMs. Hardware build-paper was reviewed, computer modeling was performed, propellant testing was completed, and other material compatibility testing was performed. A fault tree was created to properly access the observation and determine the root cause. The investigation determined the cause of the unburned propellant was due to the intrusion of 2 cups of water past the seals and into the motor case. Detailed forensic investigation determined that the cover seal was not likely in its "normal" position prior to flight. The moisture intrusion was concluded to have occurred at the launch pad during a heavy rain event 20 days prior to launch (Figure 8). Long-term exposure of the moisture degraded the retained propellant, reducing the propellant burn rate and inhibiting ignition.

The corrective action for this issue was to perform dimensional checks as well as pressurization and vacuum leak checks. The intent of these checks was to verify the integrity of the seals. Additional improvements to the processing of the BSMs included replacing o-ring grease with one that results in less swelling, defining tighter dimensional tolerances on the final configuration, enhancing the controls on chemical use around the seal and to provide access to the BSMs at the launch pad. Without recovery and assessment this condition would not have been known and future water intrusion could have occurred potentially affecting multiple motors.

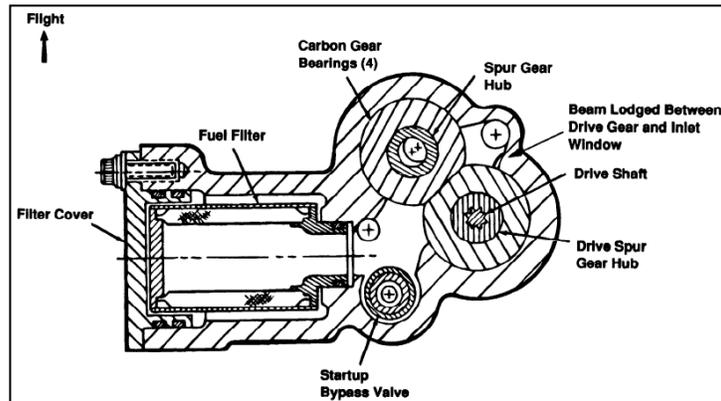
During refurbishment of an SRB APU that flew on STS 57 (1993), a broken fuel pump shaft was discovered in the hydrazine fuel pump. The break occurred about 0.7 inches from the

gearbox end of the shaft. (Figure 9) Following flight during the GN2 spin portion of Thrust Vector Control (TVC) deservicing, technicians at KSC noticed significant alcohol leakage from the overboard drain. The unit was immediately sent to the OEM for disassembly whereupon the sheared shaft was discovered following removal of the fuel pump. The fuel pump shaft failure was attributed to improper installation of a preload beam. The purpose of the preload beam is to bias the bearings to the low pressure side of the pump. Review of flight data indicates the anomaly fortunately occurred after SRB separation therefore not affecting ascent performance. All four APU turbine speed traces tracked together and were nominal. Radiographic inspection of the fuel pump prior to disassembly identified an arc-shaped object lodged between the drive gear and the pumps inlet window (low pressure side). The same x-ray identified a preload beam missing from the driven bearing on the pump load piston side (high pressure side). A metallurgical analysis of the fractured shaft (15-5 ph steel) did not identify any material or chemical anomalies which could lead to a premature failure. The fuel pump was disassembled and a preload beam was confirmed to be lodged between the drive gear and the inlet window which prevented fuel pump rotation. The bearing preload beams and mating slots were dimensionally inspected and found to be within drawing specifications. A preload beam migration test confirmed a pathway the beam could travel to arrive at the gear inlet window. Although the beam must move upwards to arrive at the inlet core, the fluid has enough momentum to lift the preload beam and position it at the inlet window. It was determined that the preload beam could not enter the gear tooth opening when the pump was running therefore it was concluded that the beam must have entered the gear teeth after SRB splash down. The failure is believed to have occurred during fuel system decontamination.

Figure 9. Fuel Pump S/N 152 Off Nominal Configuration

Recurrence control was implemented to prevent a repeat of this failure in the future, including the addition of a caution note and a visual inspection during fuel pump assembly. Radiographic inspection of all units in the field was necessary prior to flight to verify that this critical assembly did not exist, and the preload beam was properly installed.

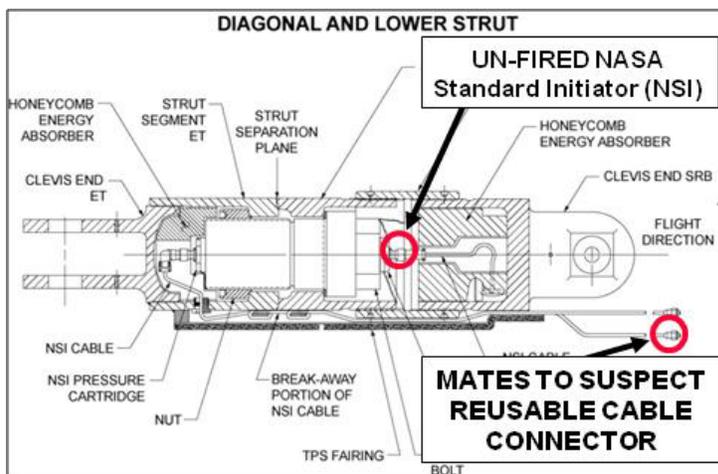
Figure 10. Lower Strut

During postflight disassembly of STS-97 technicians were surprised to find an unexpended pyrotechnic device installed on an aft separation bolt utilized between the SRB and ET. A NASA Standard Initiation (NSI) pressure cartridge located on the SRB side of the left lower strut on STS-97 failed to initiate at SRB separation (Figure 10). The aft separation bolts are designed to accommodate two NSIs for redundancy, but only one NSI functioned properly at the

aforementioned location. Electrical tests determined intermittent continuity, which varied with positioning, on the cable assembly at the NSI connector end. The entire cable assembly was x-rayed where a defect was observed in the braided shield, but no damage of the two inner conductors could be visually ascertained from the x-rays. The subject cable assembly was then transferred for failure analysis. Upon disassembly of the J2 connector, it was evident that the braided shield had been entirely broken, and both of the conductors were also completely fractured at the connector pin crimps. A microscopic examination of the wires composing the braided shield and the wires of both conductors revealed that the cable assembly failed as a result of tensile stress overload.

While the failure was possibly caused by multiple tensile stress applications, there was no evidence to indicate that the failure was not caused by a single event. No manufacturing defects of the cable assembly were found. There was no evidence of electrical arcing inside either of the two pin barrels or on any of the wire strands. There was no evidence of fatigue, corrosion, or any other deleterious condition other than tensile stress overload. Due to this critical failure the vehicle on the pad was rolled back to the Vertical Assembly Building for further interrogation. Several corrective actions were taken including radiographic inspection of all cables, flex tests prior to connection, and limiting use of reusable cables.
