**NO. KSC-2005-018-00002**

**VEHICLE ASSEMBLY BUILDING FIRE**

**MISHAP INVESTIGATION REPORT**

**March 11, 2005**

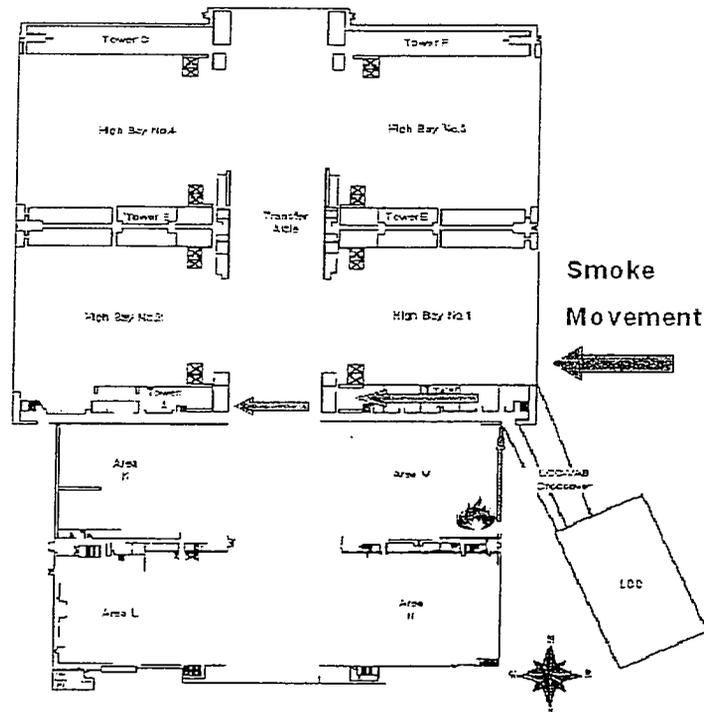
At approximately 1516, fire fighters found a small section of the roof glowing near the parapet wall. Upon further investigation, the fire fighters confirmed that there was a fire beneath the roofing membrane. Fire fighters began to extinguish the fire on the roof while other fire fighters continued to search for an additional fire source in the cable tunnel area.

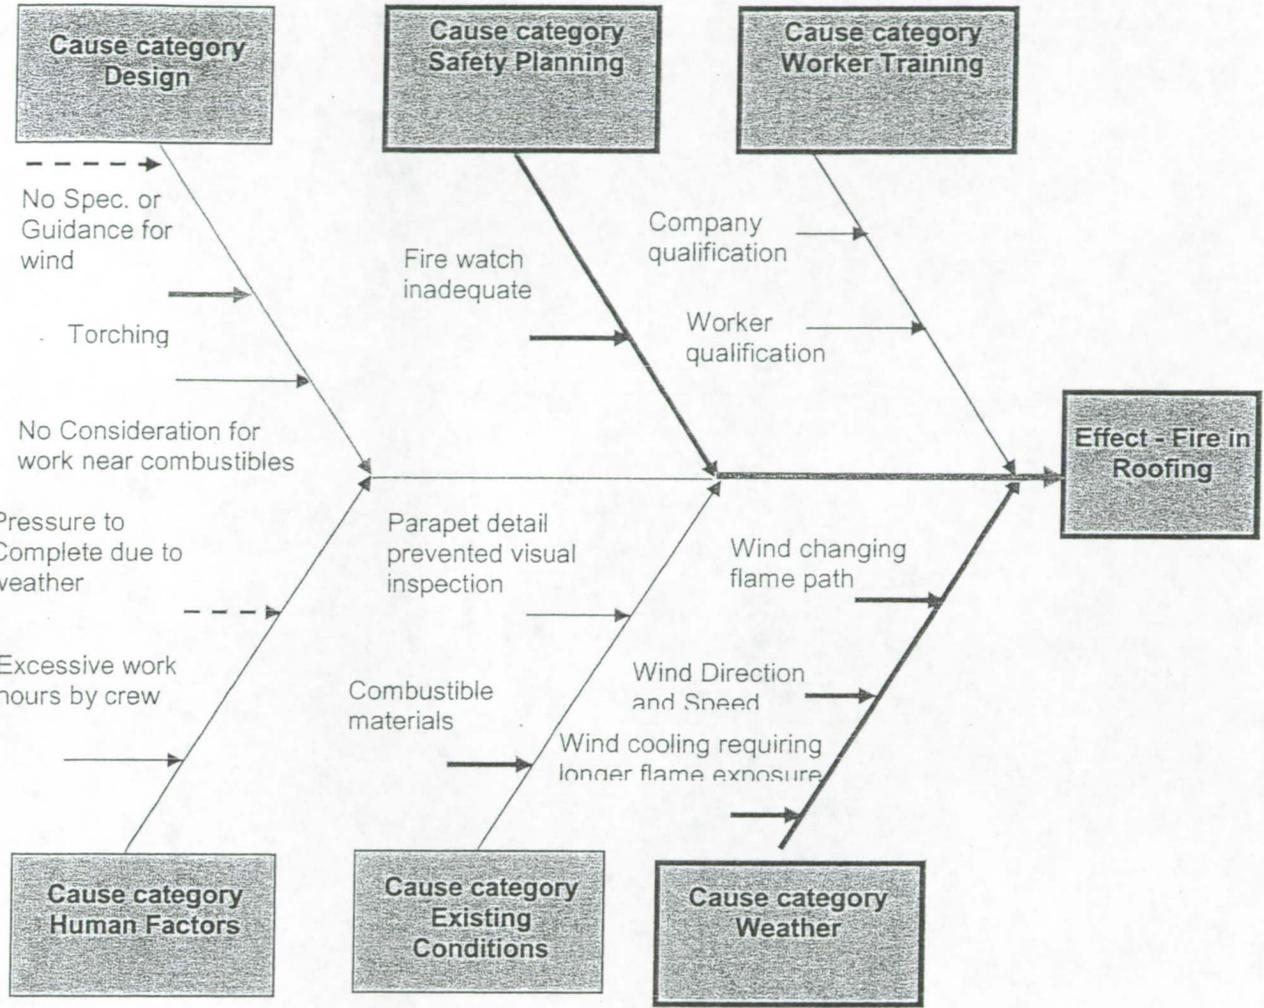
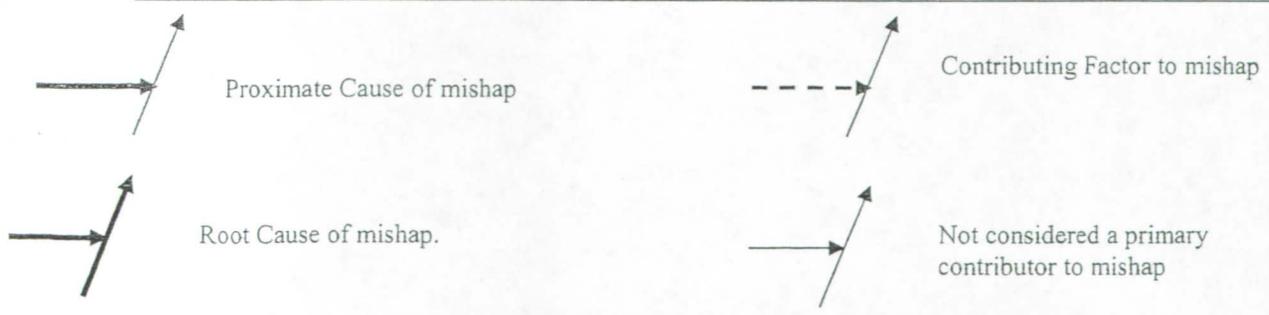
Figure 1: Cause Effect Diagram

In an effort to identify the proximate and root causes of this mishap, a cause – effect fishbone diagram was constructed (see *Figure 1: Cause – Effect Diagram*). This diagram was used to ensure all potential cause categories were considered. The categories identified include:

**The open flame torch, by providing a flame source on the roof to ignite combustibles, was determined to be the proximate cause and if eliminated would have prevented the mishap.**

**The inadequate fire watch technique is considered to be a root cause.**

**The presence of combustibles is considered to be a root cause.**

**Wind speed and direction is considered to be a root cause.**
