# FIFTEEN YEARS OF OPERATION AT NASA'S NATIONAL TRANSONIC FACILITY WITH THE WORLD'S LARGEST ADJUSTABLE SPEED DRIVE

## Abstract

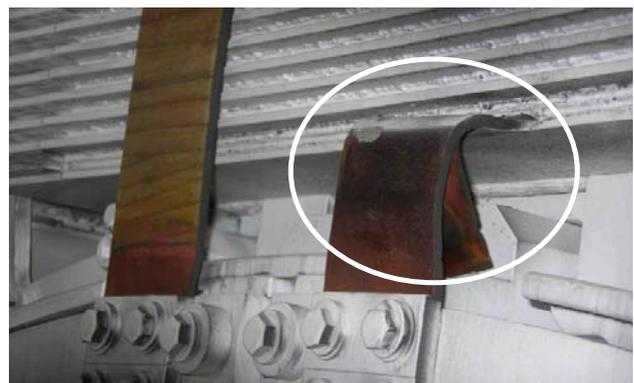
*a. Problem* - In August 2006 the drive system experienced a trip on the rotor ground fault sensing circuit. The back lamination of a short, unwrapped rotor pole connection began to peel away starting at the leading edge of the connection until the delamination contacted the rotor surface. The tear was approximately 2/3 of the width of the connection and along the interface with the bolted connection, as shown in Figure 8. The motor was operating at 600 rpm at the time of the trip. It did not tear off completely since the motor tripped offline as soon as the delaminated section contacted the rotor surface. There was evidence that several other unwrapped pole connections had signs of delamination and tears. The delamination is shown in Figure 8.

*b. Root Cause* – The short laminated copper connection to the pole pieces were not originally taped. These were initially thought to be sufficiently strong without additional wrapping. As the connections flexed at high speed, air was forced in between the laminations causing vibration that led to fatigue concentrated at the fixed ends of the connections.

Figure 8: Rotor pole piece flexible connection delamination.

*c. Solution* – The system provider recommended to cut off the delaminated portion and wrap the damaged portion with glass tape, epoxy coat, and cure. All other connections were glass-tape wrapped, epoxy coated, and cured for 16 hours.

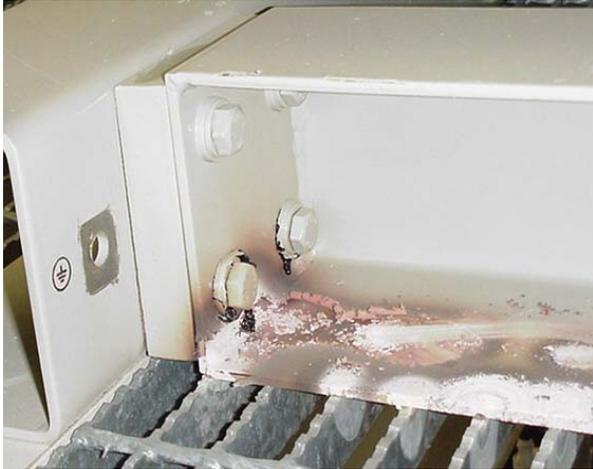
*a. Problem* - During a routine inspection of the LCI equipment in September 2001, maintenance personnel observed burn marks at each of the four DC link reactors. The four large air core reactors are water cooled and mounted above the thyristor power stacks in the LCI enclosure. Figure 9 shows the insulated corner of the reactor base frame heated from eddy current flow through the floor grating.

Figure 9: Eddy current damage on reactor frame.

*b. Root Cause* - Detailed examination of the burn areas and steel connections confirmed that an eddy current flow path had been established through the base frame of the reactor and the steel grid decking to which it was bolted. In this closed loop, the magnetic flux, caused by the ripple current superimposed to the direct current inside the winding, induced a voltage that caused high current flow. While no alarms had occurred and the drive system was fully functional, the anomaly was corrected as soon as practical.

*c. Solution* - The system provider and link reactor manufacturer were notified of the problem. The solution was to add fiberglass insulators beneath the reactor frames elevating the units off the steel grid approximately one inch, breaking the eddy current circuit path. This raised the relative height of the cooling water connections. To accommodate this new complication, the cooling water system was drained and flanged pipe spacers to match the new height to the existing cooling water piping were installed. Once the modifications were completed, there were no further issues with eddy current damage.

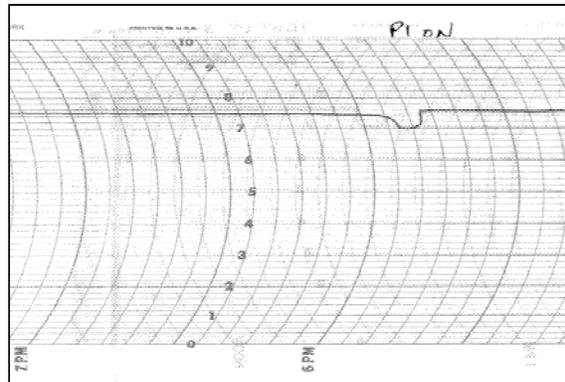
*a. Problem* - As the drive system was beginning regular operations in early 1998, an intermittent condition arose where seemingly random low voltage alarm and trips would occur on the LCI. The anomaly started by triggering the low voltage alarm on the 480 vac motor control center, MCC3, voltage monitoring relay. Since the LCI control power was fed from MCC3, subsequently an alarm and trip of the LCI on "Low Voltage Undervoltage" would occur. The event would only happen with the tunnel in cryogenic mode (using liquid nitrogen) and the drive system on line. From the facility data-logger, further correlation was made between energizing one particular liquid nitrogen pump and the trip event.

*b. Root Cause* – The liquid nitrogen pump in question, "P1", was driven by a 100 Hp induction motor which starts across the line with no inrush current limiting features. The pump and MCC3 were fed from the same upstream transformer. A recording was made of the MCC3 bus voltage during a P1 pump start as shown in Figure 10. The voltage dropped 8% for 5 seconds, sufficiently low enough and long enough to trigger a low voltage trip on the LCI. This test was made independently of any other loads on the bus, so the actual dip was probably lower.

Figure 10: 480 vac voltage dip at MCC3 when starting P1.

*c. Solution* – The parameters in the LCI control were changed to increase the allowable voltage dip and time duration. No further incidents occurred with undervoltage conditions on the LCI. A higher tap setting was connected on the secondary side of the step down control voltage transformer internal to the LCI minimizing the sensitivity to undervoltage conditions.

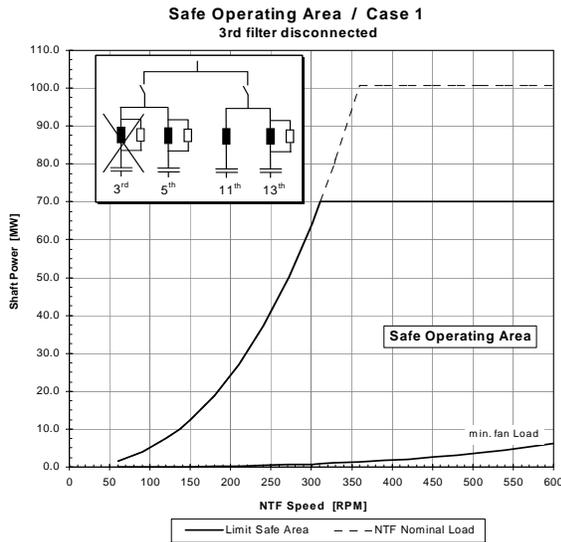
*a. Problem* - In early 1998 the drive system experienced two separate failures in the harmonic filter. The first failure involved a melt-down of the phase C reactor on the 3<sup>rd</sup> harmonic filter. There were no spares on hand. Because the facility was involved in a critical research test, the system provider was contacted regarding operational limits without the third harmonic filter so that testing could continue. This resulted in a set of operational curves defining all filter bank combinations and corresponding maximum load conditions. The load cases were constrained by overload of the remaining connected filter components, overload of the power provider's

upstream capacitor bank, and limitation of the voltage distortion at PCC to 3% [7]. Figure 11 shows the reduction in power for the case without the third harmonic filter. The drive was reconfigured to operate without the filter, and fortunately, the test conditions were within the operating envelope allowed by the system provider. Once the replacement reactor was fabricated and installed, system operation returned to normal.

Figure 11: Reduced load envelope without the 3<sup>rd</sup> harmonic filter energized.

*c. Solution* - The vendor changed the epoxy materials, installed different pumping and mixing equipment, and improved gapping in the center core to allow free flow of epoxy fully surrounding the steel shunts. The vendor also agreed to provide a complete set of six new reactors and in August 1998, the system provider completed the installation under warranty. The change out actually proved to be very challenging, because the overhead bus duct and damping

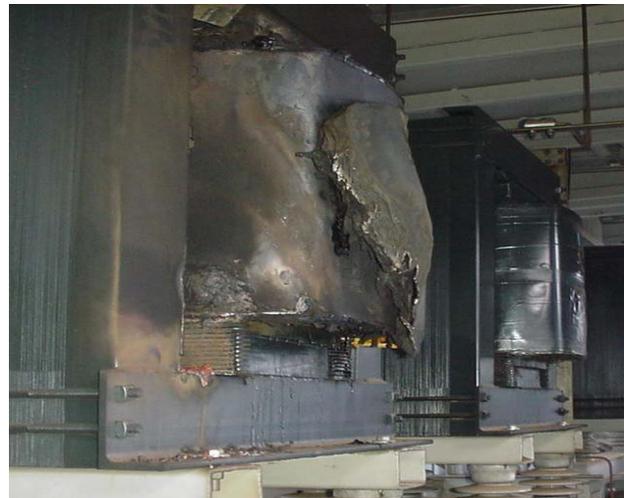
*a. Problem* - In August 2003, the drive system tripped offline again due to 3/5 harmonic filter overcurrent. During investigation of the filter bank, it was noted that the phase B reactor on the 3<sup>rd</sup> harmonic filter had failed. Figure 12 shows the damage to the harmonic filter reactor.

*b. Root Cause* – Transient overvoltage had bridged through the reactor to ground, establishing an arc that destroyed the lead connection and part of the reactor winding. The transient was attributed to the frequent starting and stopping and the arc-over event to insufficient insulation voltage.

Figure 12: Failed Harmonic Filter Reactor.

*c. Solution* - Although the root cause was traced to a transient condition from frequent starting and stopping, the decision was made to change reactor vendors. A new unit was installed in October 2003. Glastic barriers were added on each reactor between the winding and outer legs to increase the installed insulation voltage rating.

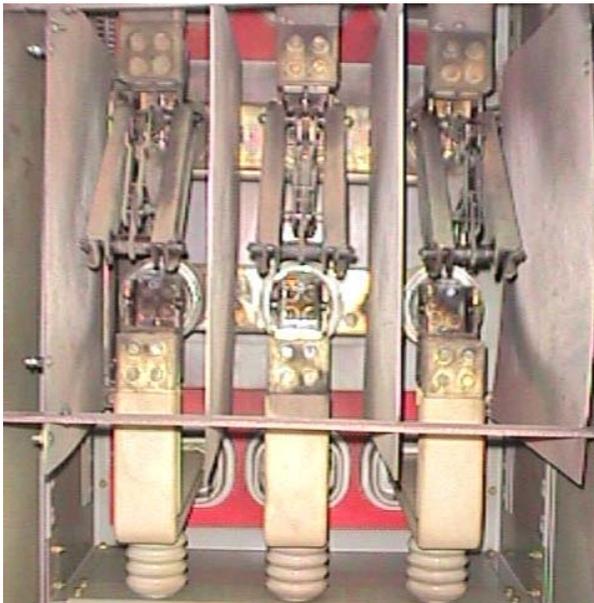
*a. Problem* - To isolate the stator side of the synchronous motor from electrical power, two motor operated line switches were installed in the switchgear line-up between the transformer secondaries and the input to the LCI line side inverter. These switches were a cost effective solution to breakers (especially since the interrupting capacity was not needed) and were believed to be correctly suited for the application. In December 1998, LCI 89-B line switch failed as the drive system was being isolated. The NTF was operating at a low fan load condition, approximately 0.8 MW, 60 rpm, prior to the failure. Personnel in an adjacent building indicated a large explosion had occurred in the switchyard. The LCI 89-B cubicle door had blown off, and the inner metal shield panels had been blown off the right side, consequently scraping into several terminal blocks, shorting them. Metal splatter and arcing throughout the cubicle indicate a phase to phase arc and phase to ground arc had been established. The rear insulating standoffs had been plated with metal plasma when the fault occurred, rendering the insulators useless. Figure 13 shows the damaged switch prior to removal. The decision was made not to replace the insulators, but instead to provide solid copper buswork in place of the switch mechanism as a temporary connection. This would allow research testing to continue while the switches were replaced. Temporary modifications to the control code and the facility operating procedures were required to control isolation of the drive by the main 115 kV circuit breaker upstream of the transformer. The old switch mechanism was removed and the undamaged switch, LCI 89-A, was left in the closed position.

Figure 13: Damaged LCI 89-B line isolator switch

*b. Root Cause* - Root cause of the fault was determined to be opening the switch with residual capacitive current flowing

across the switch contacts. This current flow was a result of the thyristor snubber circuits and leakage currents of the shielded primary feeder cables. The LCI snubber circuit resistor/capacitor networks require 1.5 amps reactive current. The 600' of (4) parallel 1000 kcmil cable runs require another 1.5 amps capacitive leakage current. The switches were designed for zero current opening and cannot open with current flow for two reasons: 1) No arc chutes/blades are provided to protect the main contacts and extinguish the arc, 2) The switches physically do not open fast enough to prevent a re-strike arc from forming. Consequently, an opening of capacitive current can initiate a re-strike phenomenon, ratcheting up the arc voltage indefinitely, causing an ionizing environment within the switch area. This ionized air will then conduct phase to phase or phase to ground current anywhere a path is available. It was also determined that the switches were designed for 250 cycles, and had already exceeded the design life cycle count. These were not designed to handle the higher cycle count required by the wind tunnel application.

*c. Solution* - The line switches were redesigned and replaced. The new switches included arc chutes, stronger release springs, and mechanical hardware designed for the frequent cycling application. As part of the quality assurance plan, a prototype switch was built, tested to failure, with results incorporated into the production units. Unfortunately, when the switches arrived at the site to be installed, both line switches had very poor insulation readings. The problem was isolated to the switches' fiberglass pushrods, which, from appearance were perfect. A new set of pushrods were installed and the switches have operated successfully since.
