Compression After Impact on Honeycomb Core Sandwich Panels with Thin Facesheets, Part 1: Experiments

Thomas D. McQuigg¹ and Rakesh K. Kapania²
Virginia Polytechnic Institute and State University, Blacksburg, VA, 24060

Stephen J. Scotti³ and Sandra P. Walker⁴
NASA Langley Research Center, Hampton, VA, 23681

A two part research study has been completed on the topic of compression after impact (CAI) of thin facesheet honeycomb core sandwich panels. The research has focused on both experiments and analysis in an effort to establish and validate a new understanding of the damage tolerance of these materials. Part one, the subject of the current paper, is focused on the experimental testing. Of interest are sandwich panels, with aerospace applications, which consist of very thin, woven S2-fiberglass (with MTM45-1 epoxy) facesheets adhered to a Nomex honeycomb core. Two sets of specimens, which were identical with the exception of the density of the honeycomb core, were tested. Static indentation and low velocity impact using a drop tower are used to study damage formation in these materials. A series of highly instrumented CAI tests was then completed. New techniques used to observe C

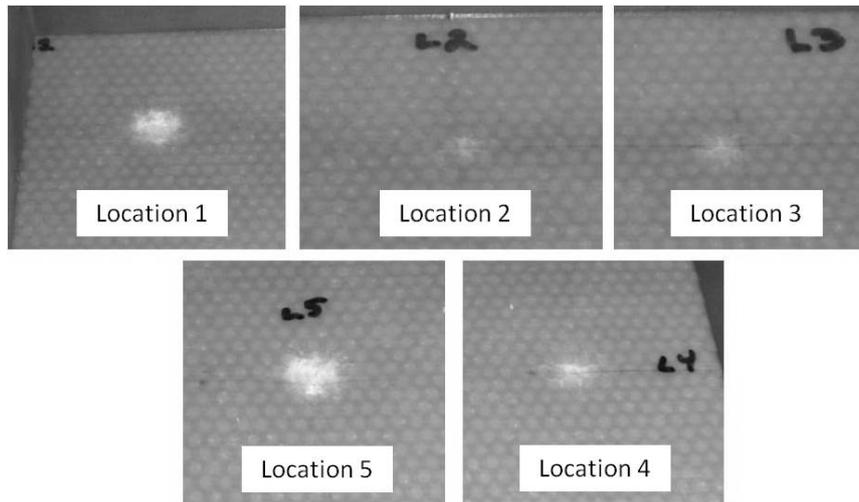
Five static indentations were made into a 3PCF-XX material coupon to investigate the coupon's response. The results of static indentation are shown in photographs in Fig. 4. The static indentation test at *Location 1* on the coupon was used to find the resultant force measured at facesheet fracture. Facesheet fracture occurred at 171 lbs and 0.133 in of applied displacement. By integration of the reaction force vs. applied displacement results, the energy absorbed was found to be 0.914 ft-lb. Visible facesheet damage included inter-fiber fracture (IFF, i.e. matrix cracking) in a circular region centered at the point of indentation. For larger indentations, fiber fracture was also present. Fiber and matrix fracture appear randomly oriented and saturate the area of damage.

Fig. 4 Results of static indentation of 3PCF-XX series material coupons: residual dents.

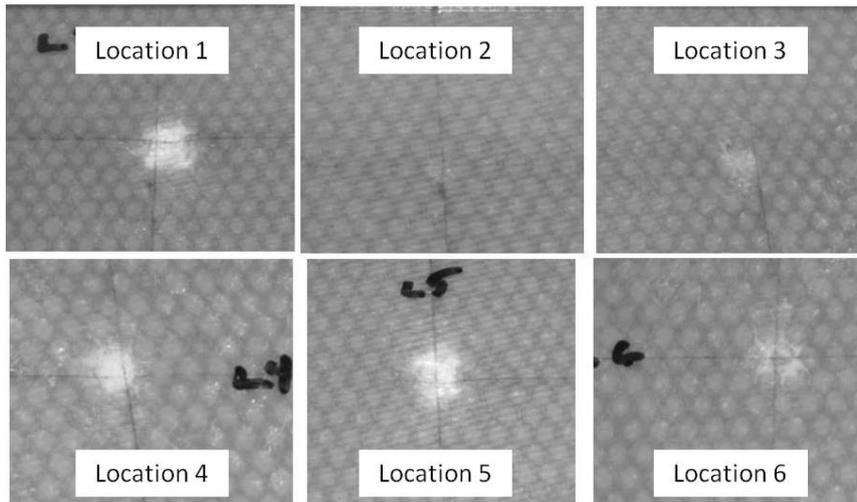
Six static indentation tests were then completed on a 6PCF-XX series material coupon. The resulting dents and damage can be seen in Fig. 6. Force vs. displacement results for these inden-

Fig. 6 Results of static indentation of 6PCF-XX series material coupons: residual dents.

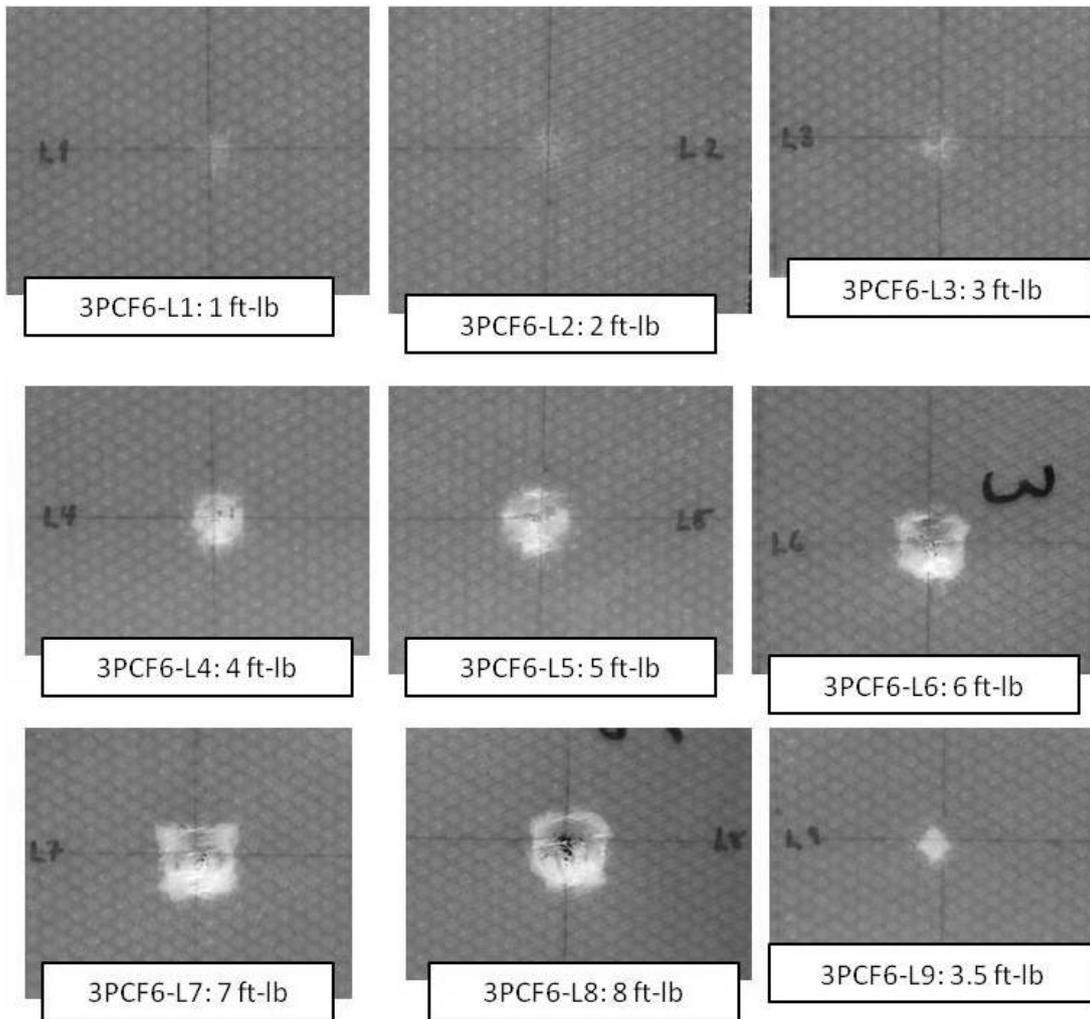
Several types of damage are present in the impact locations on the 3PCF-XX series materials shown in Fig. 17, and the 6PCF-XX materials shown in Fig. 18. At very low impact energy levels, 1 to 3 ft-lb. for 3PCF-XX, and 1 to 2 ft-lb. for 6PCF-XX, there is a slight discoloration of the

Fig. 17 Results of drop tower impact testing on 3PCF-XX series materials: residual dents.

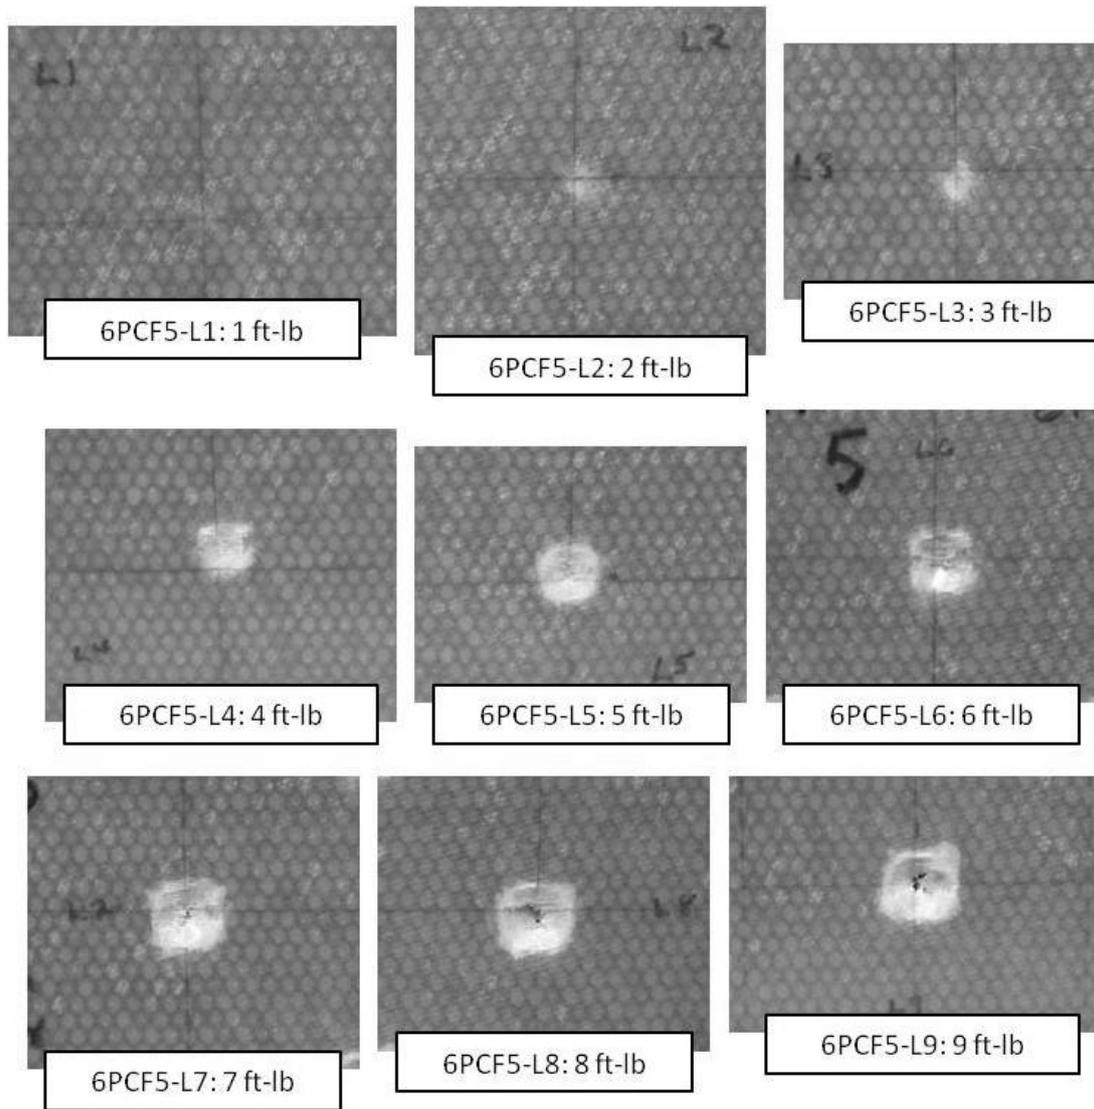
Fig. 18 Results of drop tower impact testing on 6PCF-XX series materials: residual dents.

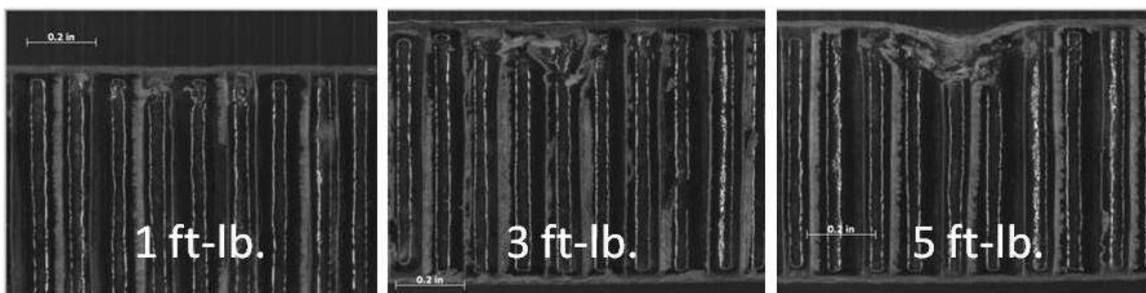
an open hole in the facesheet. Photographs of damage cross sections, taken after cuts were made, show that significant core damage is also present for panels with this amount of facesheet damage. An example of these cross-sections is shown in Fig. 19. At higher energy levels, the core damage present includes large amounts of tearing and bears little resemblance to the hexagonal cellular structure.

Fig. 19 Results of drop tower impact testing on 6PCF-XX series materials: core damage shown through destructive evaluation.

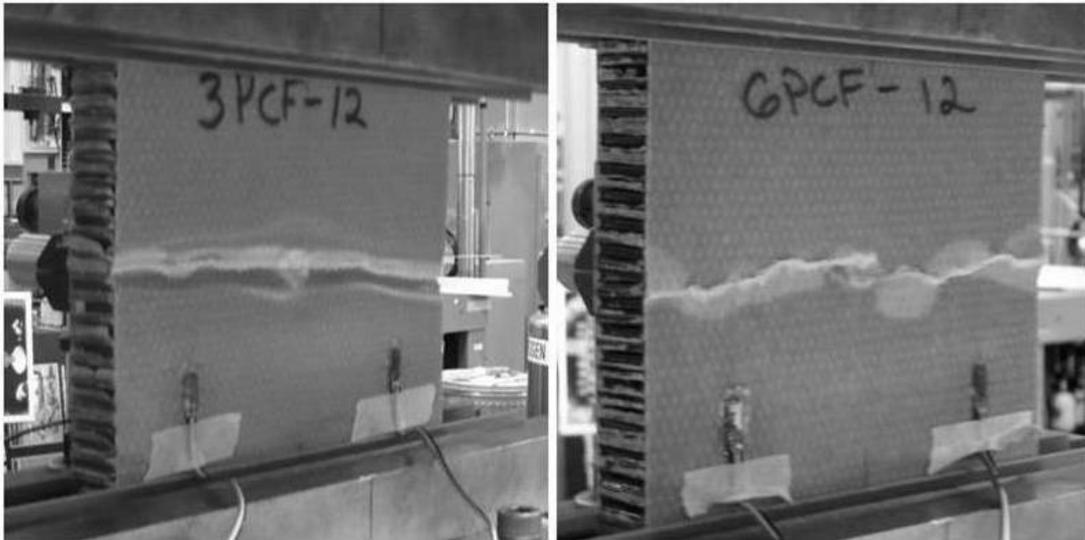
Global failure of each 3PCF-XX and 6PCF-XX CAI coupon occurred because of failure in the damaged facesheet only. The rear facesheet still carried some load prior to failure. Two failure modes were seen during CAI testing. The failure mode of the 3PCF-XX panels was indentation propagation. The failed 3PCF-XX specimens have a region of local buckling, extending transverse to the direction of applied load, from the residual dent initially imposed by the low velocity impact. The 6PCF-XX panels failed by a second, different failure mode. Instead of a region of local buckling, only a crack appears in the initially damaged facesheet, although it propagates similarly to the

indentation propagation. The differences between the two failure modes can clearly be seen in Fig. 23, which shows two test coupons, post-failure, while still loaded.

Fig. 23 Failure modes of indentation propagation for 3PCF-XX series coupons (left) and crack propagation in 6PCF-XX coupons (right).

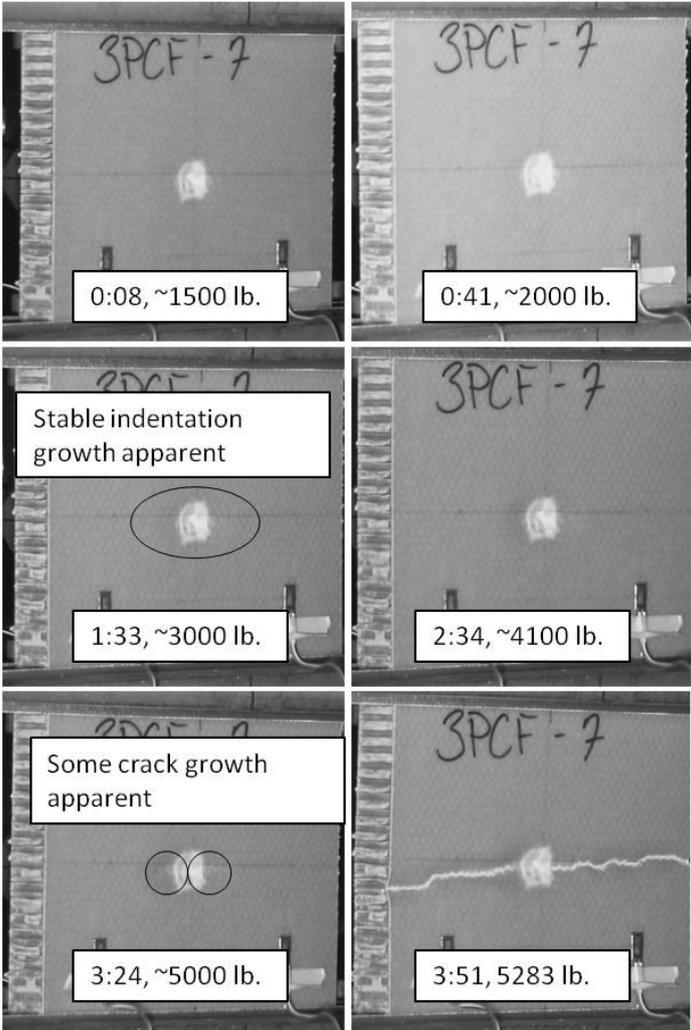
Video photography was also used for select tests of 3PCF-XX and 6PCF-XX materials. Time lapse photography of a 3PCF-XX series coupons shown in Fig. 24 indicates several interesting features of an indentation propagation failure. This example is for a specimen impacted with at a 7.0 ft-lb. impact energy level, but the results are similar for all the 3PCF-XX series test coupons. The stable indentation growth is apparent beginning at just over halfway through the test, shown at the 1 minute, 33 second mark in Fig. 24. A crack also propagates in a stable fashion once the indentation is large enough. In less damaged test specimens, the crack propagates with the indentation growth. At failure the crack and the indentation can be seen to grow transversely to the applied load.

Fig. 24 Time lapse images of 3PCF-XX CAI test.

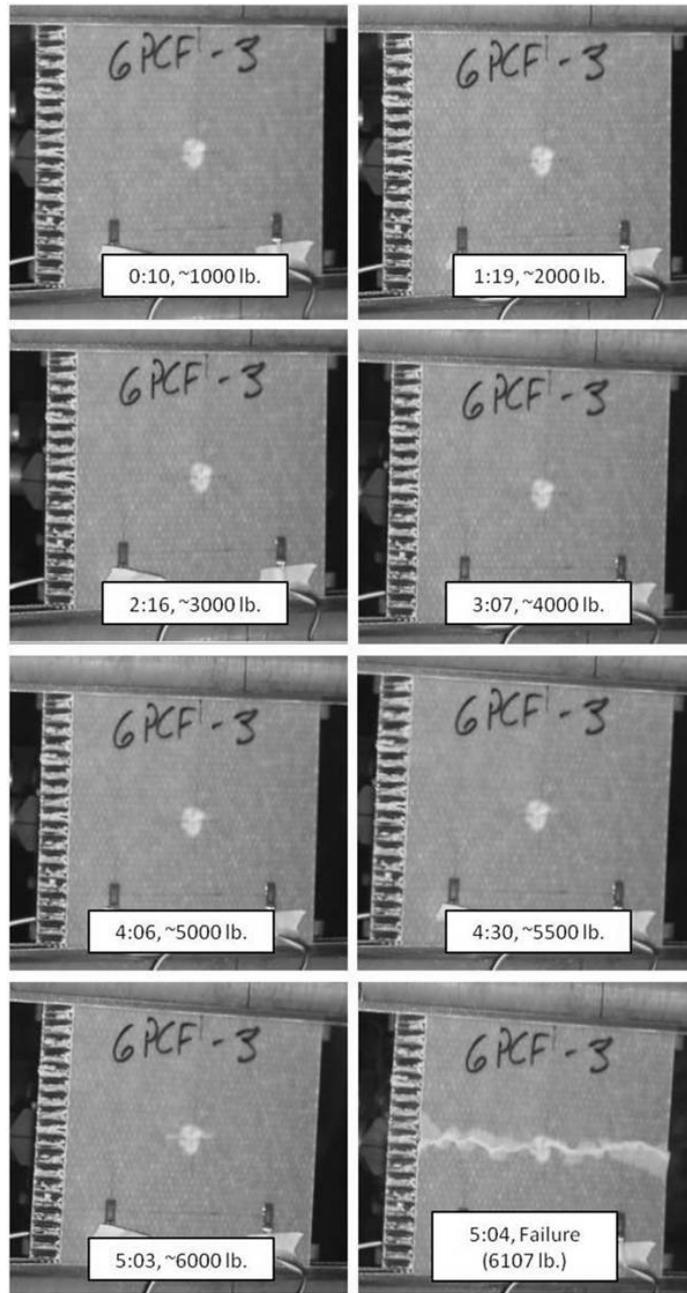
Time lapse photography of a 6PCF-XX series coupons shown in Fig. 25 indicates that the initial dent grows very little prior to the specimen failure. It appears to be nearly the same size at 1000 lbs. of load as it does at 5000 lbs. of load for coupon 6PCF-3. This particular coupon was impacted at 5 ft-lbs. of energy, but this was typical of all 6PCF-XX series CAI tests. At about the 4 minute mark, a small crack in the front facesheet appeared, advancing from the initial damage location transverse

to the load direction (vertical). By the 4 minute, 30 second mark, the crack had advanced slightly; however, by the 5 minute mark the crack was easily visible and the panel was very near to the residual strength which was found to be 6107 lbs. for the 6PCF-2 coupon. Between the 5 minute, 3 second and the 5 minute, 4 second marks in the real time video, the crack propagated to the edge of the specimen (accompanied by some interlaminar delamination and facesheet debonding), thus compromising the facesheet.

Fig. 25 Time lapse images of 6PCF-XX CAI test.

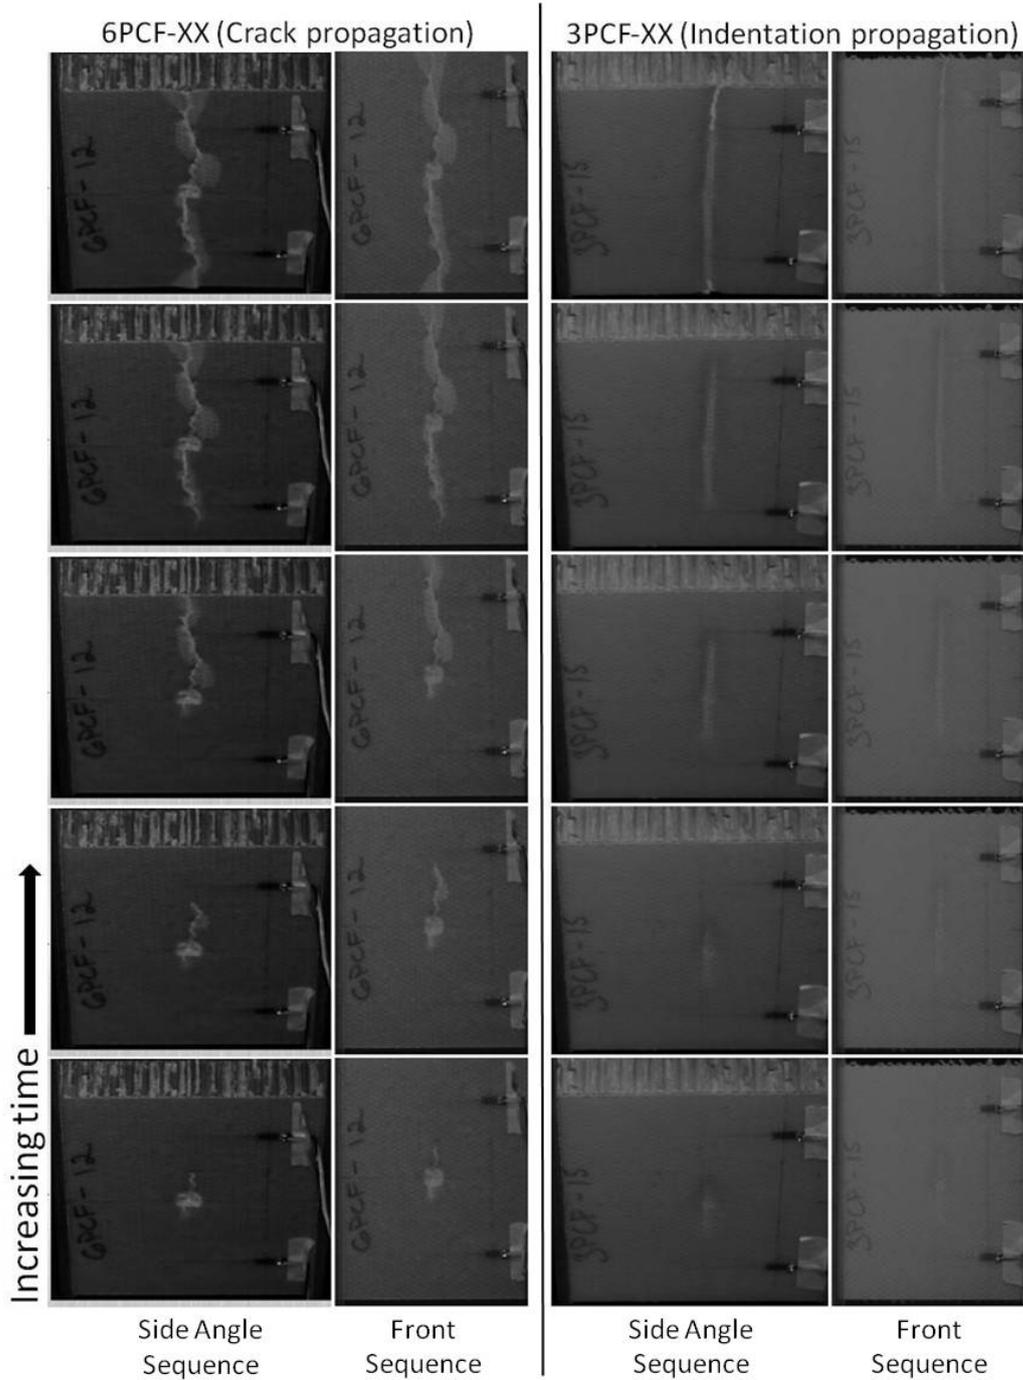
to illustrate any out-of-plane displacement of the facesheets. Frames taken from footage captured from both view points during CAI testing of coupons 6PCF-12 and 3PCF-15 show, in Fig. 26, the contrasting failure modes occurring during the moment of failure.

The sequences taken from the two cameras for 6PCF-12 begin with a small crack already visible growing from the initial impact initiated indentation. The crack propagates quickly to each side,

Fig. 26 Images taken from high speed cameras during failure of 3PCF-XX (right) and 6PCF-XX (left) materials.

although it propagates to the right slightly before the left showing that there may be a difference in stress concentration on either side of the initial damage due to impact damage asymmetry. In real time, however, this was not noticeable for most test cases. Photos, taken at high speed, of coupon

3PCF-15 show indentation propagation failure. With the aid of the side mounted camera, the high speed camera footage clearly shows the out-of-plane deflection in the locally buckled region. Also, in both cases the failed facesheet's inability to transfer load causes the entire coupon to buckle globally. Although the global out-of-plane displacement at the middle point of the coupon is small it can be seen in the side images taken from the high speed cameras. In the actual video, this feature is easier to see, as the coupon can be seen to actually move.

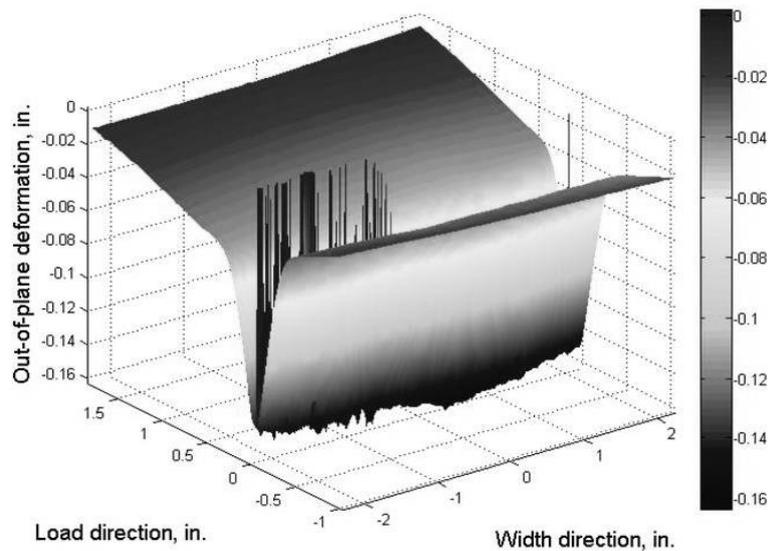
example of a 3D DIC representation is shown in Fig. 29. A 3PCF-XX coupon is shown here, after failure.

Fig. 29 Example 3D representation of the indentation propagation failure mode for a 3PCF-XX series CAI test coupon.
