Space Shuttle Columbia Aging Wiring Failure Analysis

Steven J. McDanel National Aeronautics and Space Administration (NASA), Kennedy Space Center, Florida, USA

8th Joint NASA/FAA/DoD Conference on Aging Aircraft

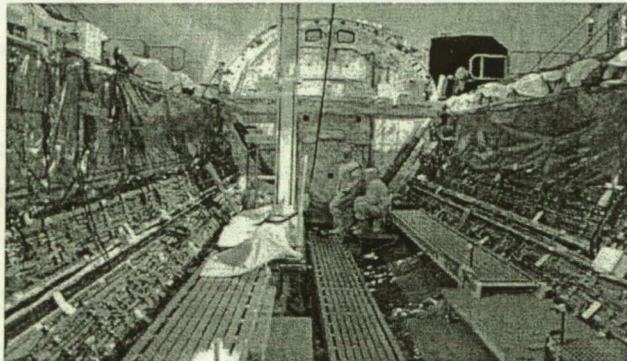
Figure 1
Cargo Bay of OV-102.

Approximately five seconds after the liftoff of the space shuttle Columbia on STS-93, a main engine controller wire short circuited, resulting in a potential single point failure for two main engine power controllers. Post-flight inspection of the Orbiter divulged arcing damage to a wire in a lower wire tray in the midbody port side of the Space Shuttle Columbia, Figure 1.

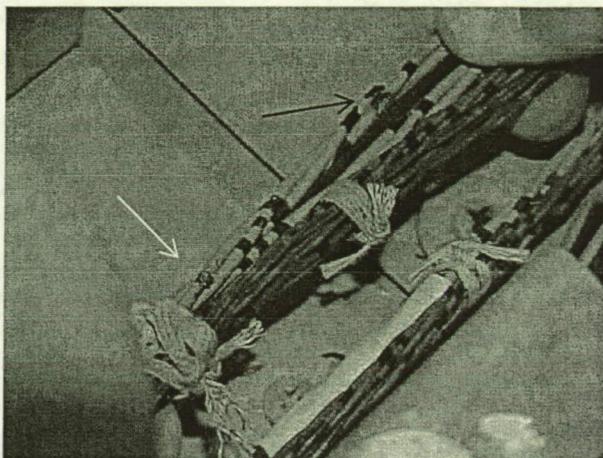
Figure 2

The damaged wire was immediately adjacent to a charred bolt head. Similarly, an additional region of damage, in this case an area of exposed conductor, was observed on the same wire approximately 2 inches away from the arced region. It was noted that another bolt head was adjacent to this damaged region as well. Each of the bolts corresponding to the regions of damaged wire had plastically deformed slots with exposed base metal where the bolt head slots had been deformed; the wiring opposite the damaged areas did not display any damage. The subject bolts and damaged wiring was harvested for failure analysis, Figure 2.

Black arrow indicates arcing location, with the corresponding bolt immediately beneath it. White arrow indicates a second area of damage.

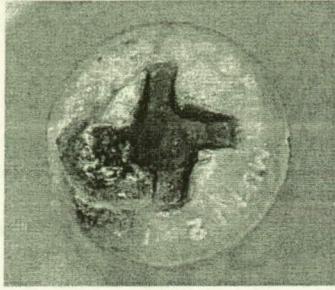
Figure 4
Deformed, charred bolt head.

A charred area on the bolt head was observed, Figure 4, in the region which was located next to the charred region of the wire. Areas of raised, shiny base metal were present on the edges of the bolt head slots. No paint was evident on the raised areas.

The subject controller wire exhibited mechanical damage in several locations; the mechanical damage was likely extant prior to the arcing event. The mechanical damage tore the insulator and damaged the underlying conductor, eventually resulting in a short when the conductor contacted the adjacent bolt head. The bolt head's base metal, exposed as a result of plastic deformation likely induced during loosening, contacted the conductor while the wires were energized. The resultant absence of a protective coating predisposed system to a short. The presence of nickel and copper, verified via chemical analyses, in the melt zone on the iron-based bolt head, indicated that the conductor had fused with the bolt head. Eventually an applied mechanical force separated the conductor and wire, resulting in MVC on the fused zone. The uniformity of the MVC, with no evidence of a progressive, cyclic separation, tends to indicate that the separation was a single event.

Based upon the results of the failure analysis, recommendations were issued to ensure that bolts would be examined to verify that no raised or bare areas of metal were present on the heads of similar bolts. Any bolt with raised or exposed metal was to be smoothed and/or repainted as necessary. Likewise, an intensive inspection of wiring from each Orbiter in the fleet was undertaken to mitigate the likelihood of additional wiring failures. During the inspection, any wires found to be damaged or bolts discovered to be deformed or with bare metal present were replaced. Likewise, installation of convoluted tubing to protect the wire bundles was performed at this point.

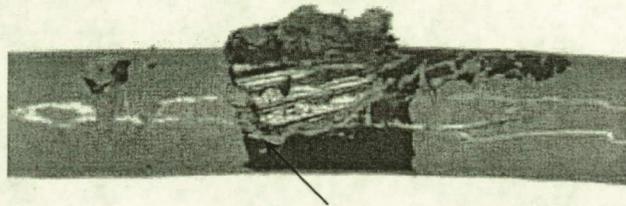
Figure 5
Second damaged area, with mechanical damage to the conductors denoted by the black arrow. Deformation was evident on the topcoat and conductors.

The second area of damage on the subject wire had its insulation pushed up in a transverse direction, Figure 5. The conductor in this area displayed mechanical gouging.

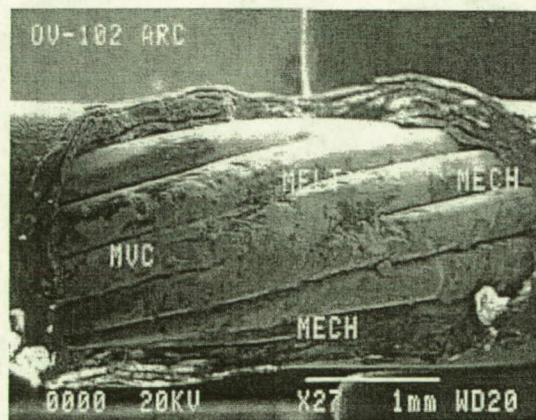
Figure 6
Micrograph of arced area. The melted region is between the "MELT" and "MVC" zones, with mechanical damage evident in the areas denoted "MECH." Magnification: 27X

Both damaged regions of wiring were examined with a scanning electron microscope (SEM) equipped with energy dispersive X-Ray spectroscopy (EDX). Electron spectroscopy for chemical analysis (ESCA) was also employed. The polyimide insulation was absent in the charred regions. The damaged insulation did not appear serrated; rather it appeared smooth and even. Three zones of distinctive topographical characteristics were observed: a melted region, a zone displaying microvoid coalescence (MVC), and a mechanically damaged area, Figure 6.

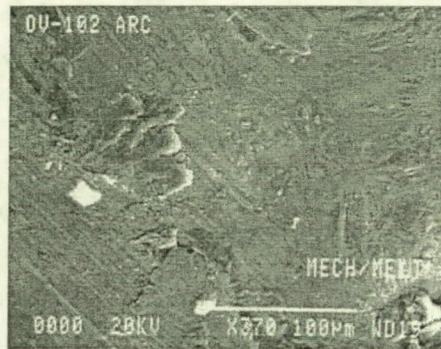
Figure 7

A mixture of melting and mechanical damage was evident on the central region of the charred area, Figure 7. Directional gouges were observed in the areas of the conductor displaying mechanical damage, Figure 8. MVC, indicative of ductile overload, was evident in the final zone of the exposed area, Figure 9. The MVC correlates to an area where the wire melted and bonded to the bolt head, Figure 10. Charring and melting appeared to be restricted to the outermost strands of the wire. The inner strands appeared intact. The bolt head was examined via EDX and ESCA; copper and nickel were present. An oxide layer was detected via ESCA on the shorted wire. The oxide layer depth of the subject wire was contrasted to oxide layer depths of exemplars of newly nicked copper wire and specimens nicked two years previously; the oxide layer depth of the subject wire was significantly deeper than the oxide layer depths of the exemplars.

Micrograph of the transition from heat to mechanical damage. Magnification: 370X

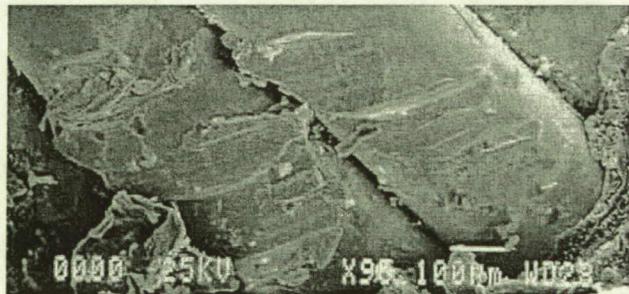
Figure 8

Micrograph of mechanically damaged region of the conductors. Magnification: 90X

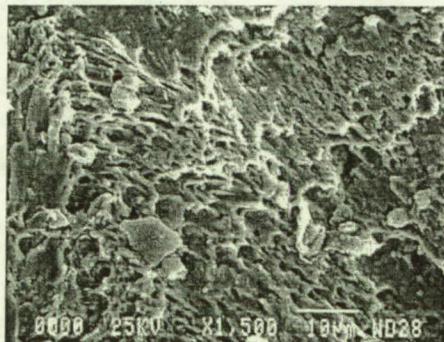
Figure 9

Micrograph displaying MVC. Magnification: 1,500X

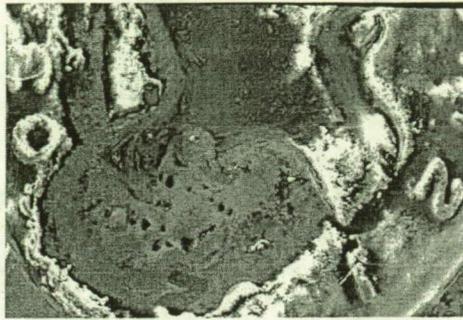
Figure 10

Micrograph of melted metal on the bolt head. Magnification: 16X

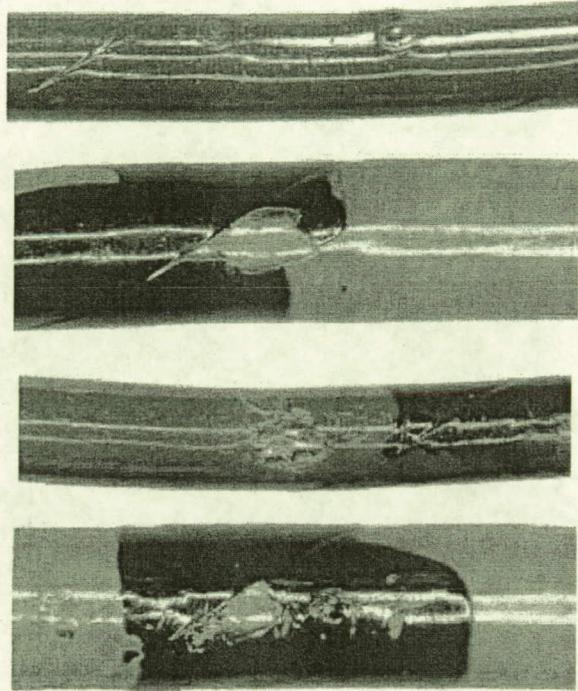
Figure 13
Macrographs of step test specimens, with increasing force.

Step testing was performed. Increasing levels of effort and force were utilized, but did not damage the conductor, Figure 13.

SEM examination of the step test specimens showed only topcoat/insulator damage. No conductor damage was observed. The drop test as well as the abrasion test, Figure 14, indicated that the convolex tubing experienced damage prior to any damage to the conductor.

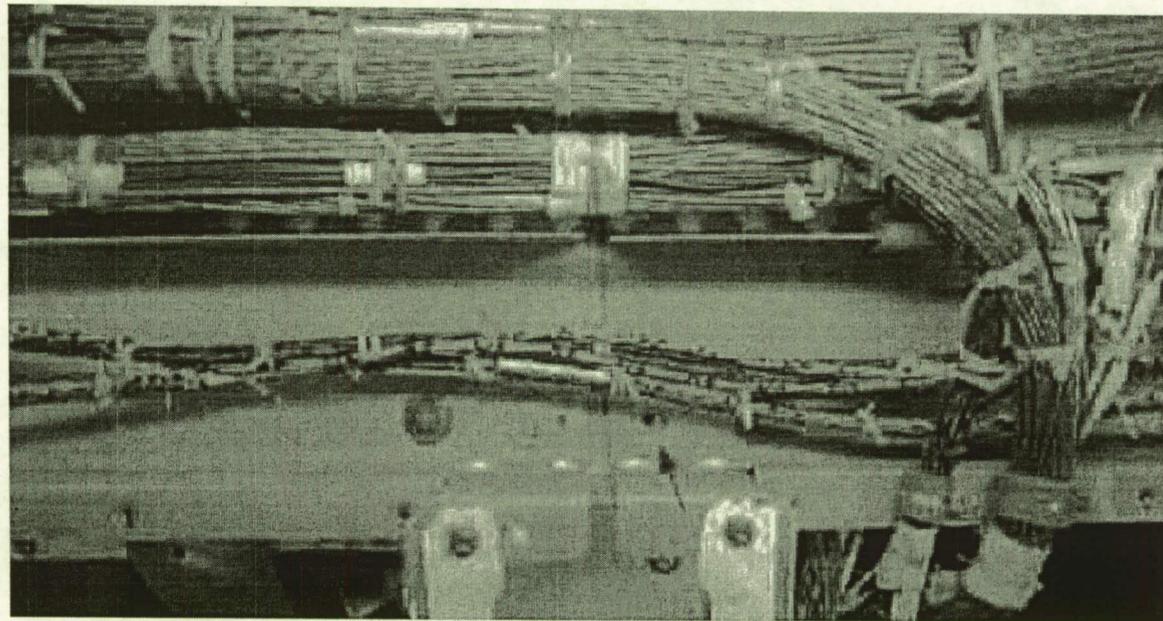
Midbody port side lower wire tray of OV-102

- Arced location (black arrow) with associated bolt head below.
- Bolt heads have exposed base metal.
- A second damaged area is also shown (white arrow).

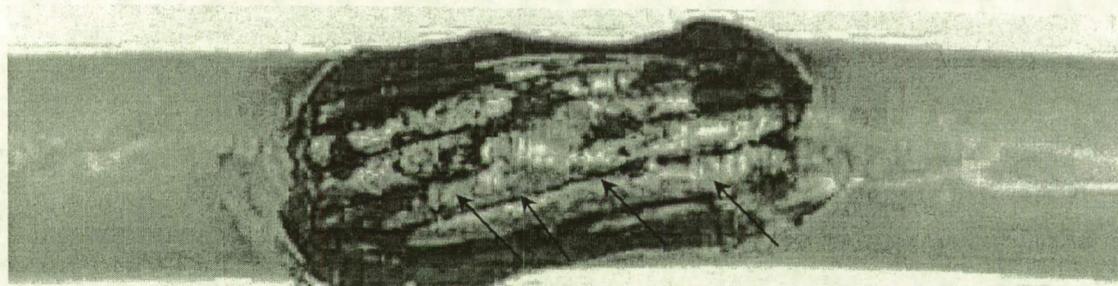
White arrows indicate shorted area;
black arrows indicate areas of mechanical damage.

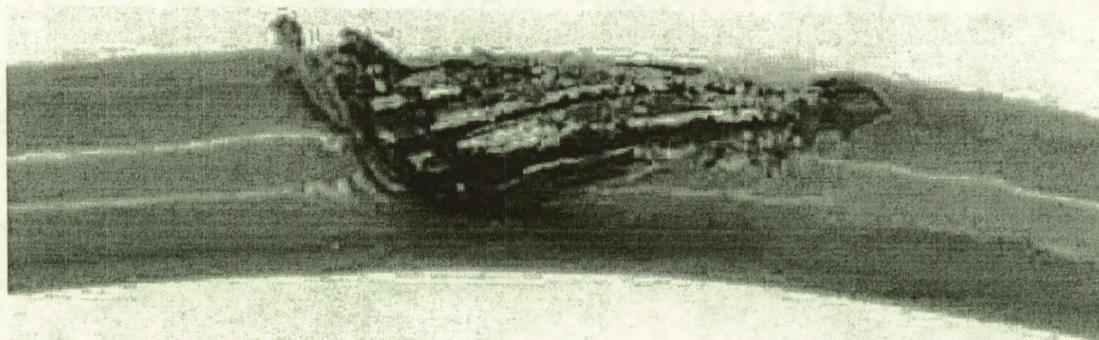
Side view of wire. Note how the topcoat is pushed to the left.

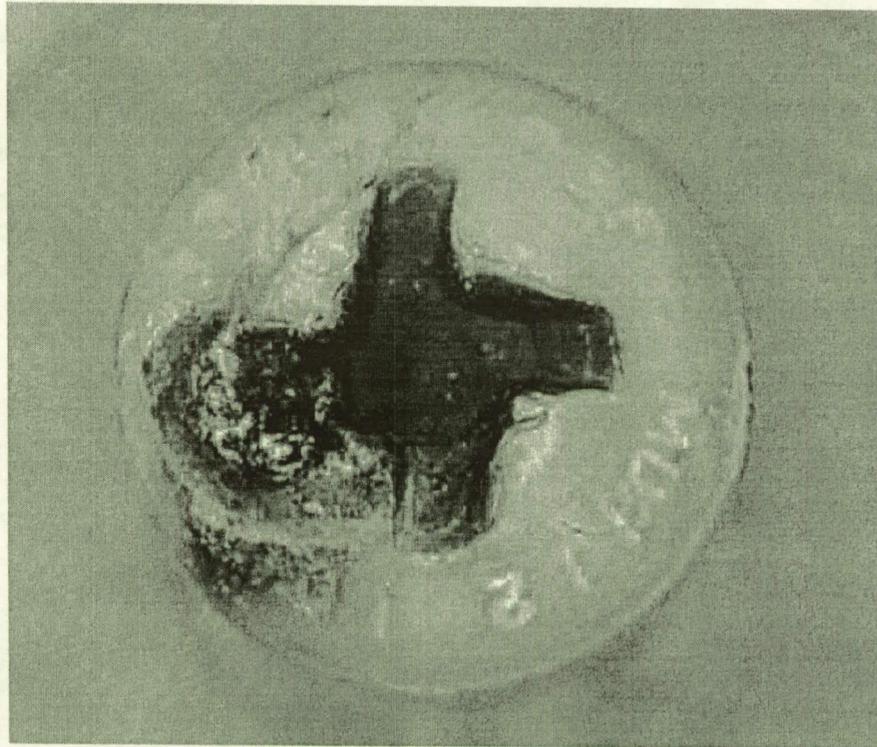
Bolt head that the conductor arced against to cause the short

Raised areas of bare base metal were evident on the sides of the slots in the bolt head; these raised areas were devoid of paint.

- It was recommended that similar bolts be examined to ensure no metal was raised on the bolt heads.
- Also to ensure that no bolts had bare metal exposed.
- If any were found, the raised areas were to be smoothed and the bolts repainted, as needed.
- A careful inspection of the wiring in the orbiter fleet was also deemed prudent to help preclude similar failures in the future.

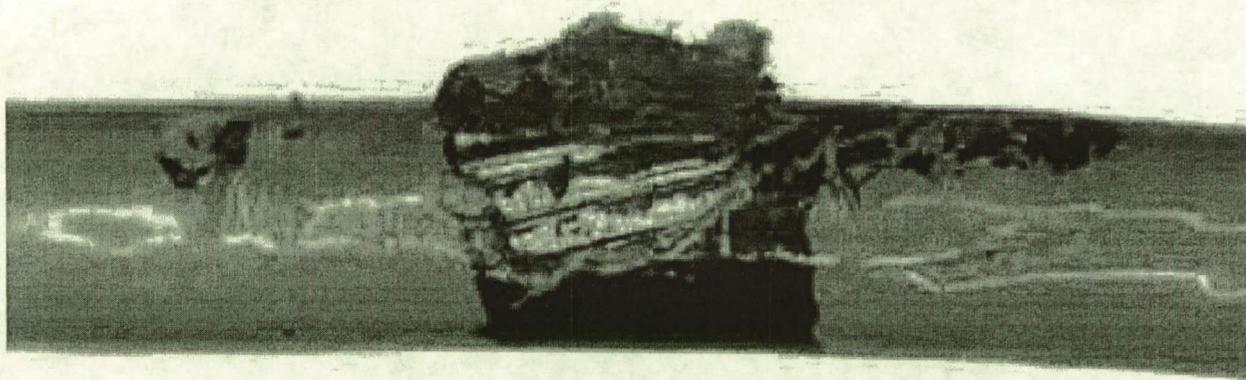
Mechanically damaged area approximately two inches from the shorted region.
Note deformation of the conductors and topcoat.

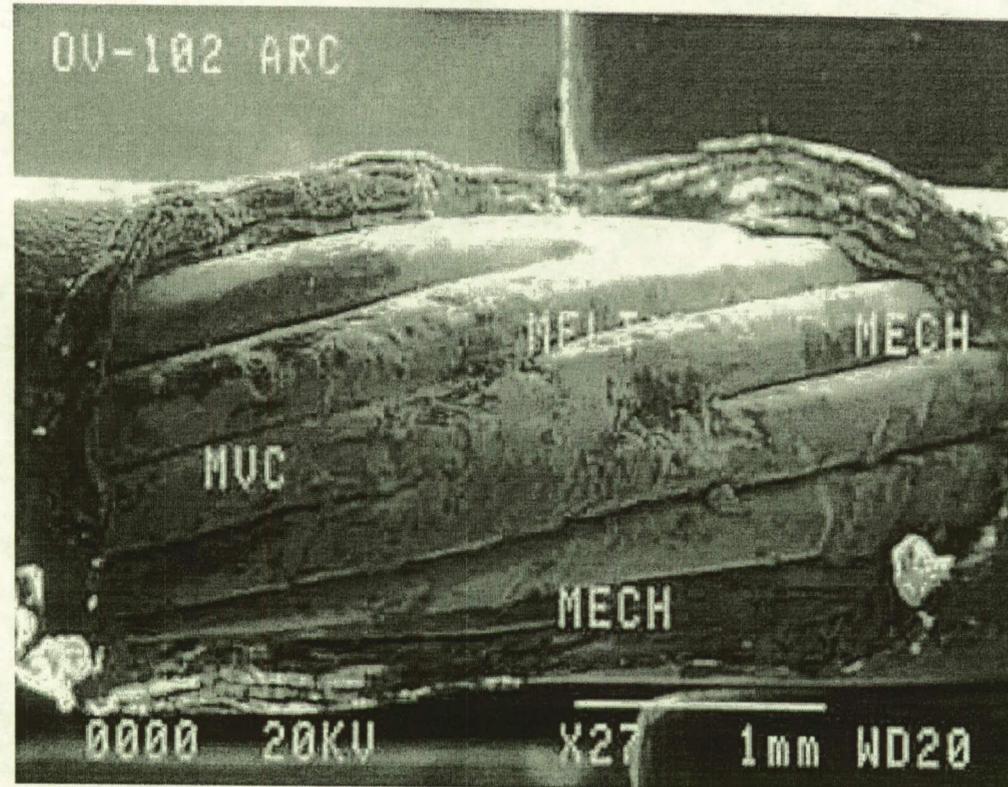
SEM micrograph of shorted region.

- Mechanical damage is evident on the conductors (denoted “MECH”).
- The melted region is between the “MELT” and “MVC” zones.
- Magnification: 27X

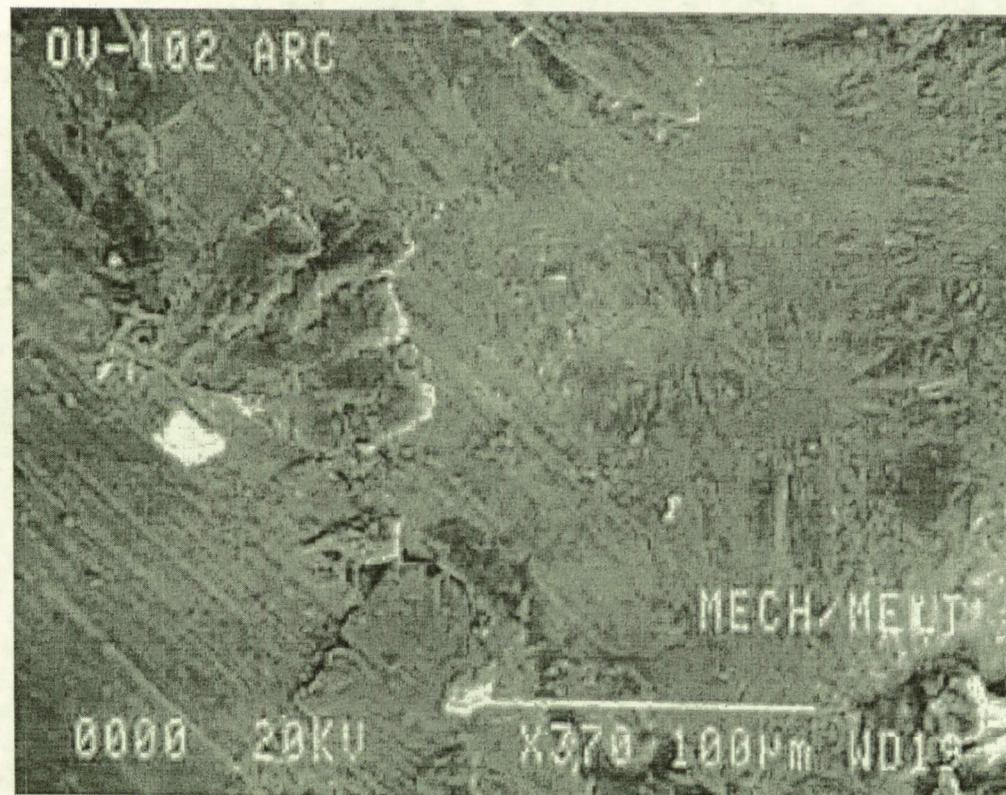
SEM micrograph of shorted region.

- SEM micrograph showing a transition from mechanical damage (left side) to heat damage (right side)
- Magnification: 370X

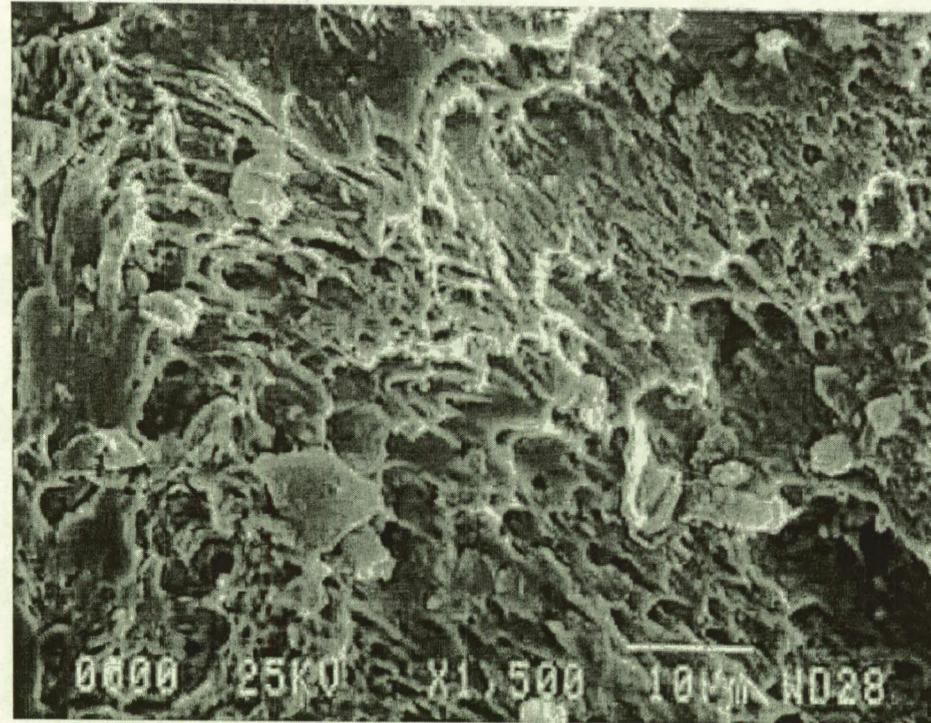
SEM micrograph of shorted region.

- SEM micrograph displaying MVC, typical of ductile overload.
- Magnification: 1,500X

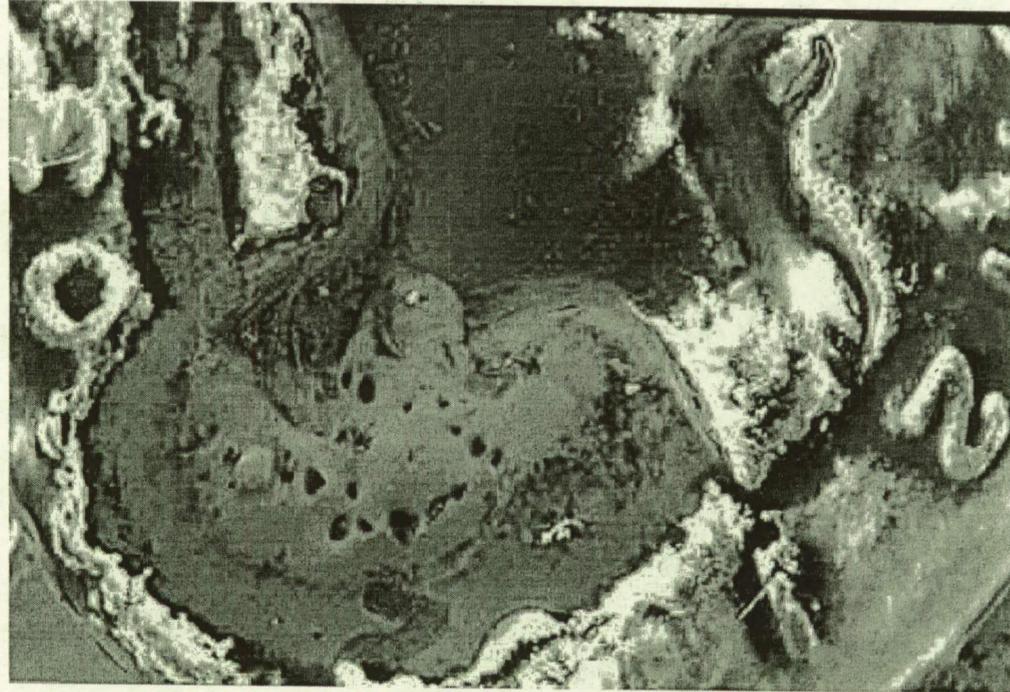
SEM micrograph of bolt head.

- SEM micrograph of the shorted bolt head, with melted metal apparent.
- Magnification: 16X

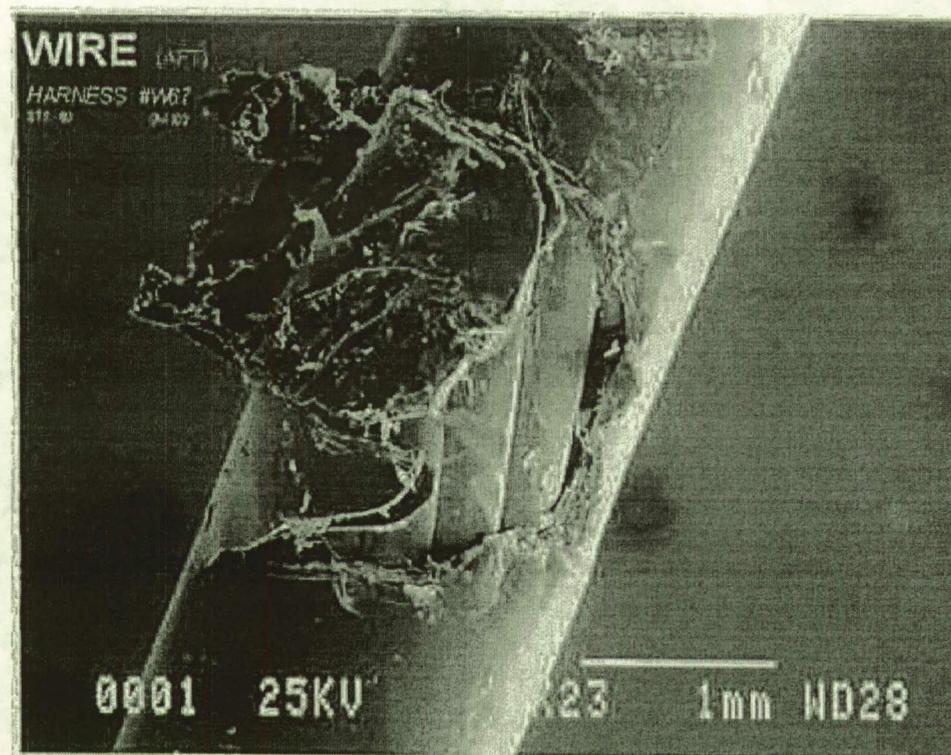
SEM micrograph of bolt head.

- SEM micrograph of a second damaged area of the wire. The conductors appear mechanically damaged, with the topcoat pushed back.
- Magnification: 23X
