**Investigation of the
Building M6-794 Roofing Fatality
Type A Mishap**

Mishap Report
May 2006

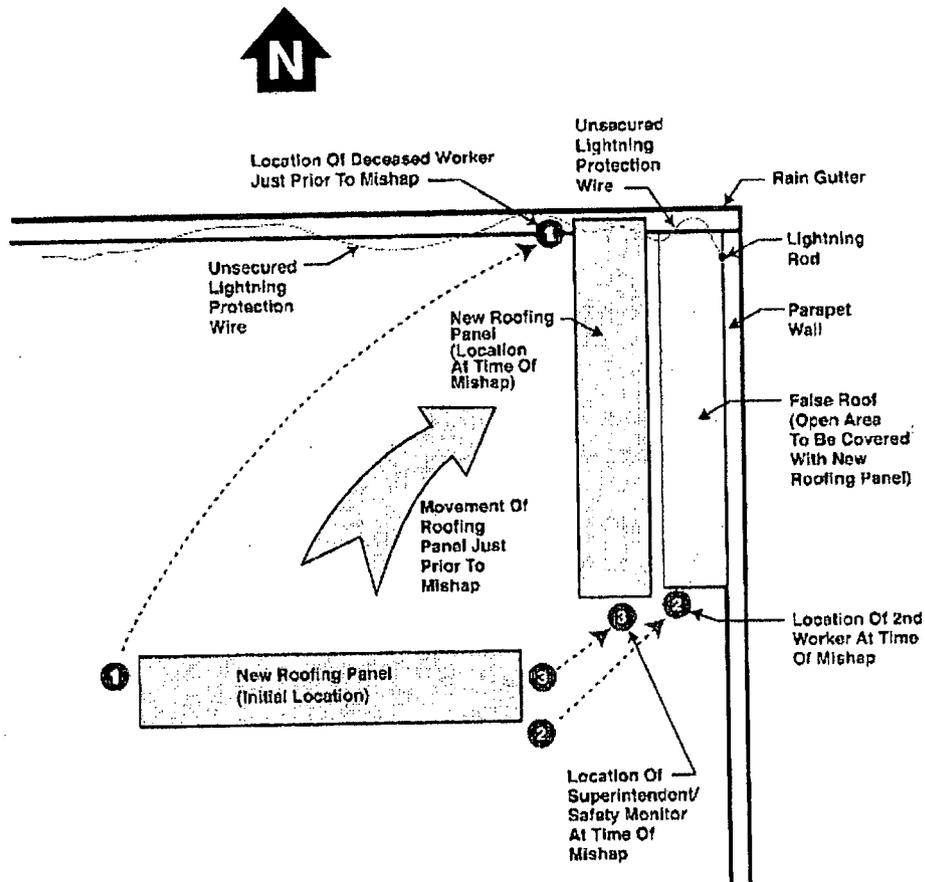
Figure 1. Plan (Bird's Eye) View of Northeast Corner of Building M6-794 (Mishap Location)

parallel to the roof edge. The superintendent/safety monitor (Worker 3) then picked up the uphill end of the new panel, while Worker 1 (deceased) picked up the downhill end. Together they began to carry the new panel into its final position, rotating it perpendicular to the roof edge. Worker 1 was located closest to the leading edge of the roof and walked with the panel toward the edge, while the superintendent/safety monitor acted as a pivot point, holding his end of the panel (see Figure 1).

At approximately 1325, Worker 1 lost his footing, let go of the new roofing panel, and fell from the roof. He fell backward approximately 10 ft, his head struck an air-conditioning unit, and he then fell an additional 7 ft to a concrete loading dock.

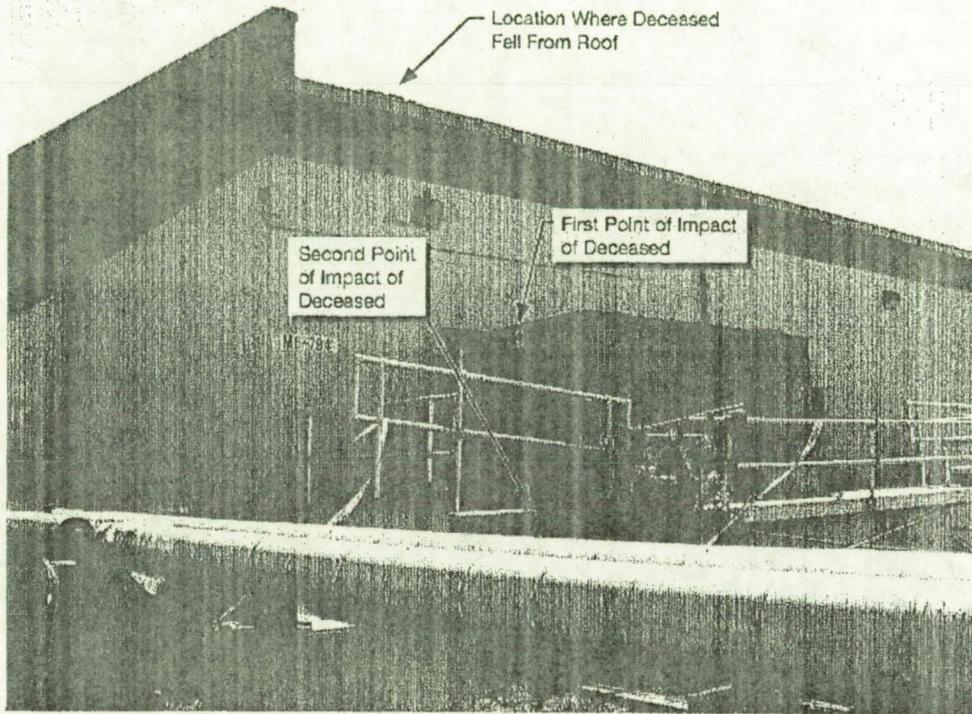
Figure 2. Mishap Site

The lightning protection wire was unsecured at the edge of the roof and posed a tripping hazard. The Board could not determine with certainty whether Worker 1 tripped on the lightning protection wire or on something else (e.g., corrugations in the roofing panels), or if he stumbled and the lightning protection wire prevented him from regaining his balance and he subsequently fell from the roof.

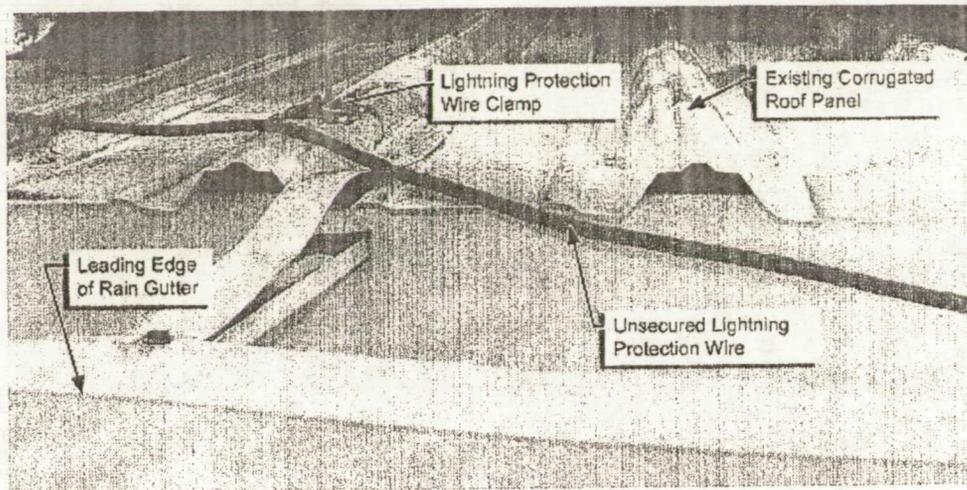
Figure 3. Close-up View of Leading Edge of Roof at Point Where the Deceased Fell

Subsequent to the mishap, the Board noticed damage to the rain gutter, near the location of the fall, with outward bending of the upper rim of the gutter in particular. The Board concluded that the deceased most likely contacted the gutter as he fell from the roof. This gutter damage can be seen in Figure 3.

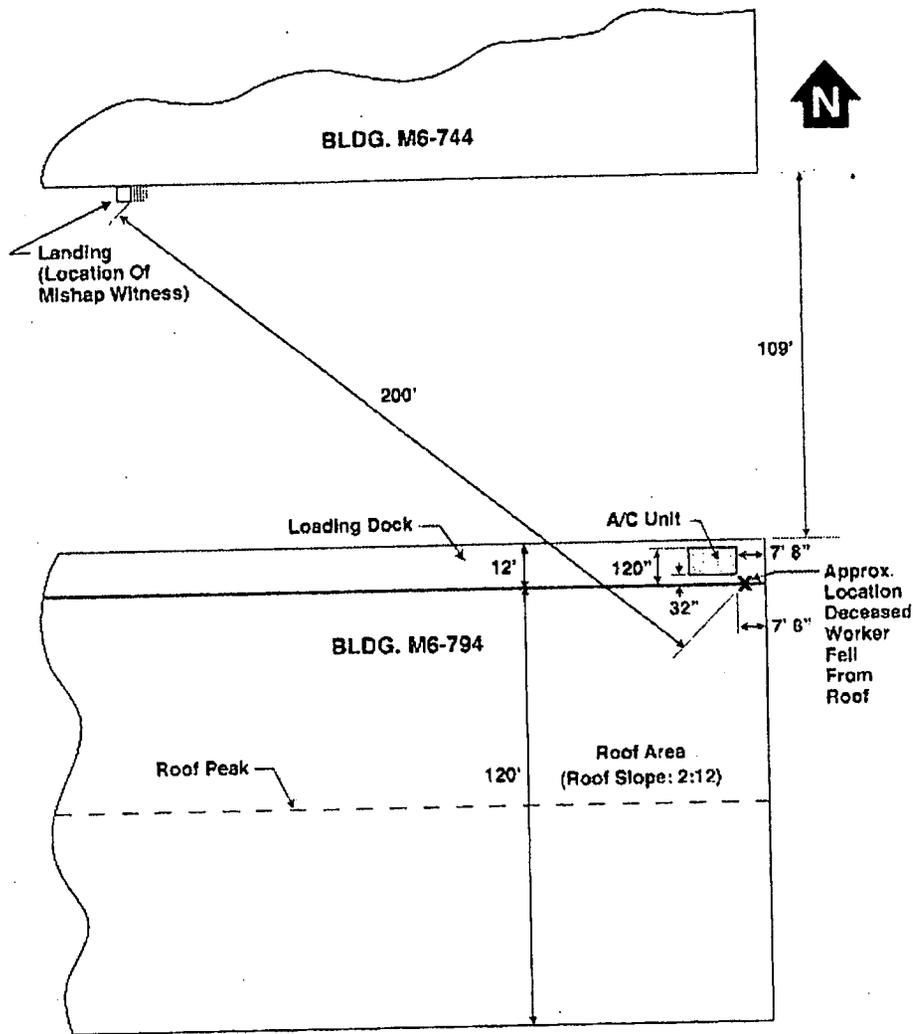
Figure 5. Location of Mishap Witness Relative to Mishap Site

The mishap was witnessed by an SGS logistics coordinator standing on a first-floor exterior landing (approximately 4 ft high), on the south side of Building M6-744, approximately 200 ft northwest of the scene of the mishap (see Figure 5). At the time of the mishap, the sun was directly overhead and did not appear to interfere with the line of sight of the witness. The witness called 911 within seconds of observing the mishap.

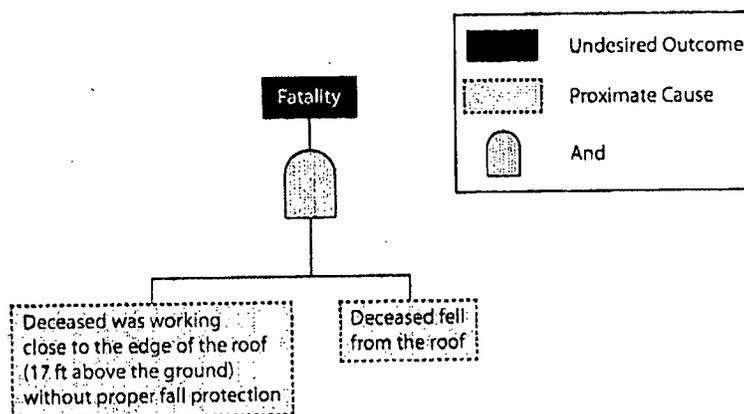
Figure 6. Proximate Causes of Fatality

Starting with the mishap event "Fatality," the Board evaluated the final proximate causes and those events and conditions that led up to them. See Figure 6.

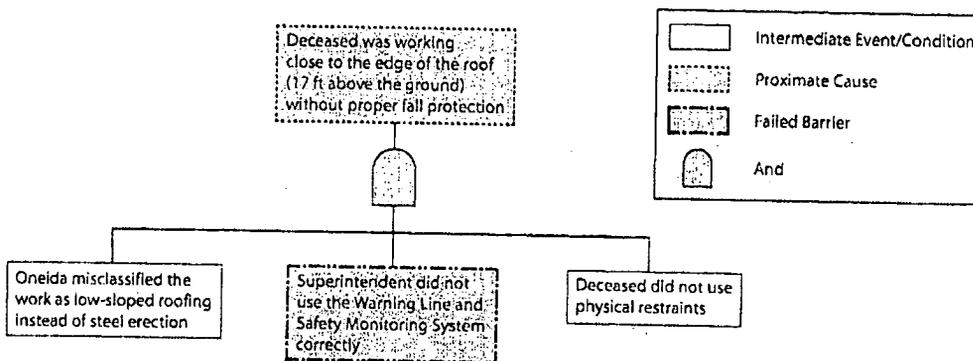
Figure 7. Events Leading to the Deceased's Working Close to the Edge of the Roof Without Proper Fall Protection

During the actual work, the superintendent/safety monitor and the deceased worker maneuvered the panel into the required position, which placed the deceased close to the edge of the roof, with his back to the edge. The superintendent, who should have provided the safety monitoring, did not warn the deceased that he was close to the edge (approximately 6 to 12 inches). No other additional fall protection (physical tie-offs, guardrails, safety nets, etc.) was provided. Therefore, the Board determined a proximate cause of the mishap to be that the deceased was working close to the edge of the roof (17 ft above the ground) without proper fall protection.

The intermediate causes of the deceased's working close to the edge of the roof without proper fall protection were identified and analyzed and are presented in Figure 7 and the following subsections.

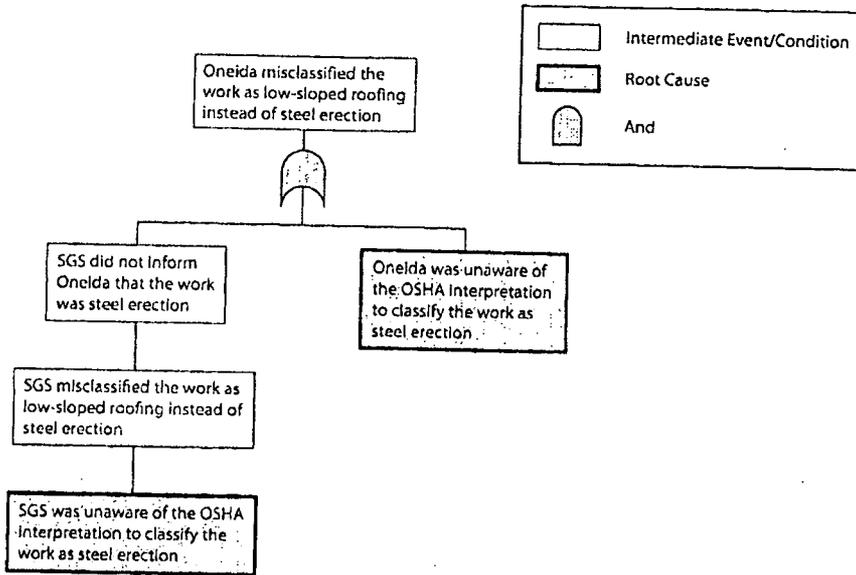
Figure 8. Root Causes of Oneida Misclassifying the Work as Low-Sloped Roofing Instead of Steel Erection

Based upon the OSHA letter of Standard Interpretation and the OSHA postmishap investigation, the Board determined that Oneida misclassified the work as low-sloped roofing instead of steel erection. **Oneida was unaware of the OSHA interpretation to classify the work as steel erection (Root Cause 1).** SGS did not inform Oneida that the work was steel erection because SGS also misclassified the work as low-sloped roofing instead of steel erection.

SGS was unaware of the OSHA interpretation to classify the work as steel erection (Root Cause 2) until OSHA conducted its postmishap investigation. Adherence to and implementation of the more stringent fall protection requirements for steel erection described in 29 CFR 1926, Subpart R, may have prevented the mishap. See Figure 8.

Recommendation (RC2-1): Prior to issuing an RFP, the prime contractor should review OSHA Standards and letters of Standard Interpretations to properly classify work.

Recommendation (RC2-2): NASA/KSC and prime contractors should review current ongoing work involving roofing to ensure proper work classification and compliance with OSHA Standards and letters of Standard Interpretation.

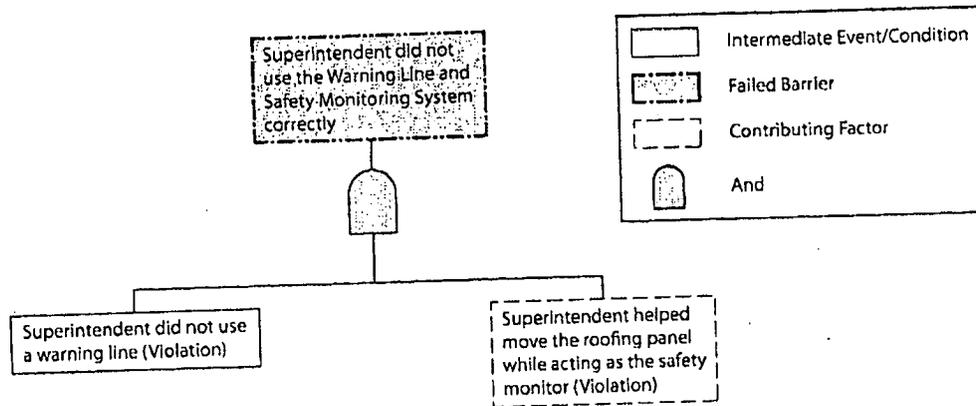
Figure 9. Violations Contributing to Superintendent's Failure To Use the Warning Line and Safety Monitoring System Correctly

The Warning Line and Safety Monitoring System, which is permitted by OSHA 29 CFR 1926.501(b)(10) for work on low-sloped roofs, was not used properly by the Oneida superintendent. Two OSHA violations were that the superintendent (1) did not use a warning line and (2) helped the Oneida workers carry the roofing panel while acting as the safety monitor (Figure 9).

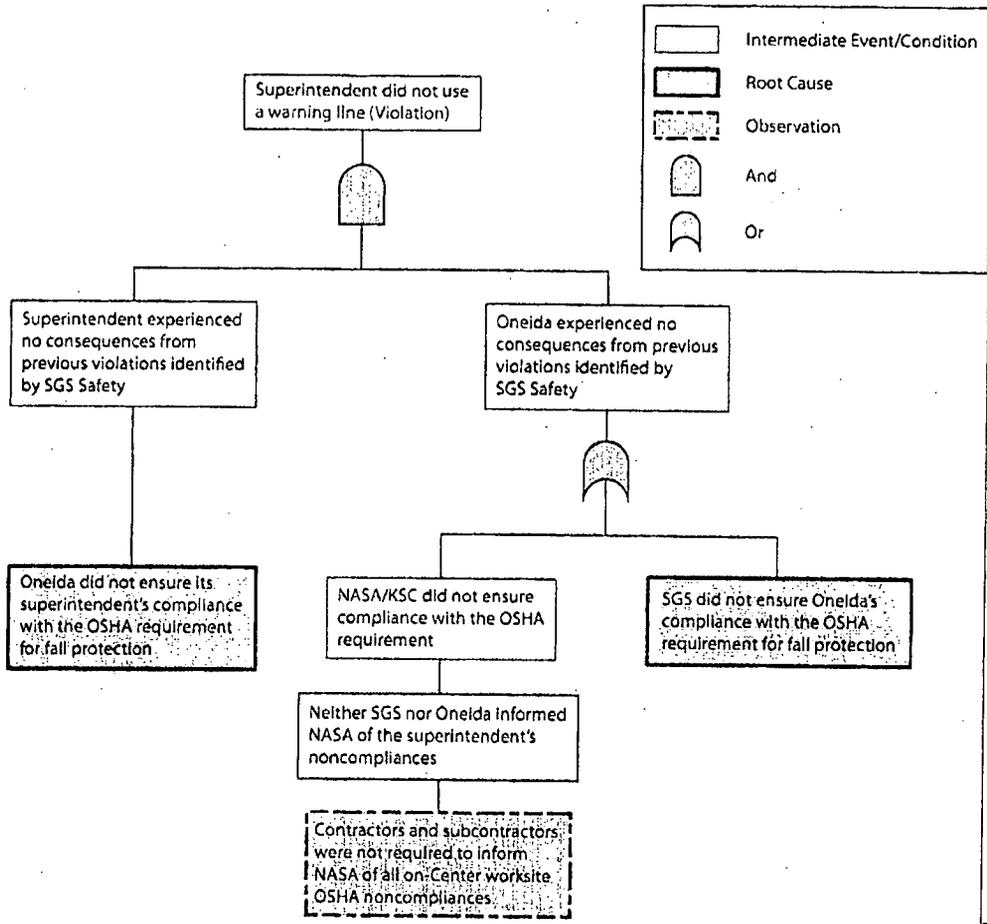
Figure 10. Root Causes of and Observations Regarding Warning Line Violation

Oneida considered this work to be low-slope roofing and was using a Warning Line and Safety Monitoring System as fall protection. The Board noted that the superintendent had been written up by SGS Safety for warning line and safety monitor violations on three separate occasions prior to this mishap. However, the noncompliances were corrected on the spot and no further retraining, corrective action, or disciplinary action was taken by Oneida toward the superintendent or by SGS toward Oneida. The Board determined that because the noncompliances could have had fatal consequences and were committed by the same individual over a 6-day period, the noncompliances should have been an indicator to SGS and Oneida management of the superintendent's lack of implementation of this

OSHA requirement. These noncompliances did not indicate a lack of knowledge of the warning line because the superintendent took corrective action after each notice of noncompliance by SGS Safety.

- c. Oneida experienced no consequences from previous violations identified by SGS Safety.

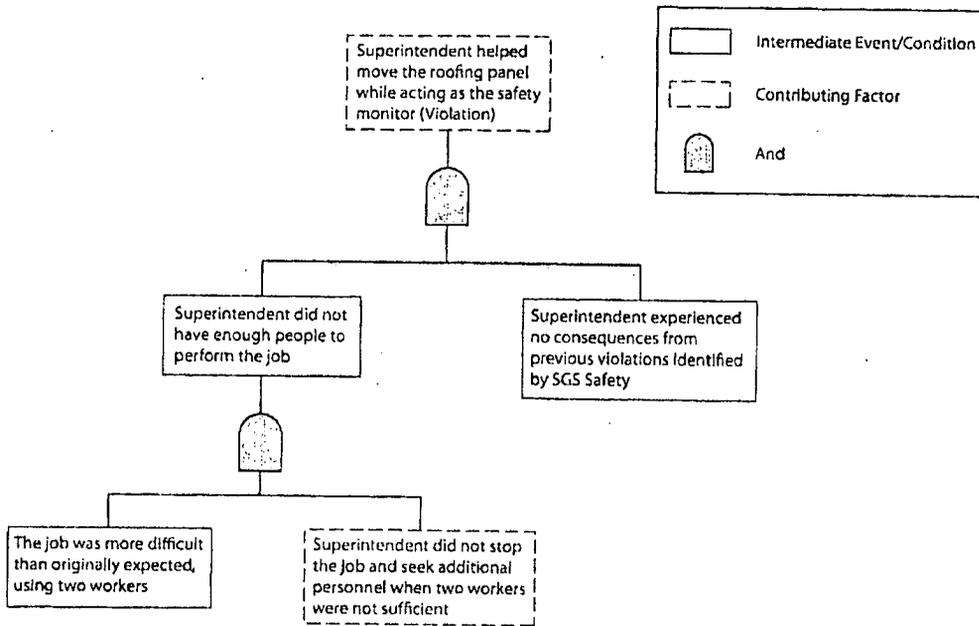
Figure 11. Factors Contributing to and Observation Regarding the Safety Monitor Violation

- a. OSHA 29 CFR 1926.502(h) states that the employer shall designate a competent person to monitor the safety of other employees, and that the employer shall ensure that the safety monitor complies with the following requirements: (1) be competent to recognize fall hazards; (2) warn the employee when it appears that the employee is unaware of a fall hazard or is acting in an unsafe manner; (3) be on the same walking/working surface and within visual sighting distance of the employee being monitored; (4) be close enough to communicate orally with the employee; and (5) *not have other responsibilities which could take the monitor's attention from the monitoring function* (emphasis added).

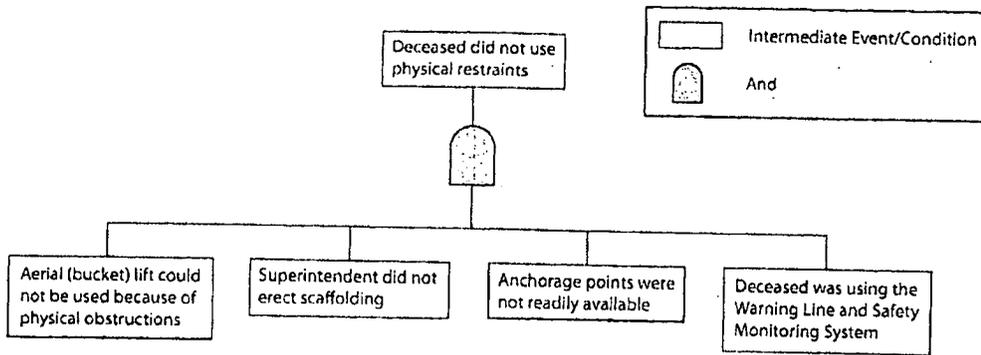
Figure 12. Events Leading to the Failure of the Deceased To Use Physical Restraints

- a. Aerial (bucket) lift could not be used because of physical obstructions.

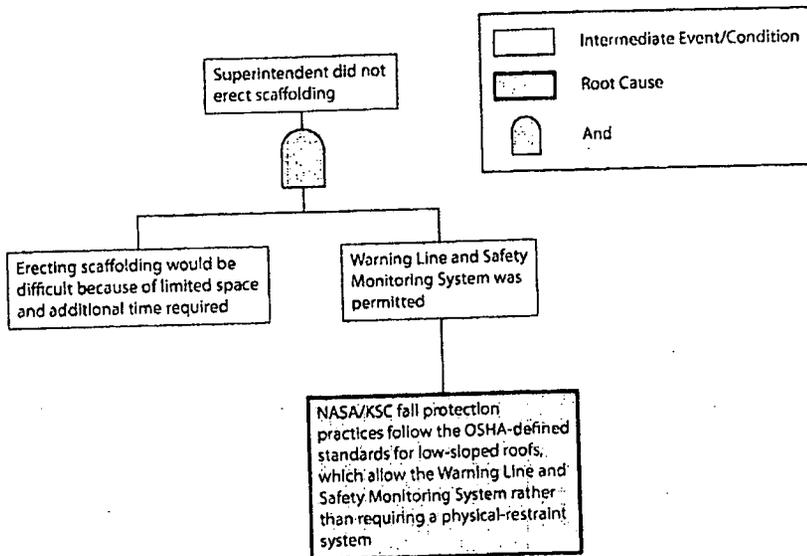
Figure 13. Events Leading to the Superintendent's Decision Not To Erect Scaffolding

After the mishap, scaffolding was installed in the available 7-ft 8-in-wide area to provide the Board a view of the roof. This scaffolding would not have allowed the workers full access to all areas of the leading edge where the work was being performed. Therefore, additional fall protection would still have been needed, besides scaffolding, to meet the fall protection requirements.

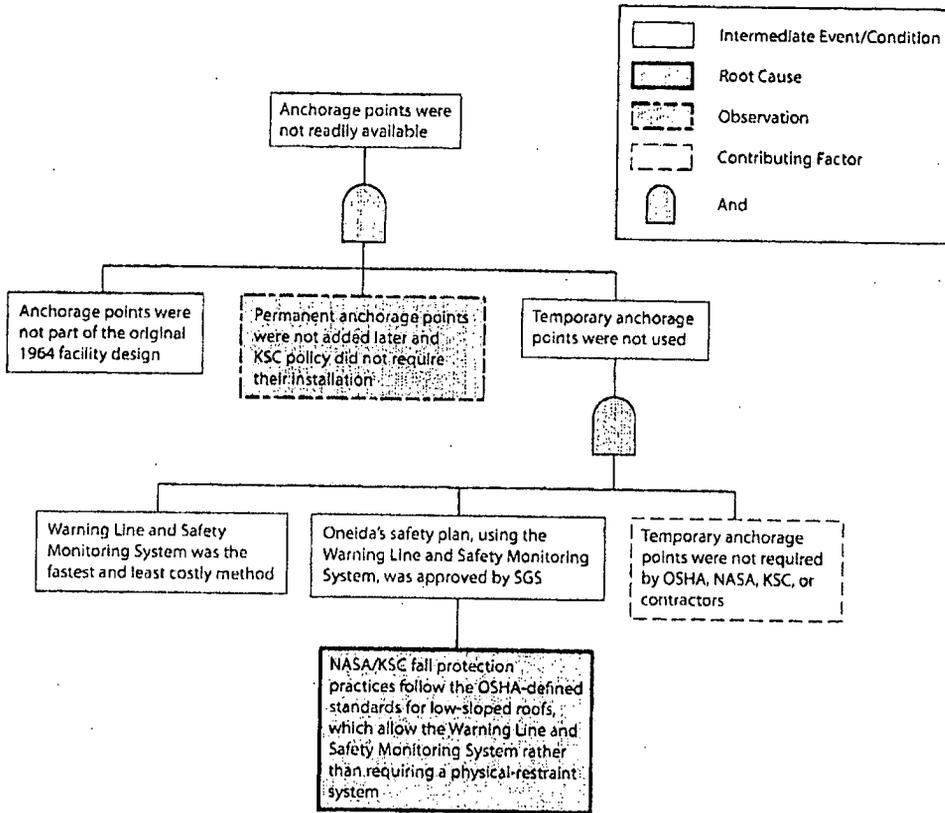
Figure 14. Events Leading to the Unavailability of Anchorage Points

Neither permanent nor temporary anchorage points were available or made available on Building M6-794 at the time of the mishap. The Board determined that permanent anchorage points were not part of the original 1964 facility design. **Permanent anchors were not added later, and KSC policy did not require their installation (Observation 8).**

Temporary anchorage points were not used by the Oneida roofing crew for several reasons. First, the Warning Line and Safety Monitoring System (permitted by OSHA for low-sloped roofing work) was the fastest and least costly method to perform this job. Temporary anchorage points were not required by OSHA, NASA, KSC, or contractors. There is no evidence that temporary anchorage points, which could have been provided by Oneida, were ever considered prior to the roofing job commencing. In fact, the Oneida safety plan, which permitted the use of the Warning Line and Safety Monitoring System, was properly submitted and approved by SGS Safety, Health, and Training in accordance with SGS OSH-P-0215, Construction and Service Subcontractor Safety Program. The plan also complied with OSHA, NASA, KSC, and contractor safety requirements for low-sloped roofing work. The use of alternative methods, such as temporary tie-offs or scaffolding, would have required additional time and cost to plan and set up. It should be noted that after the mishap, a temporary fall protection system (life lines) was used to allow the roofing job to be completed.

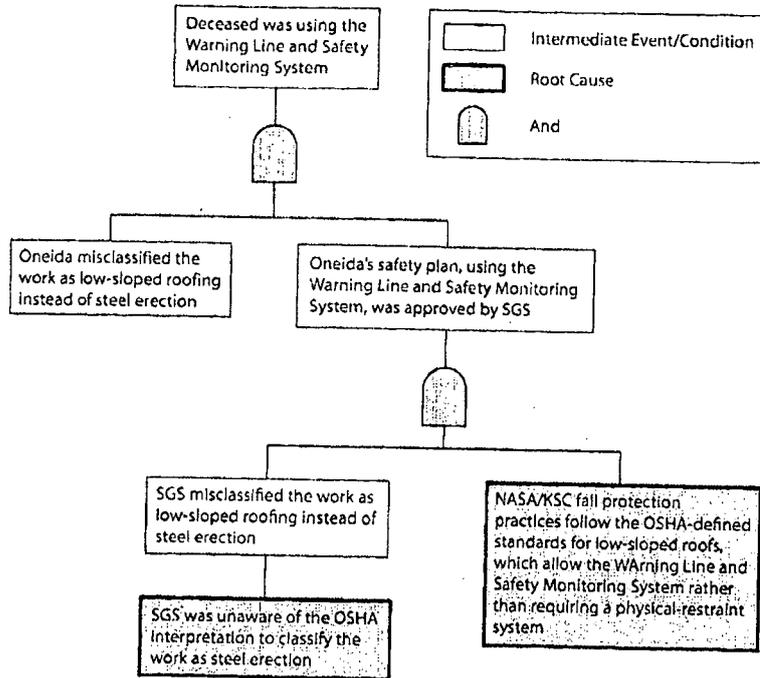
Figure 15. Events Leading to Use of the Warning Line and Safety Monitoring System

The Building M6-794 roof met the requirement for a low-sloped roof (2:12 horizontal:vertical slope) but was wider than 50 ft (approximately 120 ft). This regulation permitted the use of a warning line system combined with a safety monitoring system for the Building M6-794 roof, but a safety monitor alone was not sufficient because of the width of the roof.

Recommendation (RC5-1): NASA/KSC should develop and implement a fall protection policy and program for low-sloped roofing work that is more stringent than the applicable OSHA standard and requires the use of physical restraints when working within 6 feet of the edge. The use of warning lines and safety monitors or other nonphysical-restraint systems should be reserved for special circumstances after review and approval through a NASA/KSC formalized variance process.

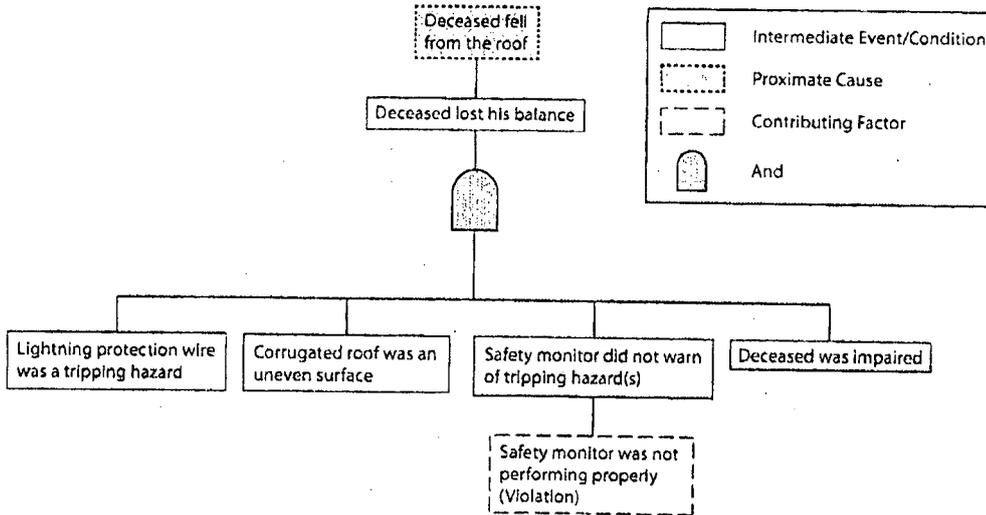
Figure 16. Events Leading to the Deceased's Loss of Balance

The Board determined that the deceased either tripped or stumbled prior to falling off the roof rather than simply backing off the roof. The two most likely tripping hazards were the lightning protection wire that was located approximately 6 inches from the edge of the roof and the uneven working surface caused by the corrugated roof. The Board also determined that there was no oral warning provided by the superintendent/safety monitor to possibly allow the deceased to avoid the tripping hazard.
