## The History of Orbiter Corrosion Control (1981 – 2011)

Richard W. Russell  
NASA Kennedy Space Center

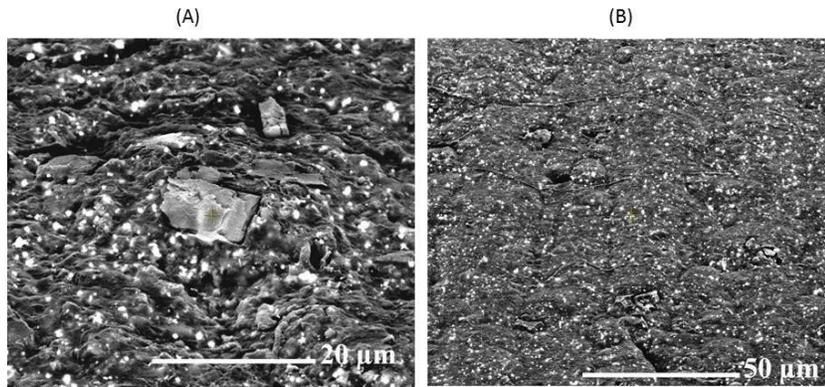
A comparison SEM image is shown in Figure 3. Even with the difference in magnification the differences between the images is apparent. The Enterprise sample is very rough and flaky while

the control sample is smooth. The light dots in both images represent chromium. Additional examination found that the particle size and distribution of chromium particles varied widely (Figure 4) and some of the particles were larger than expected.

Figure 3. (A) Backscattered SEM image of the surface of the Koropon sample from the Orbiter Enterprise. (B) Backscattered SEM image of the surface of the Koropon from the control sample.

It was concluded that the poor performance of the 30 year old Koropon primer appeared to be directly related to both a reduced level and an uneven distribution of chromium within the matrix of the film.

The CCRB used these conclusions in building rationale to either increase the inspection interval of critical areas, or as was previously mentioned strip and replace the primer. As a side note, in both commercial and military aircraft no known use of a similar primer was found anywhere

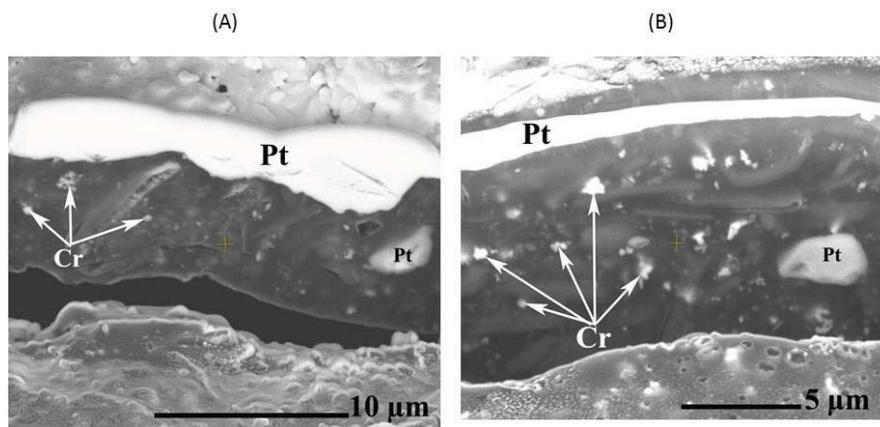
Figure 4. (A) Backscattered SEM image of the Enterprise Koropon sample showing the chromium distribution throughout the matrix in this region. (B) Backscattered SEM image of the control Koropon sample showing the chromium distribution throughout the matrix in this region.

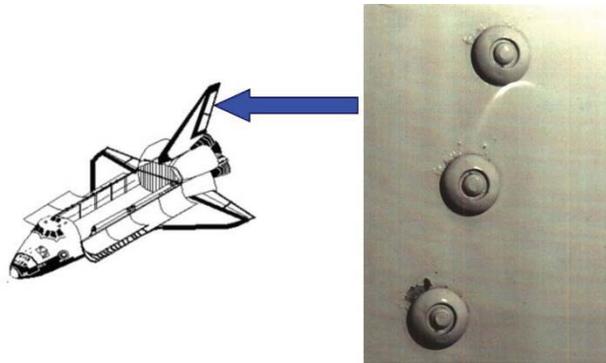
The Rudder Speed Brake (RSB) is a structure that is deployed during landing to assist in slowing down the vehicle. The RSB is constructed from conventional aluminum ribs and spars with 2024 aluminum honeycomb skin panels. The chemical filmed honeycomb facesheet has two coating of Koropon primer and a topcoat. Part of the RSB assembly included Inconel trailing edge clips which aided in door closure. The environment of the RSB was external. They were exposed to unpurged/unconditional air during OPF processing and to the seacoast air at the Pad. Two major corrosion problems surfaced. The first was pitting corrosion in the acreage and around fasteners. This was especially problematic since the facesheet was only 0.011 thick, see Figure 5. Also galvanic corrosion was found at the faying surface between the aluminum facesheet and Inconel clips. Besides implementing basic repair procedures proactive measures introduced included washing the RSB panels upon return to the processing facility. Also, the CCRB recommended that the panels be stripped and re-coated every six missions. For the Inconel clips, a barrier layer of room temperature vulcanized rubber (RTV) was applied on the faying surfaces.

Figure 5. The Rudder Speed Brake highlighting pitting corrosion near fasteners.

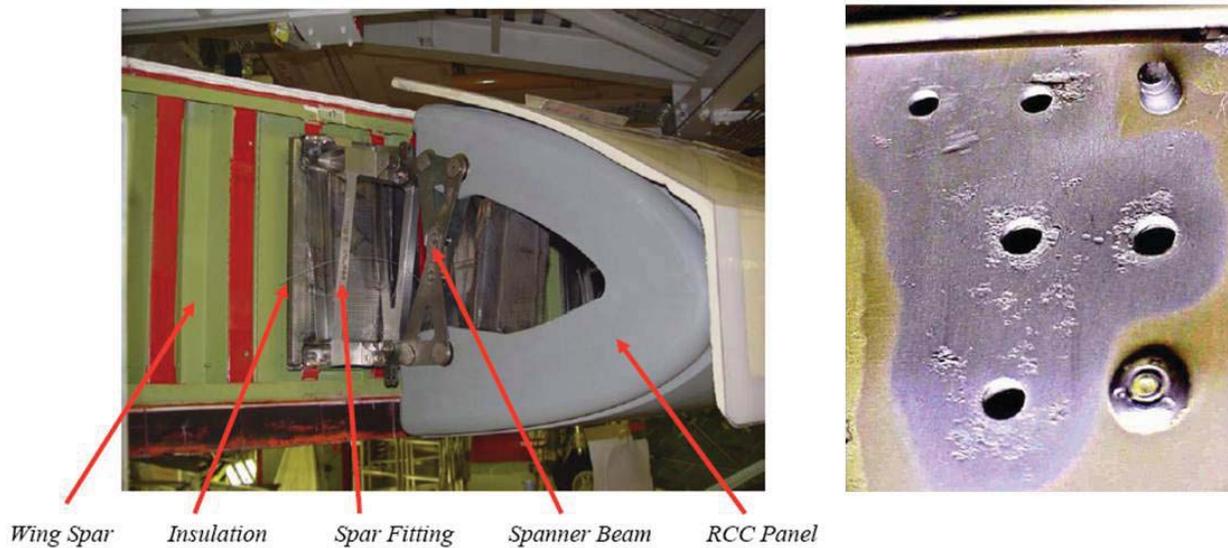
The Wing Leading Edge (WLE) Spar was constructed of a corrugated aluminum alloy panel approximately 0.040 inches thick. The Orbiter Columbia had a slightly different design with a flat honeycomb panel structure. As shown in the left side of Figure 6 attached to the WLE spar are Inconel thermal control system blankets, Inconel attach fittings and ultimately the reinforced carbon-carbon panels. The aluminum panels were chemical film treated and coated with three coats of Koropon primer. The WLE structure is not purged.

Due to the galvanic dissimilarities between the WLE structure and the attaching hardware pitting corrosion was frequently observed, as shown in the right side of Figure 6. Like the RSB panels a barrier layer of RTV was applied to mitigate this issue. Also, a single depainting and repainting

Figure 6. The basic construction of the wing leading edge and an example of pitting corrosion.

was instituted during maintenance period. Unfortunately, the Orbiter Atlantis never experienced this and an increase inspection protocol was instituted.

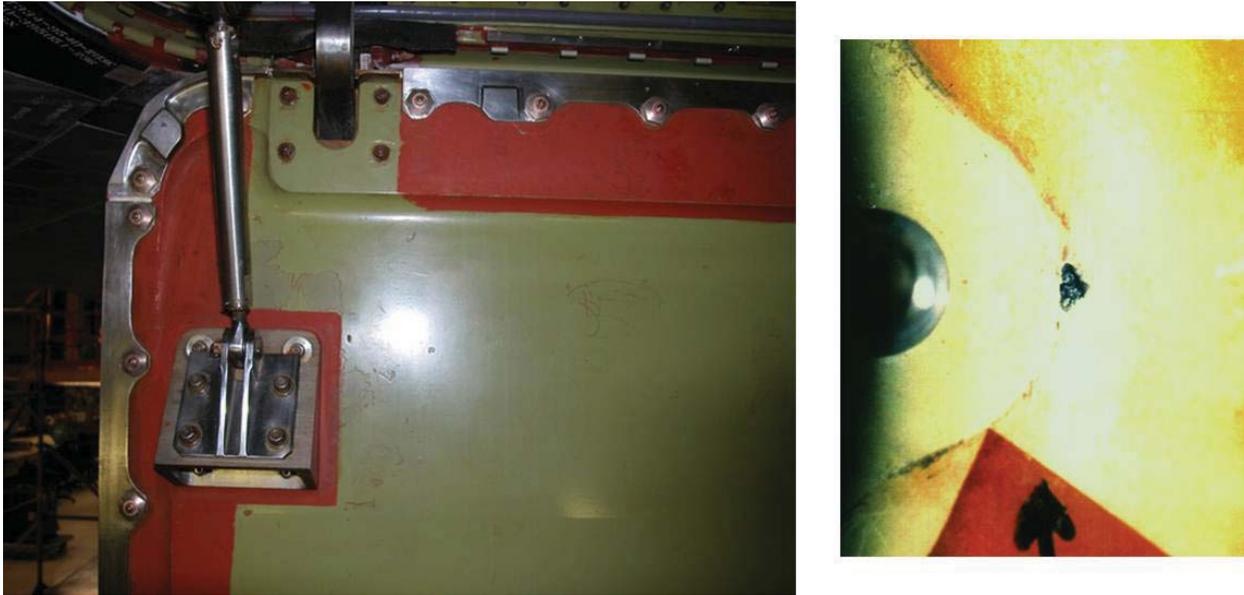
Each Orbiter has two External Tank (ET) on the underside of the vehicle. These doors close after the ET and Orbiter separate during ascent into Orbit. To maintain structural and thermal properties the ET doors were constructed from a beryllium alloy. Inconel support hardware was attached to each door. Over time the doors began to experience corrosion in both the open acreage and near or beneath the attach structure (Figure 7). Due to its unique metallurgical properties special care had to be taken when clean up or repair was performed. For shallow pits, the active corrosion product was removed and the pits were filled with an epoxy and recoated. For deeper pit removal or any sanding on the surface for primer removal special safety consideration were employed. For galvanically dissimilar regions an RTV barrier layer was applied.

Figure 7. A close up view of the attach hardware (right) on an External Tank door after the addition of an RTV barrier layer. Typical pitting is shown on the left.

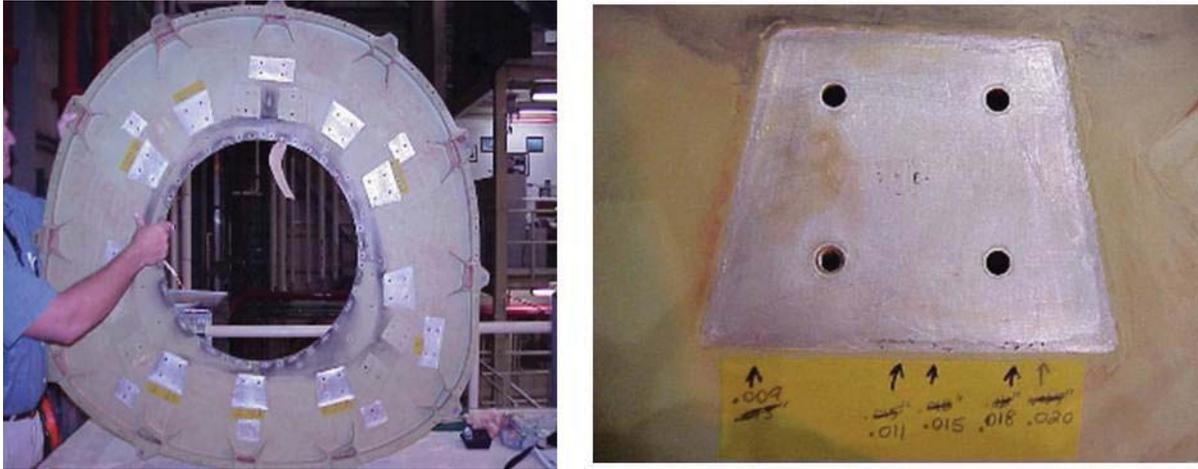
Corrosion pitting was found during routine inspections of the Nose Cap bulkheads of both Columbia and Discovery. The interface experience corrosion was one of many which were left bare to achieve an electrical bond. Electrically bonding creates a unique design challenge to the materials engineer and surfaces are designed to allow for the flow of an electrical current. To mitigate corrosion thin layers of a chemical conversion coating and a fillet seal of the joint are required. In this case the galvanic differences between titanium fillings and the aluminum bulkhead drove significant pitting. The introduction of a corrosion product not only reduces the strength of the structure but can also interfere with the conductive path this is required to maintain an electrical bond.

Figure 8 shows both the bulkhead and a close up view of the footprint for one of these electrical bonds. Pitting was found in numerous locations on the outer perimeter. For both cases the corrosion was attributed to a breach in the RTV fillet seal. Several options were suggested by the CCRB to prevent this from occurring in the future. These included the alternate use of grounding straps, the addition of an aluminum plating to the titanium faying surfaces, the addition of a conductive sealant and a change of fitting material. Unfortunately none of these changes were accepted by the program, but the lessons learned may prove to be beneficial in future designs.

Figure 8. A nose cap bulkhead after removal. The bare areas represent faying surfaces left bare for electrical bonding purposes, as see in great detail on the right.

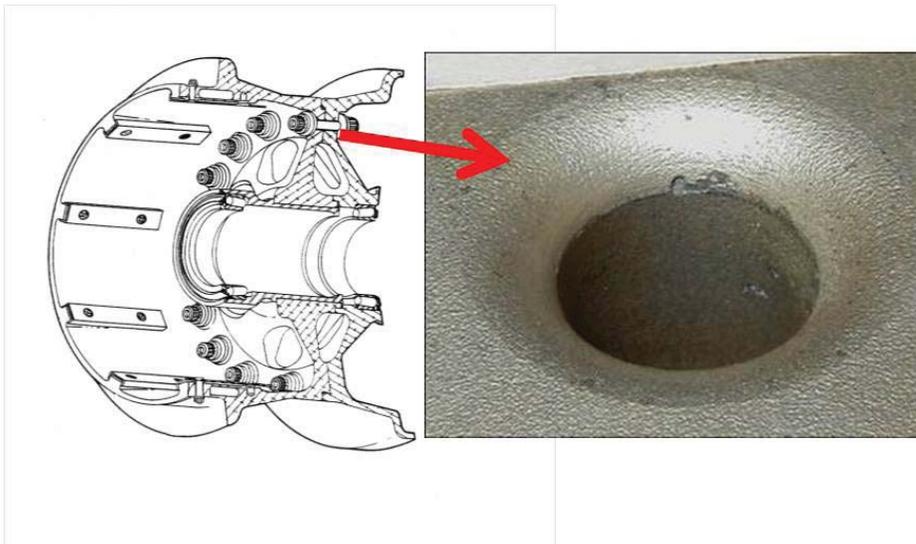
The MLG Wheels are constructed of a split wheel design with 18 tie-bolts connecting the inboard and outboard halves and made from aluminum 7049/7050-T73, as shown on the left side of Figure 8. The left picture highlights corrosion pitting which was attributed to galvanic corrosion between the wheel halves and the MP35N tie-bolts. A review of the contractor cleaning procedures found also found them to be inadequate. This issue created a great concern as the pitting could act as a stress concentration point leading to fatigue cracking and failure during landing.

Figure 9. A schematic of the Main Landing Gear wheel designs and a close up of corrosion pitting observed adjacent to a bolt hole on the inner surface.

Fracture analysis was performed and critical flaw sizes were determined. With these flaws sizes a limited number of cycles would be allowed. To further alleviate concerns testing was performed at Wright-Patterson AFB in Dayton, OH. Landing simulation tests were performed on a wheel that had seven notches cut into the outboard wheel half by EDM to represent worst-case corrosion indications. Eddy current and dye penetration analysis after each test run found no crack growth.

Design changes were made and improved corrosion protection schemes, inspection techniques and cleaning procedures were introduced.
