WHITE SANDS TEST FACILITY

Auto Ignition Temperature Test Chamber Fire Investigation

Based on Report DAA-33855

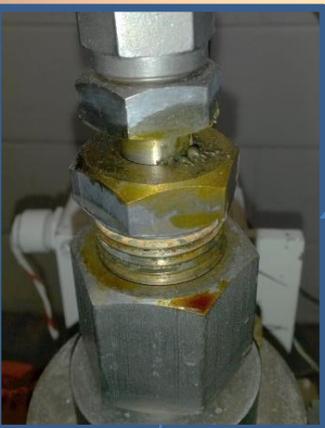
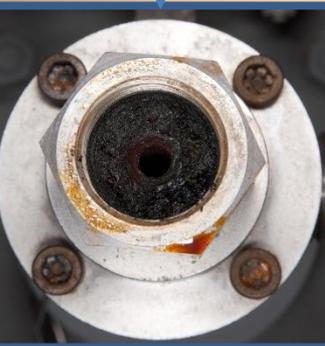
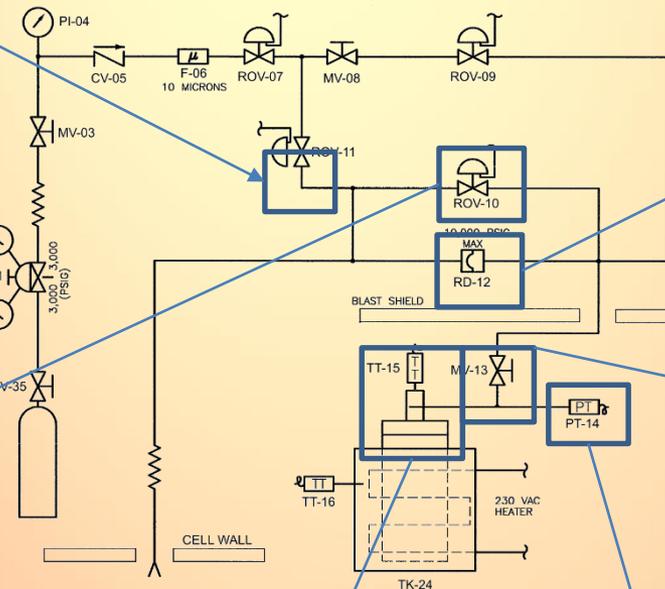
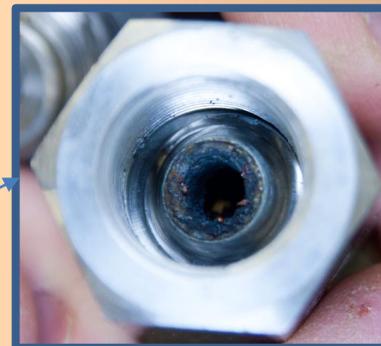
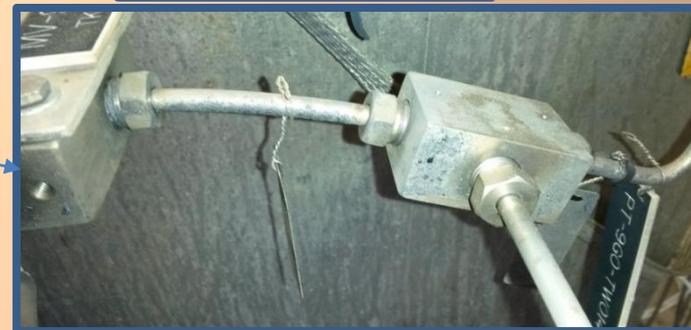
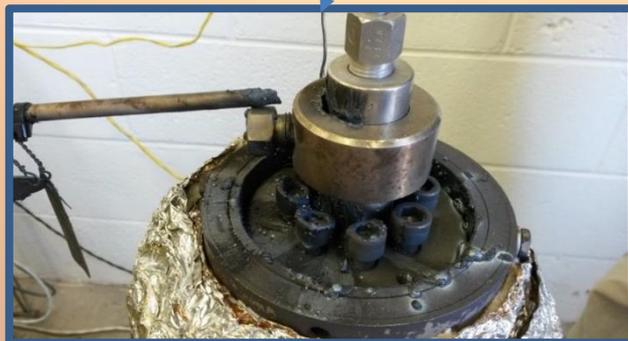
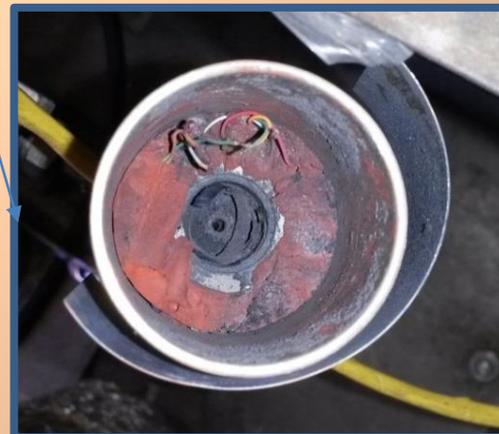
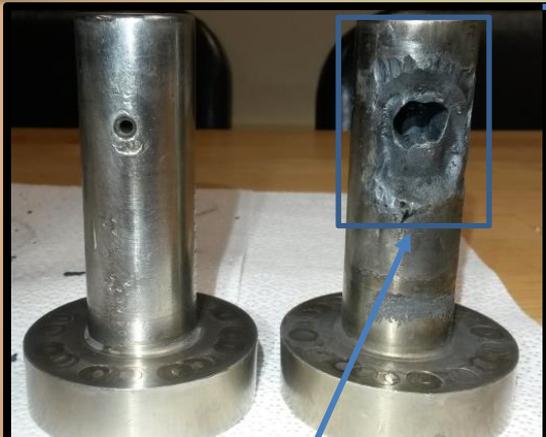
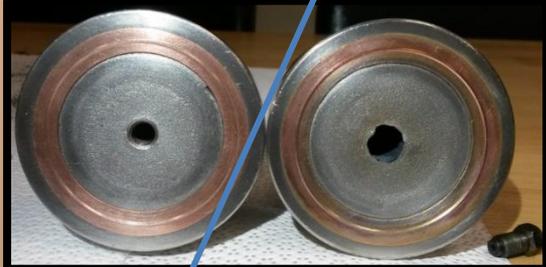
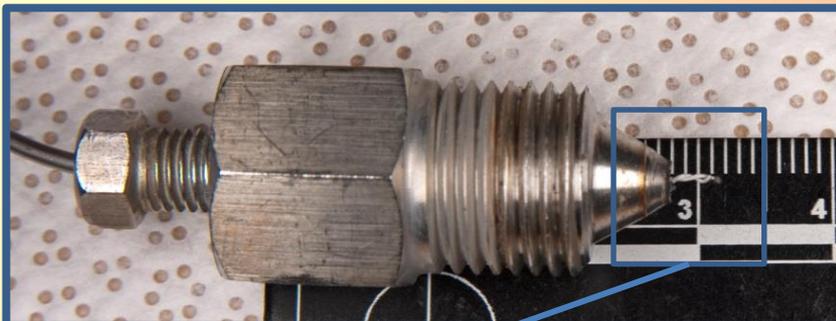
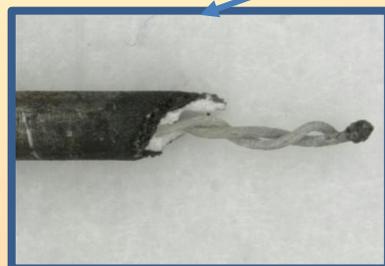
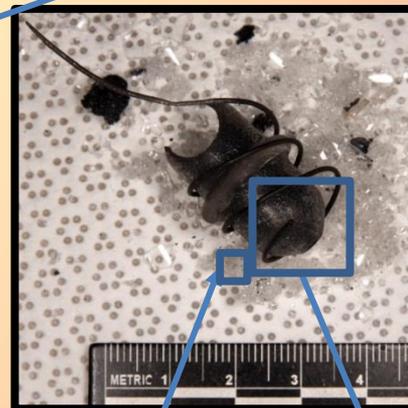
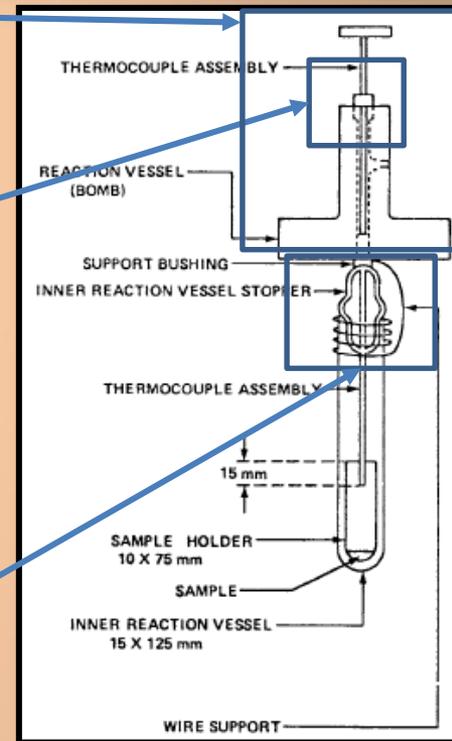
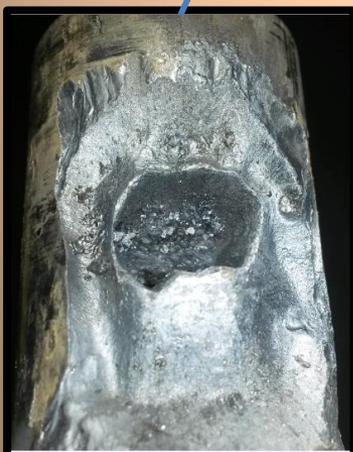
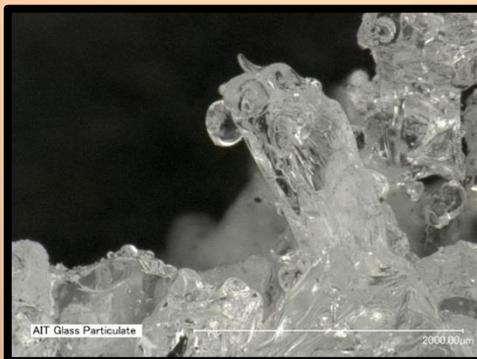
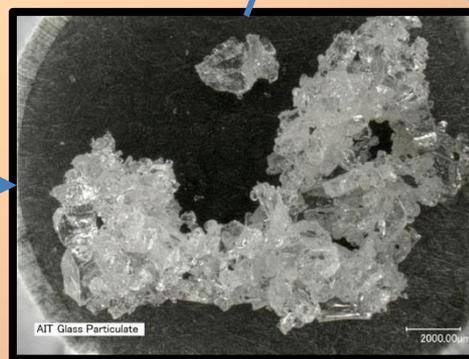
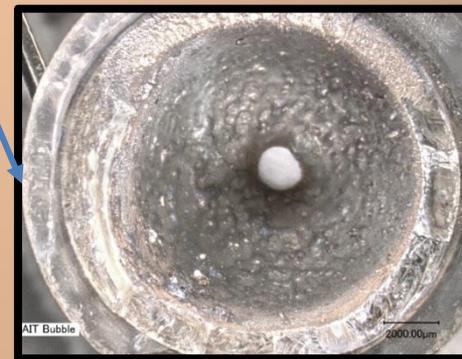
Incident

- Chemical Analysis
 - Sample weight of dodecane insufficient to cause full pressure rise alone.
 - Gordon-McBride Model
 - After 0.2g sample consumption, predicted chamber pressure 41.4 Mpa
 - Near sample 3,126 °C flame temperature @ 139 Mpa
 - Melting point of 304 SS 1400-1455 °C¹
 - ~3.5 g of SS would have to burn to increase chamber to 69 Mpa
 - ~28 g of SS was missing from inside of the reaction head
- Temperature rise happened before pressure rise.
- Secondary fire in RV-10 may have been due to rapid pressurization of contamination from previous testing.

- The stainless busing was replaced with brass to quench possible TC ignition events in the future.
- Contamination found down stream needs to be evaluated for cross contamination issues.
- Fire risks related to unexpected overpressure from contained sprayed metal fires is not well understood.
- The space suit POR was extremely robust.

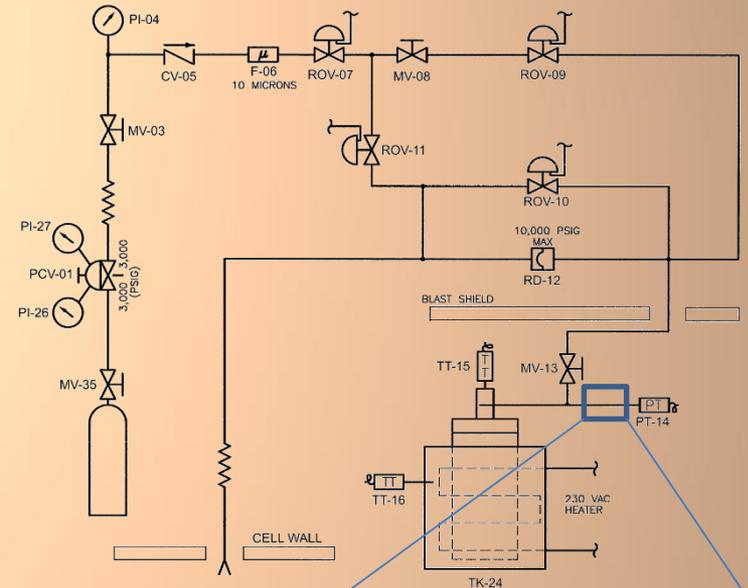
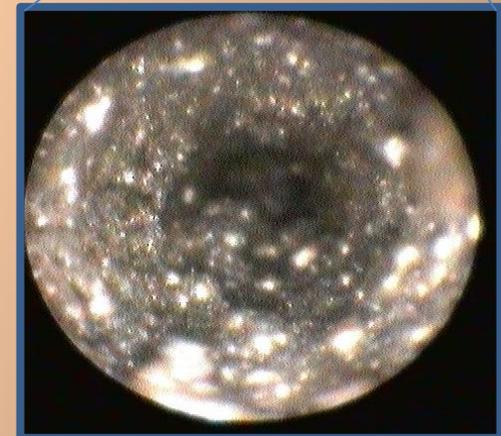
Pressure Rise

- TJE Type Transducer
 - Published Overpressure (Burst)
 - 172 Mpa (20 ksi)
- Data indicated large pressure rise between samples ~1 Hz
- Sufficient to mechanically rupture pressure transducer
- Fine Solidified Metal Spray found through out system increasing reaction rate. (Line dia 3.125 mm)
