Li-ion Soft Short Test & Cell Defect Correlation

by Eric Darcy NASA-JSC

NASA Aerospace Battery Workshop Huntsville, AL

5-7 Nov 2013

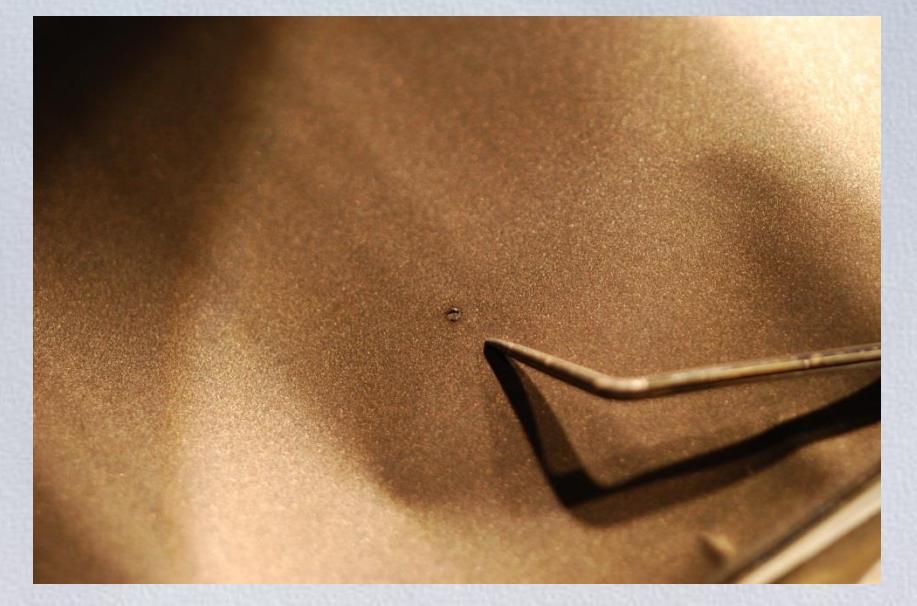
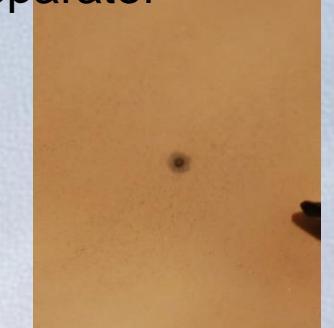
Moli Cell #PD10SABD076

Active material bump on anode coating

Active material deposit on cathode side of separator

Active material deposit on anode side of separator

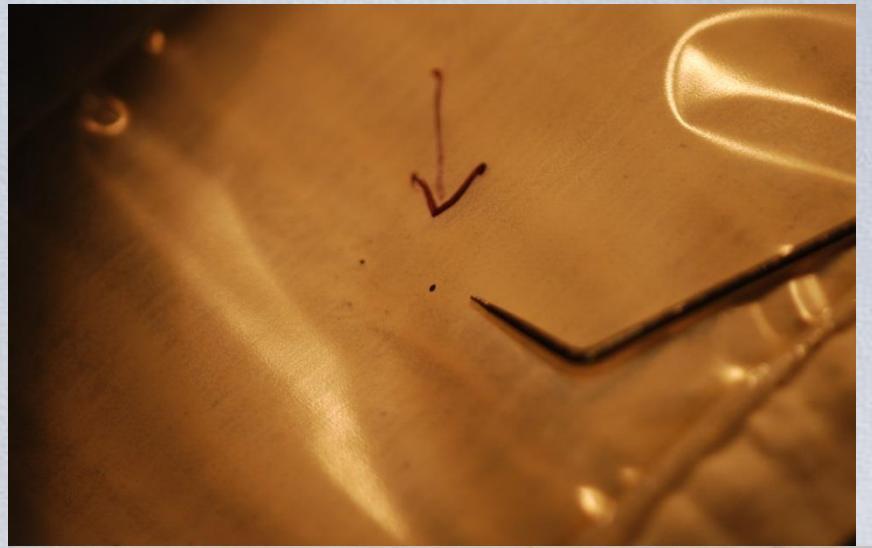
Moli Cell #PD10SABL117

- Found active material deposit on both side of separator
- Most likely cause of the soft short

Anode side

Cathode side

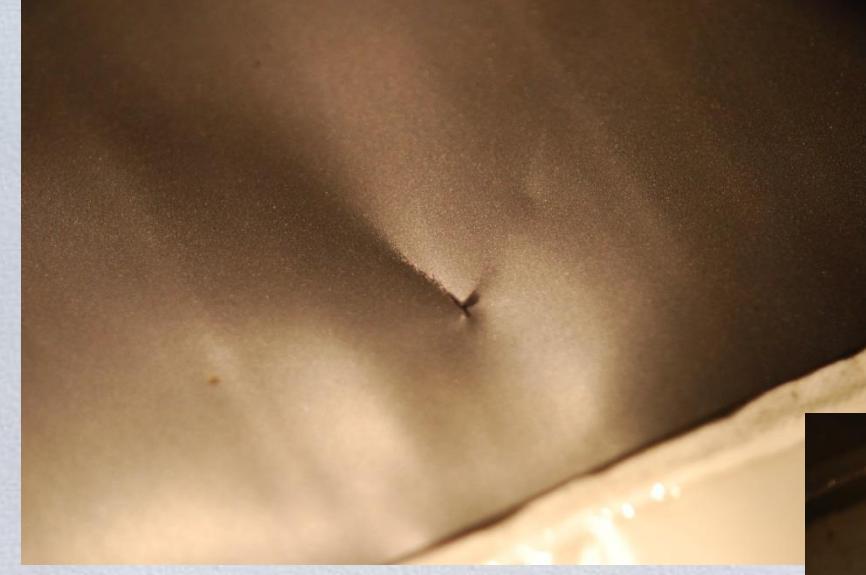
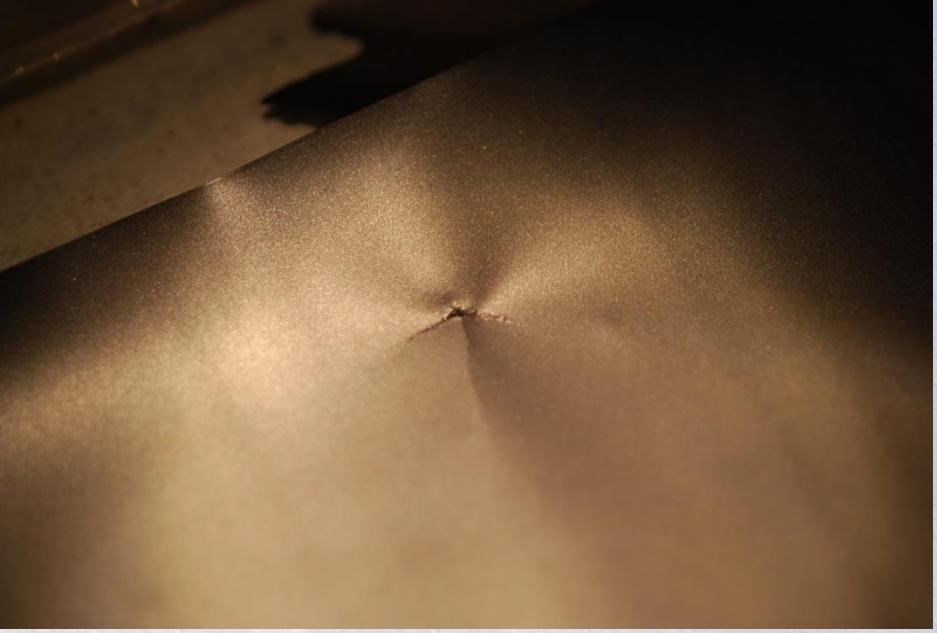
Moli Cell #PD10SABL117 (cont)

Found crease in cathode, but no separator mark

This defect may not have caused the soft short

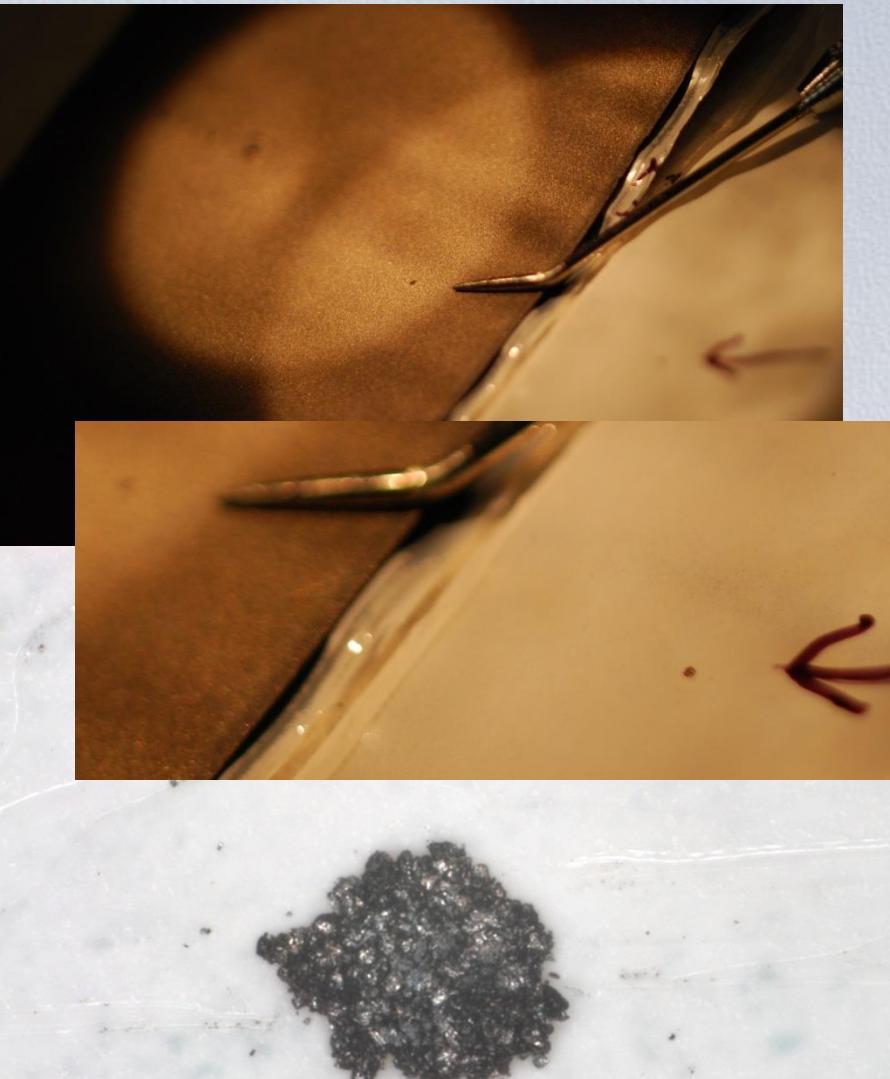
Moli Cell #PD10SAAT113

Anode side

- Found active material deposit on both side of separator
- Most likely cause of the soft short

Cathode side

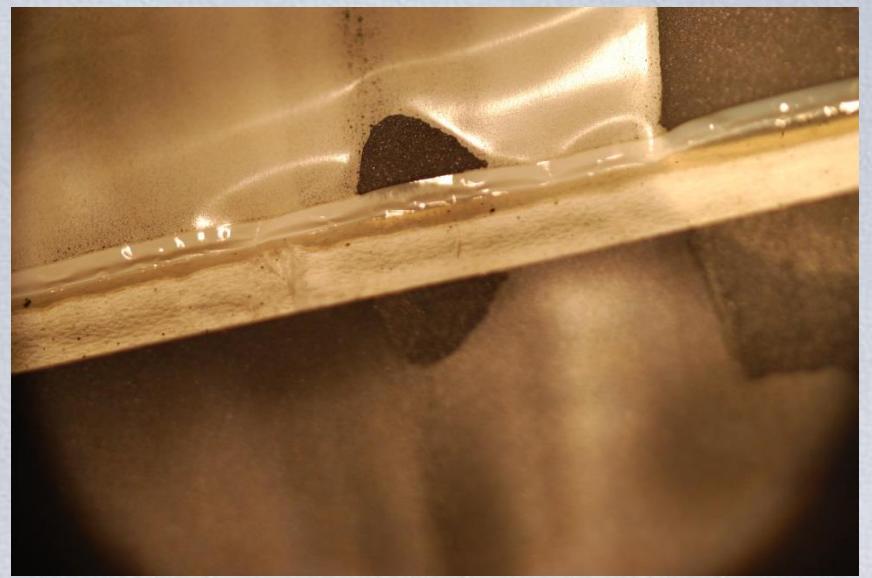
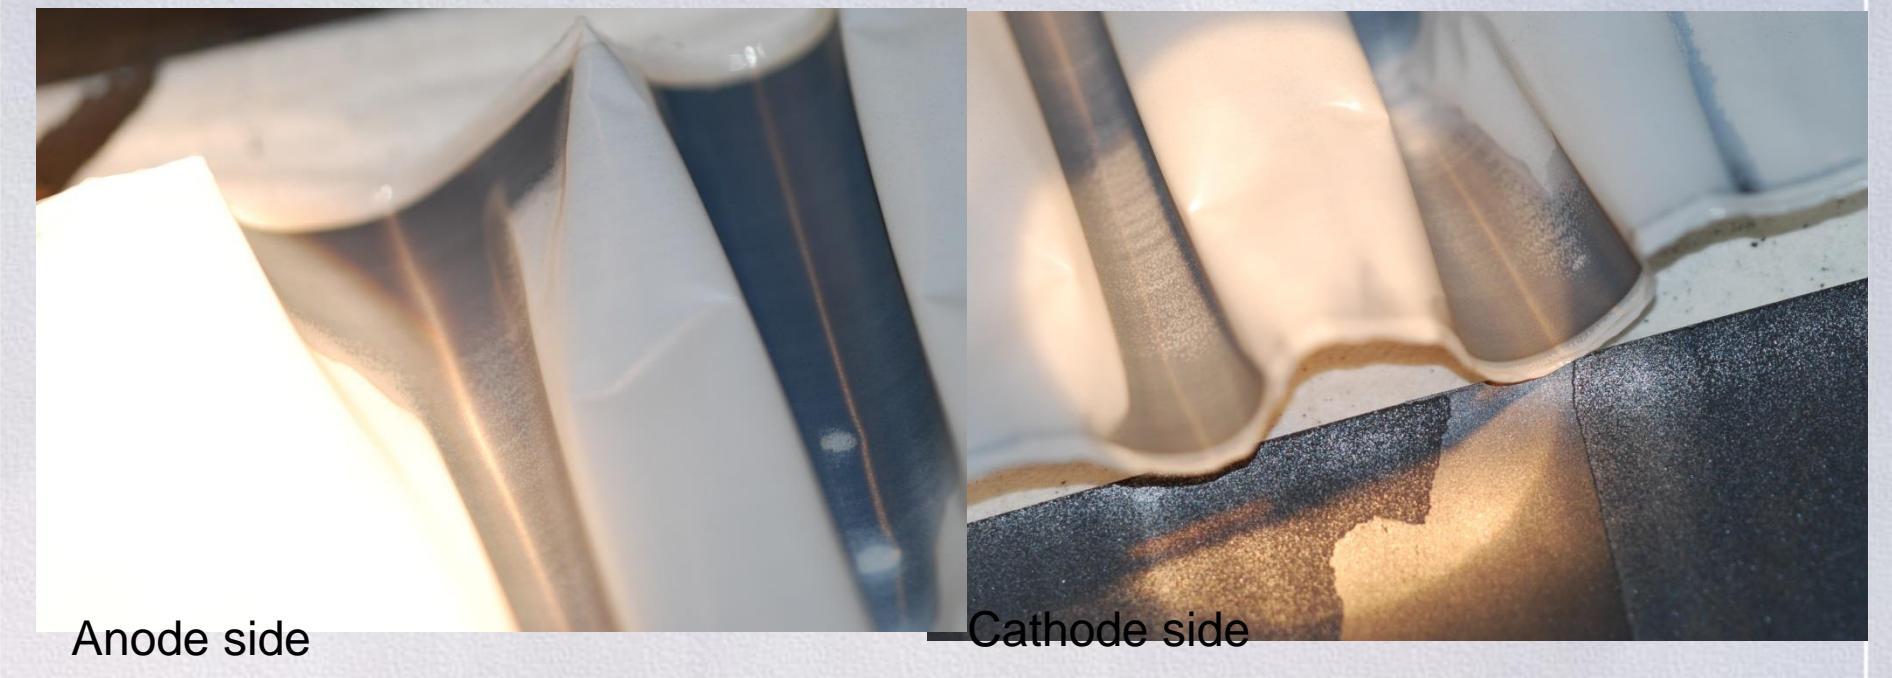
Moli Cell #PD10SAAR110

Heavy delamination of cathode active material found in separator

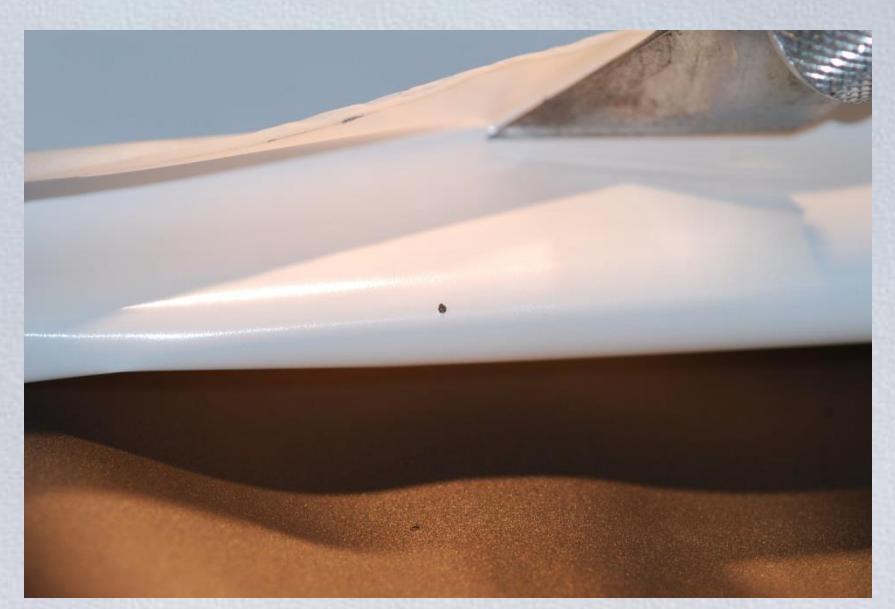
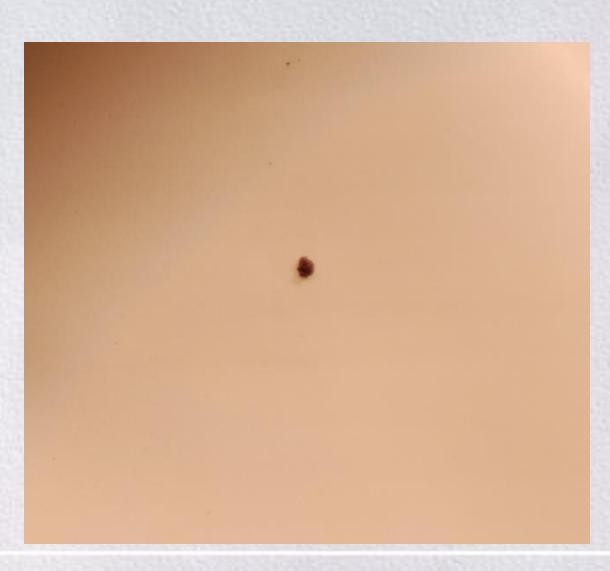
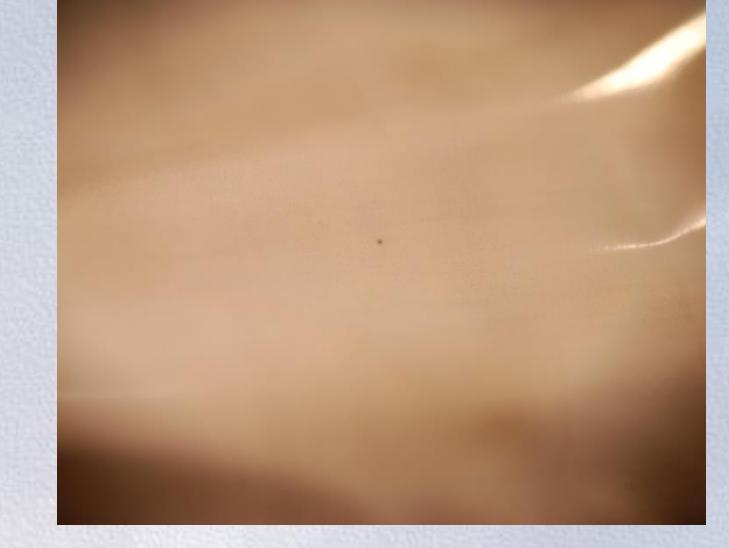
Moli Cell #PD10SAAP005

Active material bump on anode coating

OCV reject by 21.4 mV Failed Soft Short Test ($\Delta V = 2.7 \text{ mV}$)

Active material deposit on cathode side of separator

Active material deposit on anode side of separator

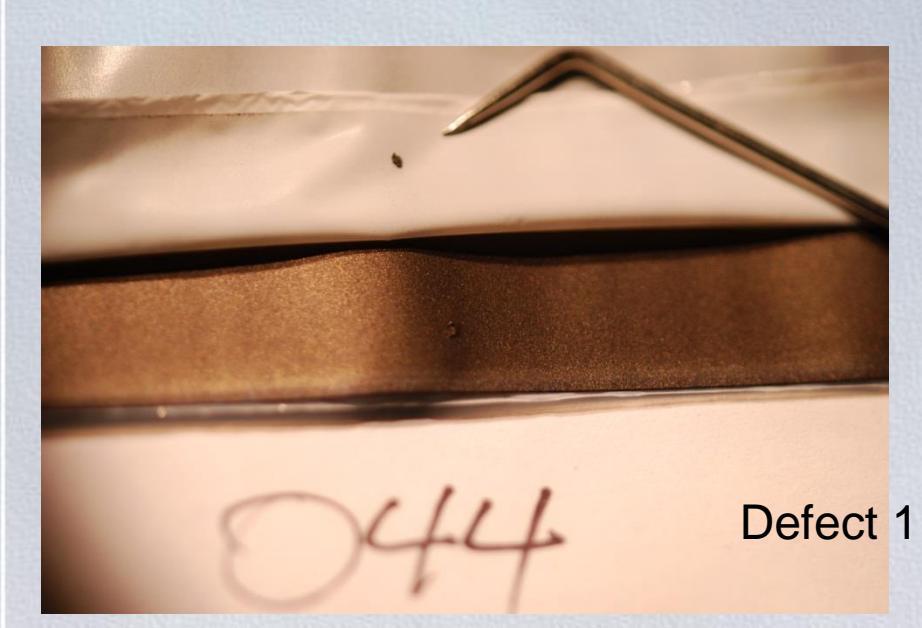
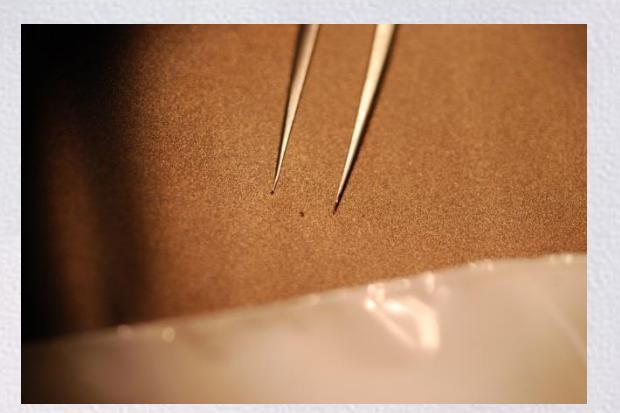
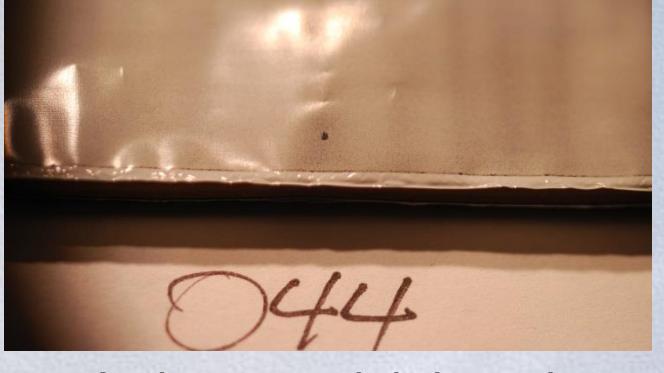
Moli Cell #PD10SAAX044

Active material spot on anode coating and adjacent spot on separator

Defect 2

Active material deposit on anode side of separator

OCV reject by 16.4 mV Failed Soft Short Test ($\Delta V = 2.9$ mV)

Active material deposit on cathode side of separator

Active material spot on anode coating

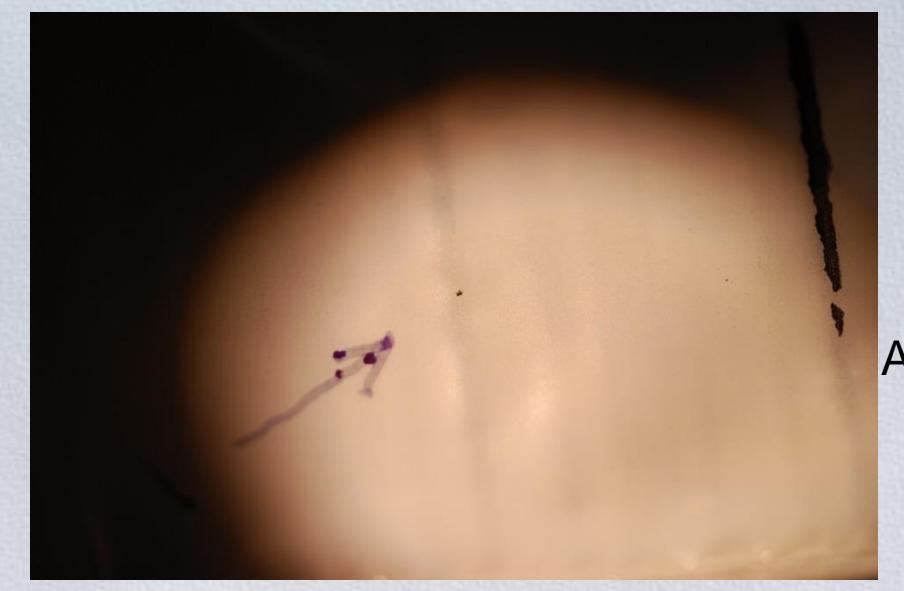
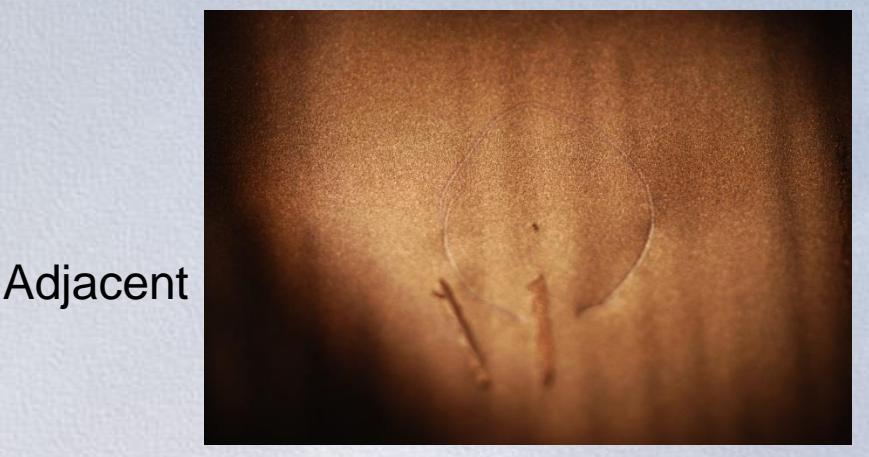
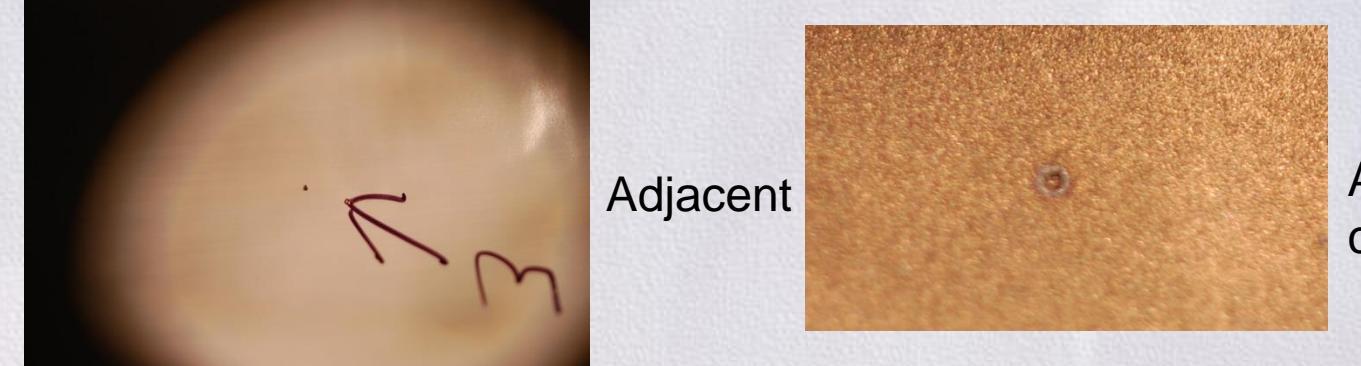
Moli Cell #PD10SAAX078

Active material bump on anode coating

OCV reject by 15.8 mV Failed Soft Short Test ($\Delta V = 2.7$ mV)

Active material deposit on cathode side of separator

Anode deposit causing halo mark

Active material deposit on anode side of separator

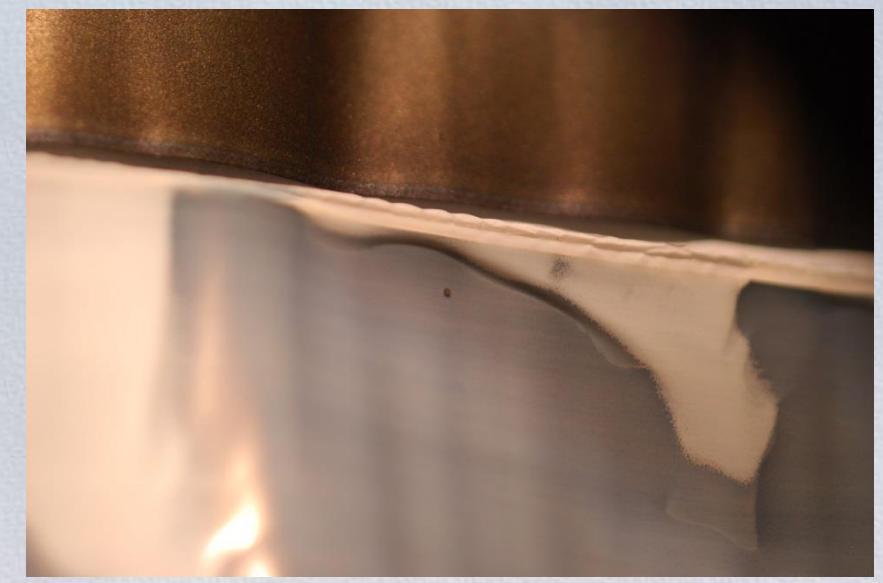
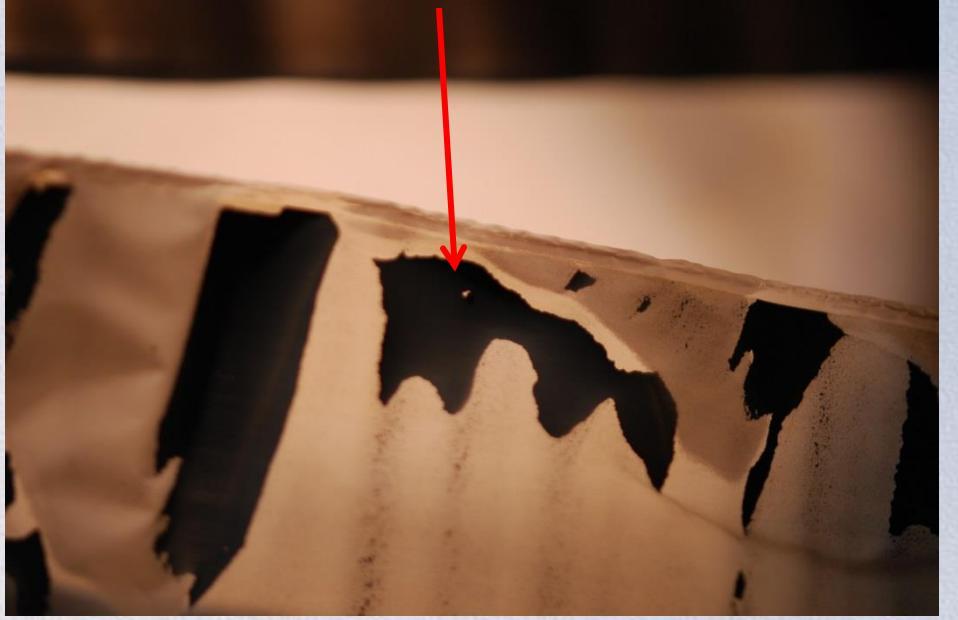
Moli Cell #PD10SABP037

Marginal OCV reject by 0.3 mV Passed Soft Short Test ($\Delta V = 0.7 \text{ mV}$)

Hole in active material laminated one separator

Active material deposit on anode side of separator with corresponding mark on anode

Separator does not appear to be bridged with active material Stereomicroscope analysis will be done for confirmation

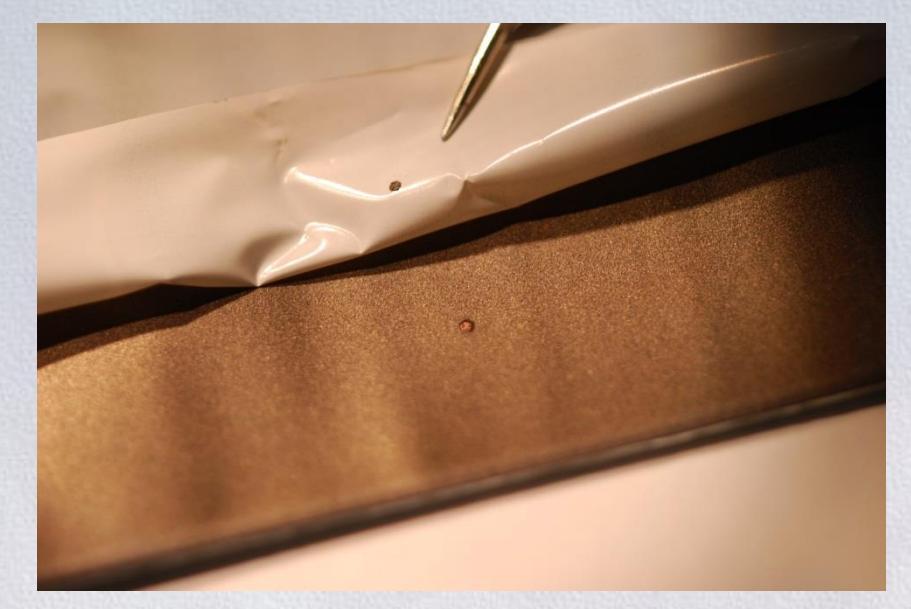
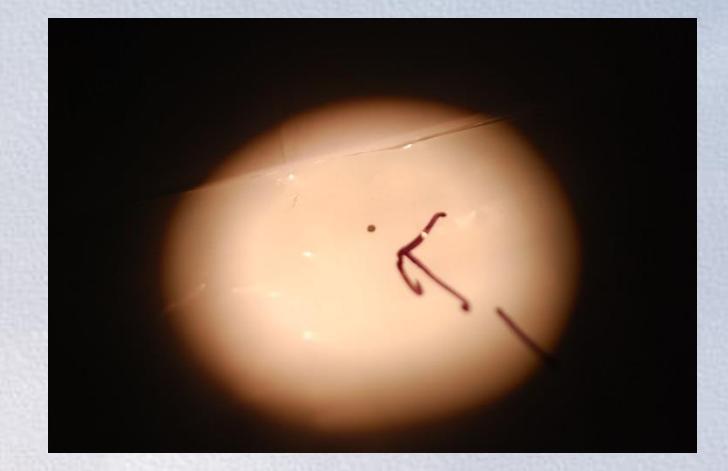
Moli Cell #PD10SAAV120

OCV reject by 69.6 mV Passed Soft Short Test ($\Delta V = 0.5$ mV)

Active material bump on anode coating With corresponding deposit on separator

Shadow of spot on cathode side of separator

Stereomicroscope analysis will determine if material bridge exists
