# **Schlieren System Enhancements at GRC**

**Advanced Schlieren Working Group Meeting  
November 21 & 22, 2013**

**RHI/Optical Instrumentation and NDE Branch  
NASA Glenn Research Center**

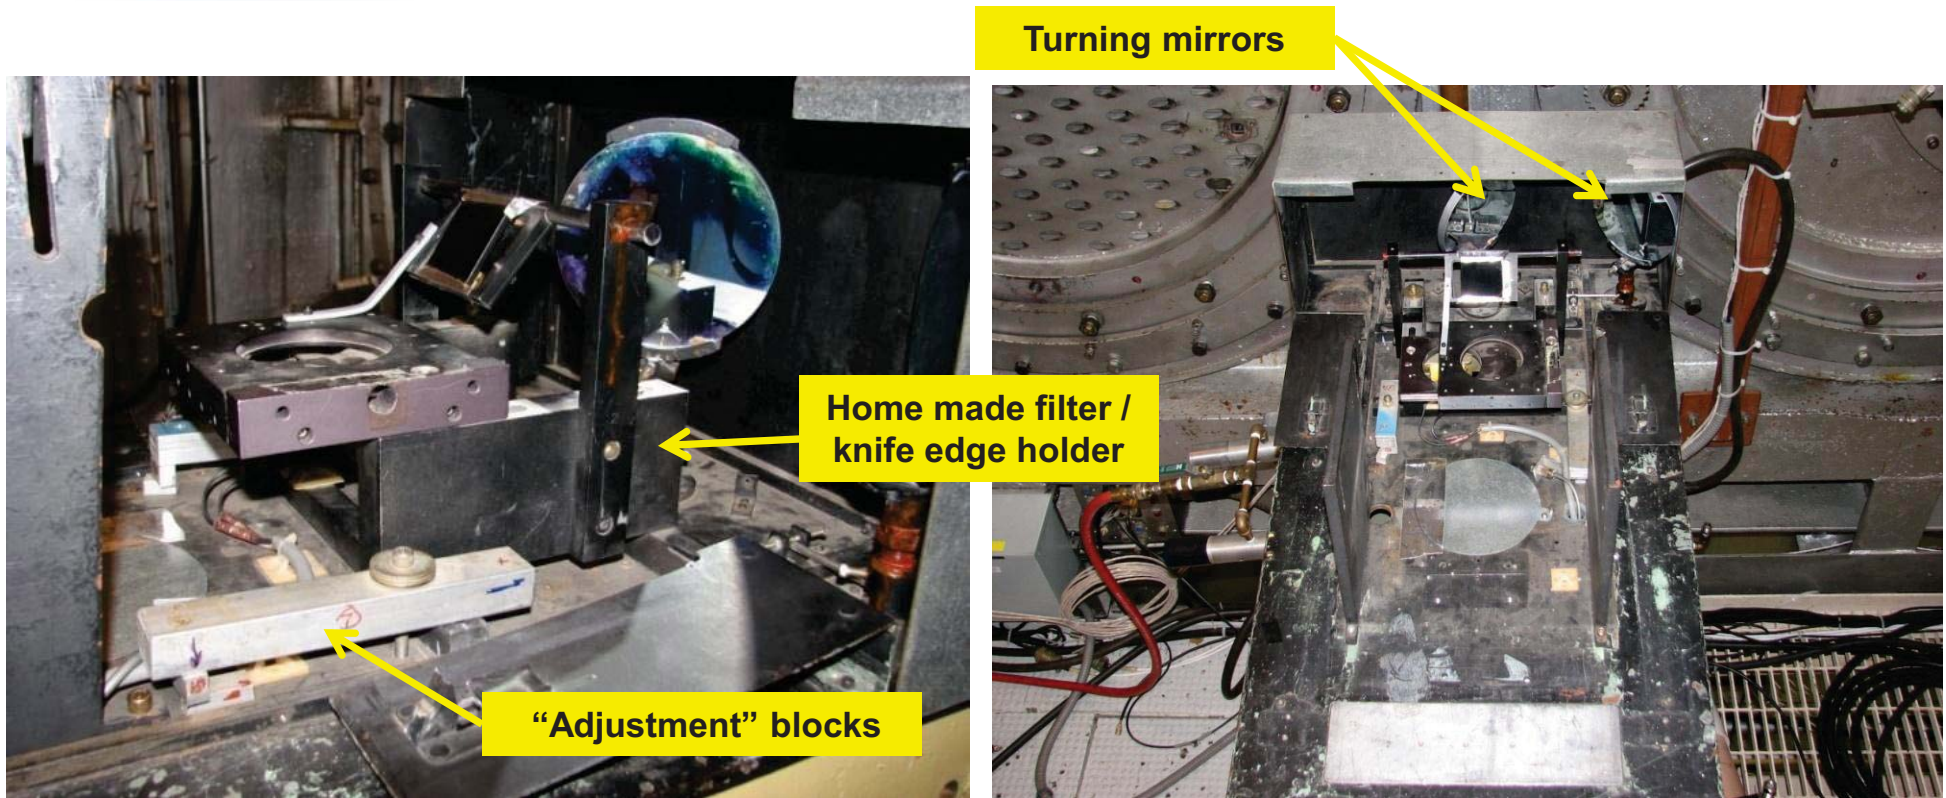
Original 8x6 Schlieren Receiving Optics

- The system used “home made” and very antiquated components
- Very hard to adjust
  - No remote adjustment capability on knife edge
- No provisions for adjustable camera mounts
  - Cameras installed as needed and attached to fixed plate
- The system was extremely difficult to set-up and very sensitive to vibration

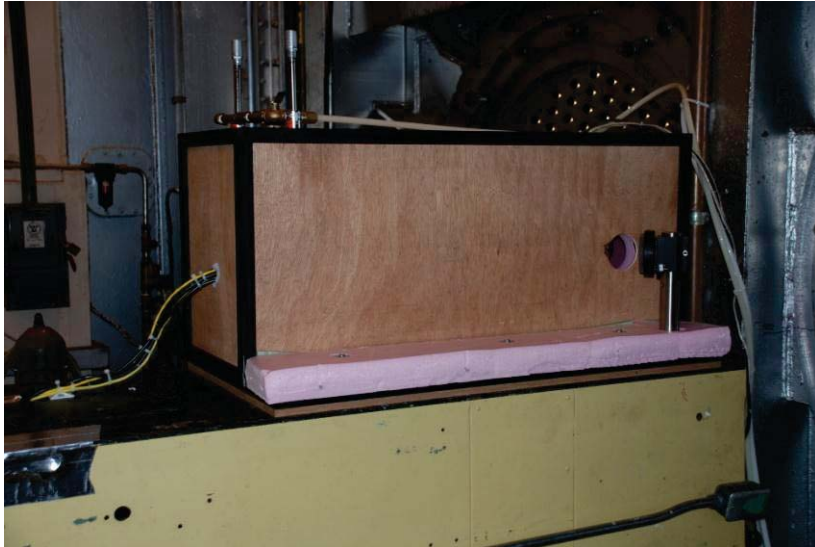
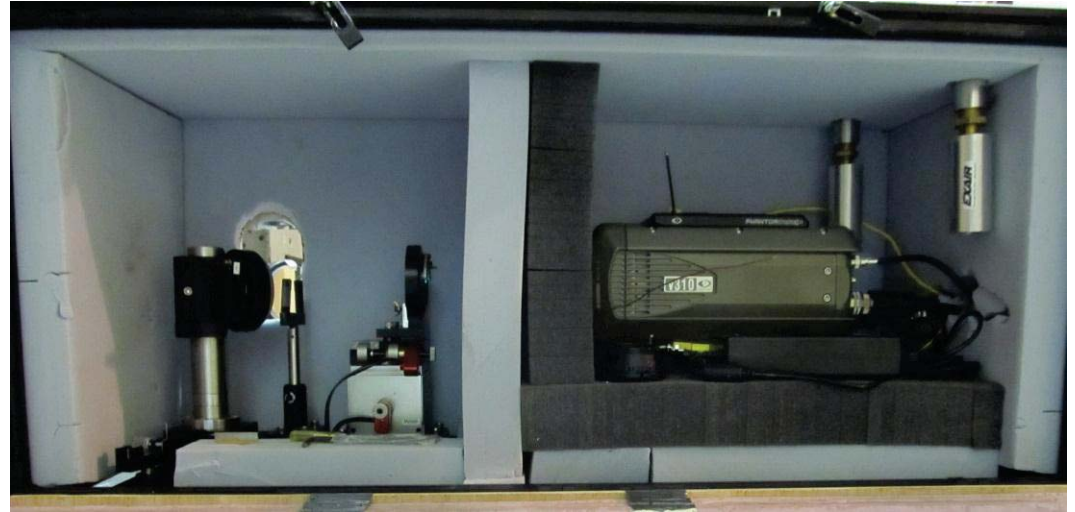
Receiving Optics Enclosed in an Environmental Enclosure

- System is located in the balance chamber.....tough environment for optics.
  - 200 deg F in temperature
  - ~3 psia
- Enclosed receiving optics station in an insulated environmental box with cooling to protect the high speed camera and associated optics
- Worked well for all of the tests to date.
  - Even at highest temp conditions, box conditions have been kept under 90 degrees F.
- Definite plans are to improve box or at least make it look better! (but it has worked!!)

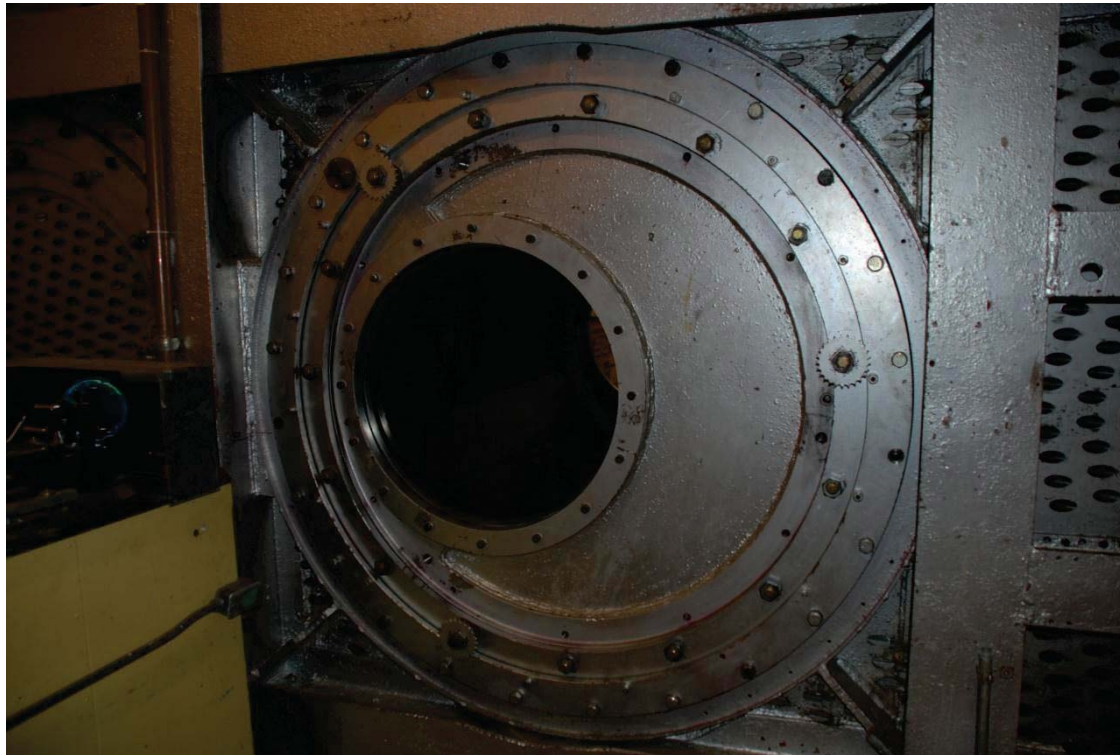
Schlieren Window at 8x6 Wind Tunnel

- The existing windows (4 total) have developed numerous nicks and flaws in them due to years of usage and wear.
- The existing windows were installed into the frames using lead seals using a very laborious process.....The windows had not been replaced in several decades.
  - Two windows had become damaged to a point where they were not usable.
- Frames were becoming difficult to align and get flush due to wear and previous installation processes.

- Design a new seal and have window frames re-machined to remove old seal and incorporate new “epoxy based” seal design.
- Re-surface & polish frames to make flat again so they are flush to the inside of the tunnel when installed.
- Design, fabricate and/or procure
  - Fixtures required for the re-machining
  - Surface table and fixtures required for the window installation
- Identify sealant material that will have low viscosity for application but cure to have minimal deflection, 100 mil thick, no more than 2 mil at tunnel test conditions, 250 deg F, 81 psi load.

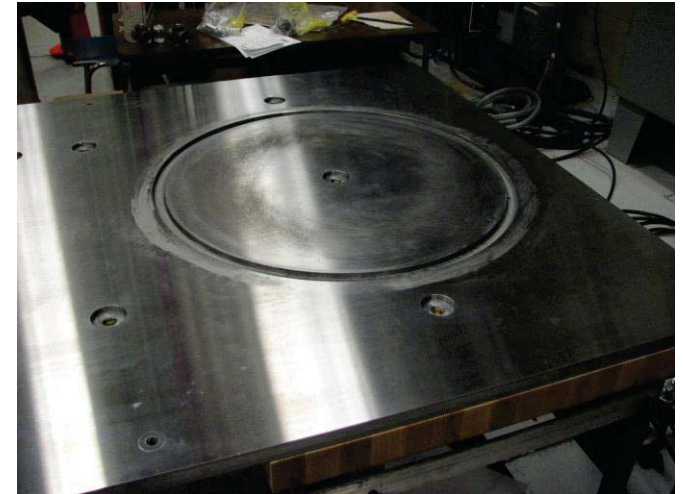
**Steel Schlieren Window Installation Table**

- **Causes**
  - Steel table not providing stable, flat surface as required. Determined it was deflecting
  - Belzona material was not of low enough viscosity for our application

- **Trouble shooting (Jan - July 2012)**
  - Able to recreate first attempt scenario using the steel table
  - At fab shop utilized granite table for mock up of installation, verified granite table would work for installation

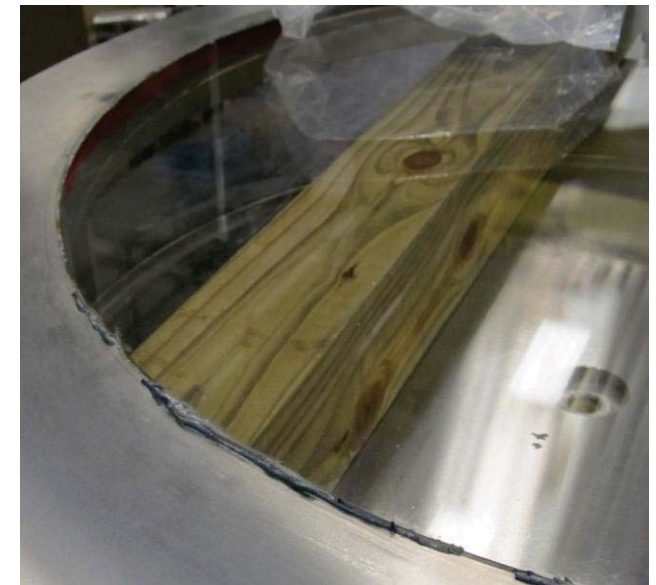
**First Window Installation Attempt**

- Vacuum applied through holes in table surface used to hold window in place during curing
- **First Attempt Results**
  - Material did not flow evenly as required, excess material in some areas voids in others.

- Window was not flush, protruded into the flow side by 3 mils causing forward facing step. Exceeds our requirements of ~1 mil, (2 mils allowable at most).

- Determined it would be better to cast seal in place around window once installed in frame
- **Revised Installation Procedure (~June 2012)**
  - Install frame on granite surface table

- Install window into frame and center using dowel pins
  - Pour sealant material into area between window and frame
  - Vacuum was again applied through holes in table to hold frame & window in place during cure

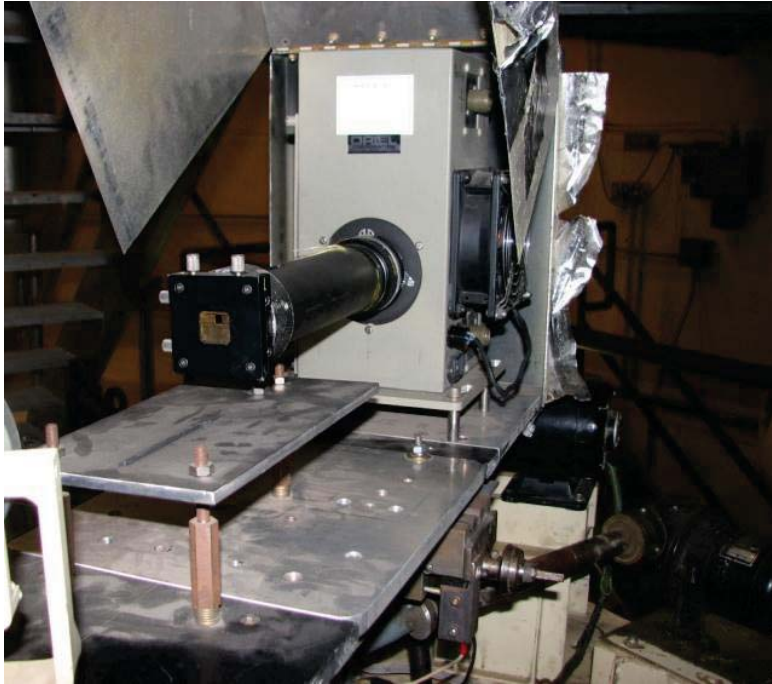
Existing 150W Xenon Light Source

- Replaced 150W Xenon Light Source
  - Required large 48V, 6A power supply, needed to be co-located in test chamber with light source
  - Bulbs & 150W Xenon light source parts very expensive to replace.
- Implemented new LED technology
  - Provides ample lighting, relatively inexpensive
  - Requires relatively low power (700ma @ 3.2V)
- Used monochromatic light (505nm) to take advantage of new knife edge technologies.
- Evaluated several NASA built and commercial LED light sources
- Installed NASA built LED units in 8x6 and used for two Boeing Sonic Boom Test (2012-13)
