INVESTIGATION OF ATLAS SOLID FUEL RETARDING ROCKET DURING ATLAS-CENTAUR SEPARATION TESTS

by Richard W. Heath, Henry Synor, Ralph F. Schmiedlin, and John H. Povolny Lewis Research Center Cleveland, Obio

NATIONAL AERONAUTICS AND SPACE ADMINISTRATION . WASHINGTON, D. C. . JULY 191

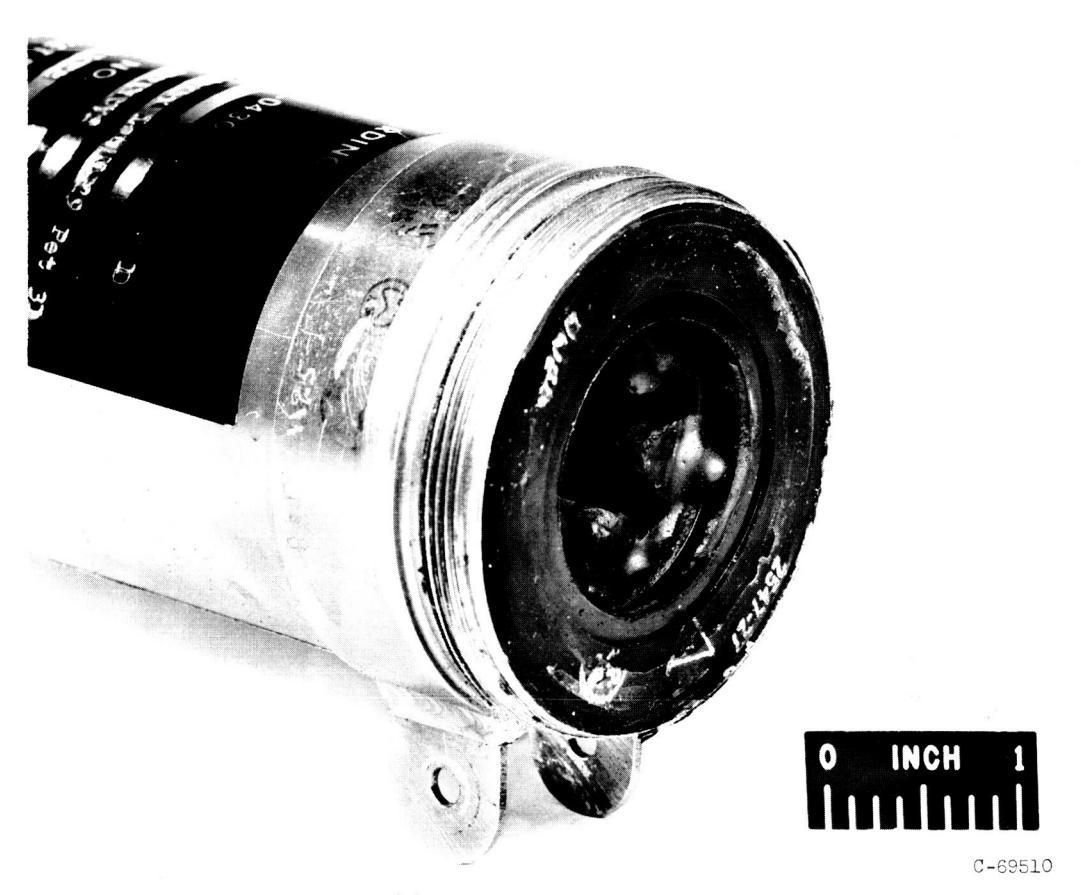
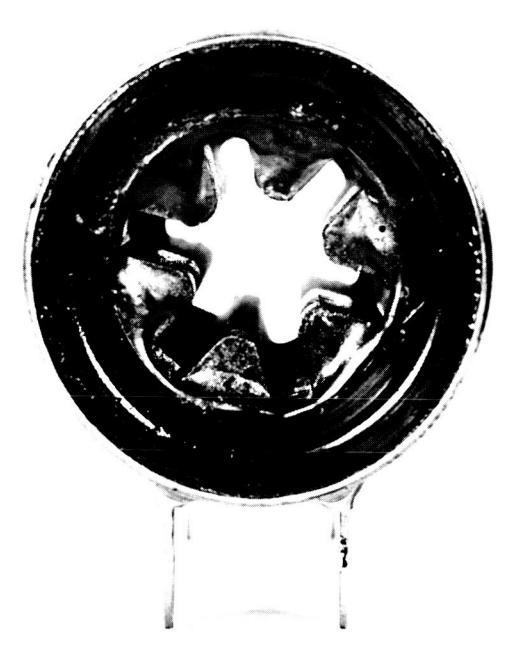
(b) Viewed from igniter end.Figure 4. - Grain of misfired rocket.

Of the 67 units fired, 6 misfires were encountered when Ordnance Associates igniters were used. Examination of the misfired units revealed that the grain was intact, the nozzle diaphragm (which was in accordance with the flight configuration) when used was ruptured and partly extruded into the nozzle, and the igniter was fired with no part of its "propellant" to be found in the rocket (figs. 4 and 5). The characteristic pressure record from a misfired motor is an abrupt pressure rise to approximately 250 to 450 pounds per square inch, after which a rapid decay ensues (fig. 6).

(a) Viewed from nozzle end.

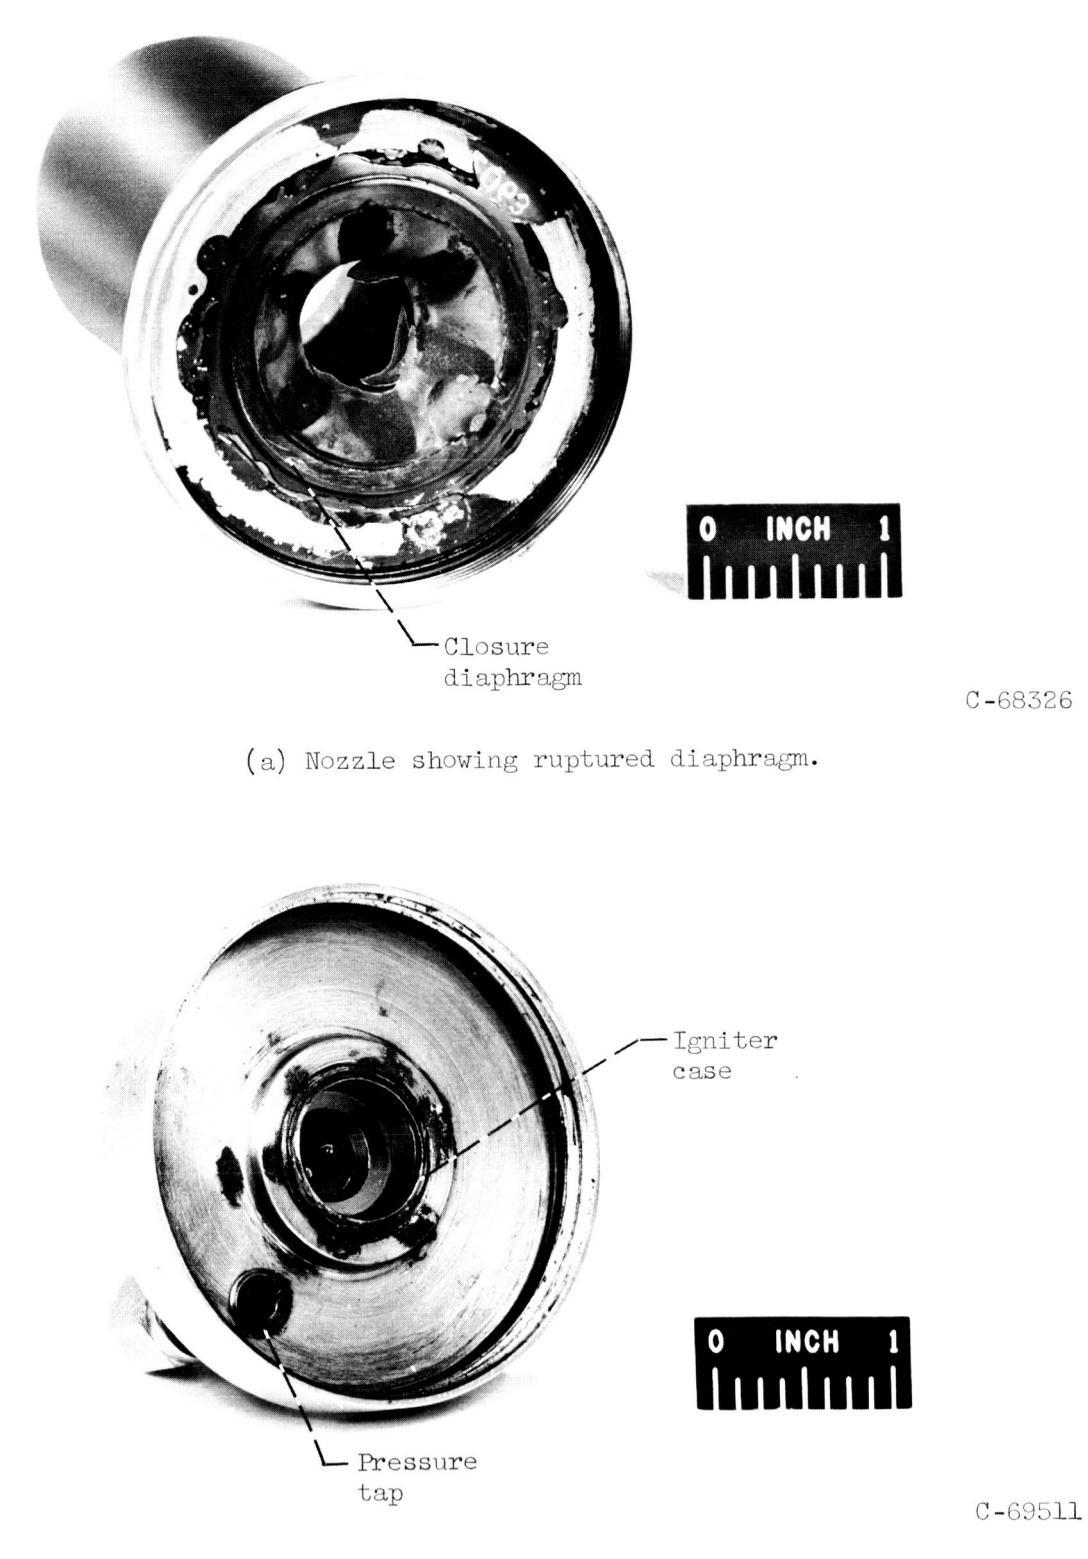
Figure 5. - Misfired rocket.

(b) End cap showing expended igniter.

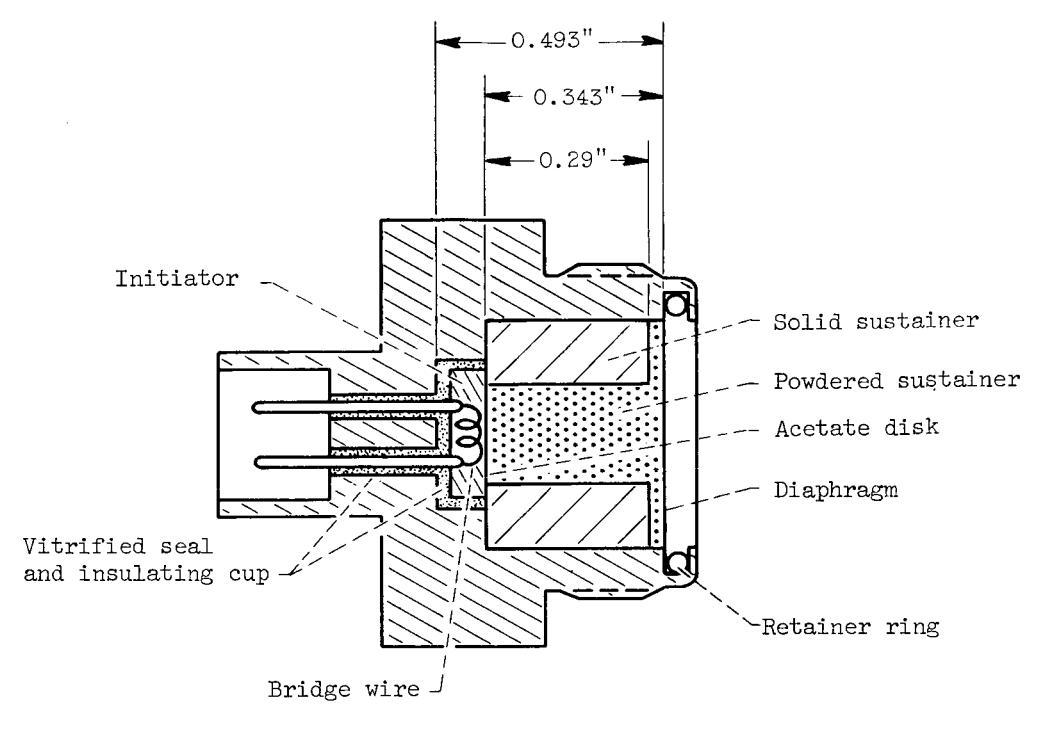
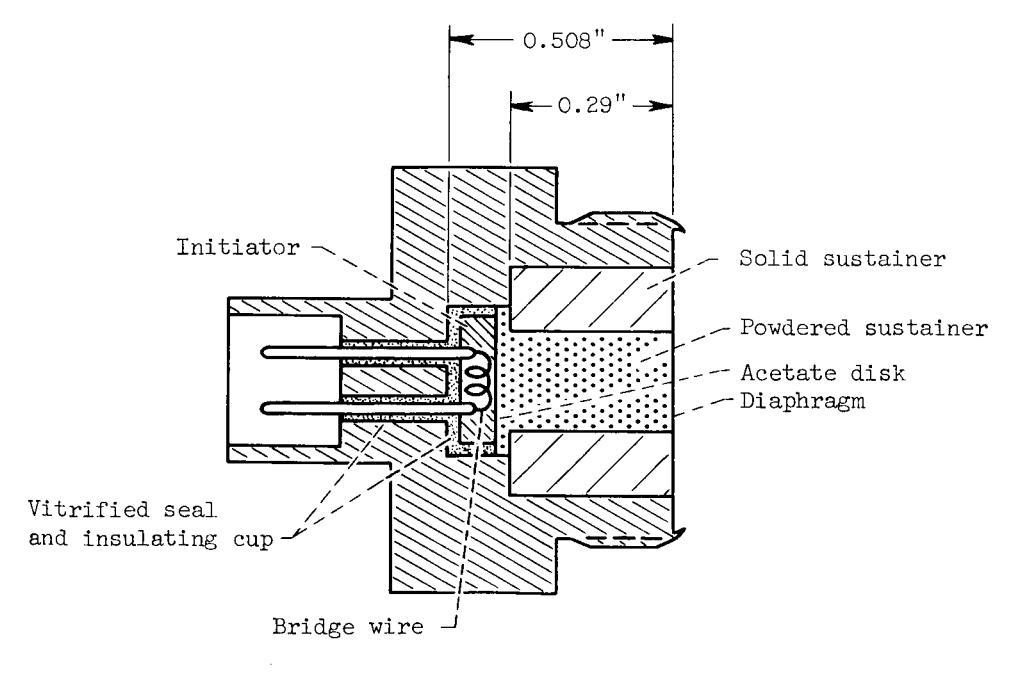
Figure 7. - Igniter configuration; P/N OA-A8, Ordnance Associates, Inc.

It was noted initially, and supported by subsequent firings, that the igniters in all misfired rocket engines using Ordnance Associates igniters (except for one special test) were from production lot 3-2 (table I). Investigation revealed that the configuration of the igniter (P/N OA-A8) had not been maintained constant; several internal configurations had been used in the igniter with changes made from one lot to the next (fig. 7). The changes from lot 2-1 to 3-2 include (1) the omission of the retaining ring at the igniter exit, (2) a decrease in the depth of the initiator cavity and elimination of a cavity at the exit of the unit, and (3) a repositioning of an acetate disk below the solid sustainer, which created a new cavity containing powdered sustainer.

(a) Production lot 2-1.

(b) Production lot 3-2.

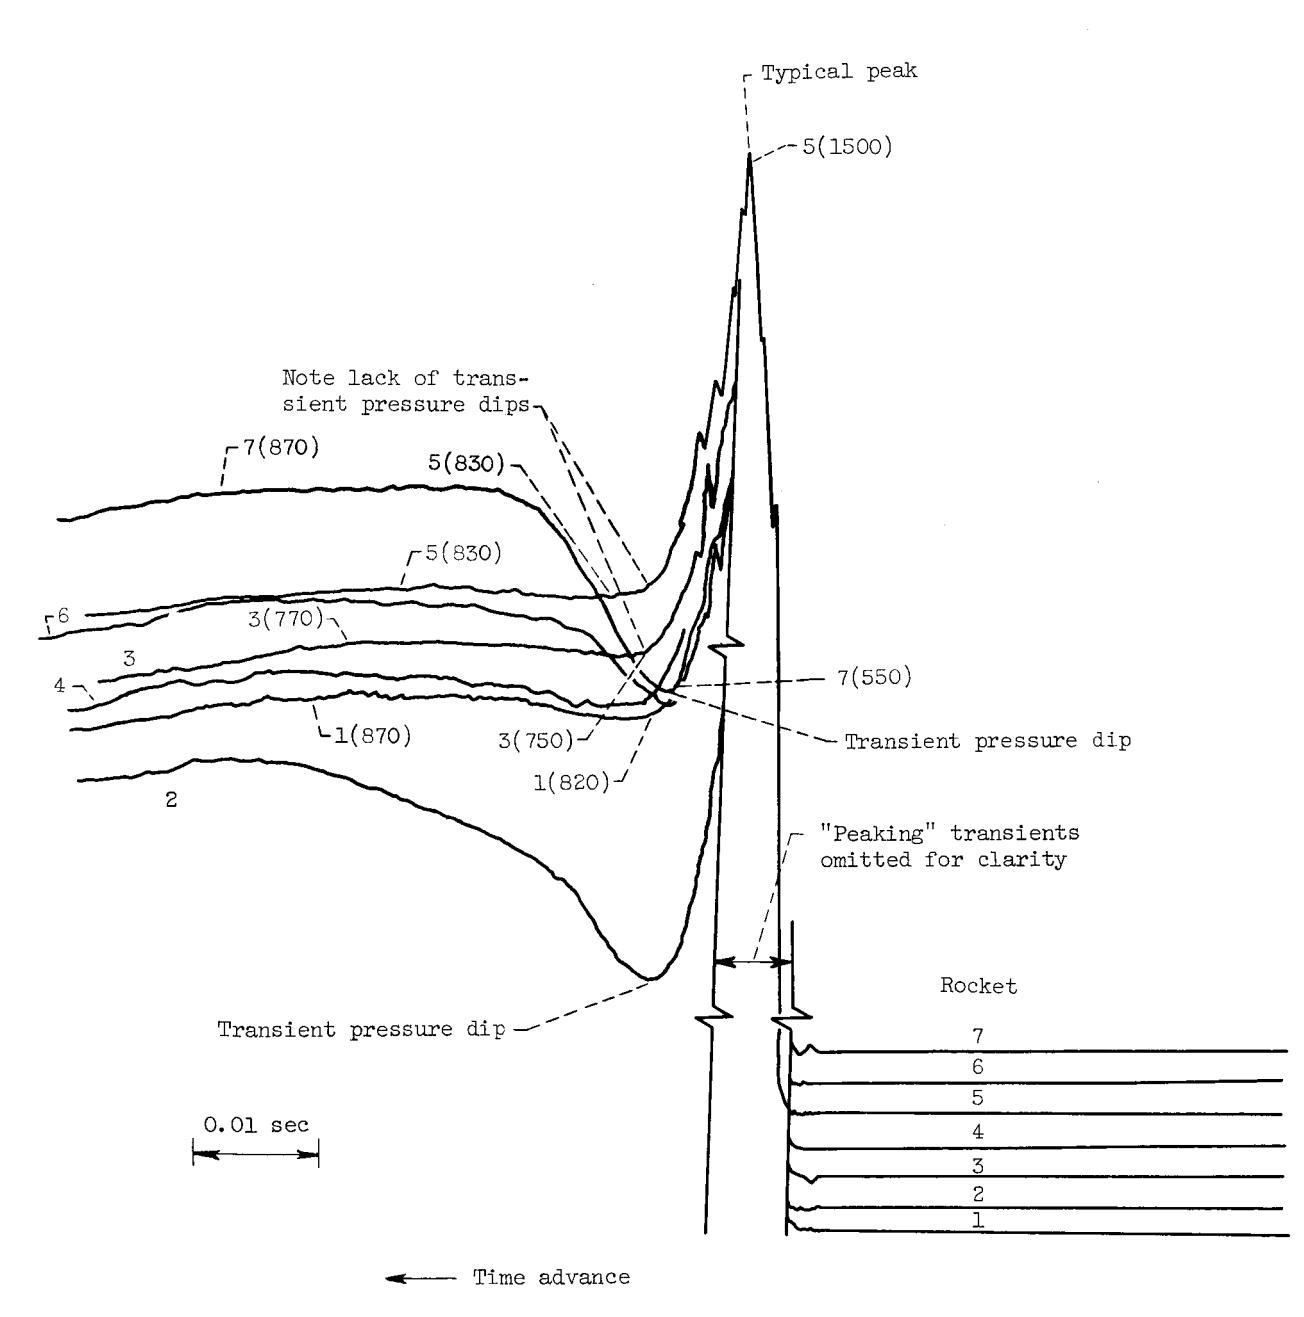
Pressure traces obtained in the test firings were scrutinized in an effort to discover any apparent inadequacies in the ignition cycle which could be related to the igniter changes. In several instances an abnormally low chamber pressure occurred between the ignition peak of approximately 1500 to 2000 pounds per square inch and the steady-state burning pressure (fig. 8(a)). In order to understand this occurrence, eight rockets having lot 2-1 igniters were fired with a 1/8-inch hole drilled through the nozzle closures so that the chambers were at a near vacuum condition prior to firing. The pressure traces from this test firing, which are shown in figure 8(b), revealed that each engine experienced a pressure falloff similar to that mentioned earlier although not quite as severe. The generation of the falloff, or saddle, in each instance is felt to demonstrate a susceptibility of the igniter to an initial low-pressure condition in the combustion chamber and to give an indication of inadequate performance margin. The pressure falloff probably results from the propellant grain not being sufficiently ignited at the time of igniter burnout and could probably be eliminated with the use of a longer burning igniter. While these tests did serve to uncover a marginal performance characteristic, they did not explain why lot 3-2 igniters produced misfires and lot 2-1 igniters did not under normal conditions.

(a) Random failures.

Figure 8. - Pressure records of incipient rocket failures. Numbers in parentheses are peak pressures and pressure dips in psia.

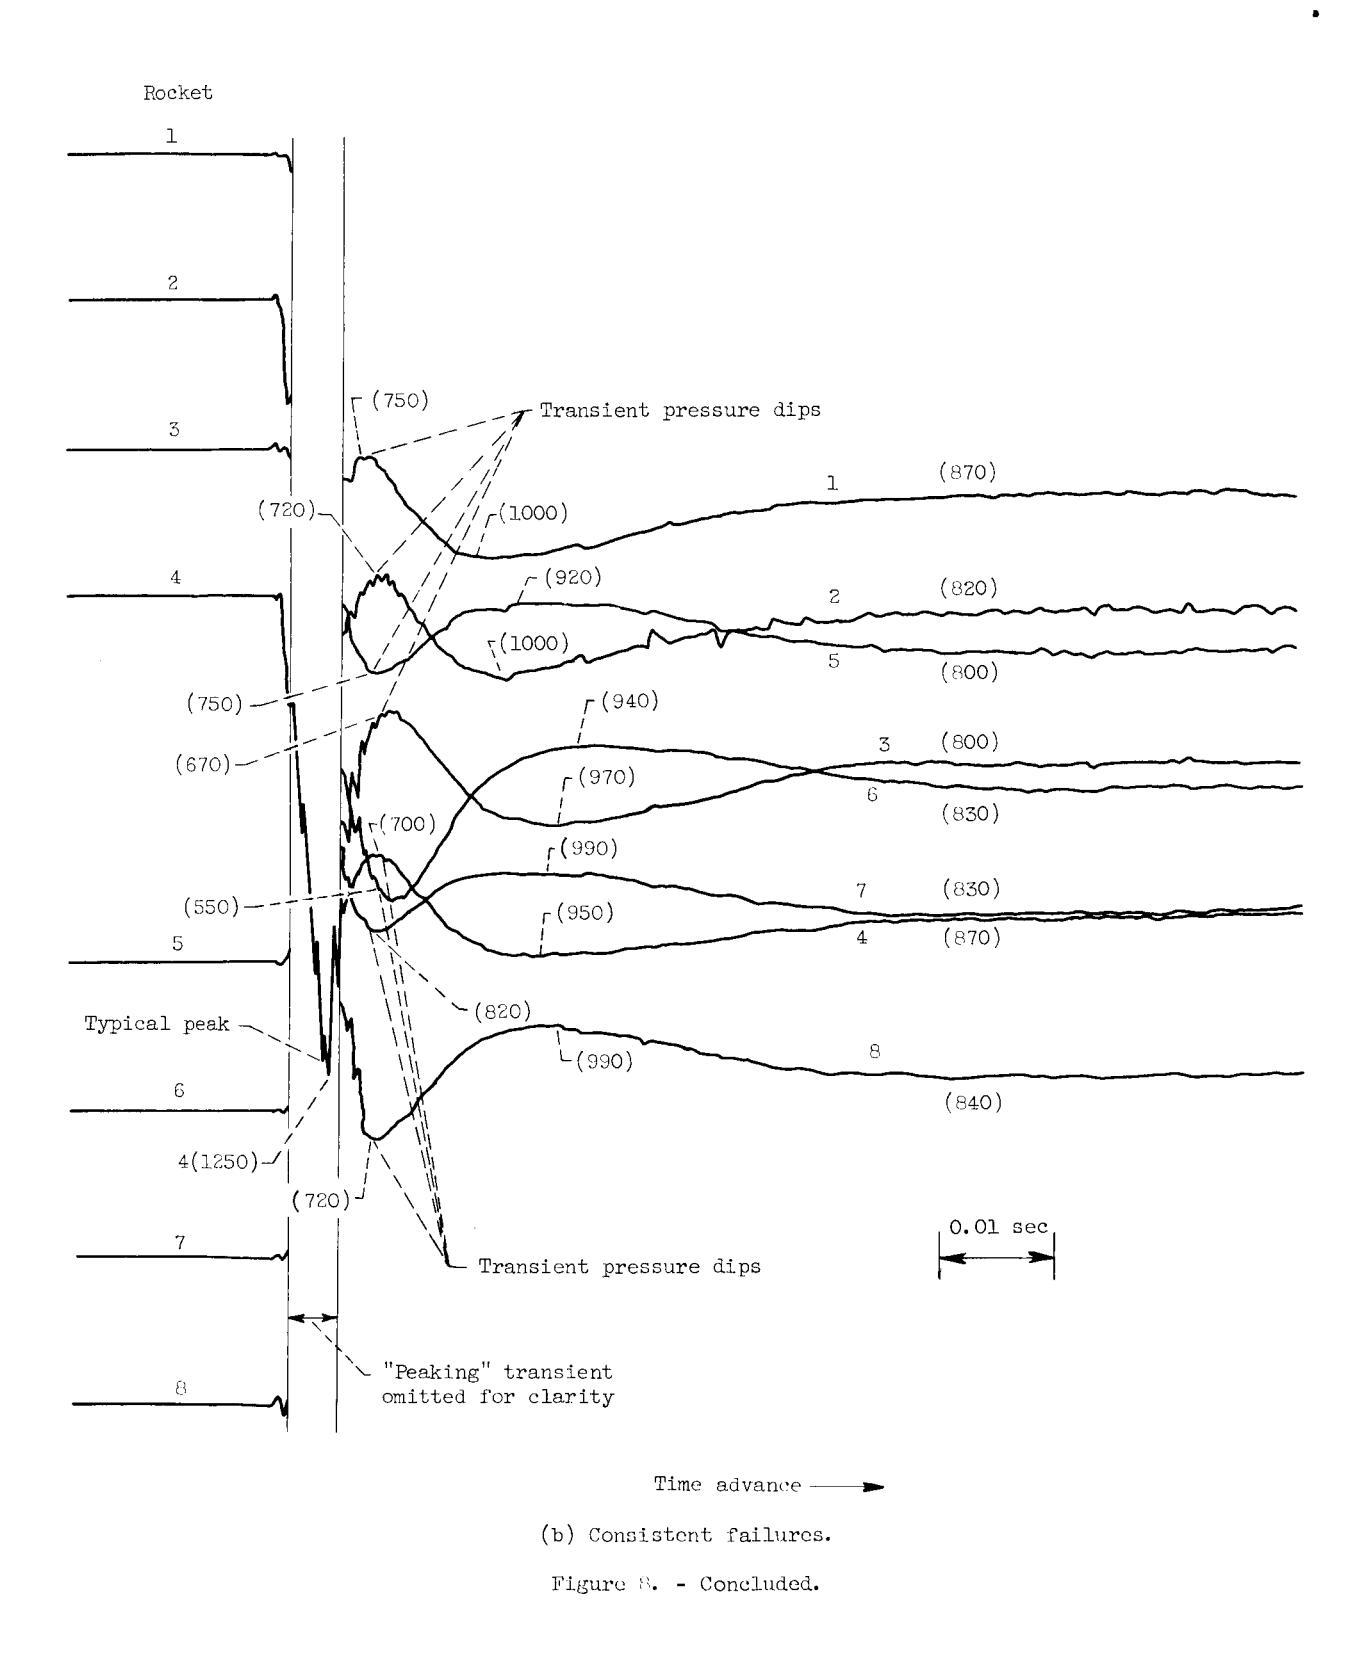
In an effort to determine how much the margin of performance could be reduced before the engine refused to fire, two rockets were tested with no nozzle closures, one with a lot 3-2 igniter (fig. 9) and one with a 2-l igniter. Both failed to ignite the rockets at the altitude condition, which confirmed that the limits of reliable operation had been exceeded. Although the ability to ignite the propellant grain successfully under vacuum conditions and with no nozzle closure is a more severe requirement than encountered during flight, it is felt that this test further illustrates the lack of adequate margin in the combination of the Ordnance Associates, Inc., igniter and the Rocket Power, Inc., rocket.

Figure 9. - Pressure record of lot 3-2 igniter fired into live rocket with no closure diaphragm.

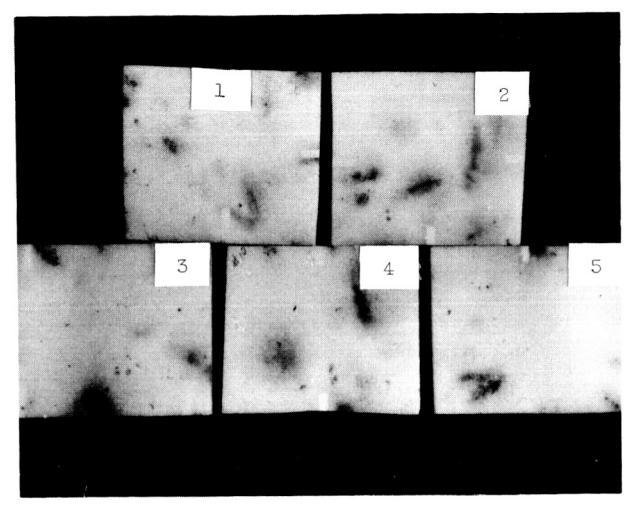
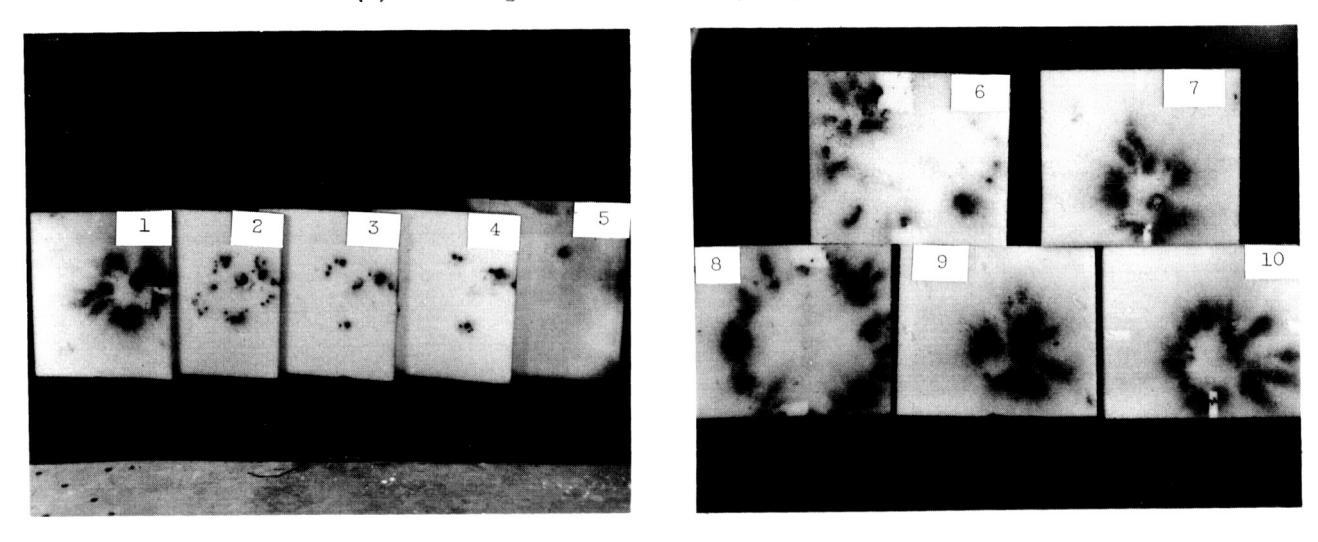
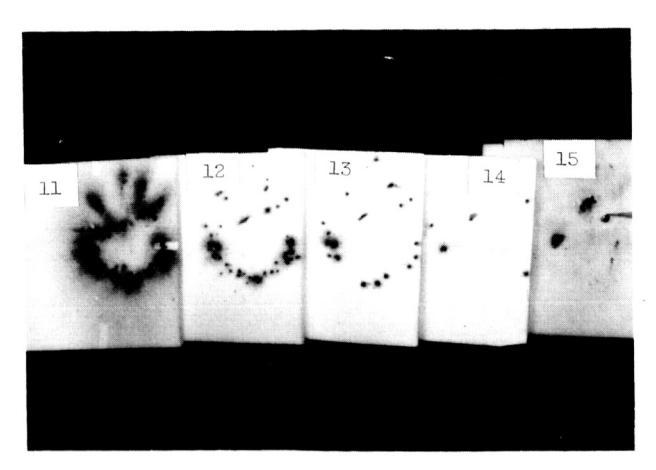
Figure 10. - Flame impingement patterns.

Some tests were conducted by Beckman and Whitley Laboratories to determine what had caused the 3-2 igniters to lose all their margin of performance. Both the lot 3-2 igniters and the lot 2-1 igniters, which had no record of misfires, were fired into Styrofoam blocks to make a record of flame-impingement patterns. Their findings, noted in references 1 and 2, reveal that the lot 2-1 igniters consistently displayed a widely dispersed flame pattern, while the lot 3-2 igniters were inconsistent. The 3-2 units occasionally fired an extremely narrow and concentrated flame front (fig. 10). This characteristic leads to the theory that the lot 3-2 igniters when their discharge pattern is concentrated do not impinge on the grain surface sufficiently and, therefore, may not impart enough heat into the grain to cause ignition. This inconsistency in performance may be inferred to result from the previously described changes in the igniter's geometry. The combination of an initial low performance margin and an inconsistent flame discharge pattern is apparently sufficient to cause occasional ignition Supporting this conclusion are data obtained at Lewis from the firing failures. of two igniters manufactured by Librascope (fig. 11) whose constituents were described earlier. The first igniter firing at sea-level ambient pressure was made into a Styrofoam block, and a narrow impingement pattern was observed (fig. 12). The second firing, at a 98 000-foot-altitude ambient pressure, involved the installation of a Librascope igniter in a Rocket Power, Inc., rocket from which the nozzle closure had been removed. The igniter failed to ignite the rocket propellant, as would be anticipated from the flame pattern.

(a) Lot 2-1 igniters. Note widely dispersed patterns.

(b) Lot 3-2 igniters. Note narrowly dispersed patterns in 1, 7, 9, and 11 and widely dispersed patterns in 4, 5, 6, 8, and 14.

The specific causes for the marginal performance appear to be (1) an inadequate igniter burning time aggravated by (2) inconsistent igniter discharge patterns, which occasionally did not impinge on the rocket propellant grain. Therefore, it is desirable to substitute an igniter which (1) burns till the rocket grain is sufficiently ignited, and (2) directs its flame pattern positively towards the grain surface.

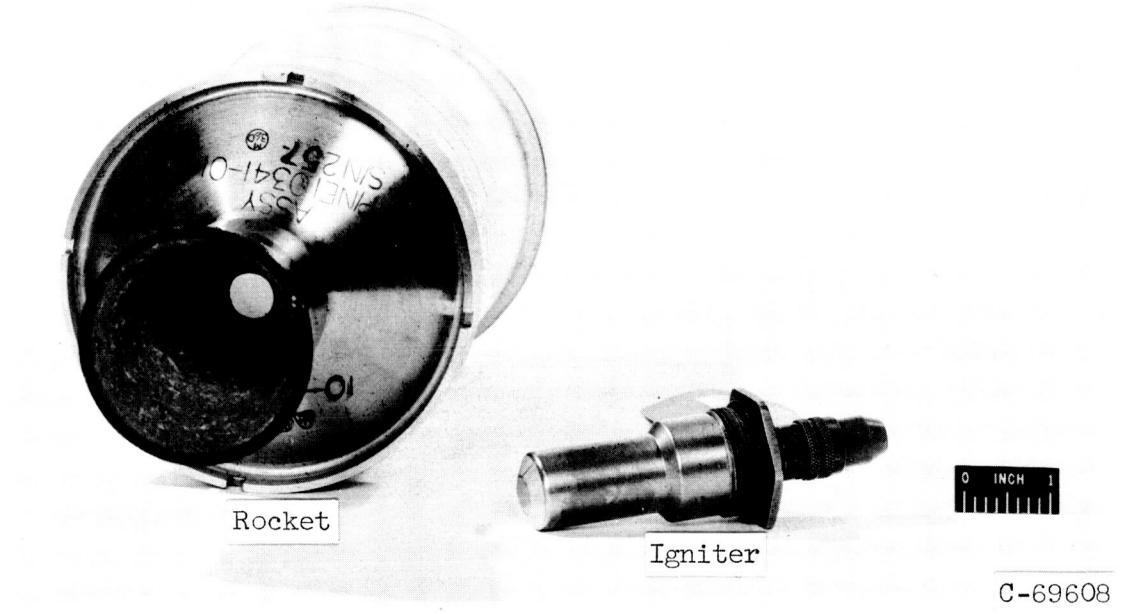
In order to further substantiate the theories concerning flame direction and igniter burning time outlined, a test was made at a pressure altitude of 93 000 feet with a Thiokol Chemical Corp. igniter (fig. 13), installed in Rocket Power, Inc., rocket having no nozzle closure. This igniter burns for a longer period of time (0.25 sec compared with 0.004 sec for the Ordnance Associates igniter) and directs the flame pattern at the rocket grain. The longer burning time is effected primarily by an increase in the igniter's constituent mass. The increase in the mass, with its resultant increase in heat content and burn time, coupled with the directed flame pattern tended to ensure that the rocket grain would receive sufficient heat to ignite. Successful ignition of the rocket propellant occurred (fig. 14).

Figure 13. - Thiokol igniter TE 350 with rocket 2.41 KS 513 for which it was designed.

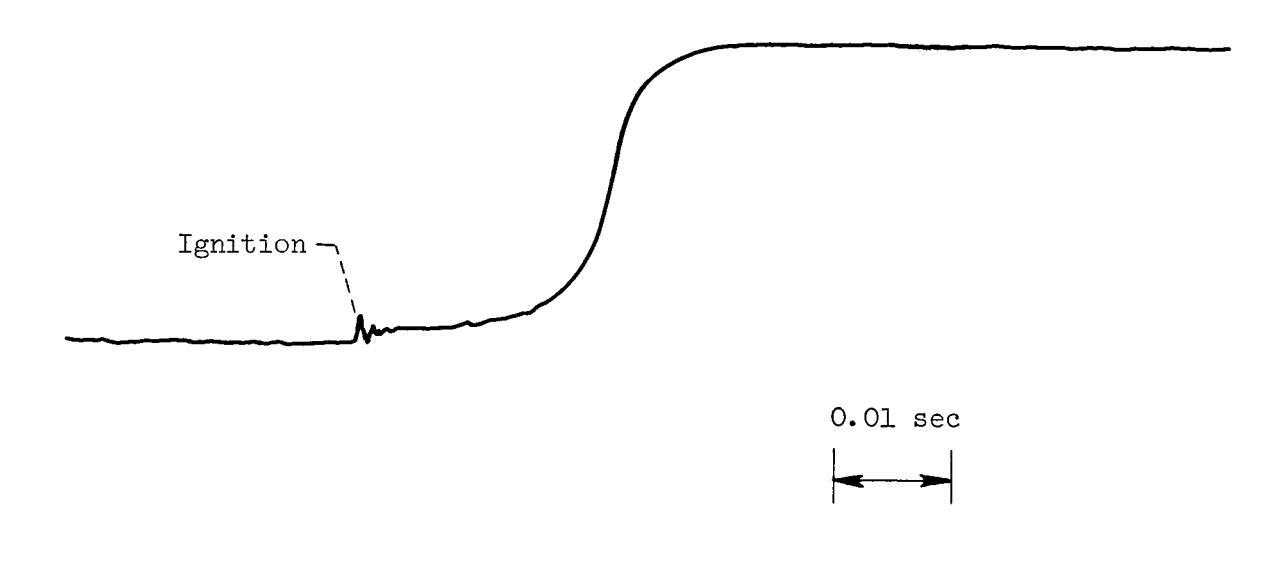
Figure 14. - Internal pressure record of Rocket Power, Inc., rocket ignited by Thiokol Chemical Corp. Pyrogen igniter.
