*Technical Report 32-1167*

*Nickel Plating of the 23-ft Collimating Mirror  
for the JPL 25-ft Space Simulator*

*M. R. Heilig*

November 1, 1967

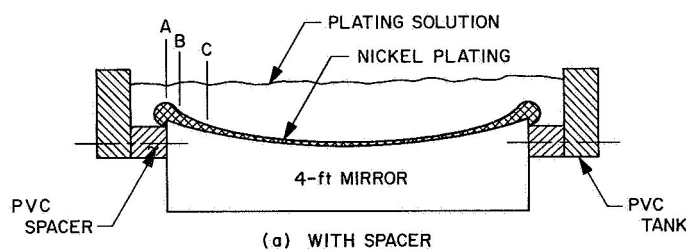
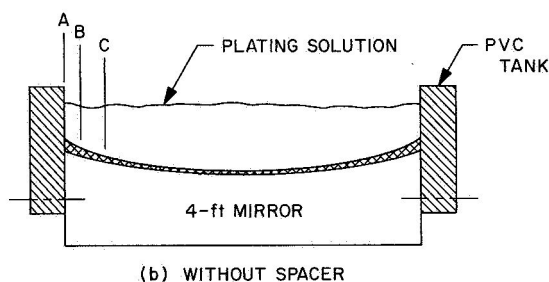
**Fig. 3. Differences in edge buildup (a) with spacer and (b) without spacer**

The typical problem with electroplated parts is the buildup of plating at the edge. Anode placement and other edge buildup problems were investigated. With a spacer between the mirror edge and the polyvinyl chloride (PVC) tank (Fig. 3a), the edge buildup was greater (0.060 in.) than without a spacer (0.040 in.), as shown in Fig. 3b. In both cases, the buildup occurred in the last 1 in. and the uniformity was very good ( $0.019 \pm 0.0015$ ), excluding the outer 1 in. The edges of the nickel anodes were directly above the edge of the mirror in these experiments. After experimentation, JPL submitted the plated 4-ft-diam mirror to the grind and polish vendor so that he could establish a complete grind and polish procedure to be used for the 23-ft-diam mirror. The vendor simulated the area ratio of the grinding tool to mirror and used different grinding compounds to establish removal rates.

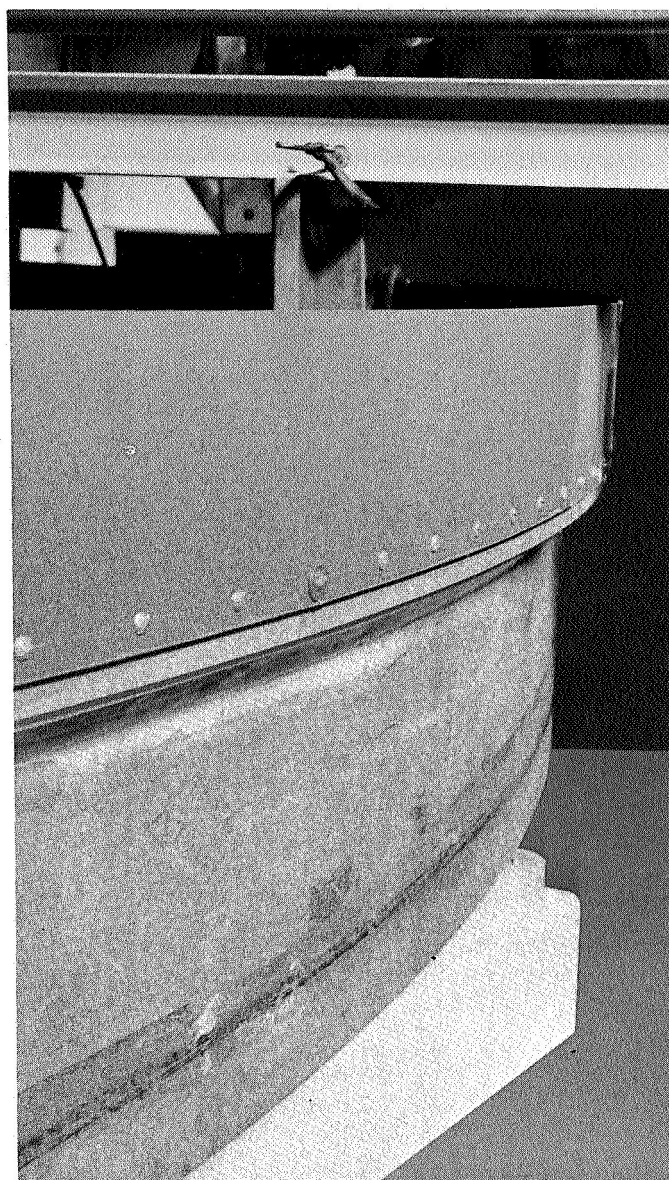
**Fig. 4. Eight-in.-wide PVC strip attached to mirror**

Next, an 8-in.-wide strip of PVC was attached to the edge of the mirror with epoxy and screws every 6 in. (Fig. 4), thus enabling the mirror to be its own tank. The different solutions required for cleaning, etching, and nickel plating were stored in tanks above and to the side of the mirror (Fig. 5). The solutions were transferred to the mirror tank by three methods: gravity-fed through a rubber pipe from one of the four tanks above

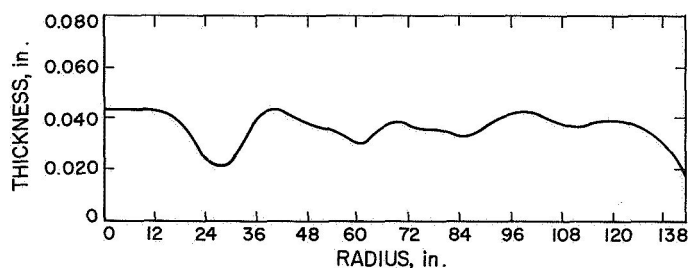
**Fig. 10. Magnagage measurements of thickness along radius of mirror**

Final nickel thickness measurements were made with a Magnagage and a Dermatron. The readings are given in Tables 3 and 4 and the data are shown in Figs. 10 and 11. There is a noticeable difference in the Magnagage and the Dermatron readings: the Dermatron readings were  $0.038 \pm 0.008$  in. and the Magnagage was  $0.033 \pm 0.010$  in., both neglecting the 3-in. outer edge. The problem with both of these instruments was that they were sensitive to many other properties of the nickel plating, such as surface finish, hardness, and probably the substrate properties. After subsequent grinding by the optical polishing vendor, JPL found that the Magnagage was the more accurate instrument.
