JPL Contract 951709  
STERILIZABLE LIQUID PROPULSION SYSTEM

STERILIZABLE LIQUID PROPULSION SYSTEM

Seventh Quarterly Progress Report

October 1968

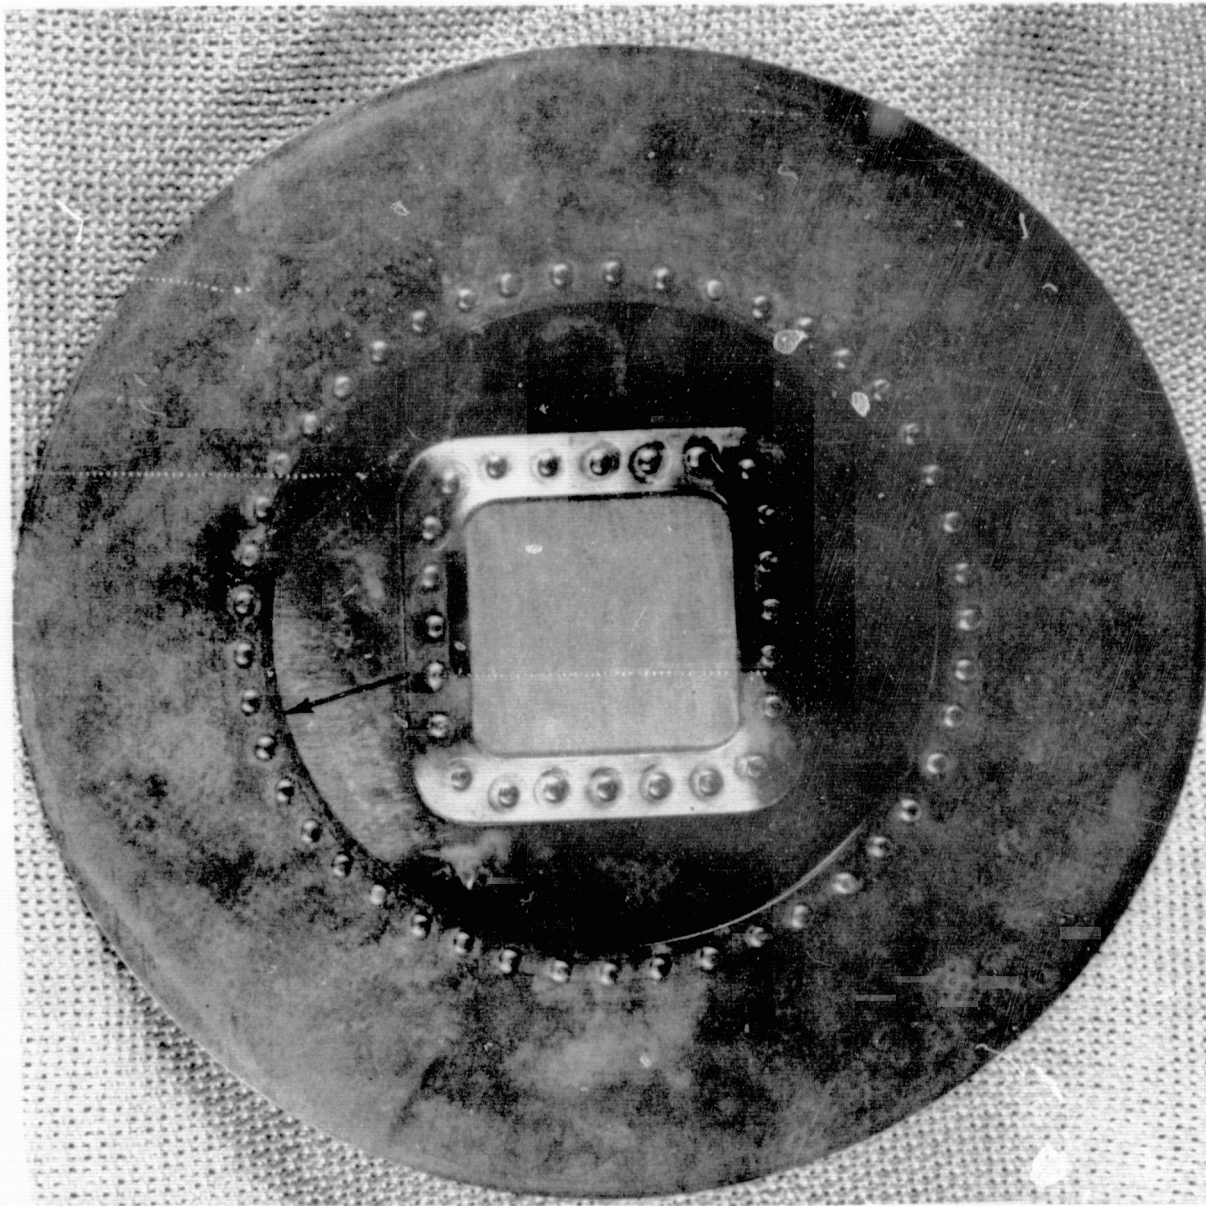
Fig. 2: Typical Trap Assembly Showing Leak Path

As a result of the work performed during this period, it was concluded the two-phase flow from the fuel tank in a negative 1-g regime was caused by leakage through the flat plate riveted joint in the trap that made the transition from steel to titanium so the trap could be welded into the titanium tank.

technique employed in loading the module. During the outflow tests, bubbles were observed flowing through the attachment area between the titanium ring and the steel body. This joint is formed by a ring of rivets which were leak tight through the joint; however, the leak path was between the surfaces shown by the arrow in figure 2.

This series of tests clearly showed bubbles emerging from the ring area resulting in a well established two-phase flow. Sealing the joint with putty resulted in the desired single-phase liquid flow.

On this basis and on the assumption that this would occur in the final assembled unit to be installed in the module, a search was initiated to find a compatible method of sealing the titanium to stainless steel surface at the rivet diameter. First, the metallic type of sealants were considered such as soft solders and brazes. The low temperature solders and brazes, up to 1200°F, were discarded because the fluxes necessary to wet the titanium might

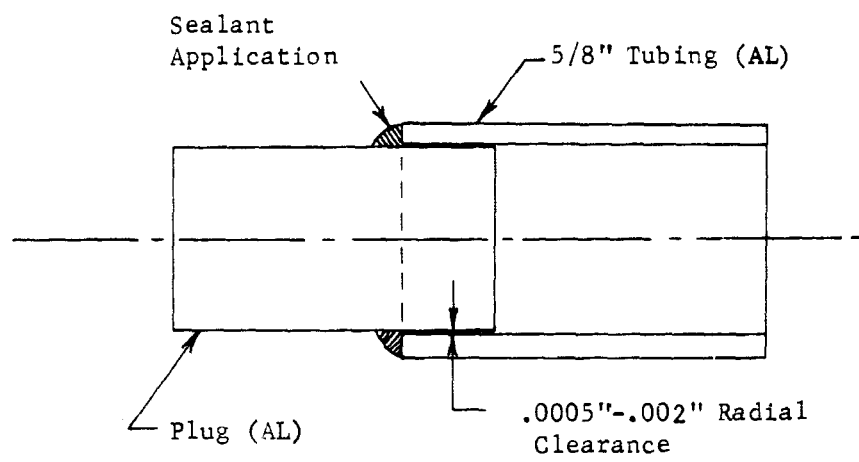
TEST JOINTFig. 3

The joints made up for the final immersion in hot MMH were fabricated as shown in Fig. 3. All the sealants were set aside for 24 hours to provide a room temperature cure. All the joints except the DC-11 were leak tested to 3 psi. The joints were then placed in bombs, loaded to a 30% ullage with MMH, sealed and placed in a bath at 135°C. Pressures rose no higher than 88 psia which compares favorably to the normal vapor pressure of 63 psia. Pressures

were checked at 24, 48 and finally at the conclusion of the test at 114 hours. No significant change occurred indicating that none of the materials caused decomposition of the fuel.

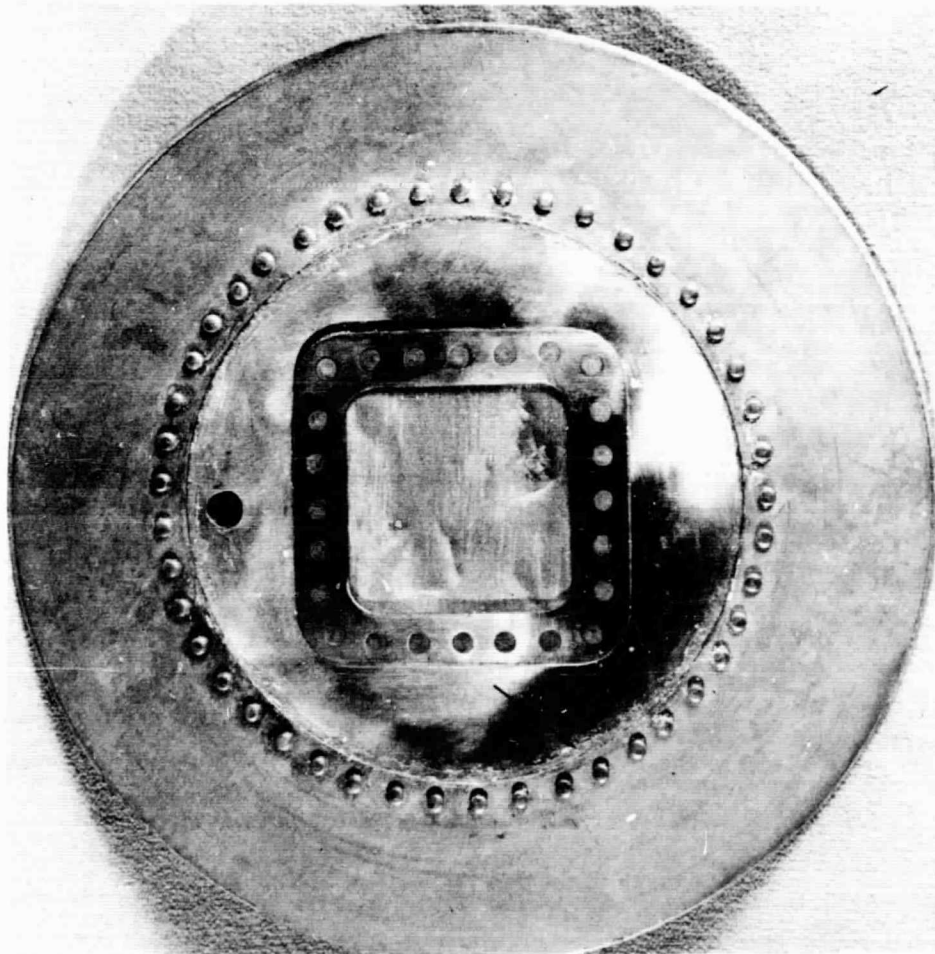
Fig. 4: Fuel Trap Assembly Showing Water-Glass Seal After Test

To assure ourselves the available trap assembly from the component tank could be properly treated and tested with the water glass, a demonstration was performed. The questionable joint was cleaned with an alkaline solution and water rinsed. Upon air drying methyl ethyl ketone was swabbed around the joint and dried. The water glass was then applied and allowed to dry for 48 hours, see Fig. 4. The unit was then assembled into the hemisphere and water flow tests proved conclusively the leak between the riveted plates had been stopped as indicated by single-phase liquid flow. These procedures will be employed for the trap installed in the modified tank prior to the final closure weld.

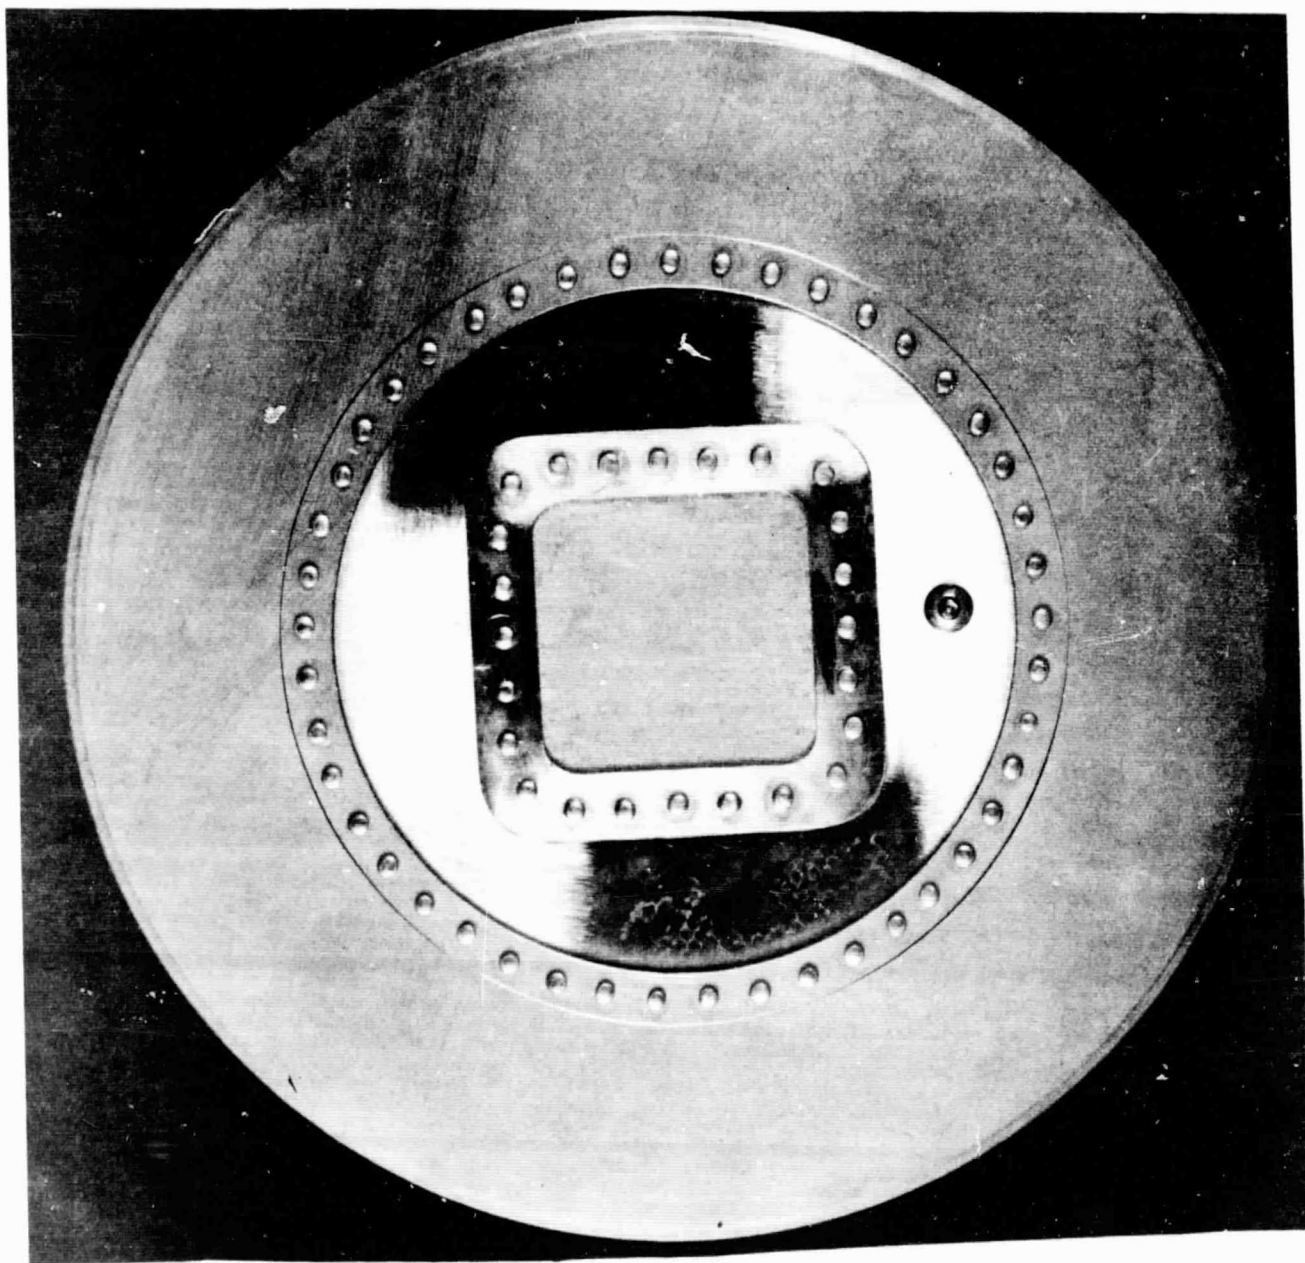
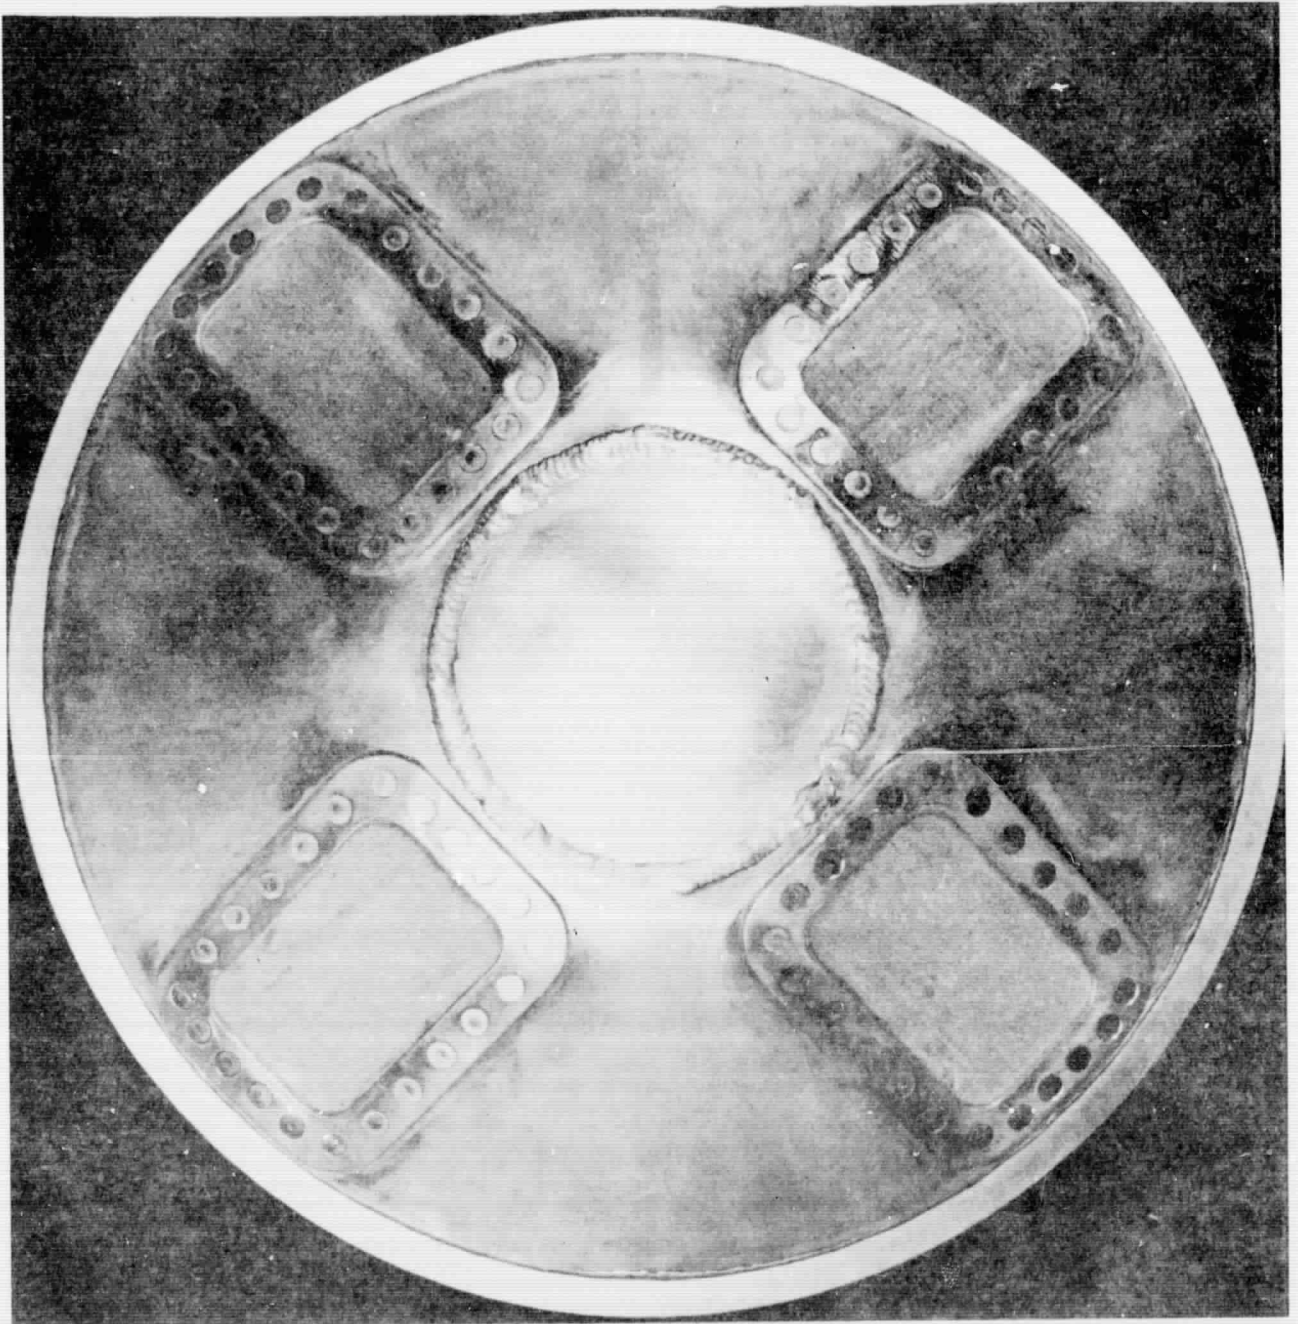
When the process was implemented, the alkaline cleaner made the surface clean. Application of the  $\text{HNO}_3$  + HF foamed considerably. The  $\text{HNO}_3$  + HF was repeated at least 4 times after which all foaming stopped. The unit was then placed in a bath of hot  $\text{N}_2\text{H}_4$  at 202°F. (local water boiling temperature) for 24 hours. Following the successful verification of passivation, the unit was cleaned in demineralized water followed by an acetone rinse and shipped to the vendor for installation in the tank on 9 August, 1968. The completed trap assembly is shown in Fig. 5 and 6.

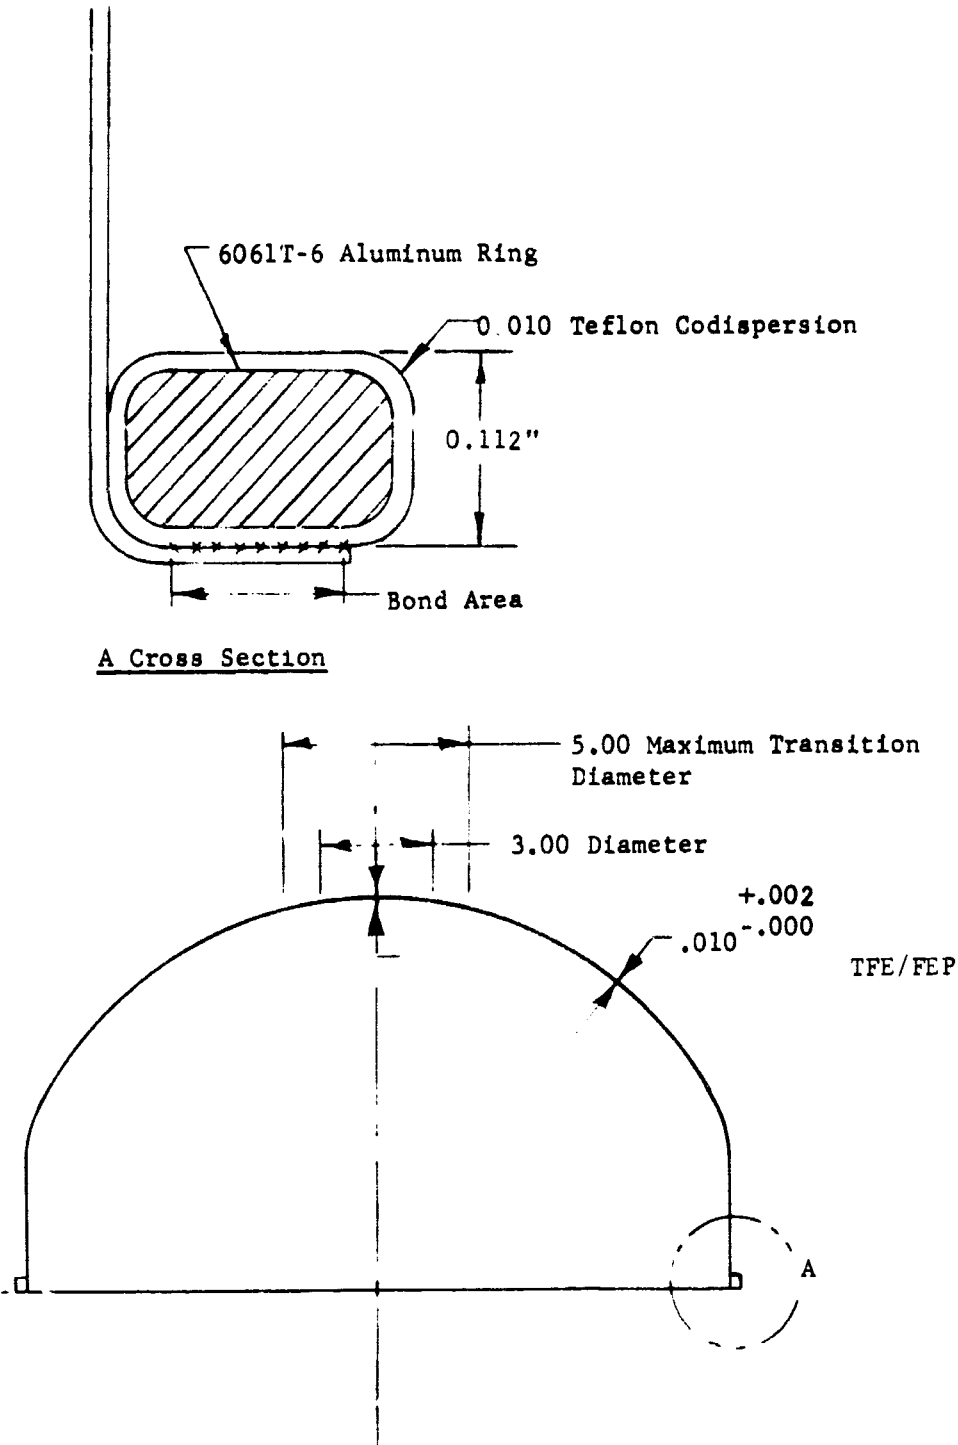
Figure 7. Oxidizer Tank Diaphragm Design

Fabrication of 2 units of the Teflon diaphragm was completed late in the report period. Fig. 7 shows the general configuration of the diaphragm. During the fabrication of the diaphragms, some difficulty was encountered in obtaining a complete and uniform bond between the TFE/FEP diaphragm and the ring flange covered with codispersion Teflon. The bonding process was repeated 3 times on unit #1 in an attempt to obtain a complete bond. After the bonding, some small pockets of unbonded Teflon were evident even though the leakage test was successfully completed. The unit was accepted on the basis of the successful leak check in the absence of a well defined bond criteria. The unit will be installed in the component tank as is to gather additional experience and data to develop the bonding criteria. Inspection of the bonding area indicated that the Teflon was beginning to flow and thus form sharp corners around the ring flange. A dimensional check revealed that the critical dimension is in excess of the drawing 0.003." The dimension is critical in that if it were under size it would affect the grip of the tank halves shown by fig. 8. Since it was slightly in excess of the required value, it was decided to not rework the diaphragm. The next report will show photographs of the condition of the bonded flange area. At the close of the report period, the units were awaiting shipment to the Martin Marietta Corporation Denver Division.
