XII. Science Data Systems SPACE SCIENCES DIVISION

A. High-g Testing Multilayer Laminate Packaging, J. H. Shepherd

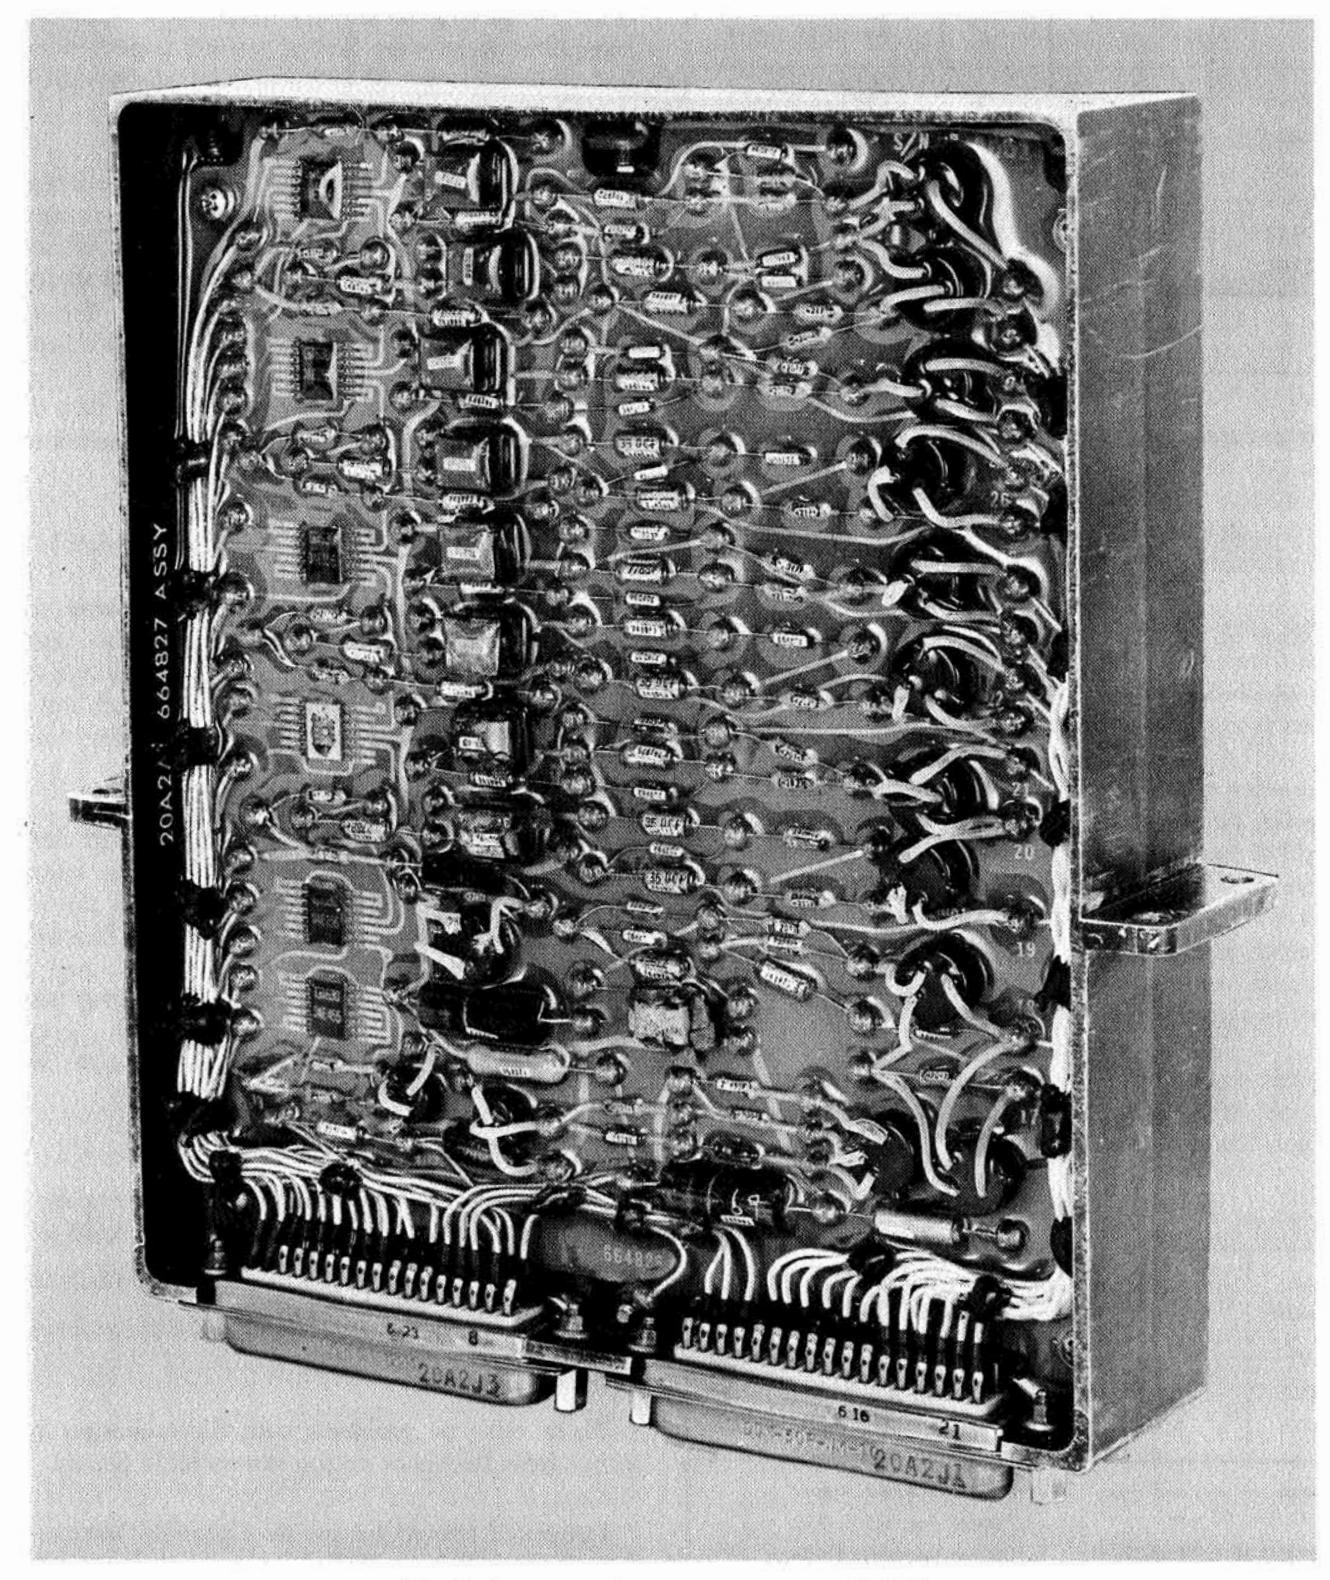
Visual examination after the slingshot test showed the chassis were bent on all four walls (Figs. 1 and 2); subassemblies webs were bowed toward impact sides 2A1 and 6A1; connectors J-1 through J-4 shells were bent; and pin holding blocks were broken.

Subassembly 20A2 lost the lid from one integrated circuit, and one side of a lid was loose on another. The glass case of the integrated circuit with the lid off was cracked on the inside of the package around the pad to which the die is attached. Due to the web flexing, five of the pulse transformers' cases were crushed, and ten transistors' leads bent against the transipads by coming in contact with the tooling fixture. Fourteen glass diodes' cases cracked on the 2A1 side, and one cracked on the far side (2A2) of the subassembly.

Fig. 1. Damaged DAS discrete assembly 2A1

Two changes are suggested for the subassembly structure to enable it to withstand shock at the 4,525 g level:

- (1) A thicker or reinforced web for the subchassis.
- (2) A conformal coating thick enough to cover the components entirely.

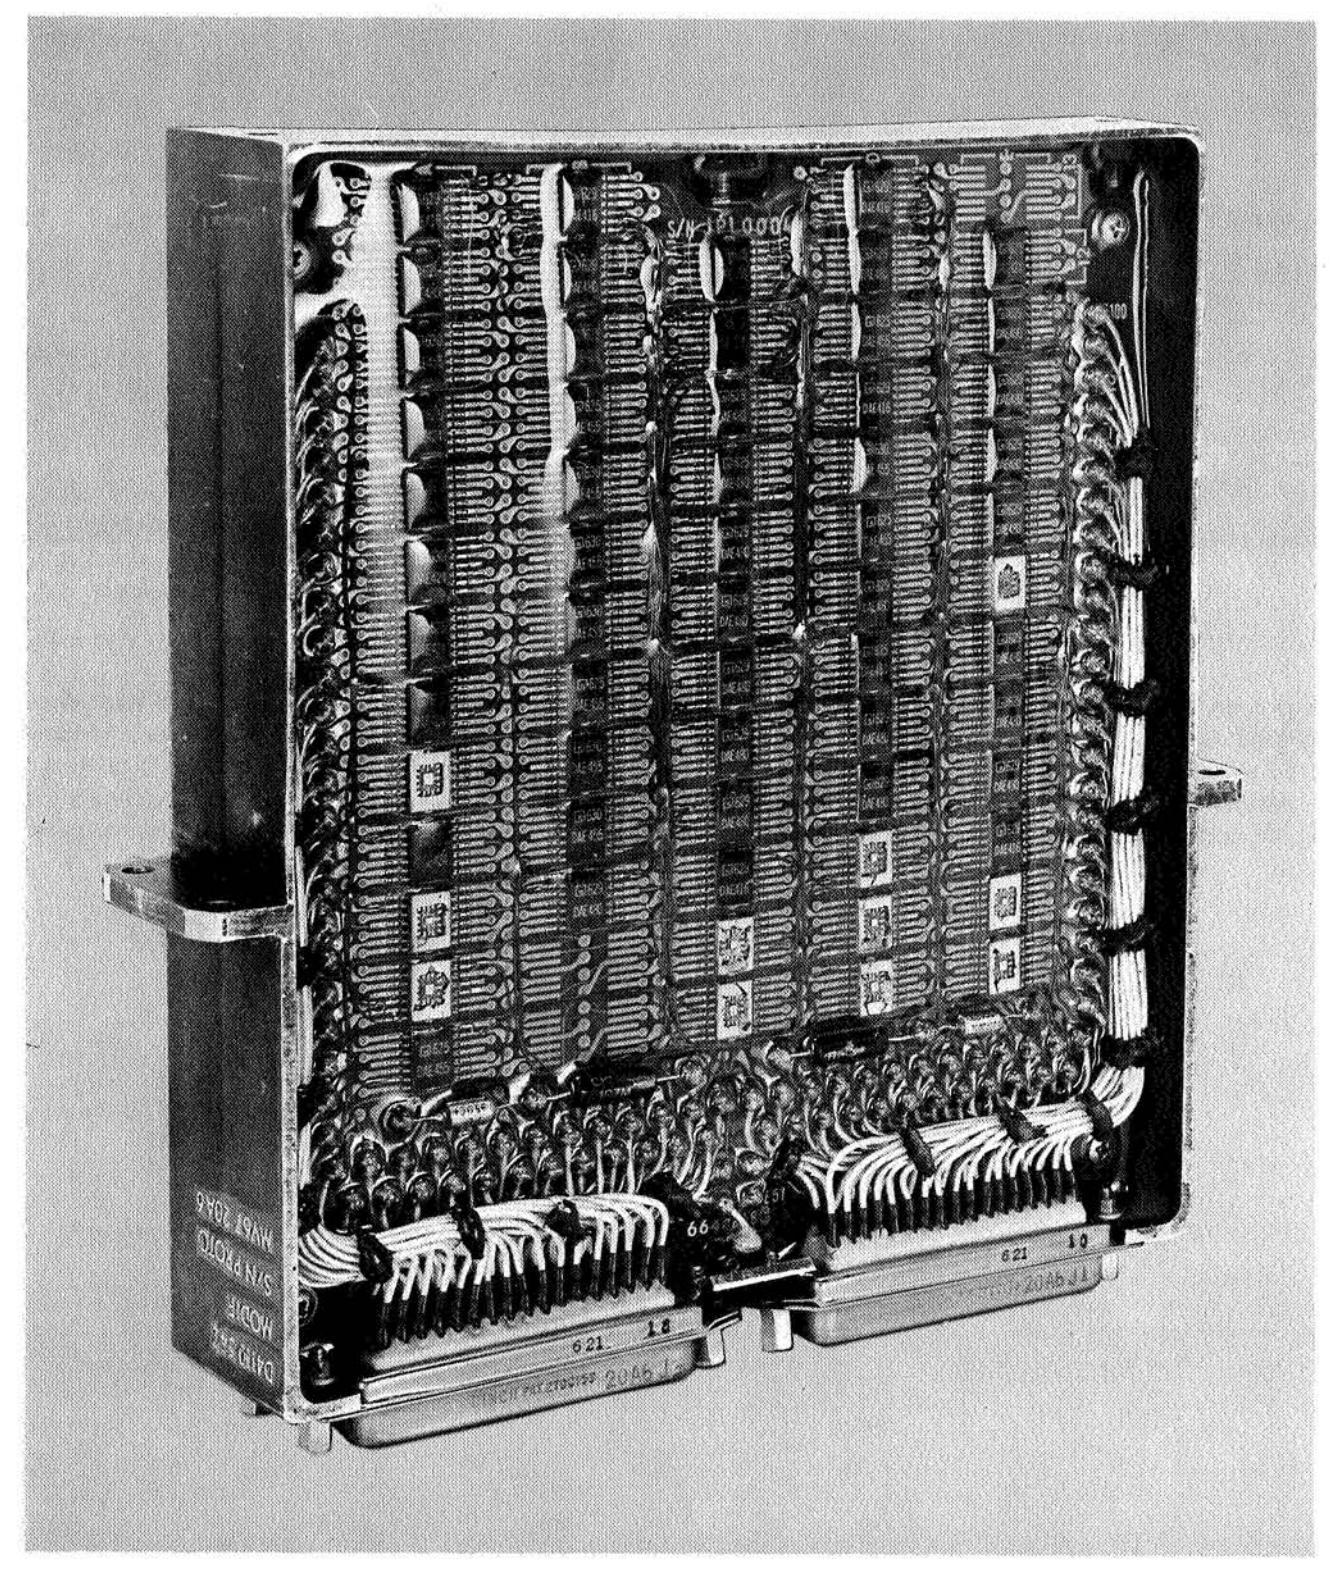
Subassembly 20A6 had the case cracked on one filter capacitor, and the lids came off of eleven integrated circuits on the 6A1 side. The glass around the pad to which the integrated circuit die is attached was cracked on these eleven integrated circuits, and the pad raised on some of them. This subassembly functioned properly without changing any components, and the prototype passed a complete subsystems test without malfunctions.

Fig. 2. Damaged DAS logic assembly

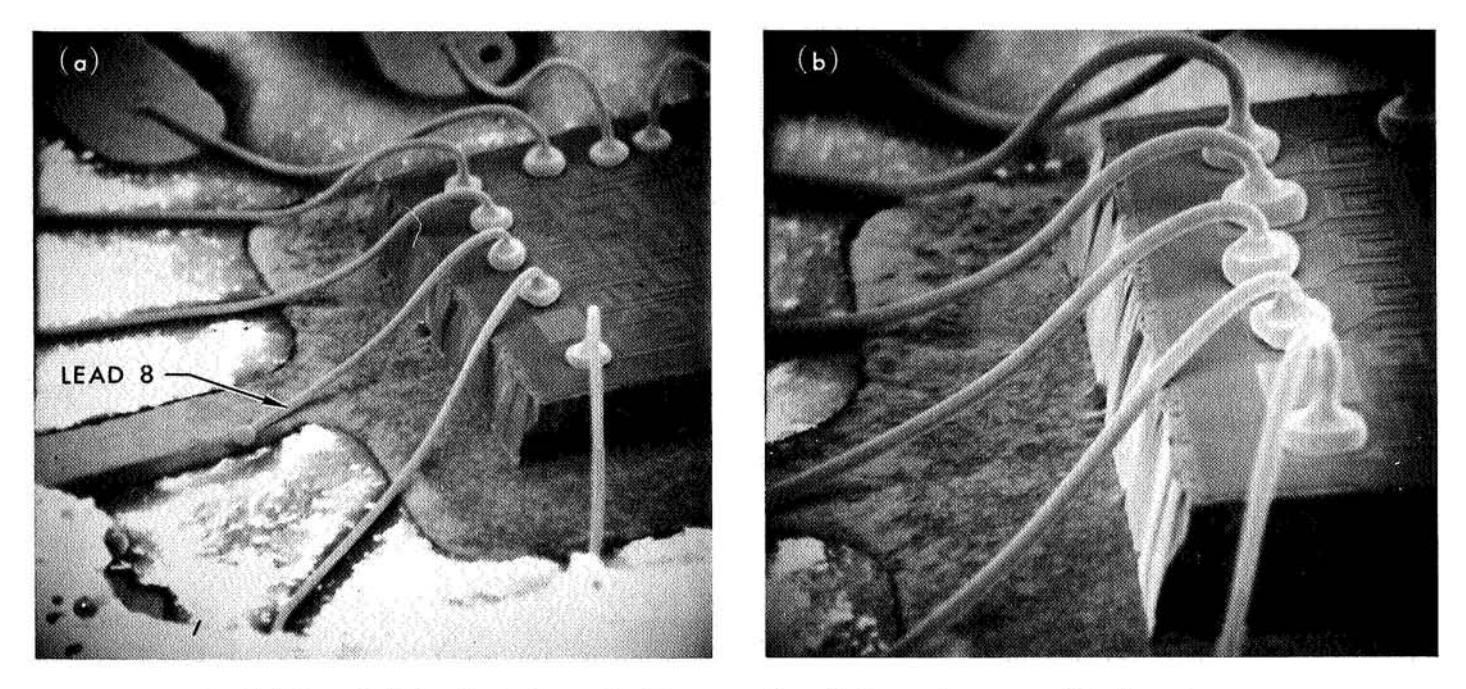
Subassembly 20A2 did not function properly until nine of the fifteen damaged diodes and three integrated circuits were replaced. One of the integrated circuits replaced was on the far side of this assembly; the gold bond wires internal to the integrated circuits had sagged down against the edge of the die, and lead eight was open where it had shorted to ground, melting the wire (Fig. 3a).

Fig. 3. Integrated circuit photographed by scanning electron microscope showing wire sag: (a) magnified 50 times, (b) magnified 100 times

Integrated circuits for use on a possible *Mariner* Mars 1971 flight will most likely have a strengthened ceramic package with a gold-plated molybdenum-manganese die

attach area instead of the gold-plated kovar die attach pad used on the *Mariner* Venus 67 system. This change should prevent the die attach area from separating from the bottom of the package. Aluminum wire will probably be used instead of gold, since it has less mass and does not have a loop in it as the gold wire does. This should solve the sagging wire problem. Stringent environmental and mechanical tests are in process at the integrated circuit manufacturer at this time to qualify the aluminum wire interconnect and ceramic package.
