HARVARD COLLEGE OSO-IV POINTED EXPERIMENT AN ANALYSIS OF THE MALFUNCTION DURING ORBIT 637

BY: R. Dower N. Hazen J. Rechavi

Technical Report No. 7 NASA Contract NASw-184

February 1969

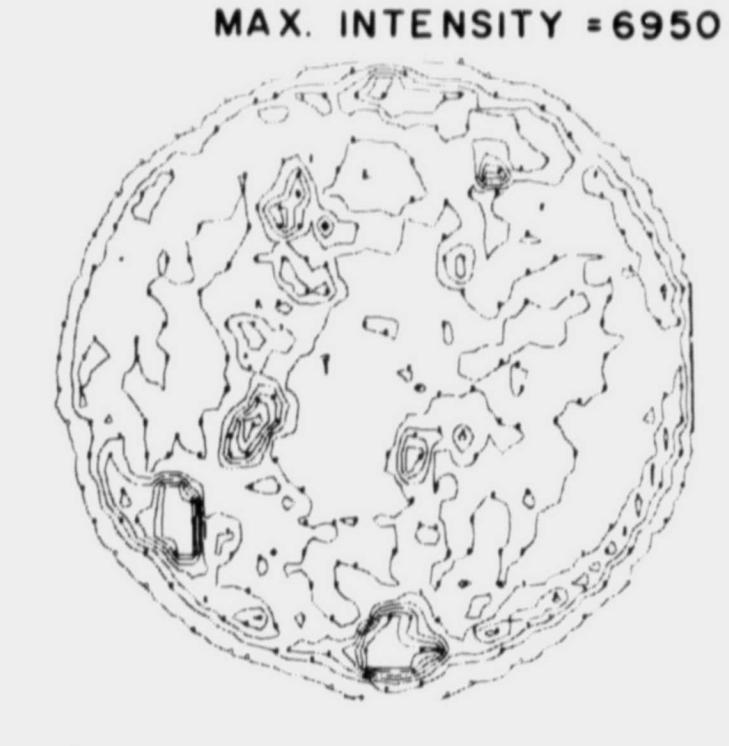
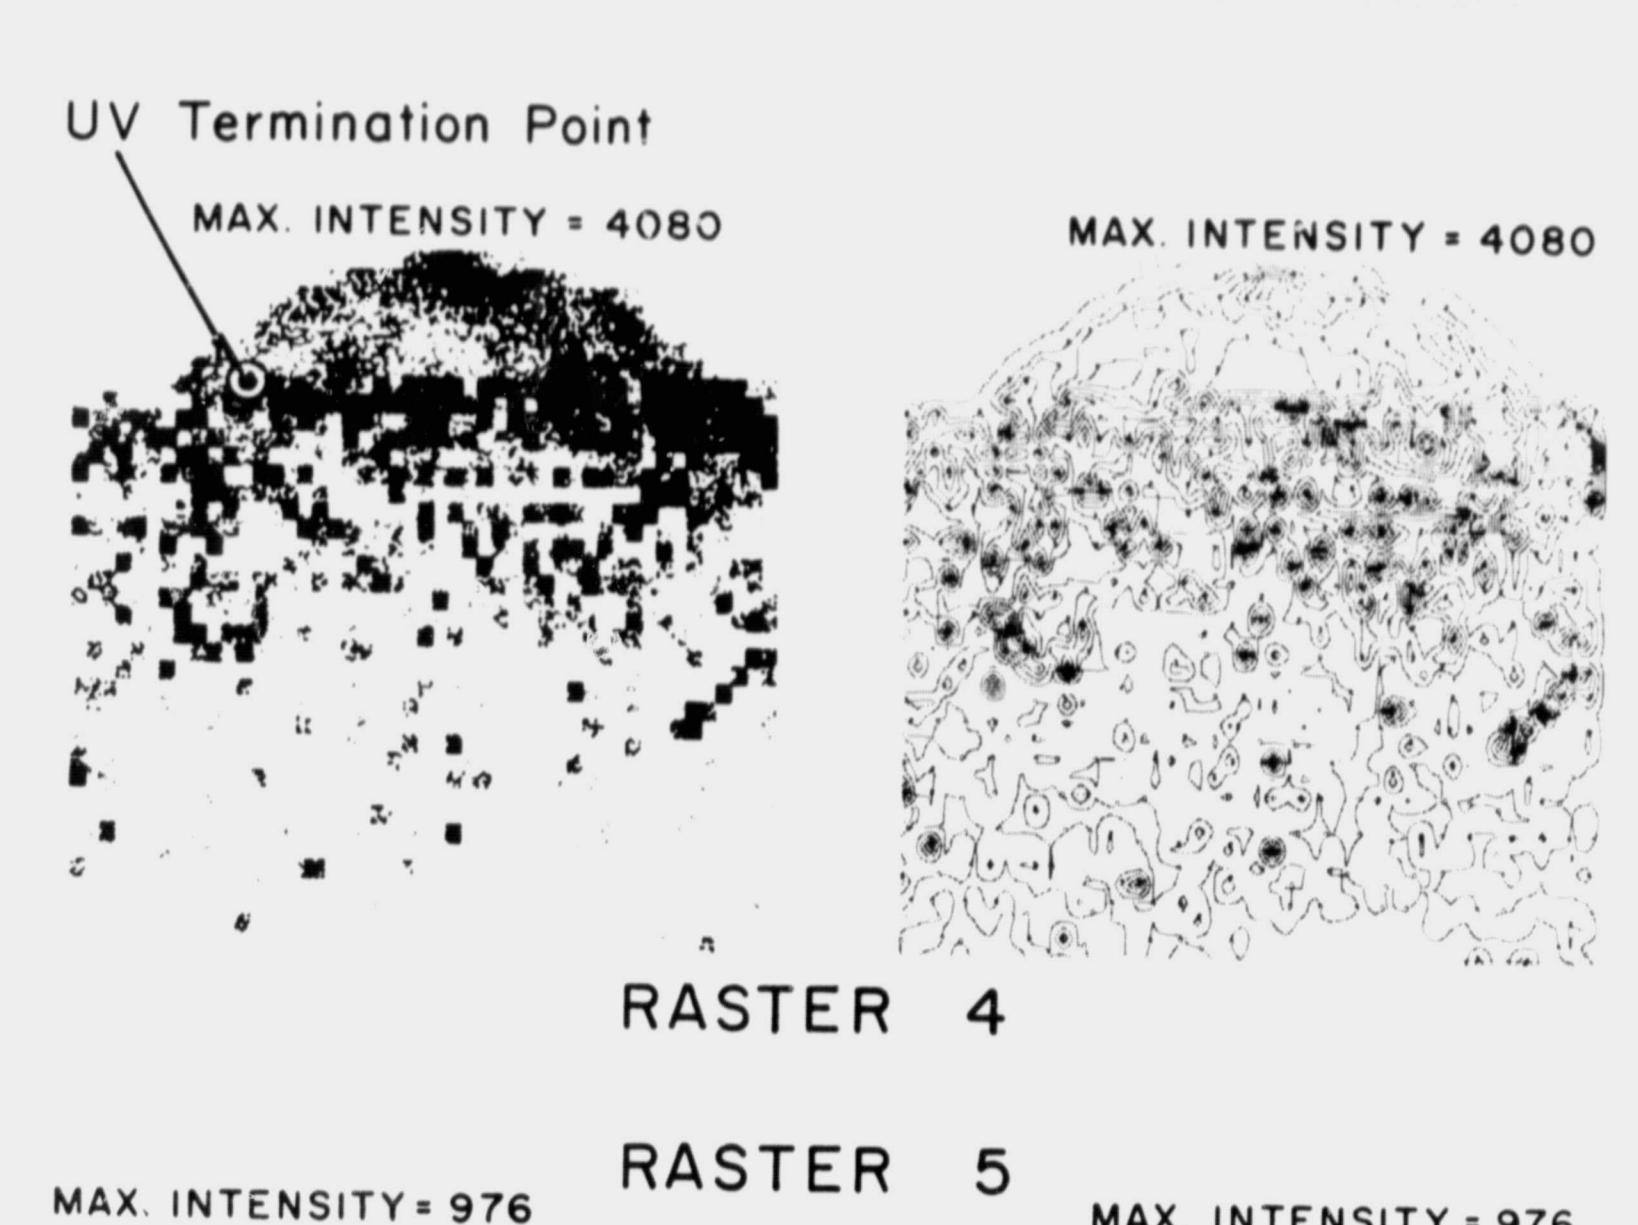
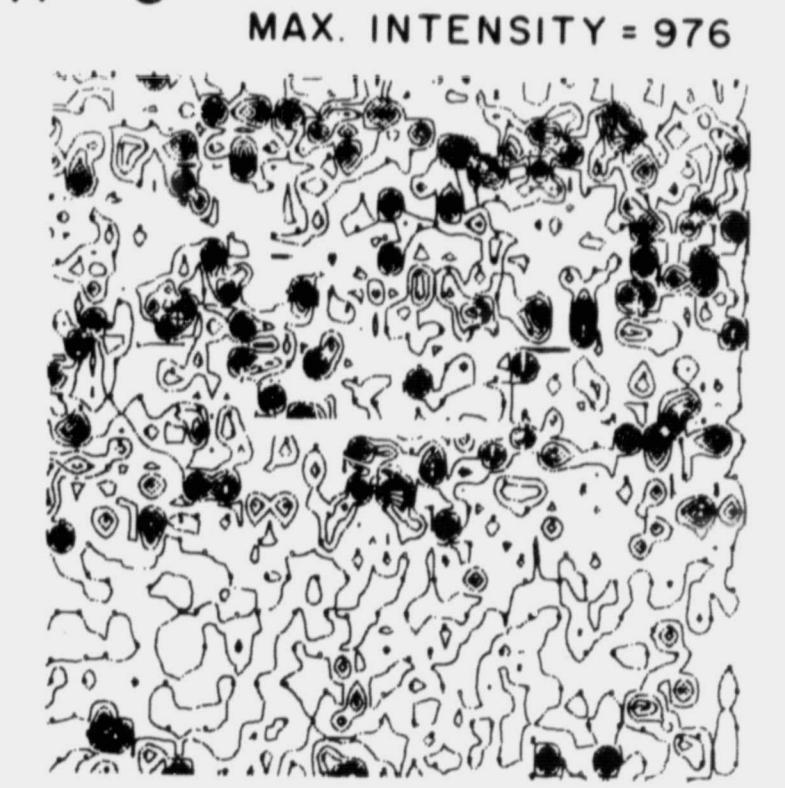
Figure 5B RASTER PLOTS AFTER UV TERMINATION

indicate intensity by the dotted lines of constant intensity (isophotes). The highest data count recorded during each raster is printed above the raster picture as a maximum intensity figure. Raster 2 and raster 3 show the coherent solar images and very close correlation with expected intensities. Raster 4 begins at the top with a good rounded solar image, then the picture suddenly deteriorates as an image of the sun in ultraviolet light. The plots of raster 5 show no apparent relationship to a solar image.

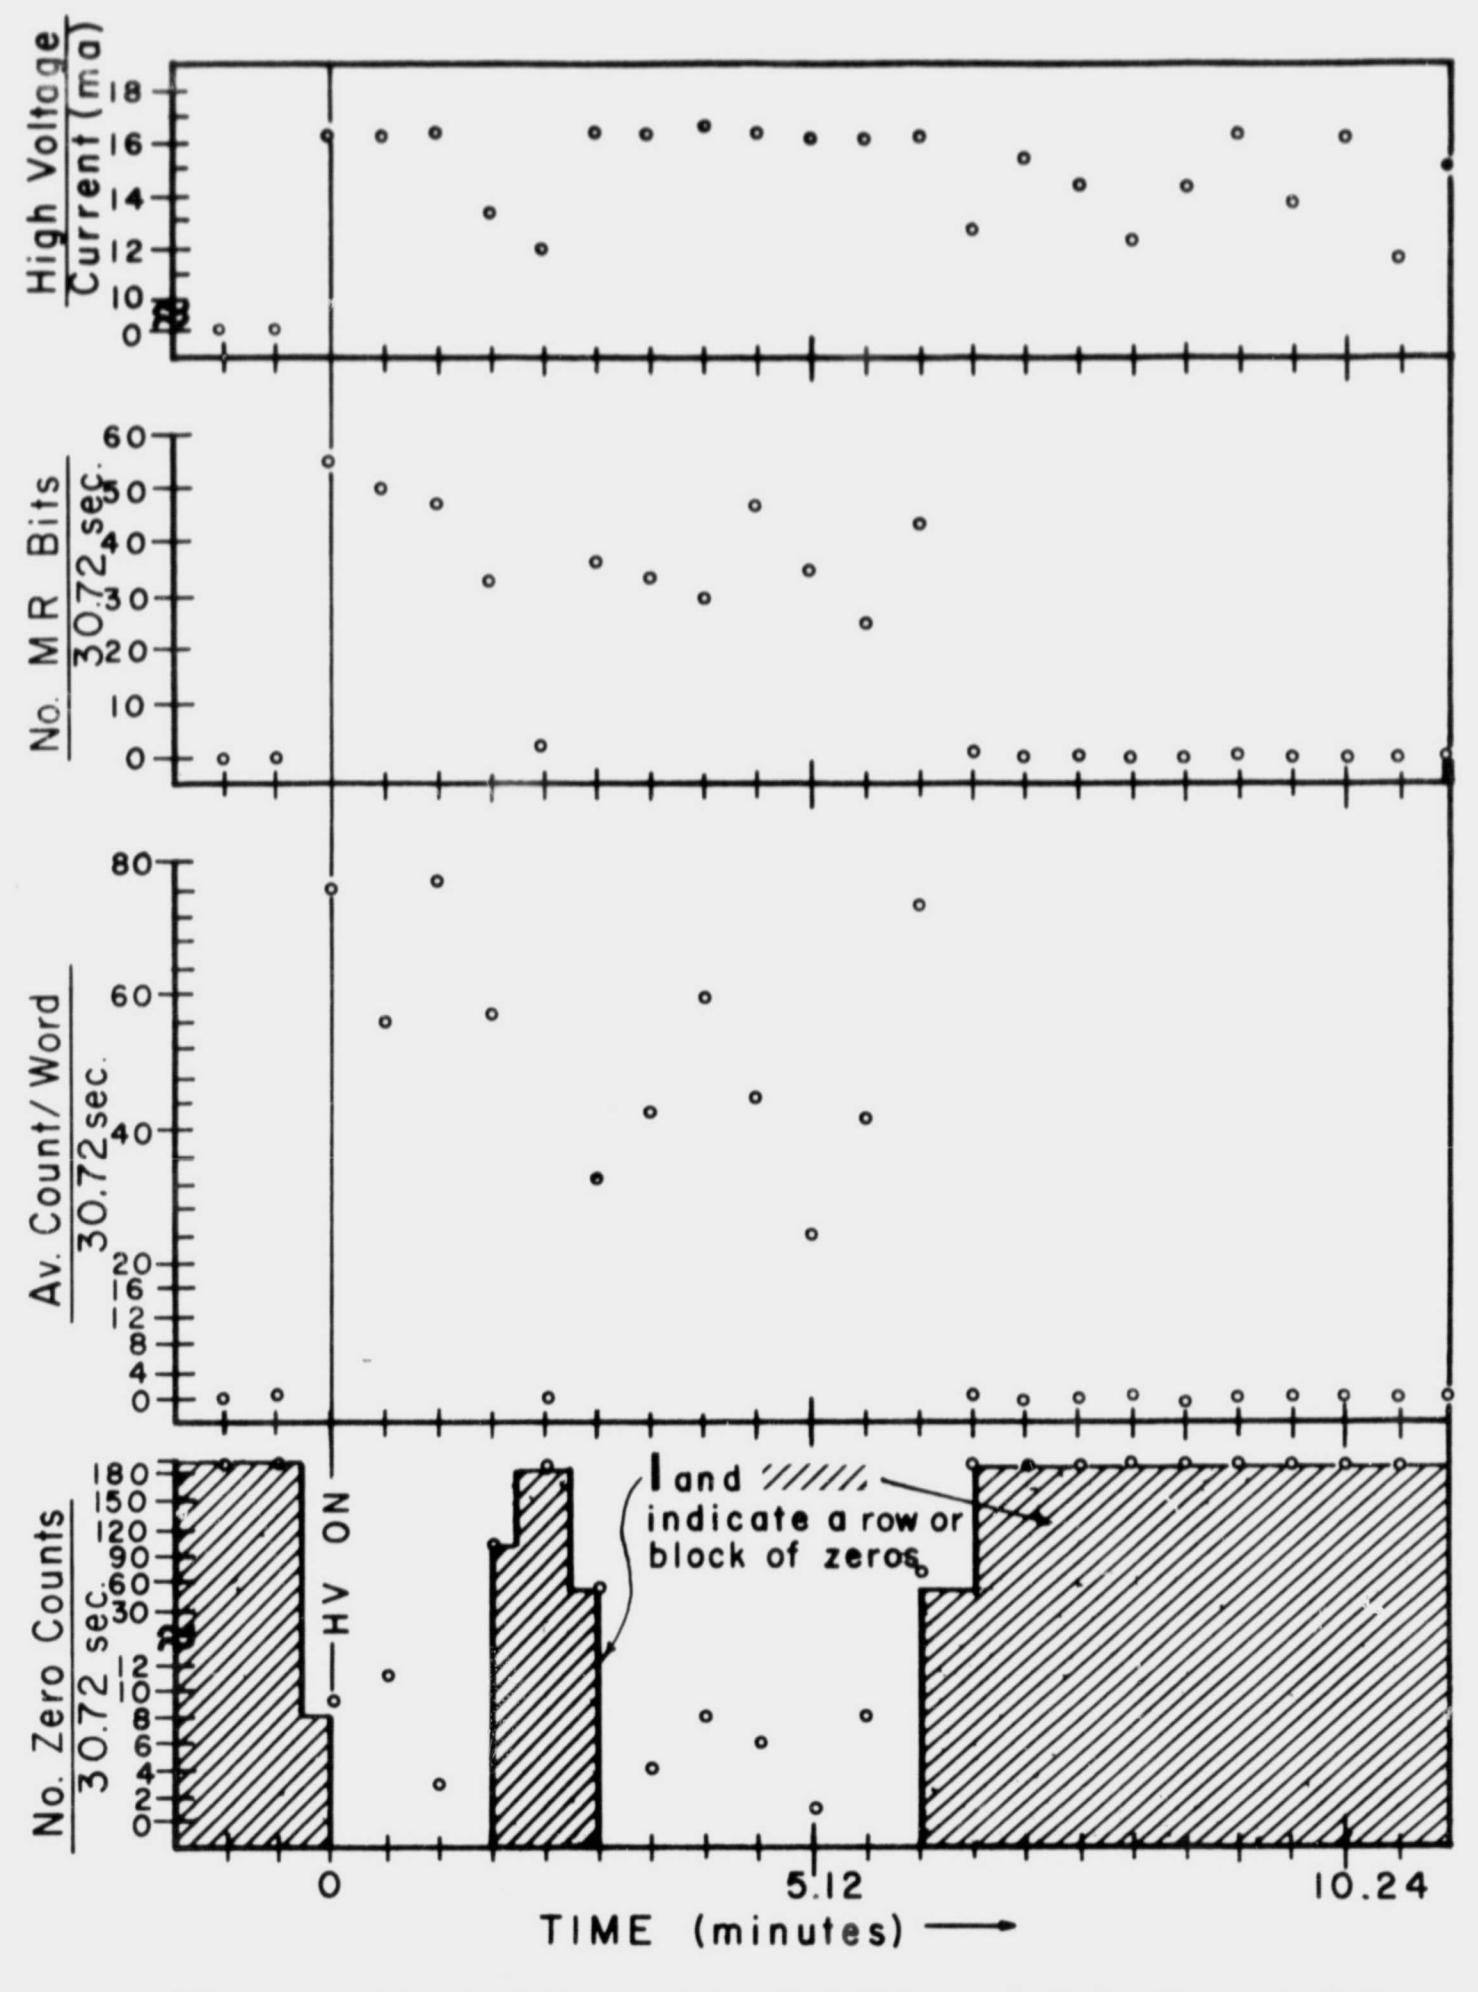
Figure II-HARVARD DATA- ORBIT 1238

Five weeks later on January 8, 1968 during orbit 1238 the HV power supply was turned on for 2 hours and 50 minutes. For 1 minute and 45 seconds noise counts, false MR indications, and high, constant HV current readings indicate Mode I operation. This was followed by one minute of Mode II, three minutes of Mode I, then Mode II until the HV was turned off. Figure 11 shows plots of data from orbit 1238.

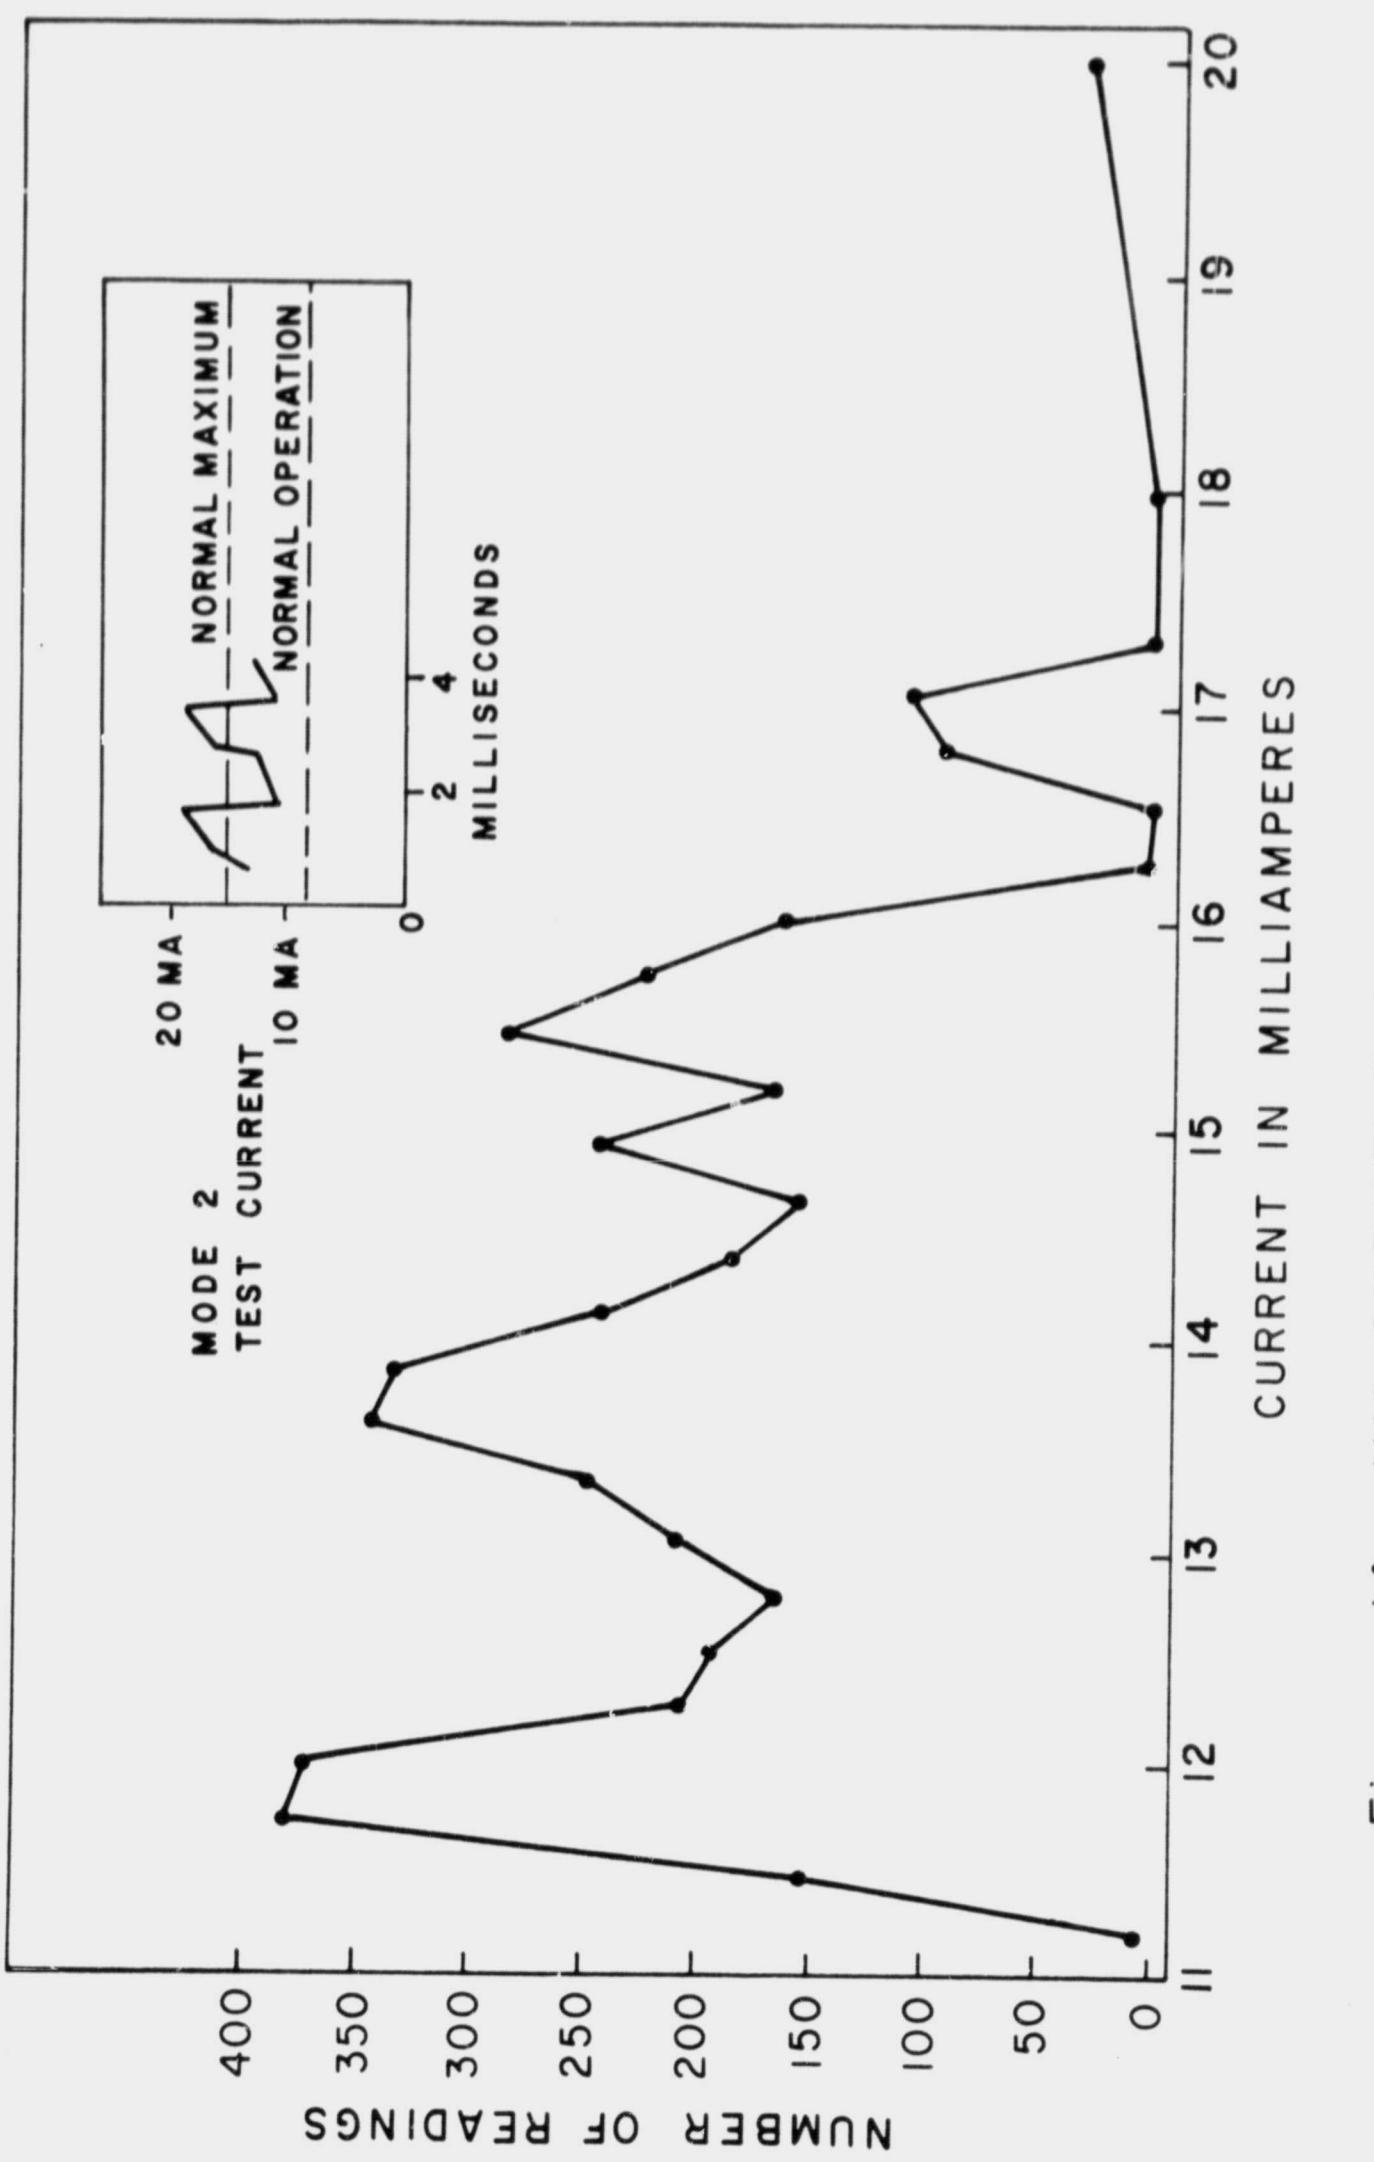
2) READINGS (MODE HV CURRENT Figure 14-

The high voltage current readings from a total of 44 orbits (in January and February 1968) are plotted in Figure 14. During these orbits Mode II conditions prevailed in the instrument. Illustrated in the upper right corner of Figure 14 is a current waveform obtained in the prototype instrument with capacitor Cl open and a high voltage lead shorted to the common line.

As mentioned previously, the analog subcommutator data sample is a period of 160 µsec., taken every 30.72 sec. For the purpose of this discussion it can be considered a brief sample (small compared to the period of the signal) and taken at random intervals. Although by no means conclusive, the sample distribution shown in Figure 14 can certainly be interpreted as a statistical sample of the waveform shown. Note that no readings were obtained below 11 ma (i.e., approaching the normal current range).

Assuming that Cl opened during Mode I operation (perhaps during the first minute after UV termination) we can tentatively explain Mode II as the result of a low resistance connection developing between a high voltage source and the common line. The alternation between Mode I and Mode II conditions can best be explained to have resulted from the time variant character of such a connection (e.g., transition between a corona breakdown and a short circuit).

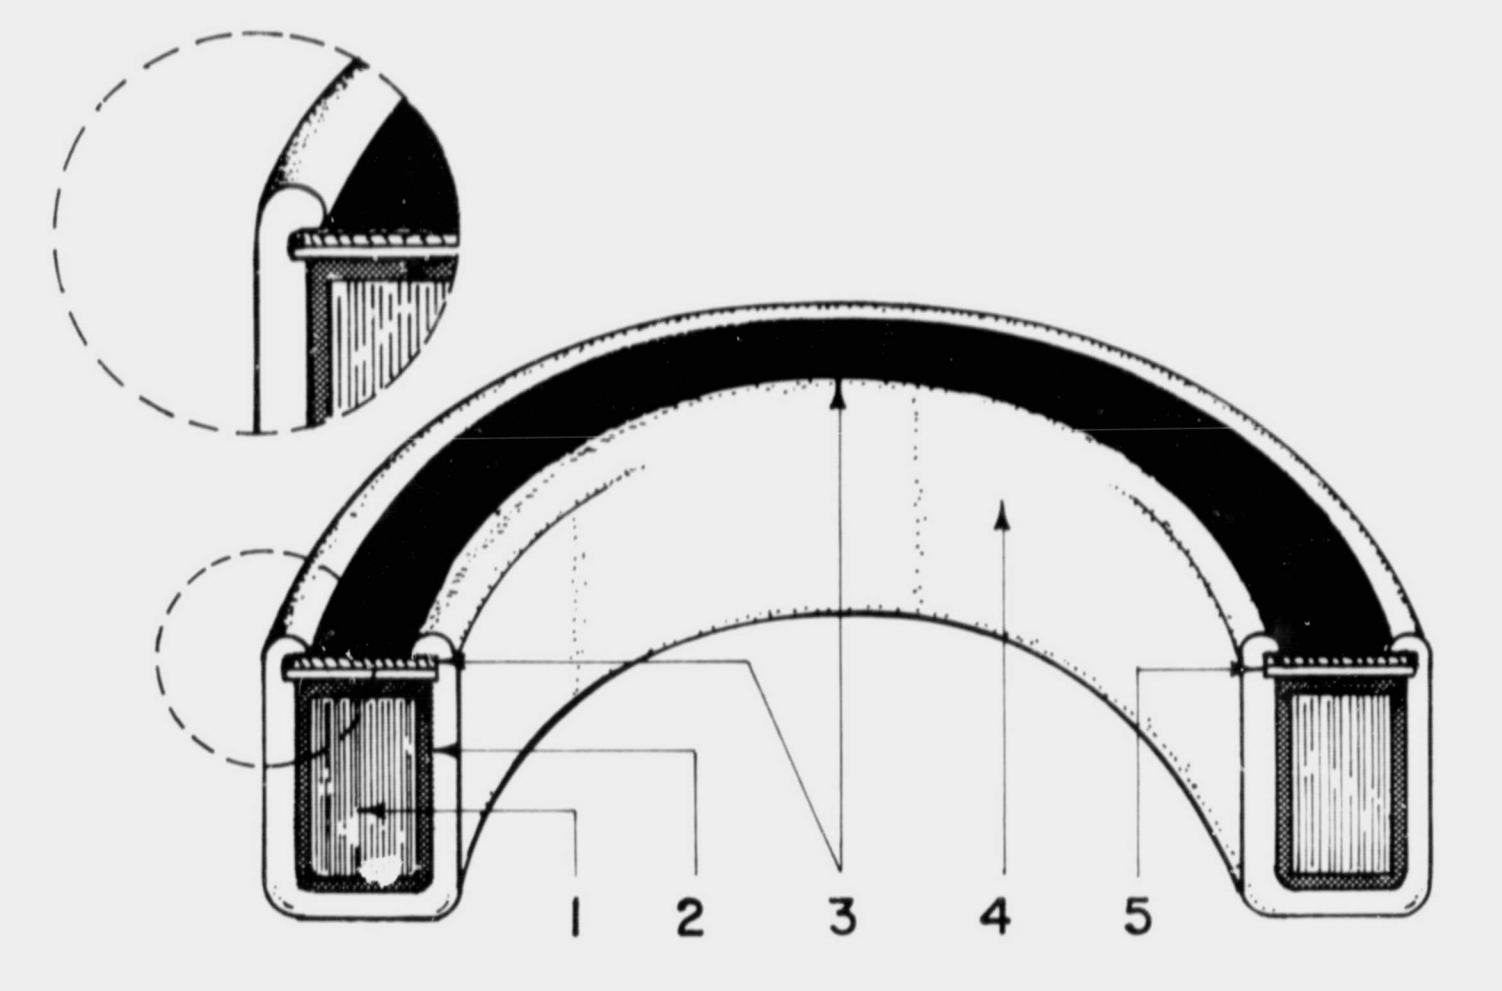
Figure 16 HV TRANSFORMER CORE The glass-laminate board serves to break the electrical path around the core box. The core construction is illustrated in the cut-away view of Figure 16.

We now consider the high voltage transformer. The toroidal core assembly used in this transformer is manufactured by GL Electronics (Part No. GL-A-4057-Ml). The core tape is supermalloy foil and is embedded in a silicone grease within an aluminum housing. The housing is sealed by a crimp seal against a rubber washer backed up by a glass-laminate board. The housing is black anodized and has rounded corners. The silicone grease is used to protect the core from mechanical stresses on the box due to winding which might alter the magnetic properties of the tape. The grease also cushions the core during vibration and shock testing.

The transformer assembly is conformally coated with RTV-11 silicone rubber which has been degassed in vacuum. It is then cured at room temperature, and baked at moderate temperature and atmospheric pressure. On the sample transformer examined in our laboratory a layer of RTV-11 between .010 and .030 inches thick was found which has not penetrated through the outermost layer of TFE tape.

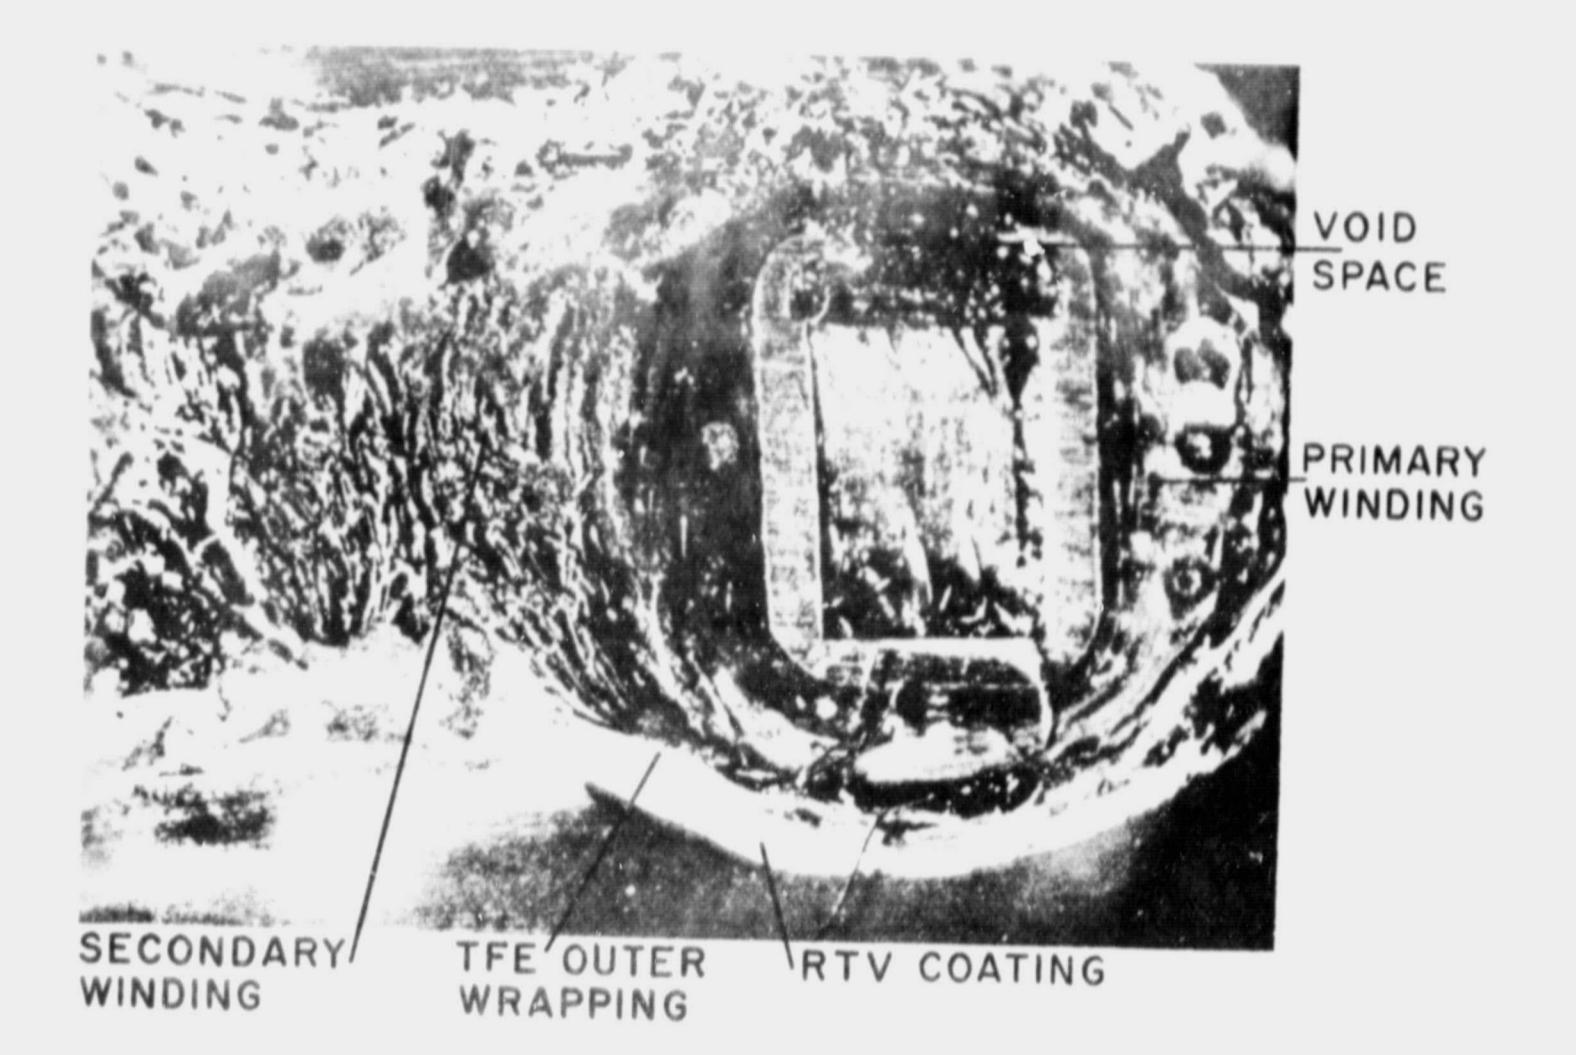
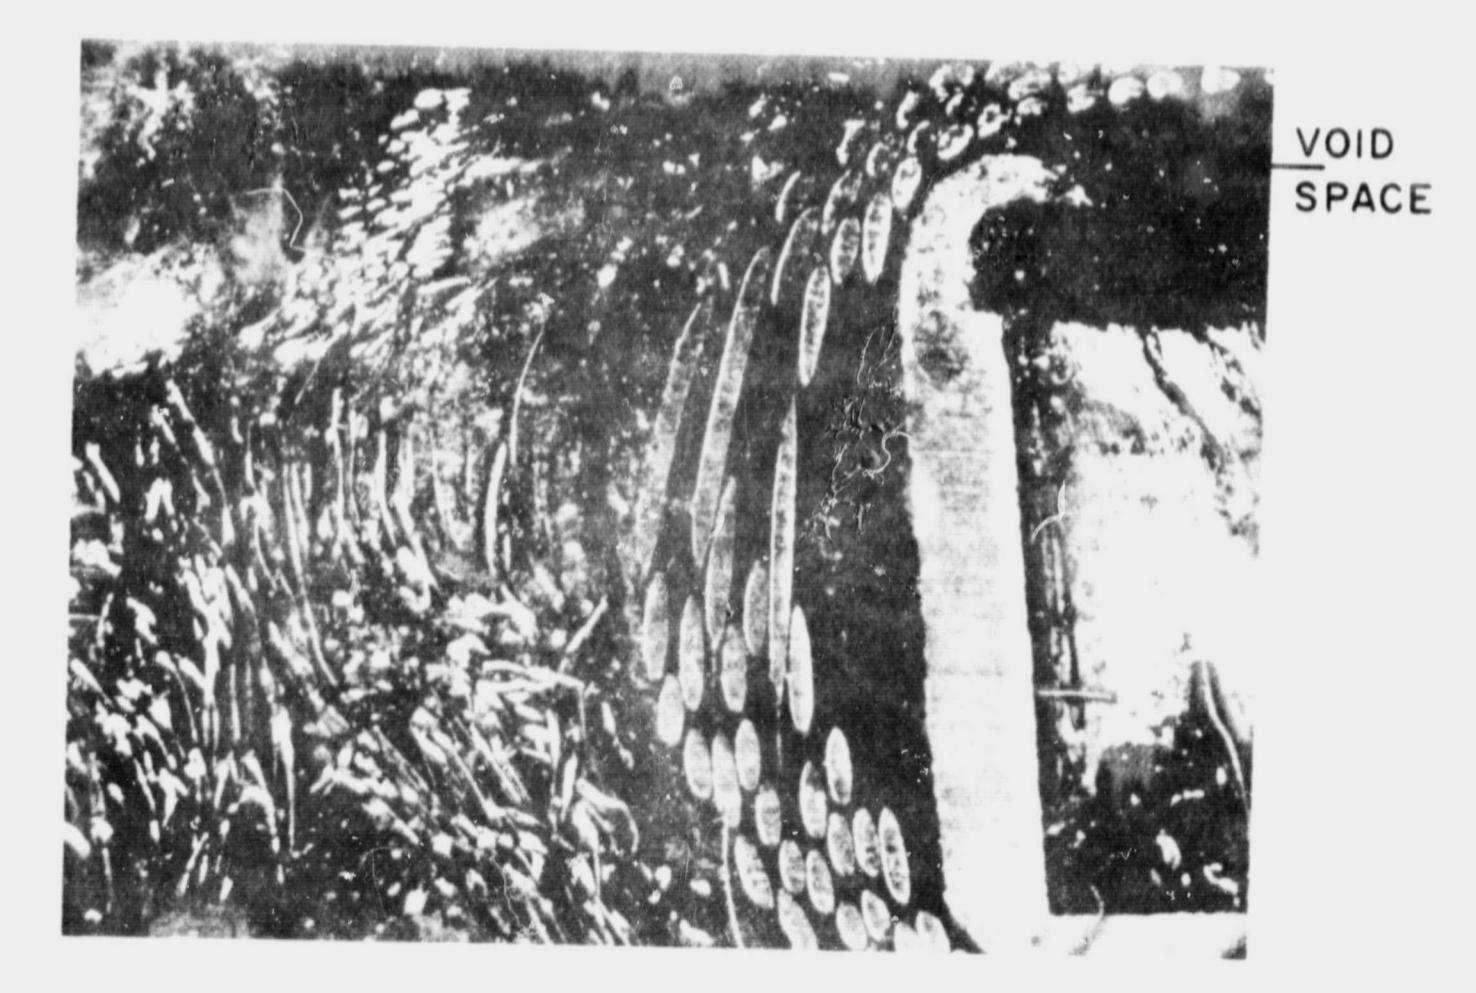
Figure 17 - UV TRANSFORMER CORE MODULE

Inspection of a sample module (see Figure 17) in our laboratory indicates that the C-7 did not penetrate through the RTV into the secondary winding area. However,

it did penetrate down the primary leads and partially encapsulated the primary winding. The manufacturer of the HV power supply said that this was a random occurrence. In our sample the C-7 had not bonded to the aluminum box of the core. The TFE tape winding on the core box was stretched across the top of the rolled aluminum edges on the core box and this created a void space between the rubber washer seal of the box and the TFE tape.

The encapsulation process included degassing the module at a pressure of approximately 20 torr. After degassing and restoration of atmospheric pressure the C-7 encapsulant presumably backfilled some of the spaces which under vacuum conditions were of the residual gas trapped inside the transformer. It appears that a significant volume of air at a pressure above corona pressures was probably well sealed within the transformer windings.

In the light of the information which has been described in this section we can put forward a theory which is substantiated by all the available data. Following launch of the instrument, the air trapped within the transformer element in the high voltage power supply gradually leaked or diffused out of the module until its pressure reached a region favorable to corona breakdown between the leads or windings of the primary and secondary coils (see Figure 13). Then such breakdown occurred, yielding our "Mode I" condition and producing large transients on the common (return) line of the primary circuit, which were aggravated by the presence of the inductor and series resistor in that leg. These transients caused the capacitor Cl to open. As the corona breakdown condition continued, interaction with the materials of the transformer developed and reduced resistance paths, first intermittently and then more permanently, eventually producing the "Mode II" condition. Variation (with time) of the condition of these synthesized resistance paths produced the occasional reversion to Mode I observed on several later orbits. Clearly this is a theory, not a proven fact, although it is consistent with all the information available.

- No reversion to a mode capable of gathering
 UV data has occurred since the first event.
- 7. The probable failure of the high voltage transformer is in all likelihood due to inadequate manufacturing and encapsulating technique. This resulted in trapping a significant pocket of air within the windings of the transformer, which gradually leaked out allowing eventual electrical breakdown.
8.0 RECOMMENDATIONS

In the system design, two recommendations can be made. 1) High voltage failures, both in the laboratory and in this case in orbit, seem to be progressive affairs in which the continuation of one kind of effect precipitates another. A way of avoiding this chain of events is through the use of overload sensing devices coupled with an automatic off switch. This technique will be used in our OSO-G experiment, and although it will not guarantee the avoidance of irreversible change, it should reduce the probability of it. Another technique to be considered is the use of redundant high voltage power supplies or complete systems to extend the probable life of an experiment.

The matter of testing needs further examination. This failure brings up a question of testing philosophy and whether flight units should be tested for relatively small proportions of their expected life or longer amounts. For example, typically a motor is subjected to tests equivalent to a small proportion of its expected life before flight. However, perhaps a high voltage power supply, for example, should be exposed to vacuum for a period equivalent to its designed exposure time as a routine acceptance test. More generally the recommendation here is to thoughtfully design test procedures which completely explore as many areas of weakness as possible.

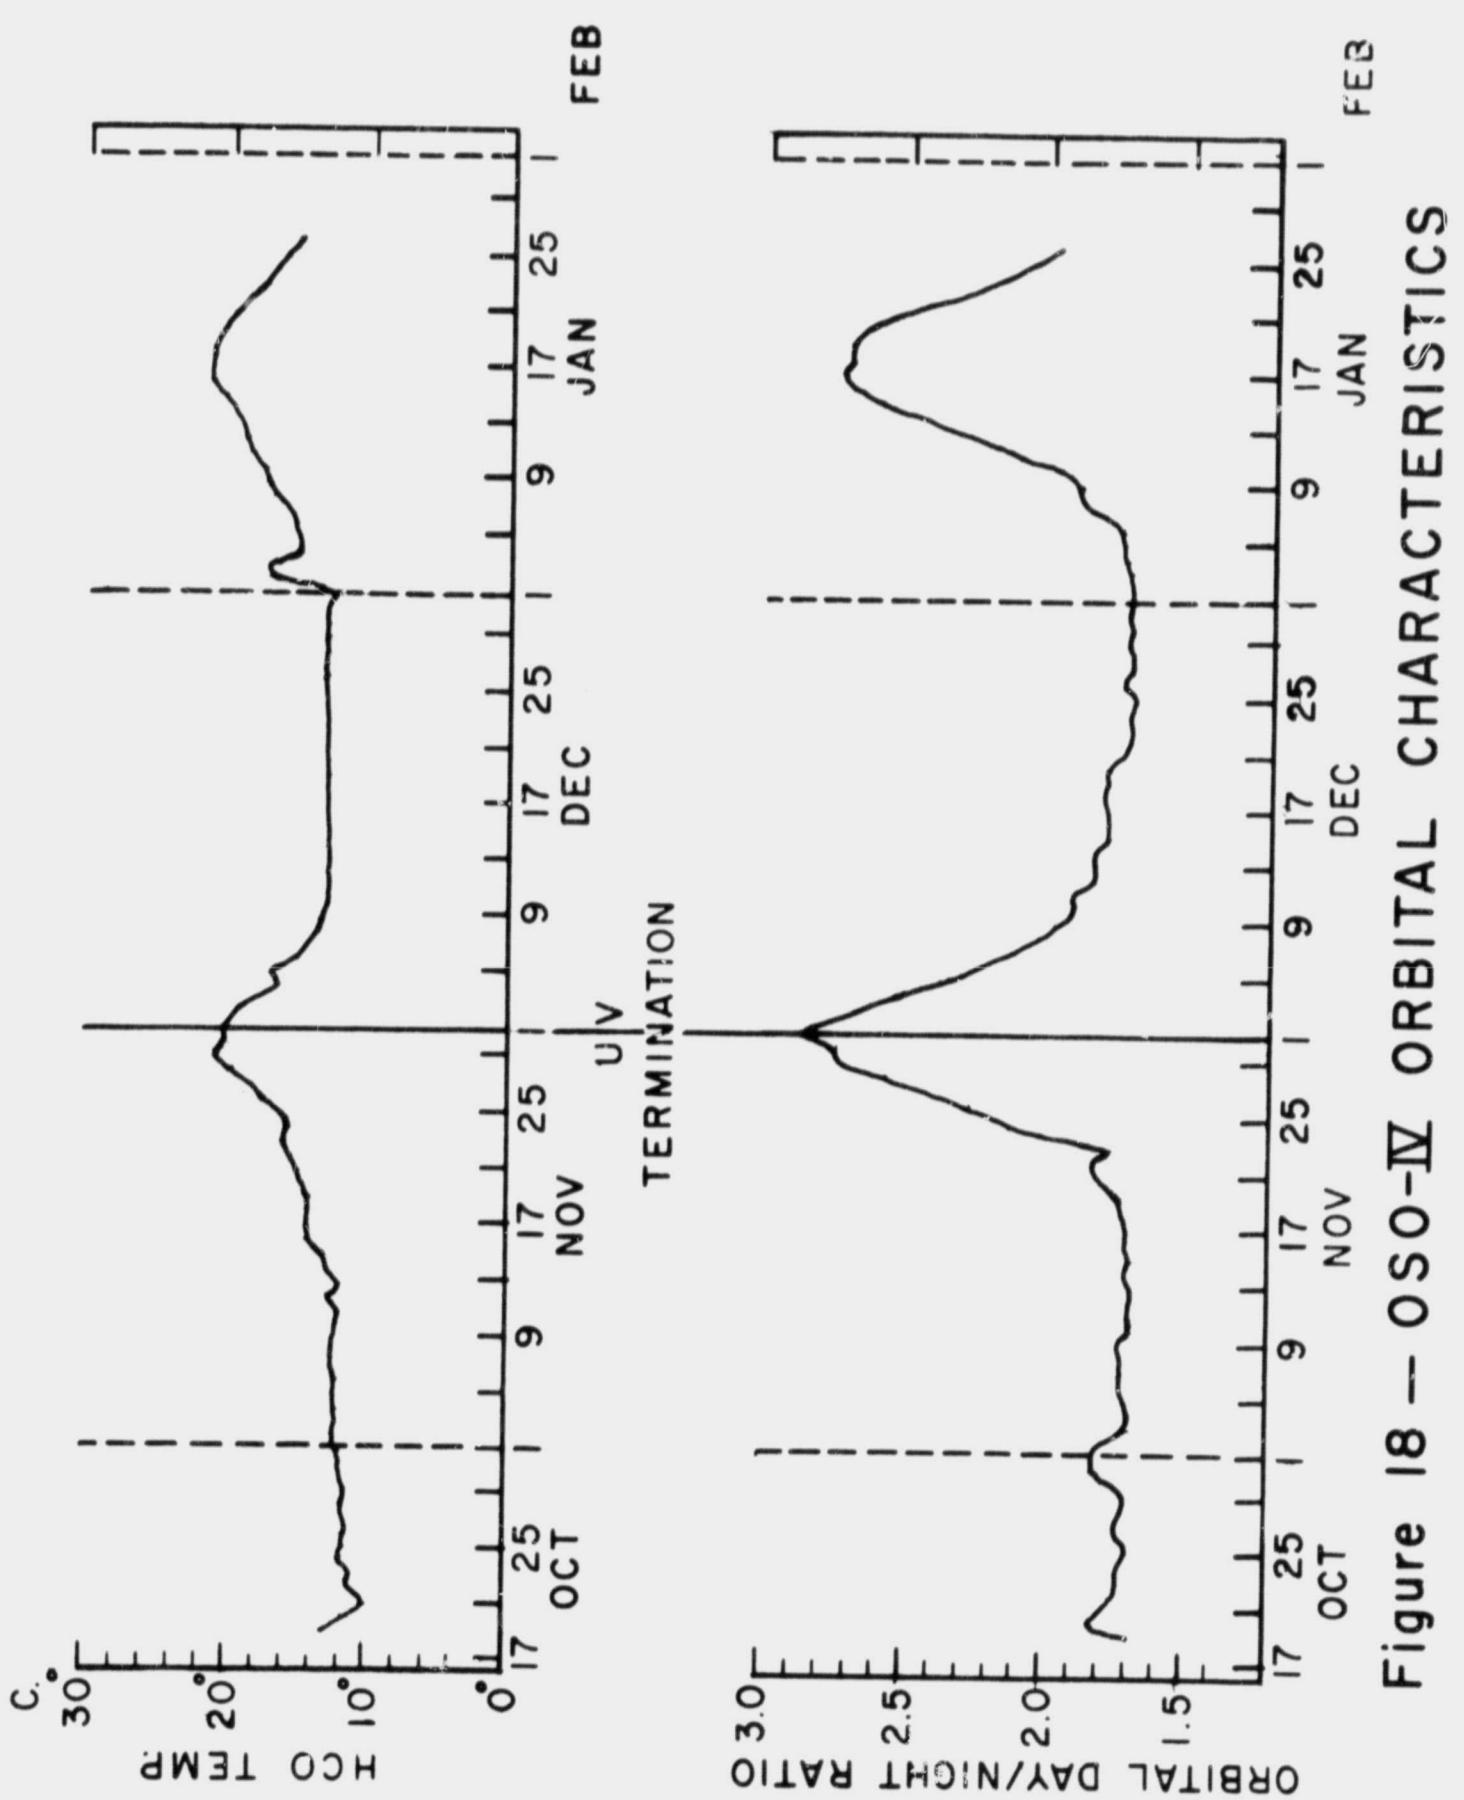
Shortly after the malfunction, it was observed that the instrument's absolute temperature had risen from 17°C to 21°C in the period from November 25, through November 30. This was at the end of a long gradual rise in temperature (from 11°C) beginning in late October. In the eight days following the malfunction while the instrument power was off, the absolute temperature returned to 15°C and subsequently went even lower. How this related to the failure was uncertain. The instrument and its sub-assemblies had of course been acceptance tested over a much wider temperature range, in excess of 0°C through 30°C.

summarized in Figure 18. Fairly abrupt rises occur in this ratio periodically, because of the precession of the orbital plane at intervals of approximately 47 days. The instrument temperature appears to have followed these intervals faithfully. This was confirmed when the next peak occurred in mid-January and the instrument temperature performed a similar excursion. This effect has been noted on previous OSO's. Therefore the fluctuation in instrument temperature are believed to be a result of external causes rather than any pre-failure self-heating effect. However, it should be noted that the fluctuation in temperature might still have had a secondary relationship to the malfunction by altering the physical geometry of the gas leakage paths from the high voltage transformer by thermal expansion. A check of orbit 1238, in which a mode transition was observed, has shown that the thermal expansion occurred shortly before but not during one of these temperature excursions. 6.3 SOUTH ATLANTIC ANOMALY
