FINAL REPORT
1969 SOLAR-TRACKER
BALLOON FLIGHTS
3051, 3052, 3053, 3054

December 1969

FINAL REPORT

Report No. 3399
Project No. 59714

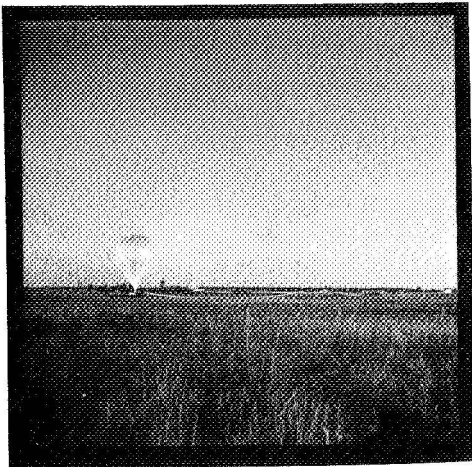
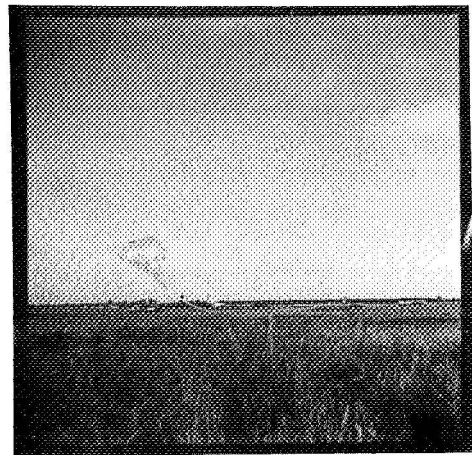
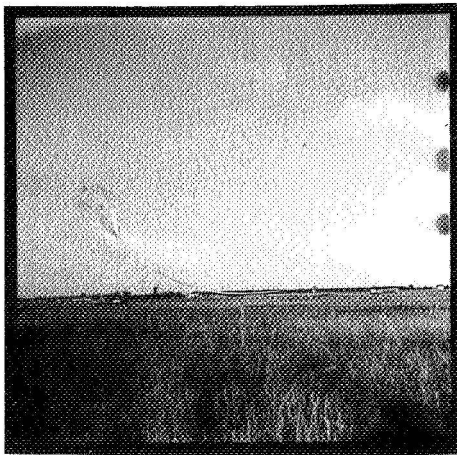
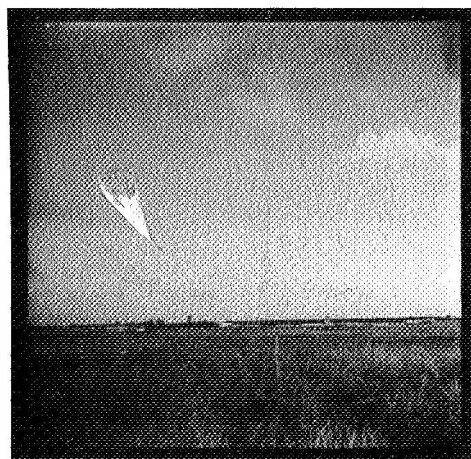
Figure 1. Launch Sequence Photos Showing Reefing Sleeve

The manufacturer made two modifications to the balloon designed for this program. One change was the addition of a high-slip reefing sleeve enclosing the lower 200 feet of the balloon to reduce wind effects during inflation, launch and low-altitude ascent. The sleeve is designed with a very thin tear panel and automatically opens as the balloon expands. The launch sequence shown in Figures 1 and 2 shows that the sleeve effectively retains the materials and is, therefore, a worthwhile design improvement. The second change was the use of a single gasport on the side of the balloon, in place of the three used on previously ordered balloons for the purpose of system descent. A query to the balloon manufacturer upon receipt of the balloon indicates that their calculations (through a computer) showed this valve size and placement would provide the specified system descent characteristics.
