N71 - 27697 NASA TM X-67851

SHOCK AND VIBRATION TESTS OF A

SNAP-8 TURBOALTERNATOR

by Andre J. Stromquist and Lawrence Hibben Lewis Research Center Cleveland, Ohio

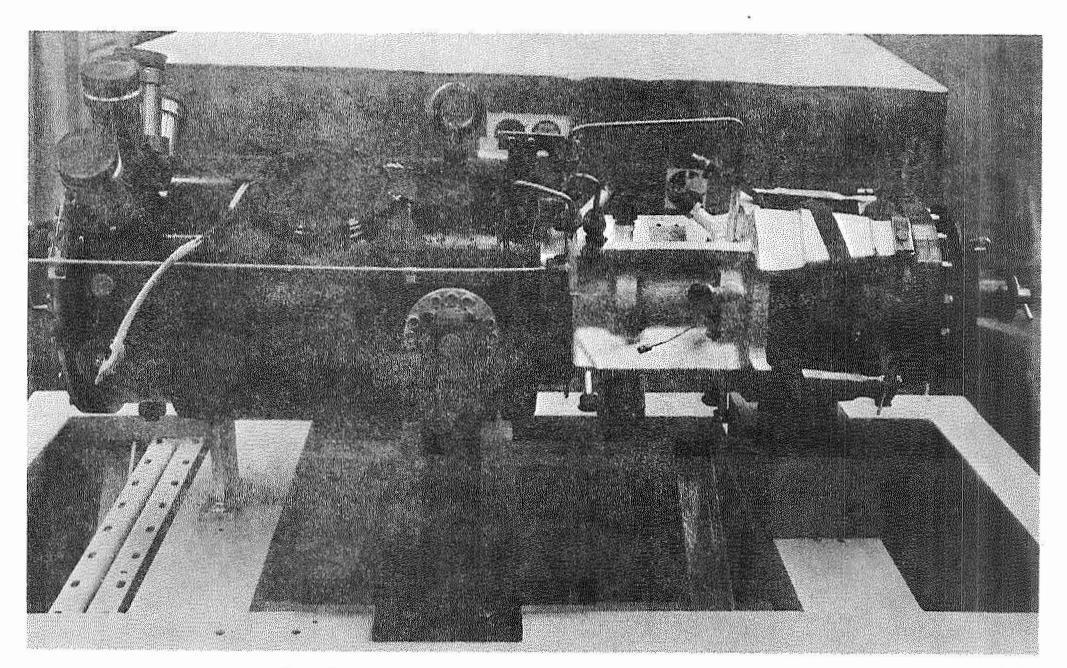
An external examination of the turboalternator shown in the as-received condition in figure 6 revealed no failures of the basic structure. Some of the external instrumentation and plumbing connections failed during the tests, but these were confined to nonflight parts such as the space seal manifold, thrust balance tube, and a lubrication plumbing manifold tube. The seal cavity pressure tap was also cracked at the root.

Figure 6. - SNAP-8 turbine alternator assembly unit 6/3 after vibration and shock testing, and upon recepit at A.G.C.

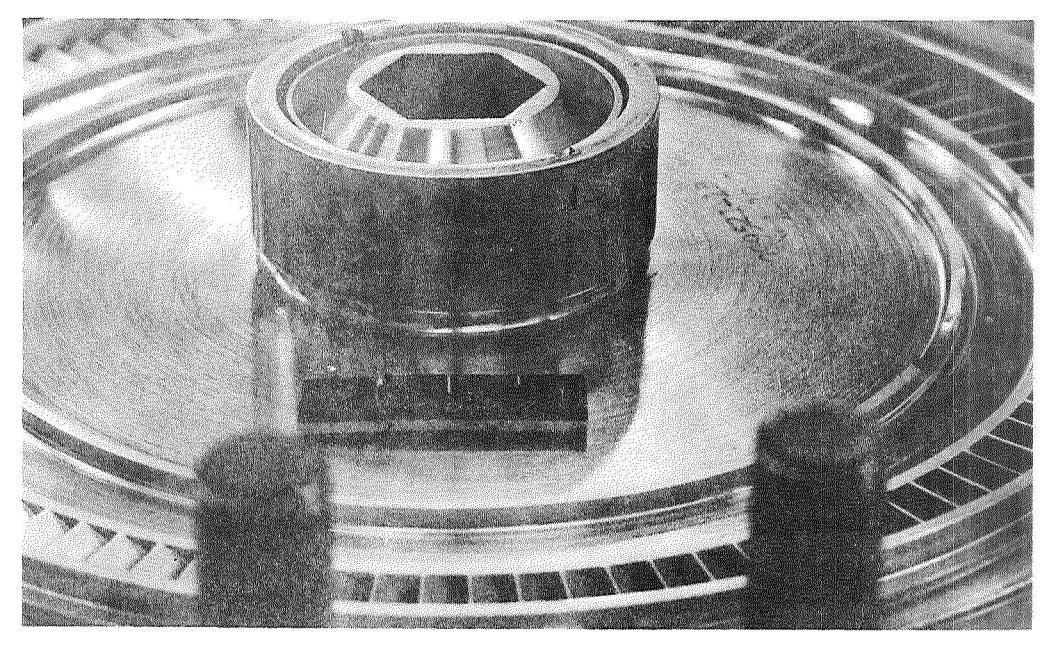
The inlet housing nuts were removed at normal torque values and the labyrinth seal slid freely over the 1st stage wheel hub. A light intermittent pattern of labyrinth contact marks was noted on the first stage wheel hub (fig. 7). This unit, 6/3, is equipped with fixed style labyrinth seals. No other contacts were noted. No chatter or vibration marks were noted on the K-seals or the inlet to turbine case flange joints.

The marking of the turbine wheel hubs from contact with the labyrinths clearly shows the limit of deflections of the shaft. The marking is superficial in nature and is found on both the first and second stage wheels with a uniform distribution around the periphery. This minor contact is apparently sufficient to dampen the vibration without serious impact effects. It should be noted that the lightly clamped labyrinth designs, such as used on previous turboalternators which are employed normally, would not necessarily act in a similar fashion but would be deflected under the vibration and shock impact forces.

Figure 7. - First stage wheel close up of light labyrinth marking of outboard hub.

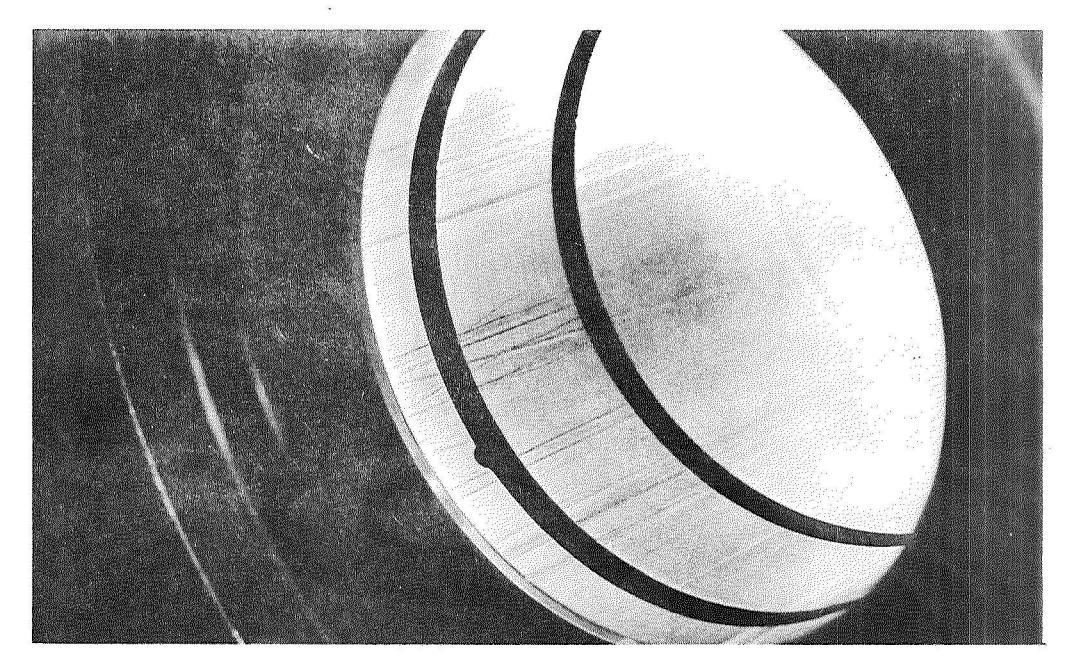
Rotor rotational torque was 5.54 newton-meters (78 oz-in.) with only one seal in contact after the turbine case was removed. The running ring was removed thus disengaging the face seals. A torque of 0.1775 newtonmeters (2.5 oz-in.) was then measured which reflects bearing friction only. The removal of the rotor group from the bearing housing was difficult. The normal sliding fits between bearing outer rings, bearing lube rings, the spacer sleeve and the bearing housing had become damaged and galled. This is shown in figures 8 and 9.

Figure 8. - Turbine bearing housing internal view showing gall marks from rotor removal.

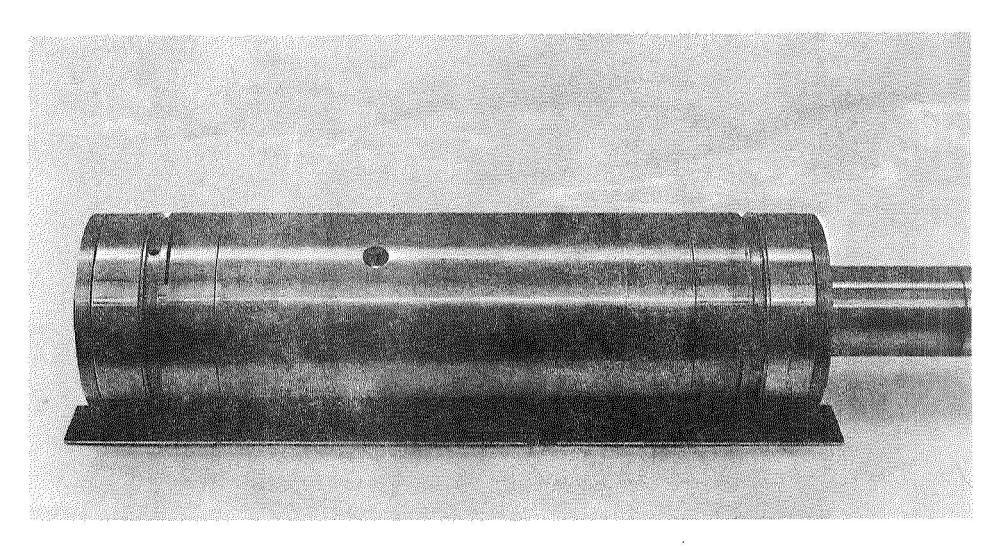
The shaft and slingers were in good condition. The bearing housing bore was in poor condition with many scratches and galls particularly at the alternator drive end (fig. 9). All significant parts of the turbine were fluorescent penetrant inspected to supplement the visual inspections of the parts and ensure discovery of damaged areas. A crack was found at the root of a pressure tap line on the inlet housing by this method.

Figure 9. - Turbine shaft and bearing assembly.

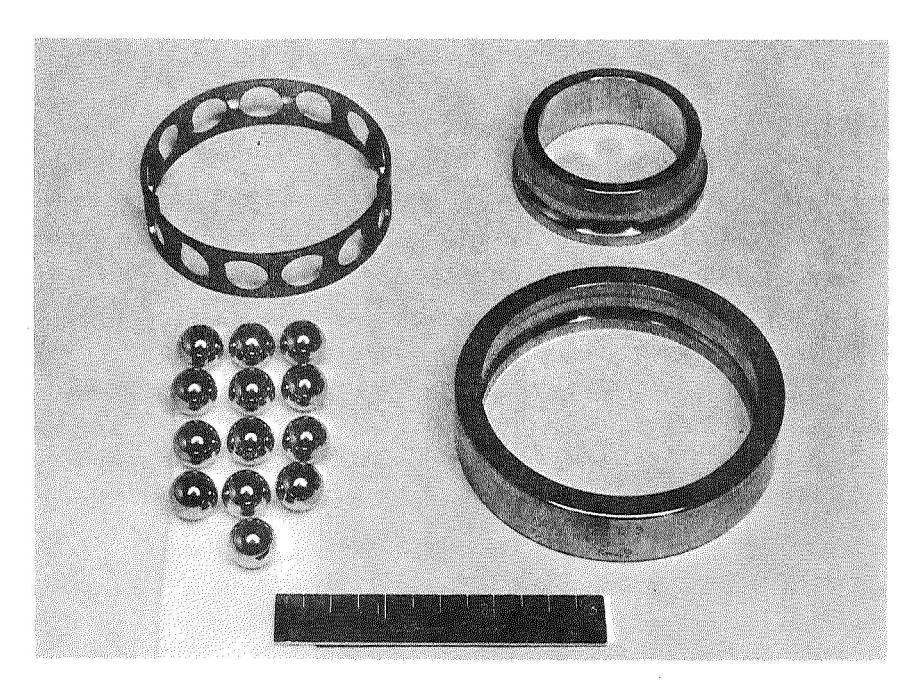
Figure 10 shows the disassembled turbine bearing for the alternator end. The alternator end bearing was in good condition except for three gall areas on the outer ring outside diameter originating at the thrust face edge; this is not readily visible in figure 10. The outer ring raceway only had a light ball vibration pattern marking at 0 radians (0°) contact angle with normal ball spacing between the patterns.

Figure 10. - Disassembled view of turbine bearing for the alternator end S/N A-49.

1. Reduction in turbine shaft axial motions was caused by sticking of the outer ring in the housing due to vibration-induced motion and consequent galling. The turbine and alternator were still functional since the bearing spring preload was maintained. To alleviate this condition, it is recommended to rework the bearing journals in existing turbine and alternator hardware by plating, hard facing, or by Microsealing to prevent fretting and galling. The same applies to the outer ring of the bearing.

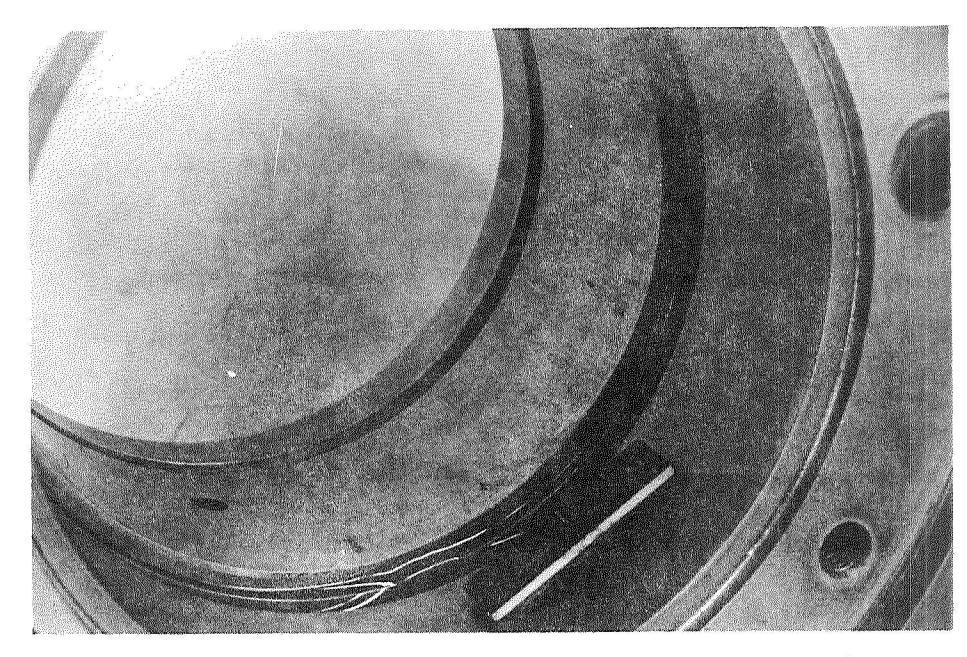
The disassembly of the alternator proceeded normally until the end bell at the antidrive end was removed. The bearing and the lube ring came off with the end bell, even though the bearing inner ring to shaft fit is tight. When the bearing was eventually pressed out of the end bell, the outer ring outside diameter and the bearing stop were found to have galled and scratched the housing seat. This is shown in figures 11 and 12. Each damaged area originated with material transfer from the end bell bearing seat to the outer ring of the bearing. There was no noticeable loss of material from the bearings. When the drive end bell was removed, the drive end bearing and bearings stop were marked in similar fashion. No damage was found to the preload springs and they retained the same load characteristics as at assembly.

Figure 11. - Alternator antidrive end bell showing galls and scratches in bearing seat.

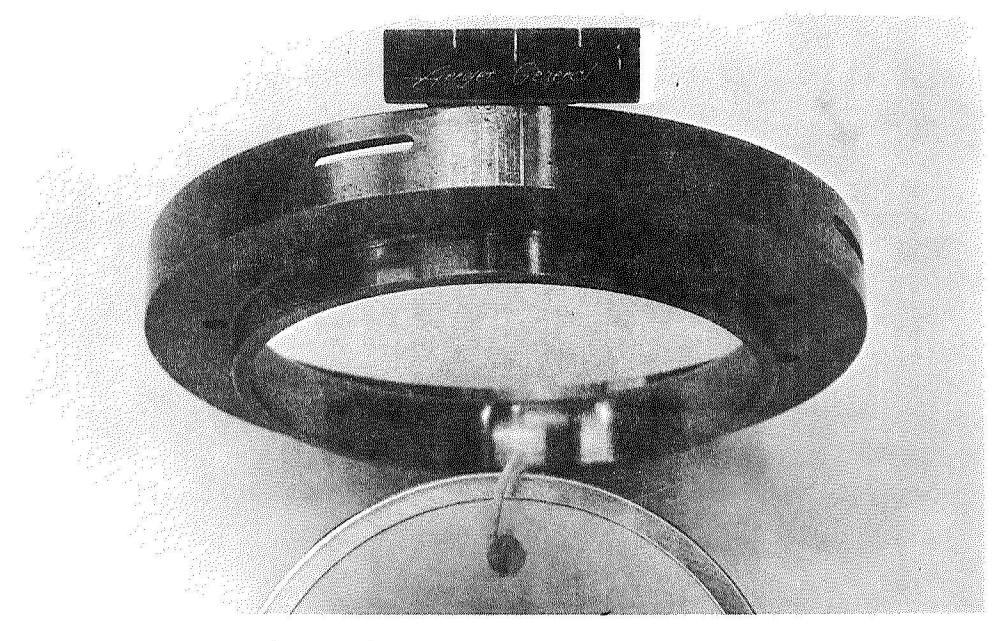
Figure 12. - Alternator antidrive end bearing stop showing galls and scratches.

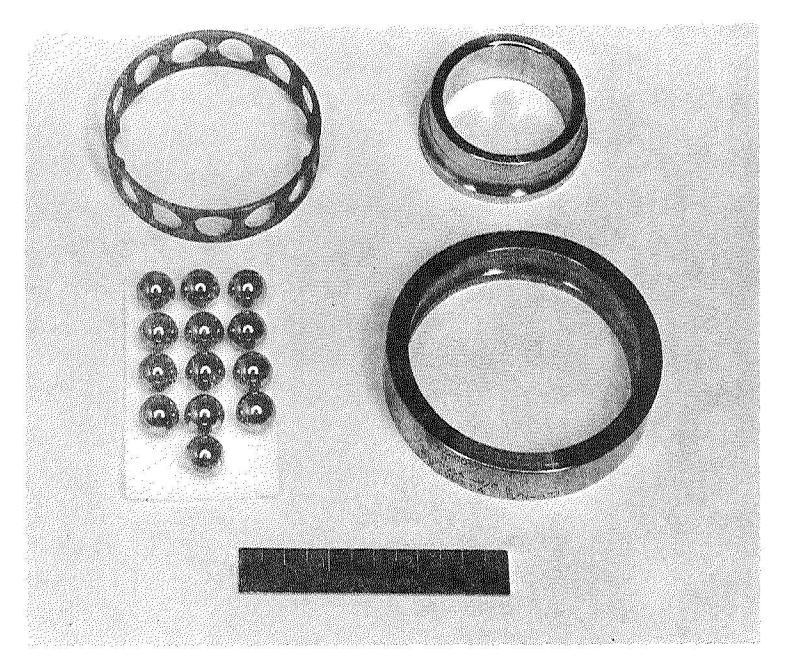
The outer ring of the alternator drive end bearing had a large amount of metallic pickup in one area. In addition there were smaller spots of pickup and small areas of fretting corrosion (fig. 13, not readily visible). The thrust

Figure 13. - Disassembled alternator drive end bearing S/N A73.

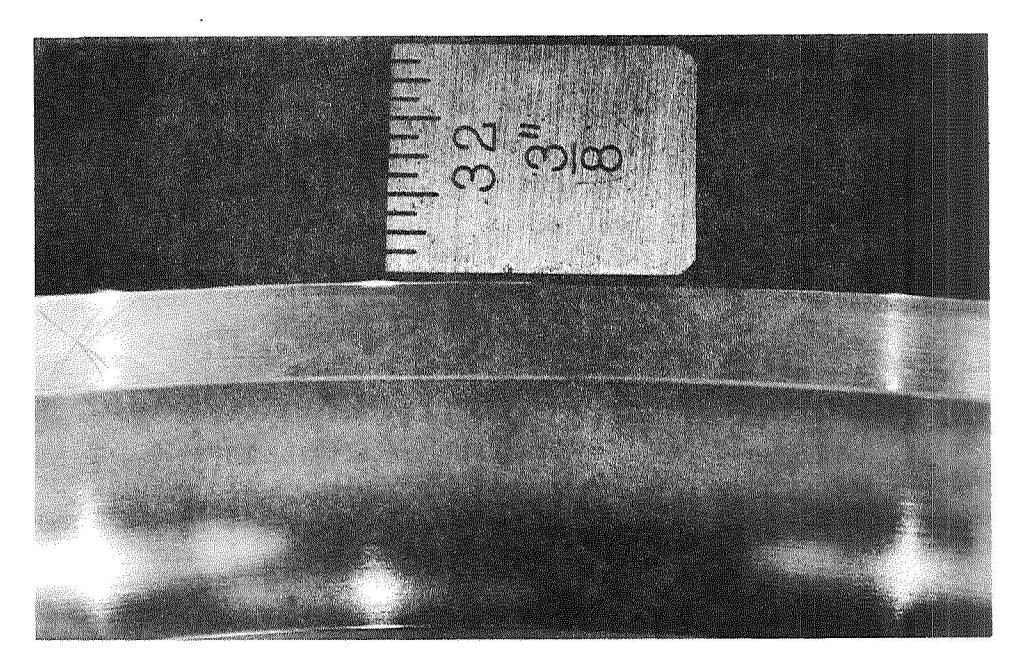
The outer ring outside diameter of the alternator antidrive end bearing had one large, several medium, and many small sized galls and pits. The ring faces were clean. The raceway had several ball spaced chatter marks at zero degrees contact angle, as shown in figure 19. The separator had very light contact marks on the outside diameter and light contact marks in the ball pockets. The pocket contact patterns were heavier than those in the other bearings, both turbine and alternator.

Figure 14. - Alternator antidrive end bearing outer ring raceway-S/N A74.
