Orientation System for  
Gamma Ray Astronomy Experiments

Report On  
Orientation System Performance Test  
NCAR Flight 659-P  
4 February 1972

Department of Physics  
UNIVERSITY OF NEW HAMPSHIRE  
Durham

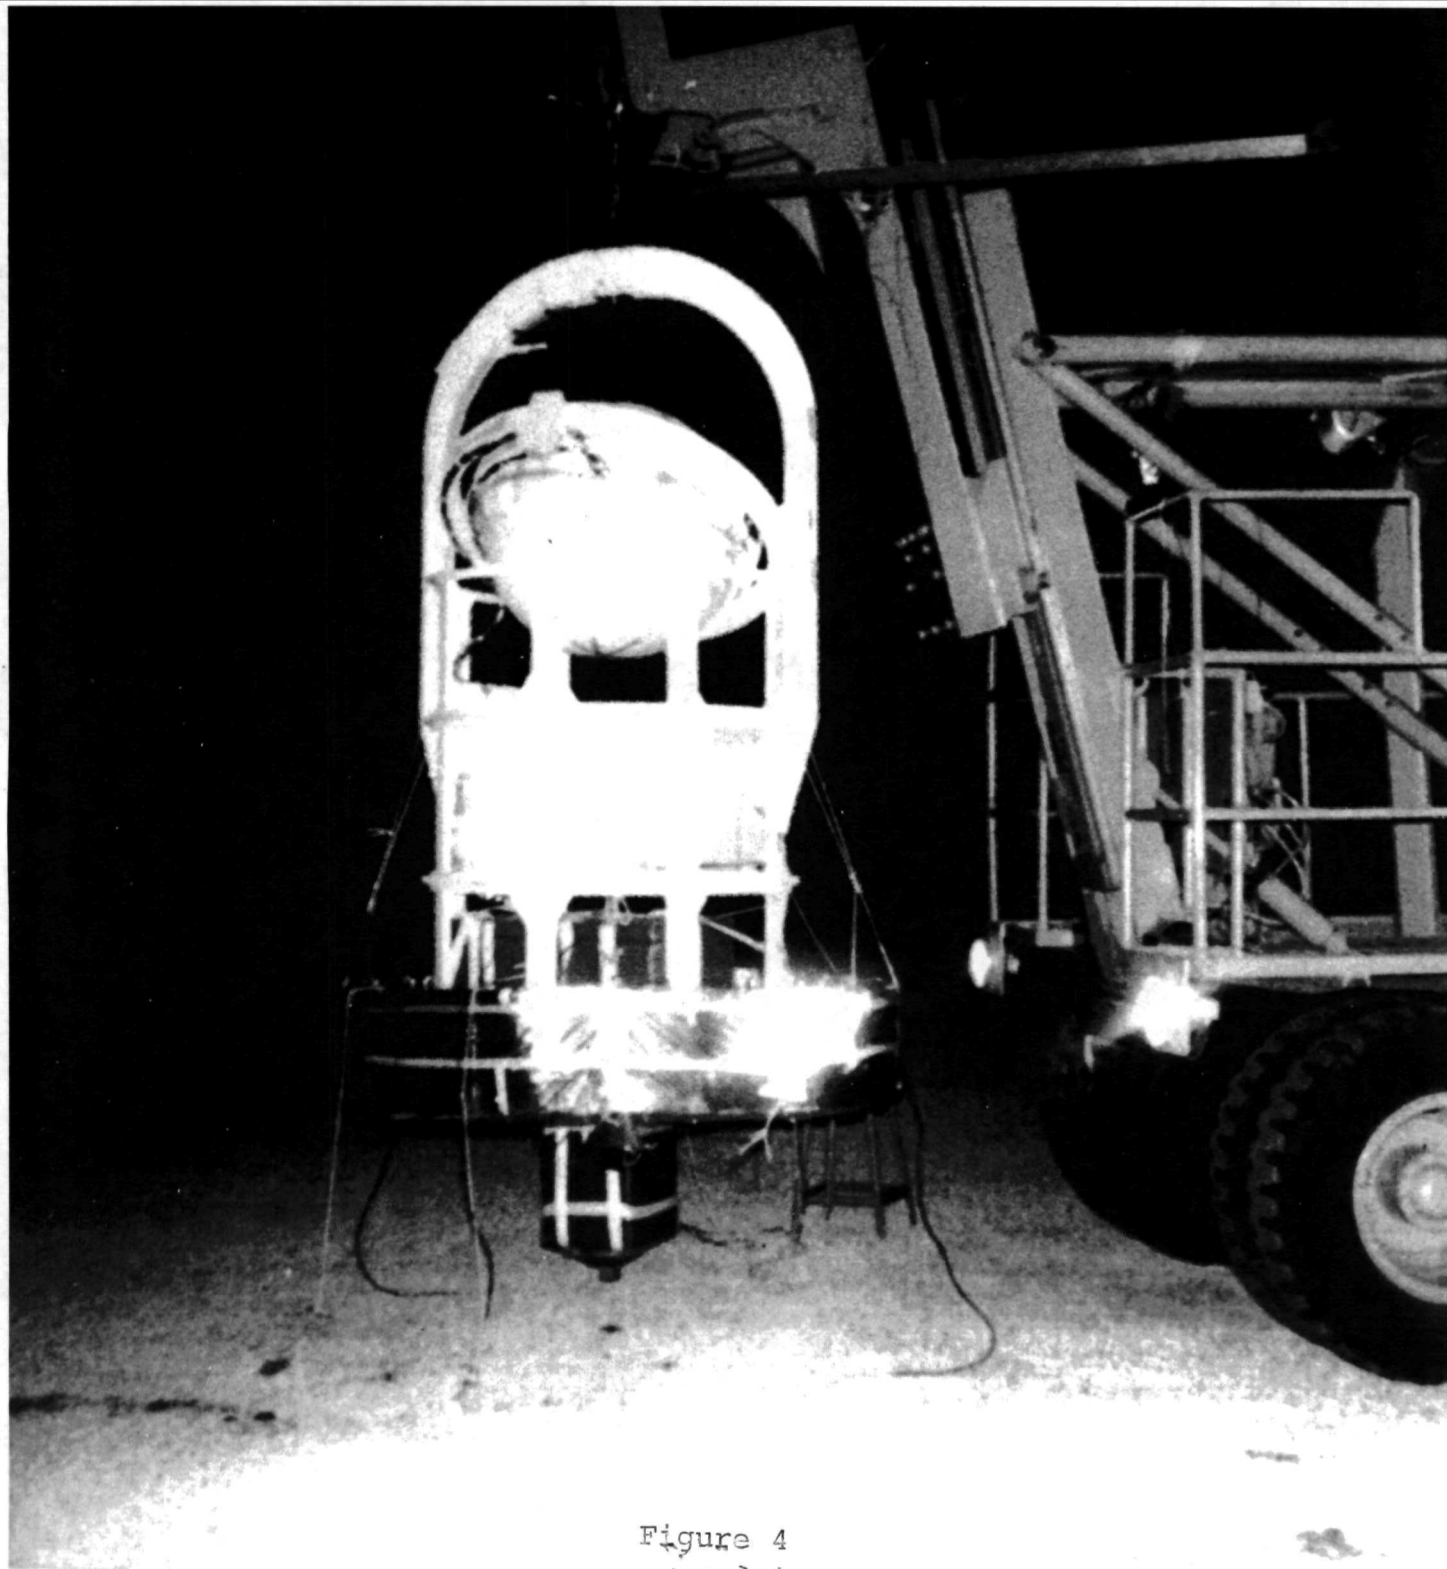
Figure 4

On 4 February 1972 the gondola described above (see Figure 4) was launched from Palestine, Texas at 2150 GMT. The launch weight of the gondola, including crush pads and exclusive of NCAR flight electronics, was 578 lbs. For this flight the inertia boom was 15' long with 15 lbs. of lead on each end. The complete system was isolated from the balloon and flight train by means of a low friction swivel. The balloon used was 11.1 million cubic feet. The altitude achieved was 130,000 feet which was planned float for this flight, and the flight duration was less than desired due to very high winds at this altitude. The usable data at float was approximately three hours because of the range limits of the telemetry. The payload was recovered in a ravine 40 miles southwest of Roanoke, Virginia, on 6 February 1972. The physical damage to the entire gondola was extremely slight.

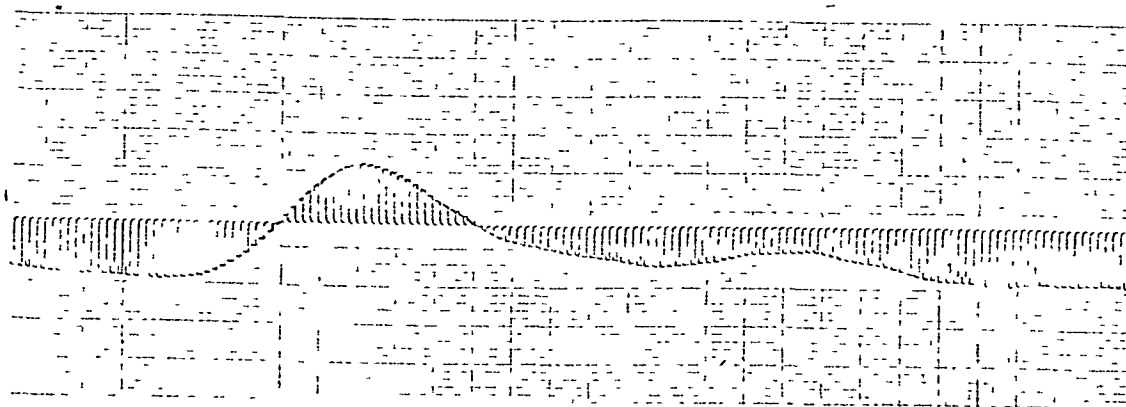
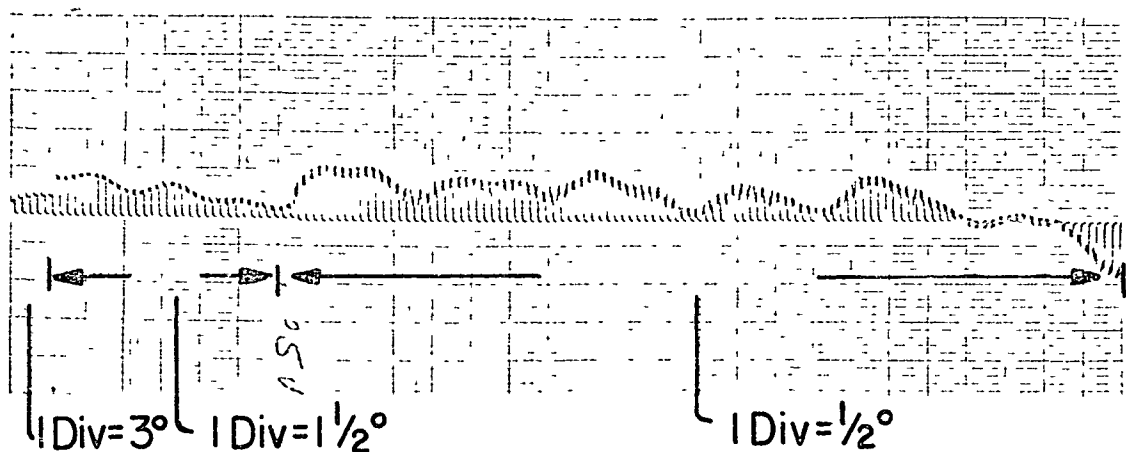
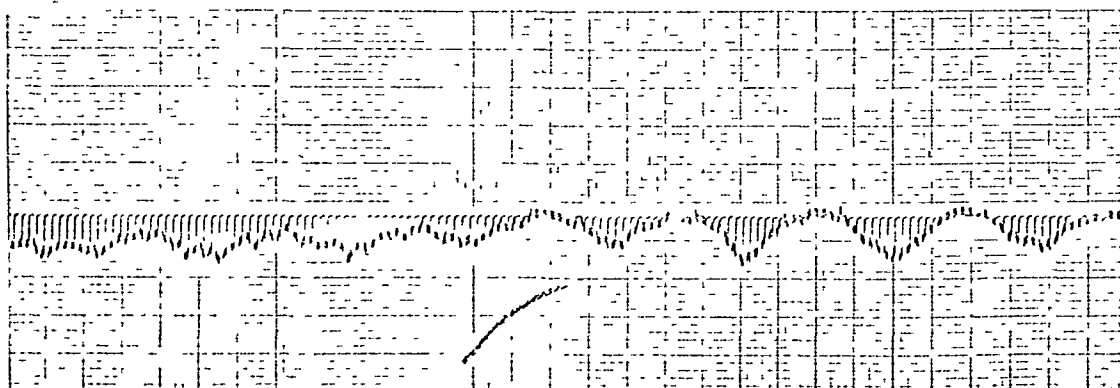
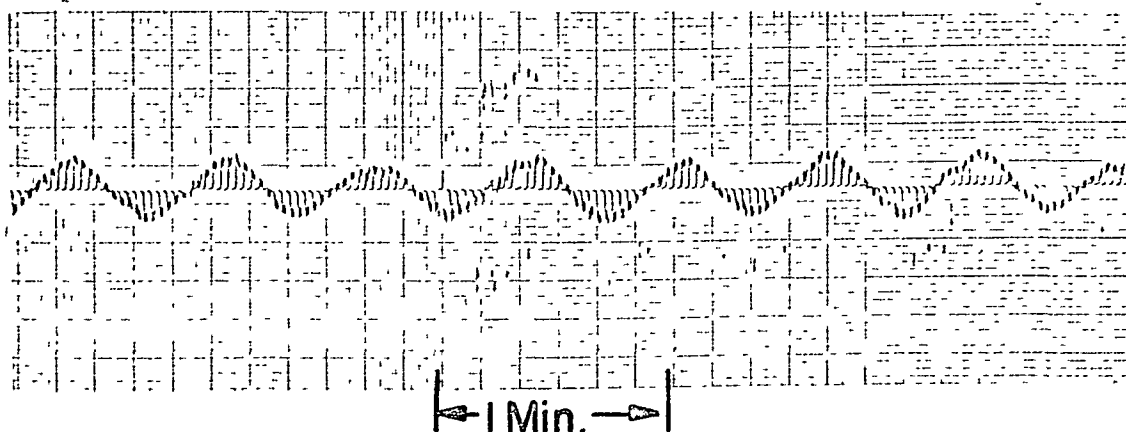
Figure 5

When the gondola had nearly reached the desired float altitude, the correction drive system was turned on to bring the platform to the desired pointing attitude. Approximately 30 seconds after turn-on the system had rotated from its free position to near its desired reference pointing position or null. Nine minutes from turn-on the platform achieved a maximum plus or minus deviation from null of  $\pm 5^\circ$ , and at 12 minutes the platform achieved its flight deviation from null of  $\pm 2^\circ$ . This period is due to incomplete decoupling of balloon from the platform (see Figure 5).

No correction  
drive

30 Seconds  
after correction  
drive turned on.

9 Minutes after  
correction drive  
turned on.

12 Minutes after  
correction drive  
turned on.

Though there are no major changes proposed in the current design, some corrections should be made for future flights. Improvements can be made in the correction drive. While the system did maintain the  $\pm 2^{\circ}$  pointing accuracy, the correction drive response was slower than desired. An adjustment in the correction drive sensitivity and a better decoupling from the balloon flight train should be attempted. It might be possible to eliminate some of the hour angle error of  $\pm 1 - 2^{\circ}$  by a gear box with less play. Some readout error is undoubtedly due to the encoder which should be improved noticeably by a more accurate alignment of the encoder brushes. Another improvement, or check, on pointing accuracy could be the use of another magnetometer, camera, or solar sensor of some design to verify the pointing direction.

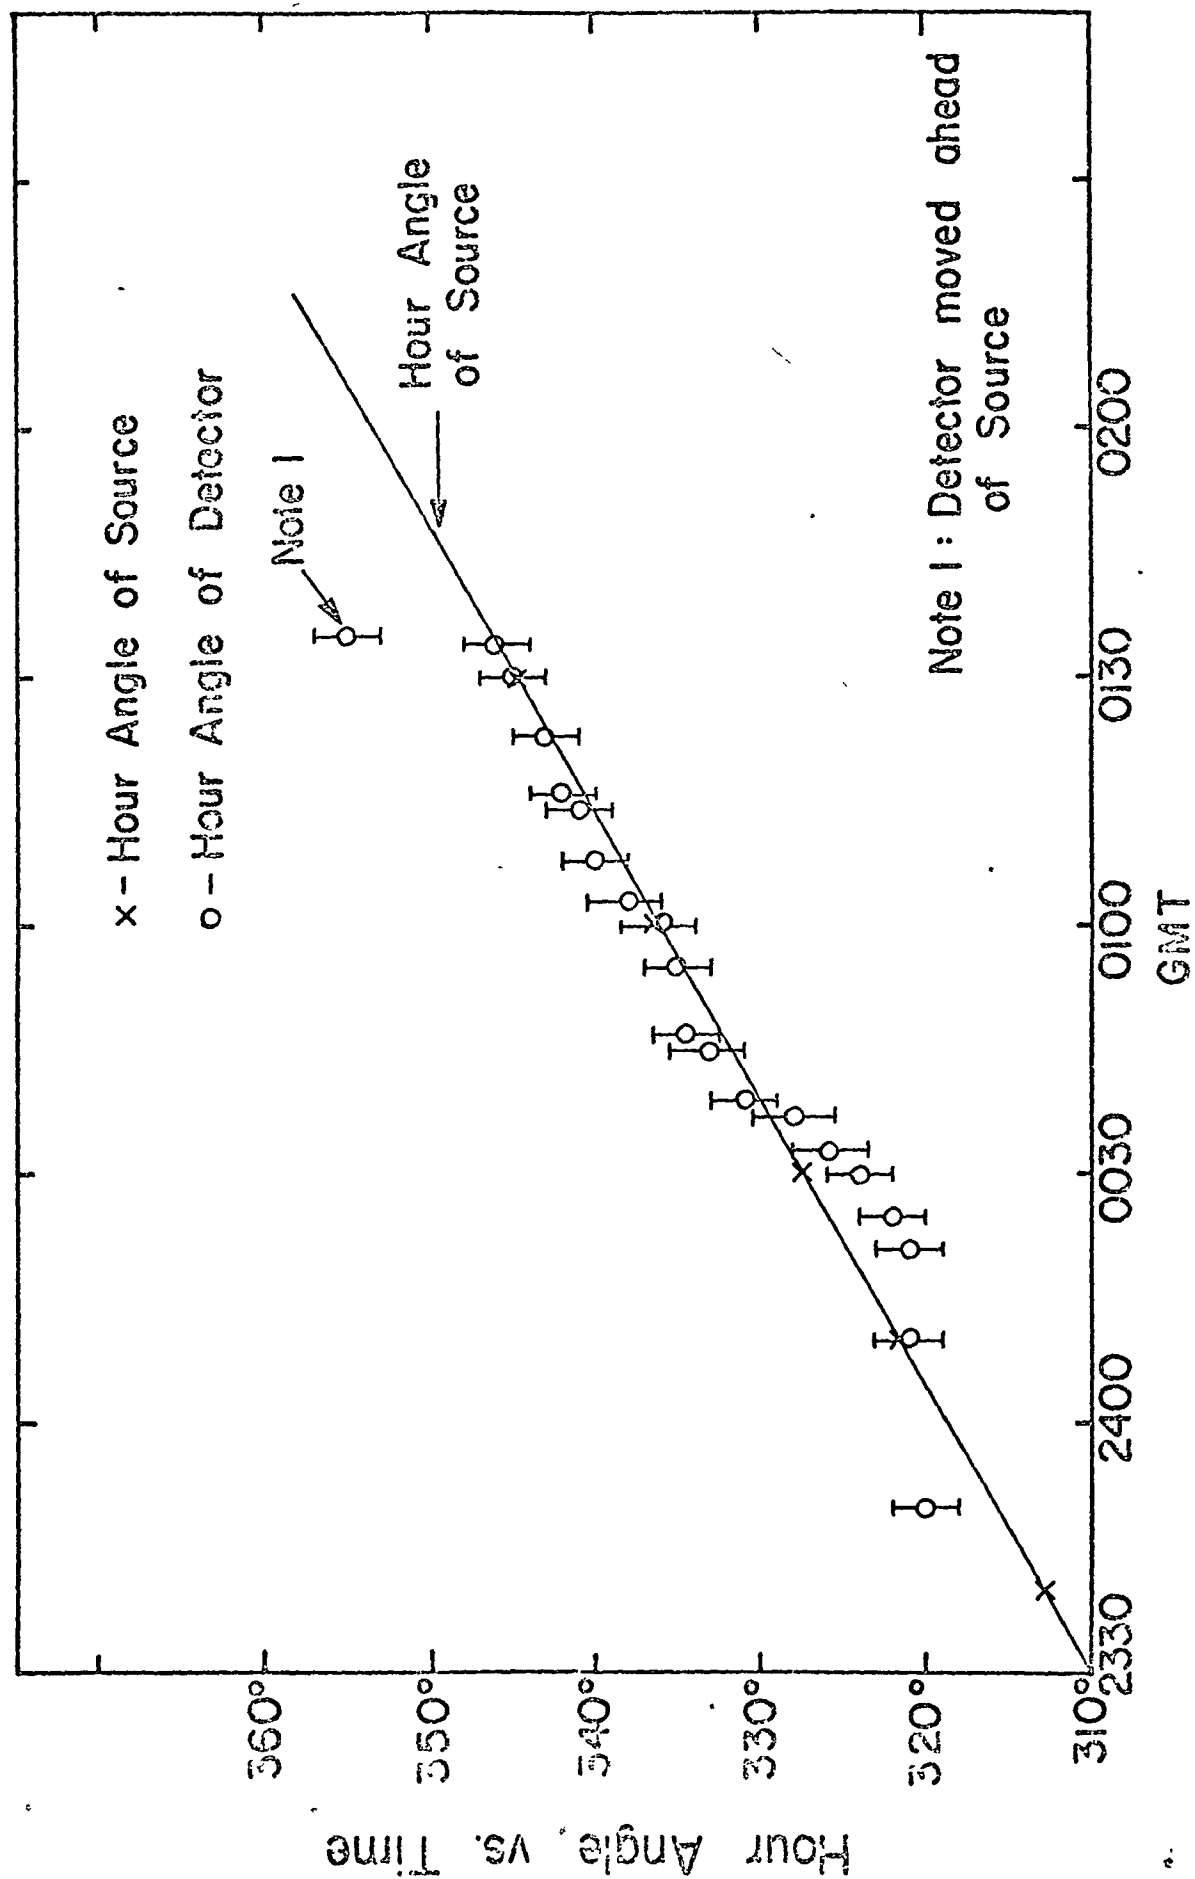
Figure 6

observed. The commands to execute changes in angles were given in  $1^\circ$  and  $10^\circ$  increments. The  $90^\circ$  command was not used in flight as the corrections were always less than  $90^\circ$ . The pointing angle of the system was displayed on the ground station and an occasional error was noted when command for a  $1^\circ$  would effect no change in the readout. When the next command for  $1^\circ$  was given, a  $2^\circ$  change was noted in the readout. A log was maintained at all times documenting the response of the pointing system to commands given, thus eliminating questions dealing with the pointing direction of the detector (see Figure 6).

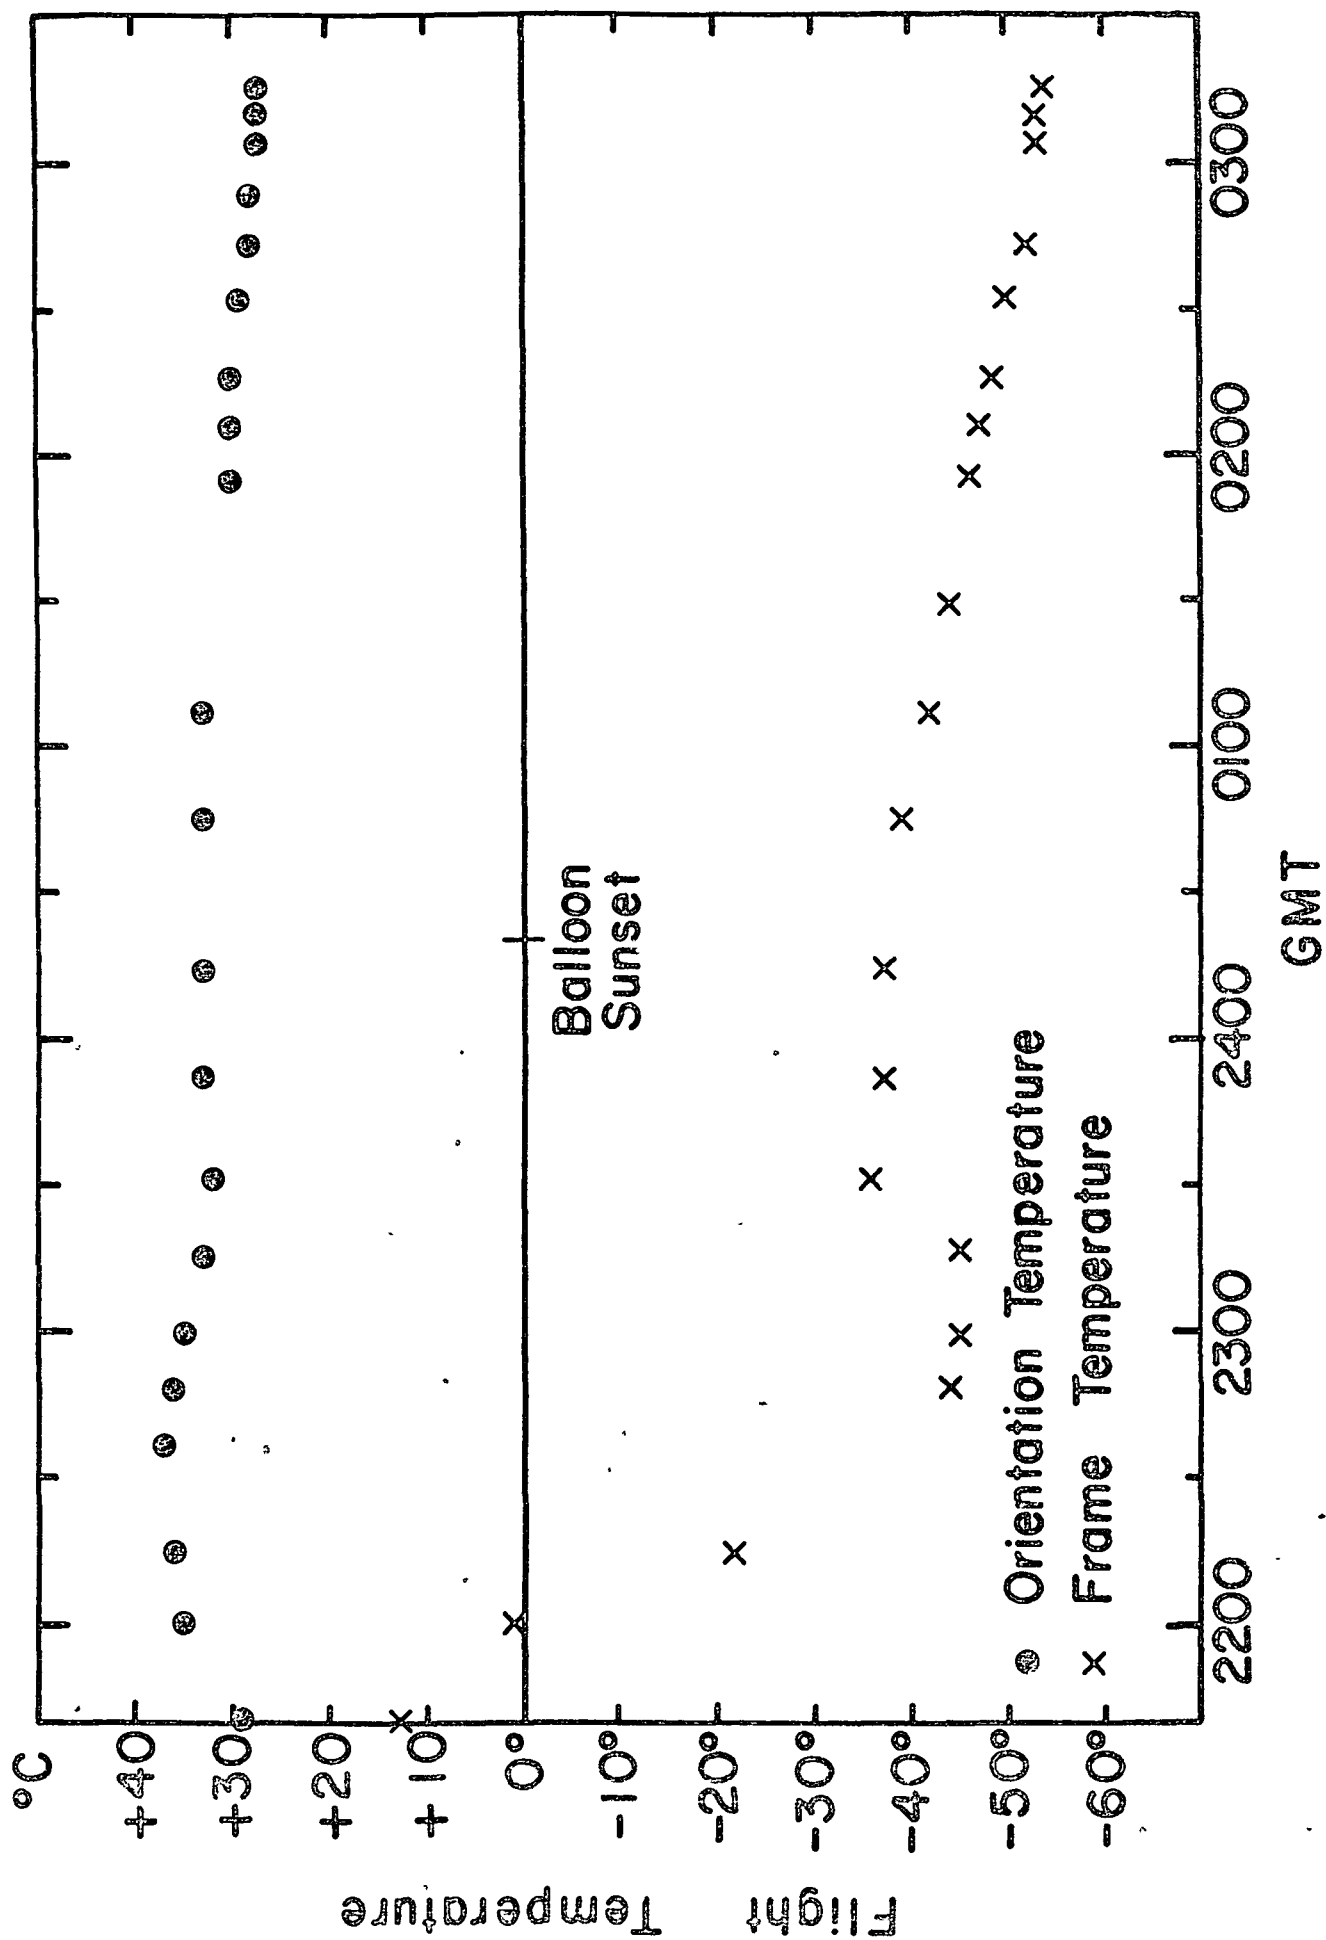
Figure 8

aluminum foil and painted white. The power consumed by orientation electronics  $\approx$  12 watts. External heater power of 18 watts was provided if needed. This power was thermostatically controlled to apply heat if the temperature dropped below  $15^{\circ}\text{C}$ . The temperature of the orientation electronics was well within design tolerance (see Figure 8). At launch it was  $29^{\circ}\text{C}$ , reaching a maximum temperature of  $37^{\circ}\text{C}$  and minimum temperature of  $27^{\circ}\text{C}$ . This verifies that external heat was not needed. The outside frame temperatures for this flight ranged from  $13^{\circ}\text{C}$  at launch to  $-36^{\circ}\text{C}$  and  $-49^{\circ}\text{C}$ . This proves the quality of the temperature control system of the orientation electronics.
