A METALLOGRAPHIC EVALUATION OF SOME COATED  
COLUMBIUM ALLOYS.

V. Griffiths

Montana College of Mineral Science & Technology

Technical Report on NASA Contract

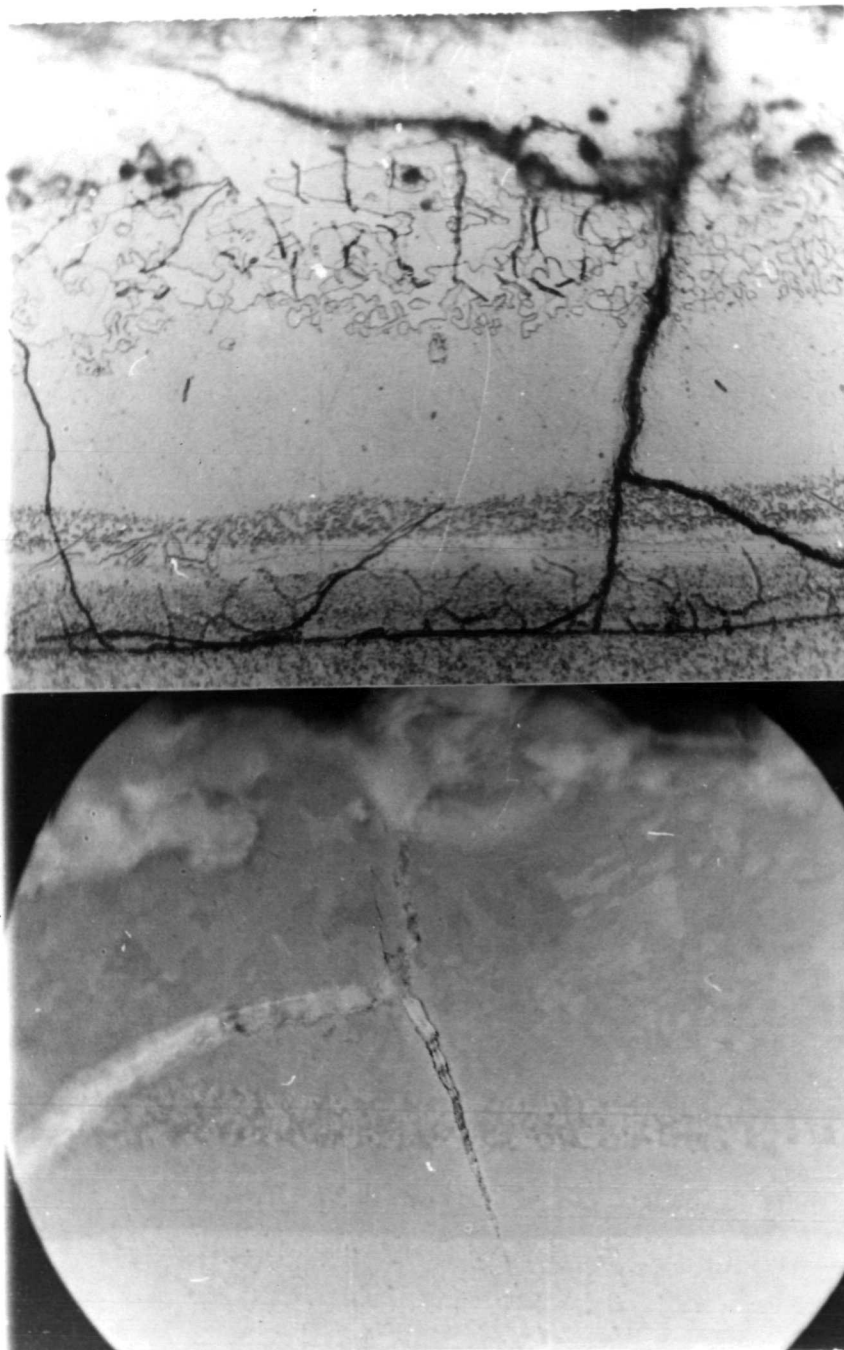
Representative optical metallography sections of R512E, and VH109, both as received, are shown respectively in Plates 1 and 2. R512E is shown etched in Plate 1A and in Plate 1B it is shown through deeply crossed polarizer/analyzer and essentially unetched. These do not show the same field but nonetheless the difference between the two is quite striking. The polarized light micrograph 1B, reveals the grain structure of the coating and reveals generally a very fine grain size next to the substrate (bottom) and a large grain size near the outer surface (top). Different layers are visible but fine cracks are not readily discerned. The etched sample shows cracks readily and also shows different composition layers and apparent second phase. Cracks in the coating do not follow the grain boundaries; they usually do not penetrate the substrate but 1B is an illustration of a crack which has penetrated the substrate. The cracks are usually wider at the outer surface than at the substrate; this and other characteristics generally suggest that they were induced by thermal (tensile) stresses set-up during cooling from the formation temperature. Cracks are also seen in optical and SEM micrographs of the surface (see for example Plate 4 & 5).

Plate 1A) R512E coating deeply etched bright field substrate at bottom. Note cracks and evidence of differing composition across coating. 425X B) R512E, etched, crossed polarizer/analyzer. Grains structure of coating is visible. 425X

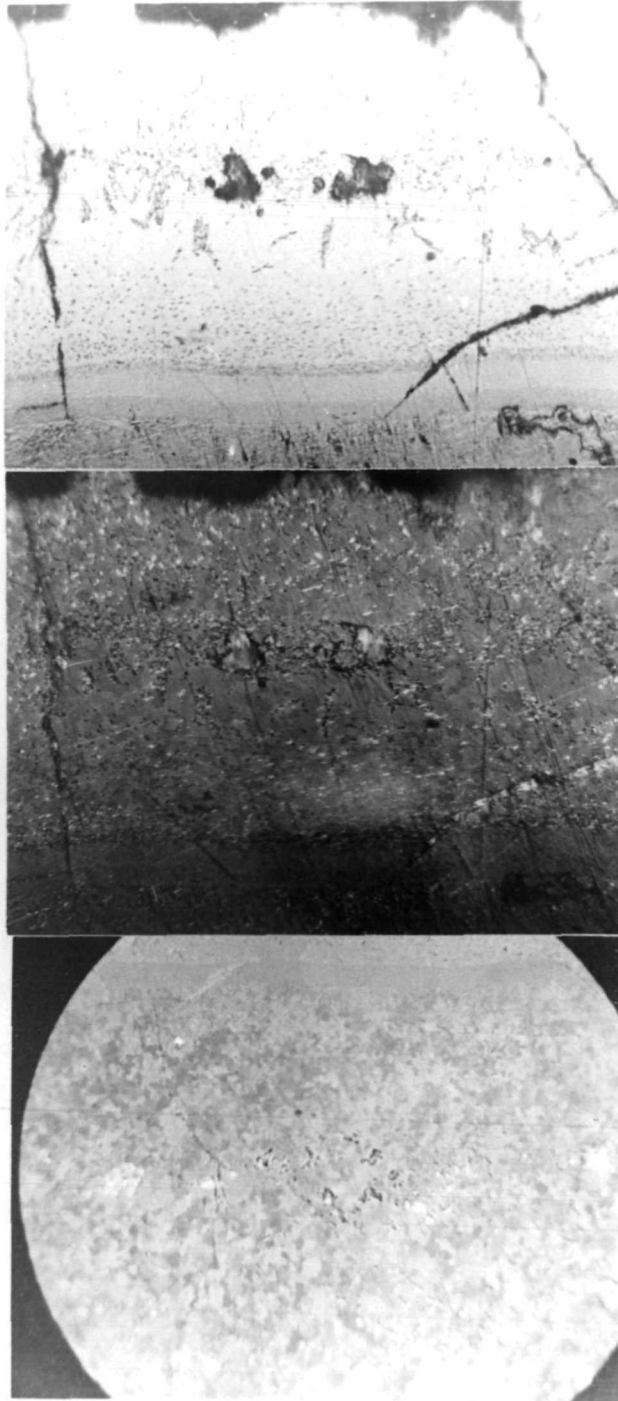
Plate 2 shows VH109; 2A and 2B are of the same area, etched, in bright field and in polarized light. The etchant has eaten away second phase leaving small pits which appear as very bright areas under polarized light. 2C is another field under polarized light, this sample etched very lightly relative to 2A.

Plate 2 A & B (top & middle) show same area. VH109, bright field & polarized light respectively. C shows another area, polarized light. All at 425X.

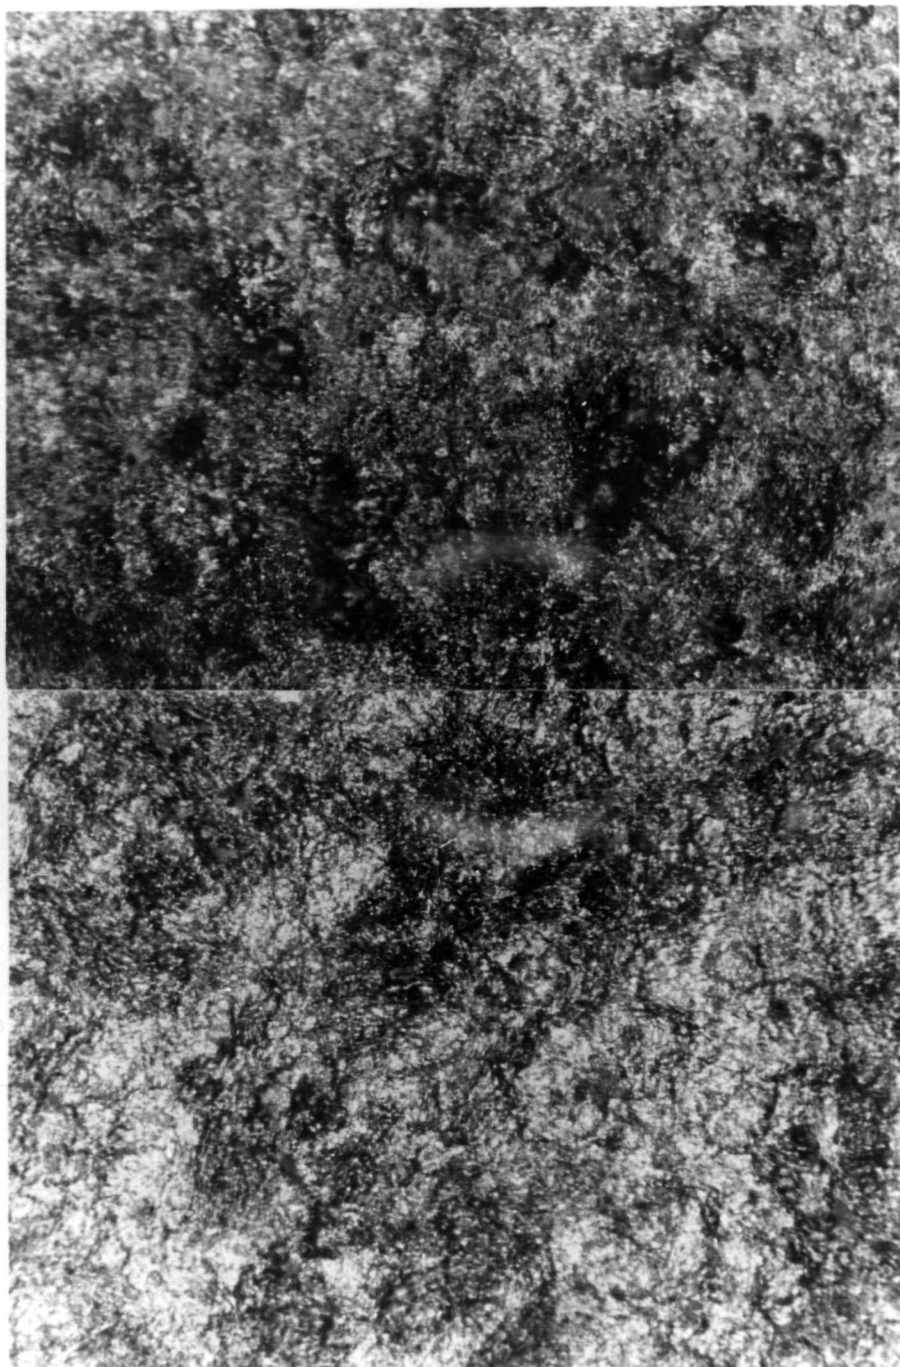
Plate 3 shows dark field micrographs of R512E and VH109. Although both 3A and 3B have surface cracks they are not readily visible in these photomicrographs and generally these plates illustrate the desirability of higher magnifications such as are possible via SEM.

Plate 3 A) Bottom, dark field optical micrograph of outer surface of R512E at 90x. B) Top, same but VH109. Both show surface cracks.

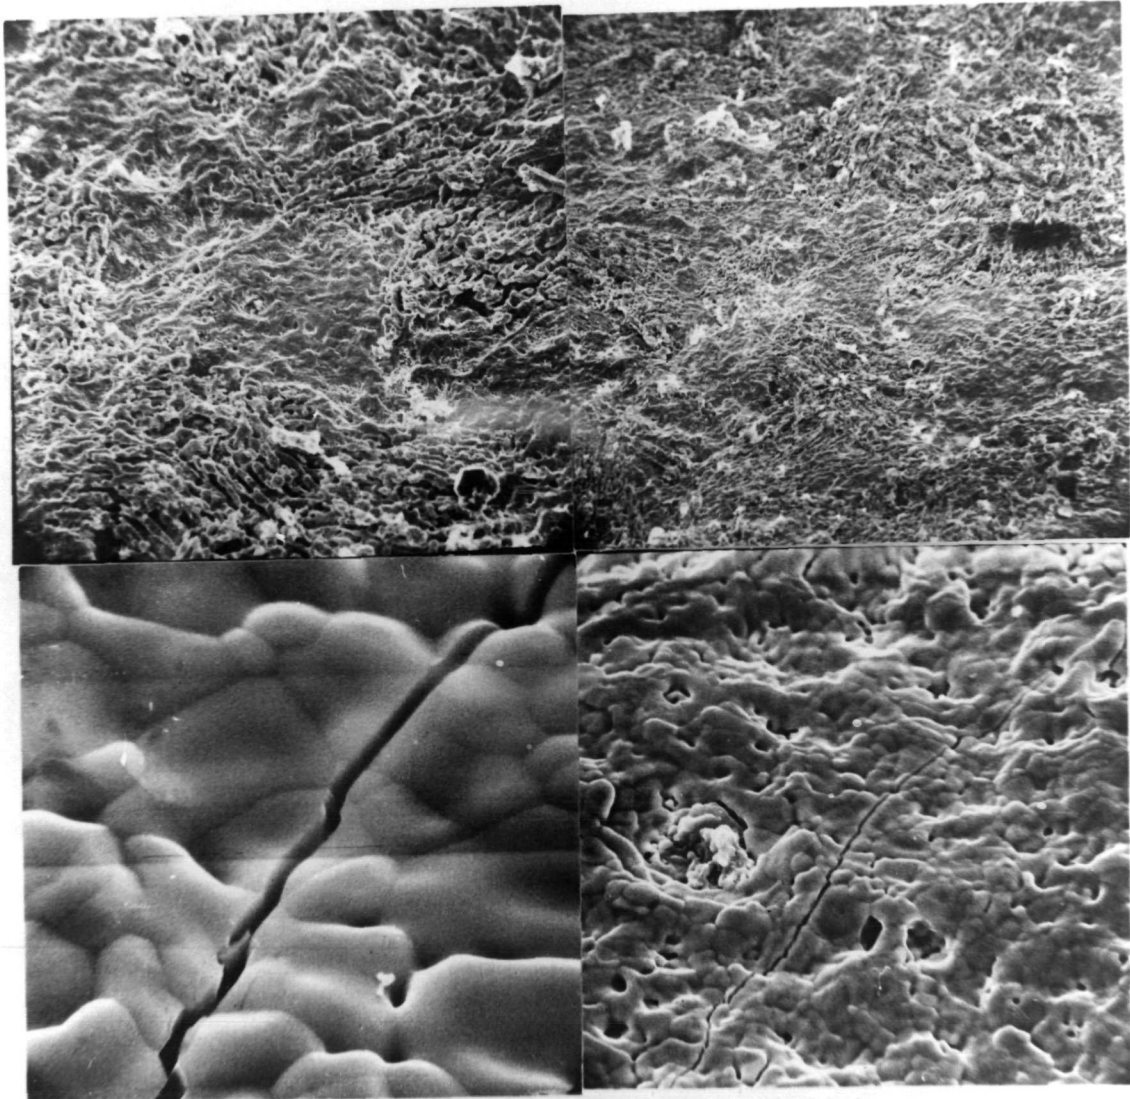
Plate 4 shows SEM micrographs of as received R512E and Plate 5 shows SEM micrographs of as received VH109. These micrographs illustrate the superior rendition of surface detail that the SEM makes possible. Both coatings are seen to be cracked, the variation in texture of the surface from point to point is clearly visible particularly in Plate 4 of R512E at 500X. The cause of this texture is unknown. Plate 4D, at 10,000X shows features suggesting grain boundaries. The diameter of these "grains" corresponds very roughly with the grain size one might estimate from polished cross sections. The crack visible in Plate 4 crosses these grains more or less randomly suggesting a crack which opened up under a tensile stress.

Plate 4 SEM micrographs of R512E. All are of same area. Upper right 200x, upper left 500x, lower right 2000x, lower left 10,000x. Note surface cracks and varying texture in 200x and 500x photos. Compare with Plate 3A. Features in 10,000x photo are thought to represent grains.

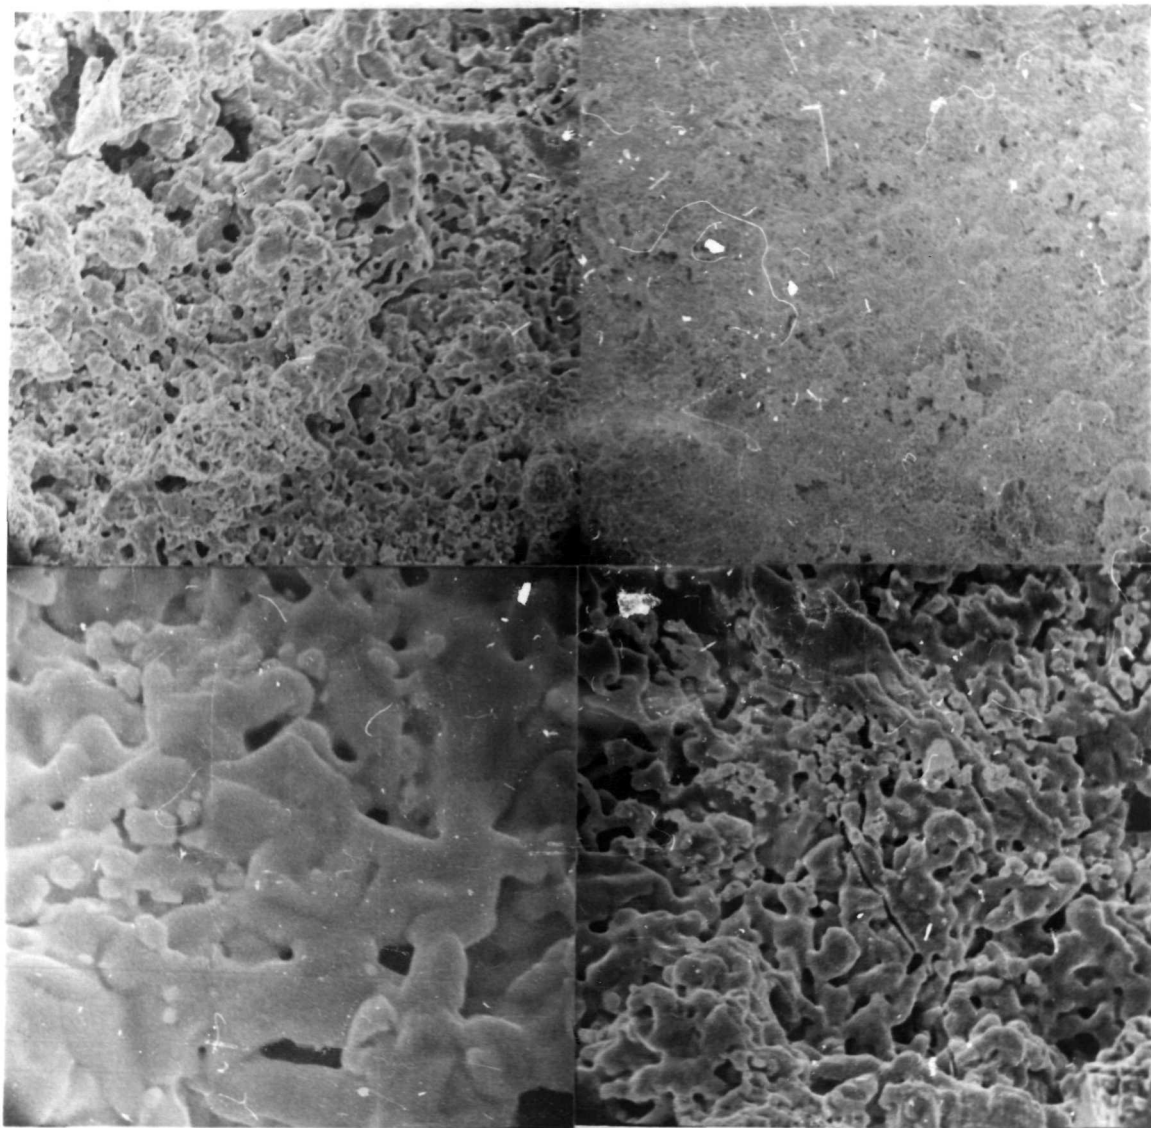
The surface structure of VH109 shown in Plate 5 is seen to be different in detail and is presumably due to the different composition and method of application. Plates 6, 7 and 8 show optical metallography sections of coatings after cycling to elevated temperature. Plates 6 and 7 show R512E. Plate 6 is after furnace cycling, 5 times, in air to 2400<sup>o</sup>F and Plate 7 is sample R1 (Ecord), which has been arc-jet tested to a similar temperature. Plate 8 shows VH109 after furnace cycling. The polished sections show little change except that a columnar morphology may be deleterious if it offers easy crack paths through the coating. The reason for the development of the columnar structure is unknown.

Plate 5 SEM micrographs of VH109. All are of same area. Upper right 200x, upper left 1000x, lower right 2000x, lower left 5000x. Surface cracks are also present here.

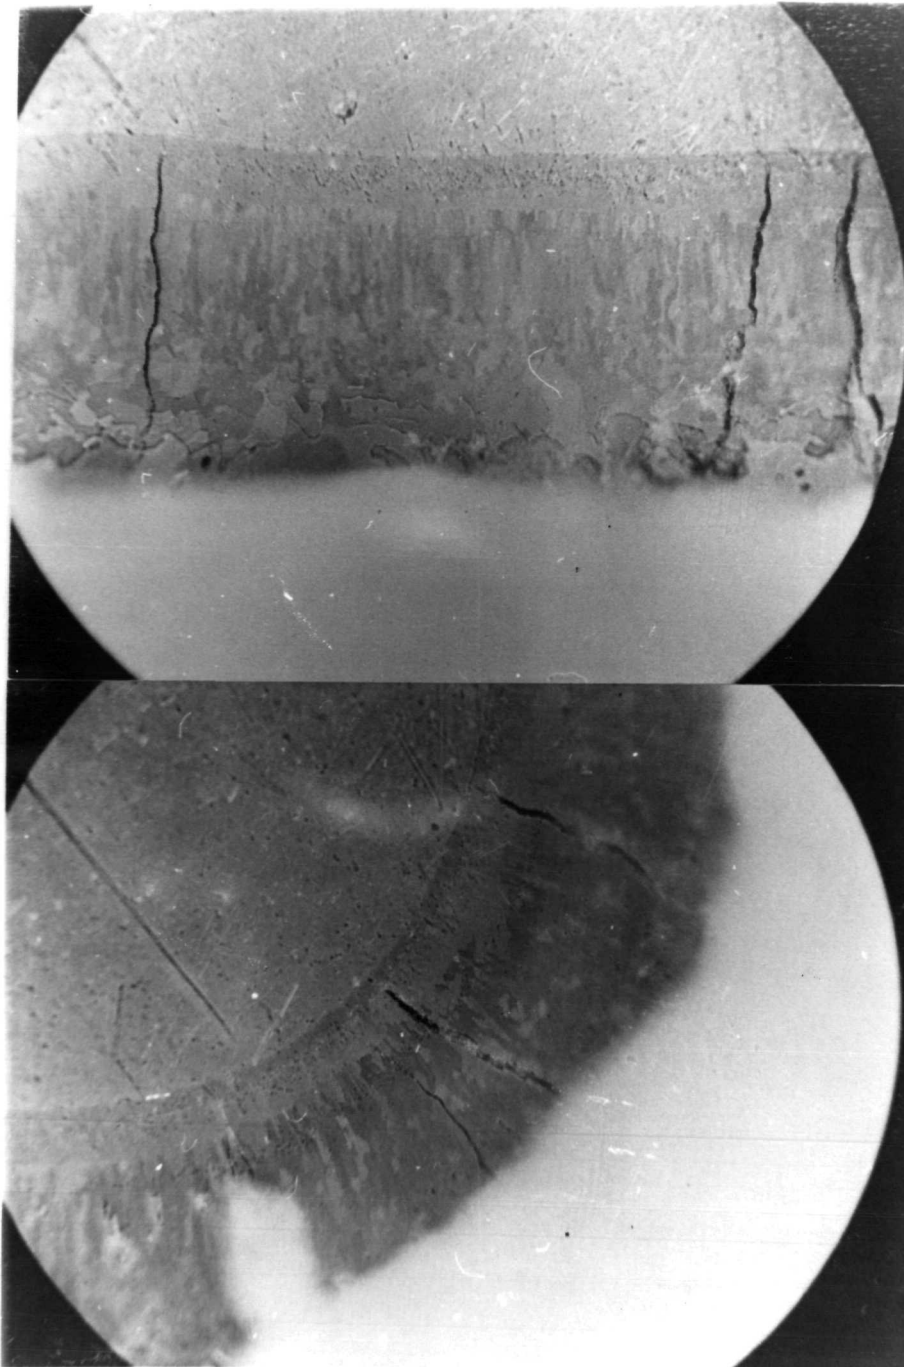
Plate 6 R512E after furnace cycling, 5 times, in air, to 2400<sup>o</sup>F. The coating has developed a columnar morphology but no other changes are discernible. Polarized light, 425x.

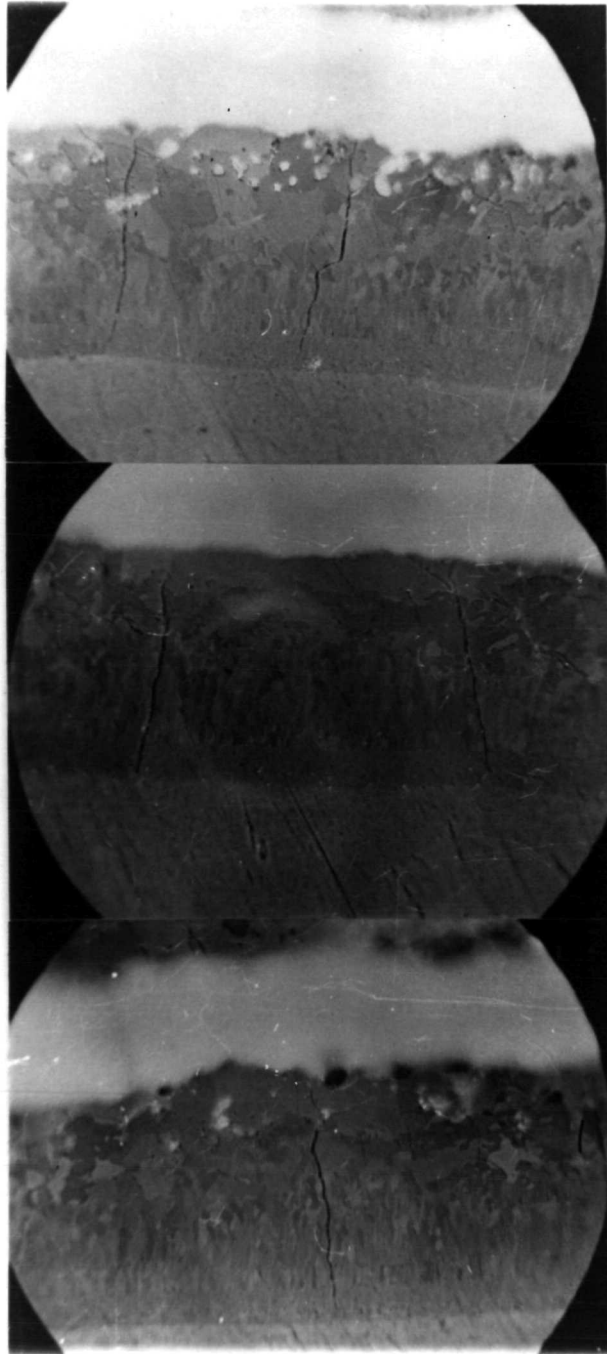
Plate 7 R512E after 5 cycles of arc-jet testing to nominal 2400<sup>o</sup>F. Columnar coating morphology. Similar to Plate 6. Polarized light, 425x.

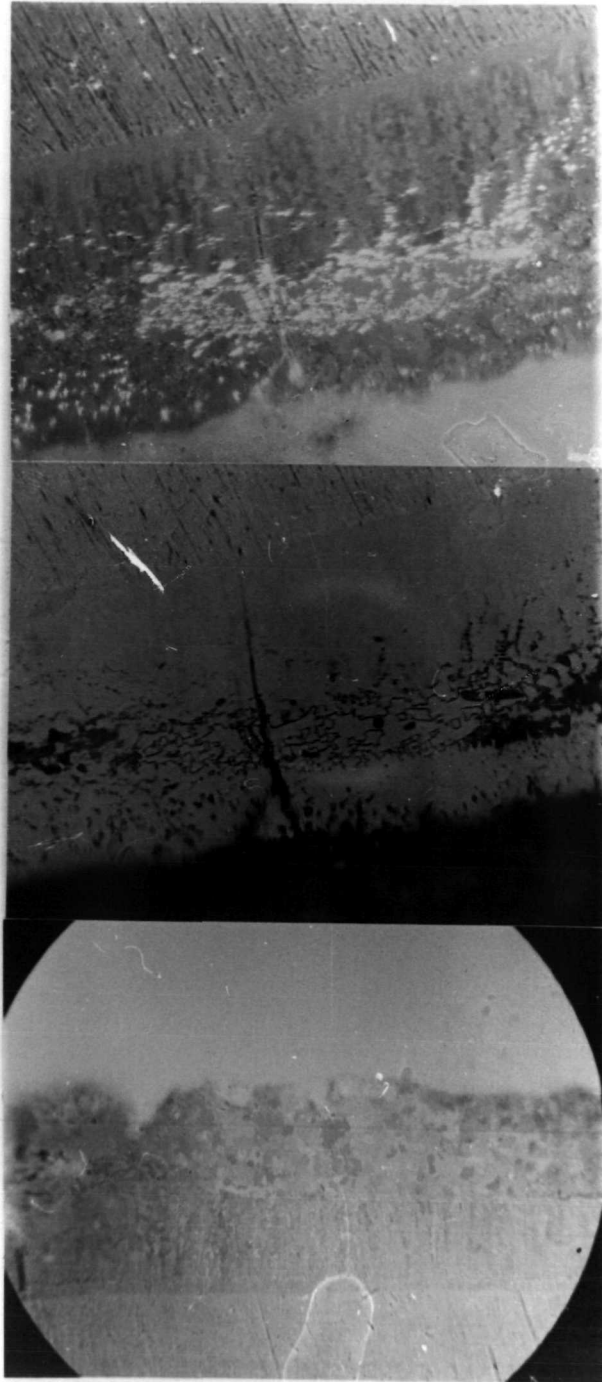
Plate 8 VH109 after furnace cycling, 5 times, in air to 2400° F. Coating has developed columnar morphology. Top & center photo show same area, bright field and polarized light respectively. 425X (bottom), 660x (center & top).

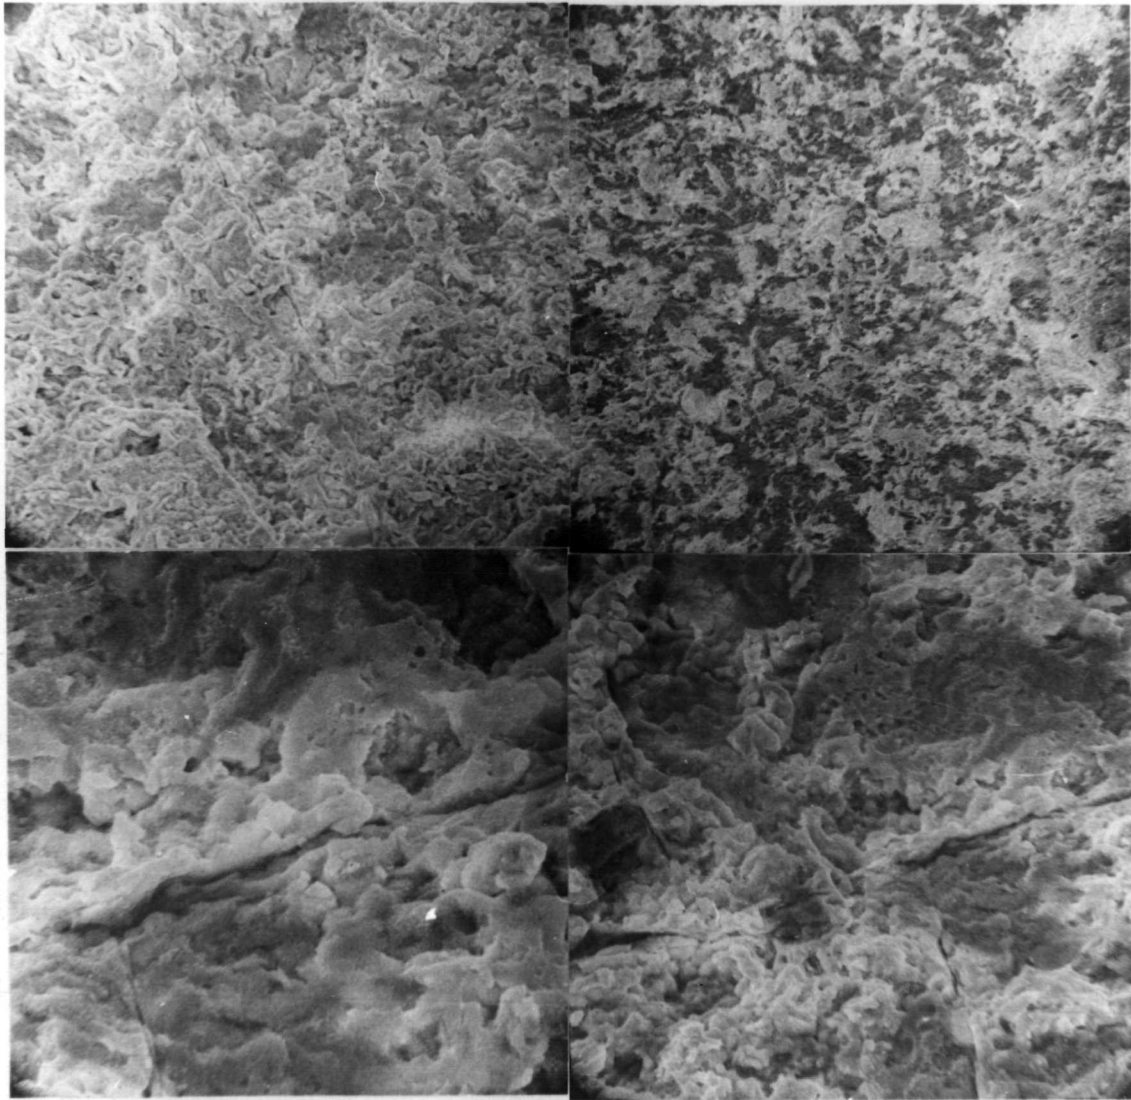
SEM micrographs of the above samples are shown in Plate 9 (R512E, Furnace Cycled), Plate 10, (R512E, Arc-jet, tested) and Plate 11 (VH109, Furnace Cycled). All samples are very similar in appearance. Cracks are visible in both R512E and VH109. Whether the number of cracks per unit area is changed cannot be positively stated since this question was not investigated. Plate 10 (R512E, Arc-jet, tested) shows the appearance of an artificial defect which has been introduced by drilling a 0.01" hole through

Plate 9 SEM micrographs of R512E, furnace cycled in air, 5 times to 2400° F. All same area. Upper right 200x, upper left 500x, lower right 1000x, lower left 2000x.

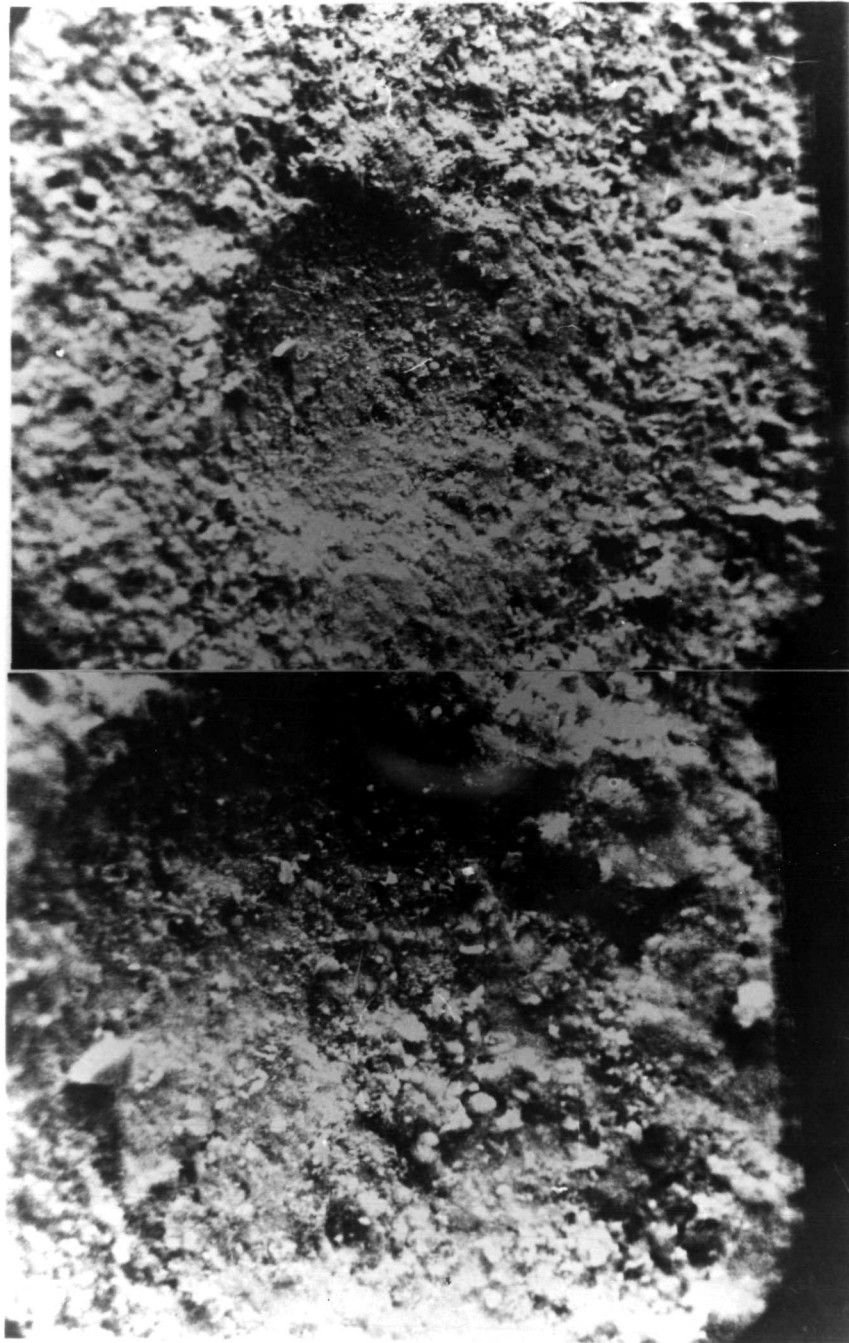
the coating to the Cb 752 substrate. It may be seen that the defect has healed and is not greatly different in appearance from the surrounding coating. Unfortunately the SEM micrographs of Plate 10 were taken with a different instrument at different settings so that no photographs are available to properly compare the coating by appearance of R512E after furnace cycling as compared with Arc-jet testing. To the unaided eye there was little difference. Optical dark field micrographs, Plate 12 suggest a greater difference than was apparent. It is thought that a detailed and careful investigation will be necessary to ascertain what the differences really are. Since Arc-jet testing is slower and more expensive such a study may be worthwhile.

Plate 10 R512E after arc-jet testing (see plate 12)  
This is an SEM micrograph of a synthetic defect (a 0.01"  
hole to the substrate) after testing. Upper 190x, lower  
440x.

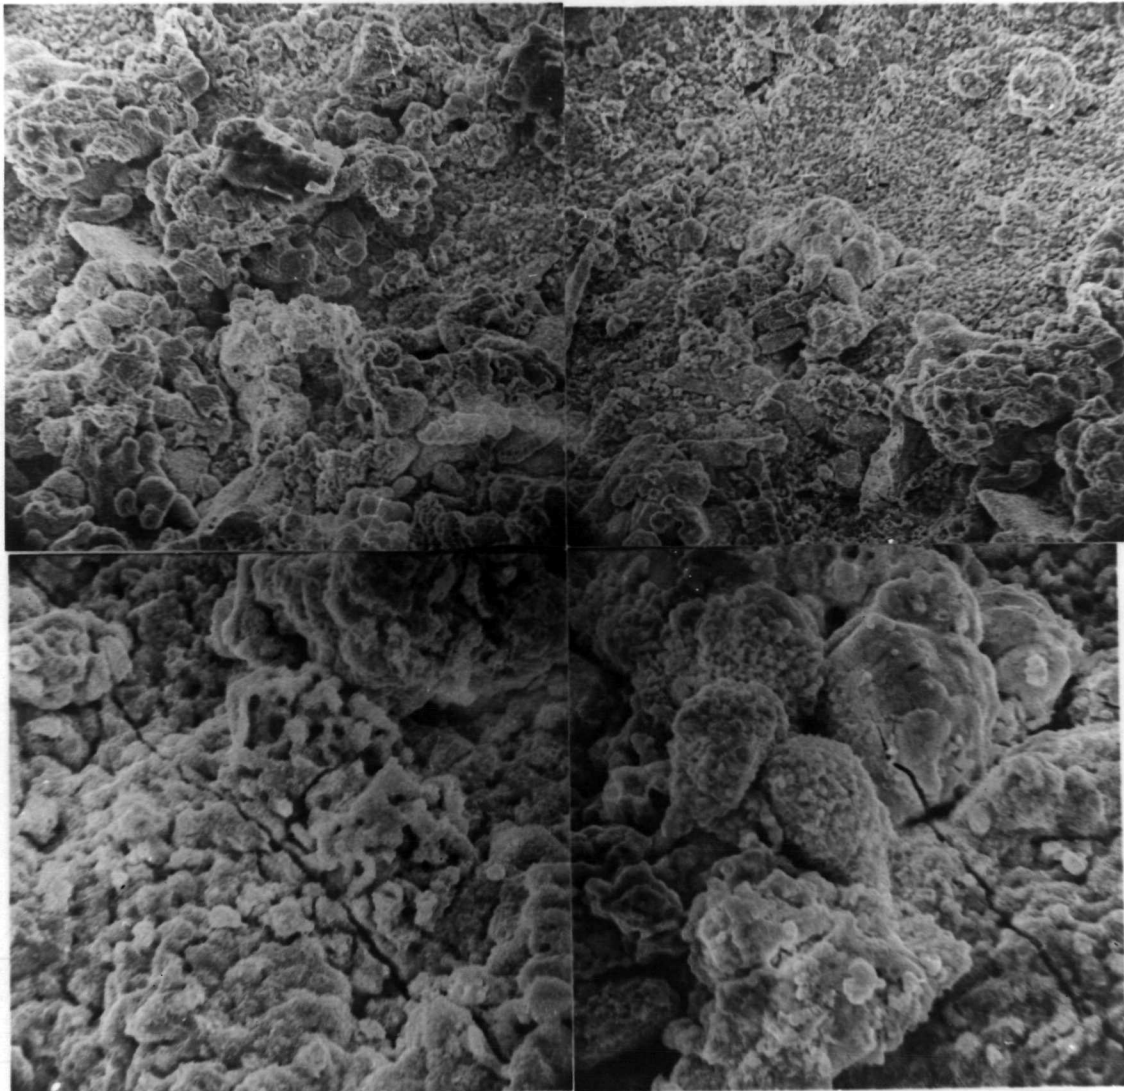
Plate 11 SEM micrographs of VH109 after furnace cycling, 5 times, in air to 2400 F. All same area. Upper left & right, 500x. Lower left & right, 2000x.

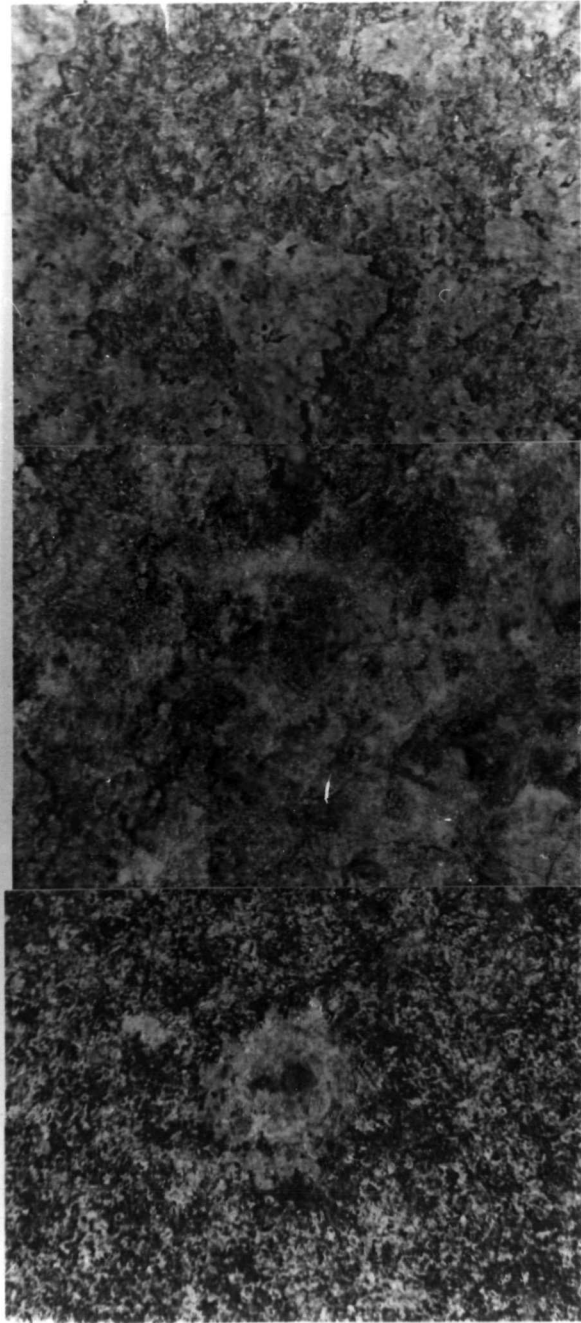
Plate 12 Optical dark field micrographs. Top, 90x, R512E after furnace cycling. Center, 90x, VH109 after furnace cycling. Bottom, 75x, R512E arc-jet tested, synthetic defect in center.

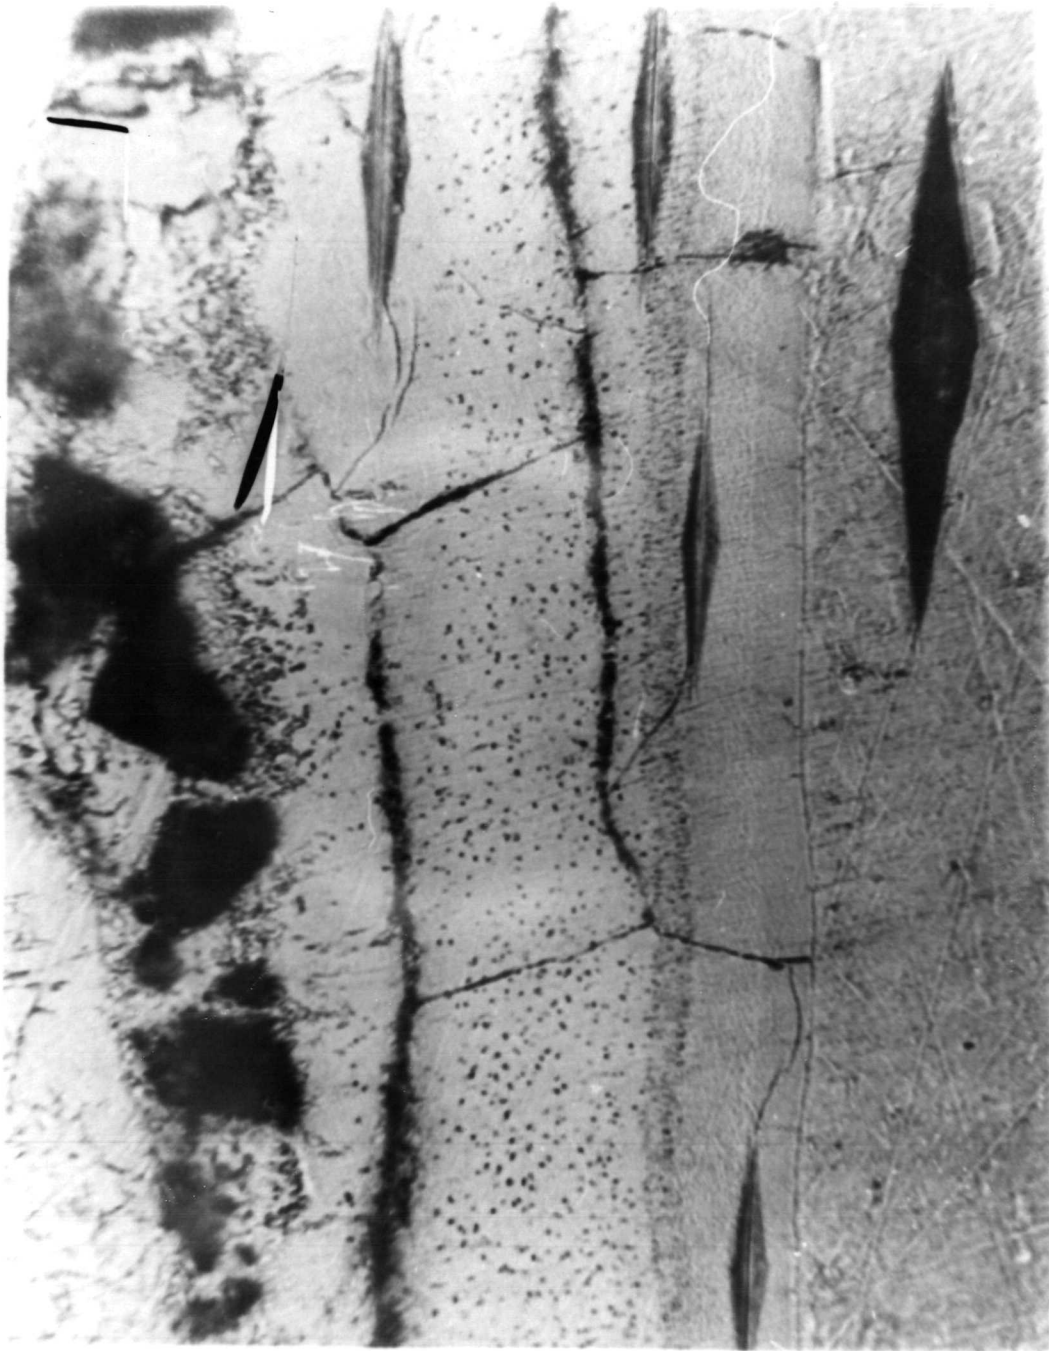
The microhardness measurements were conducted with a 200g load and revealed that the coating is extremely hard. The Knoop indenter which was used caused cracks to appear at the indentations thereby inducing hardness numbers which are probably erroneously low. The microhardness tester could not load at less than 100g and even this load caused cracking. Some data obtained is presented in Table 2.

Plate 13 Microhardness indentations in R512E. Substrate at right. Note cracked indentations in coating. 425x (enlarged twice in reproduction)
