APOLLO 15 MAIN-PARACHUTE FAILURE

By Donald D. Arabian and Joseph E. Mechelay*

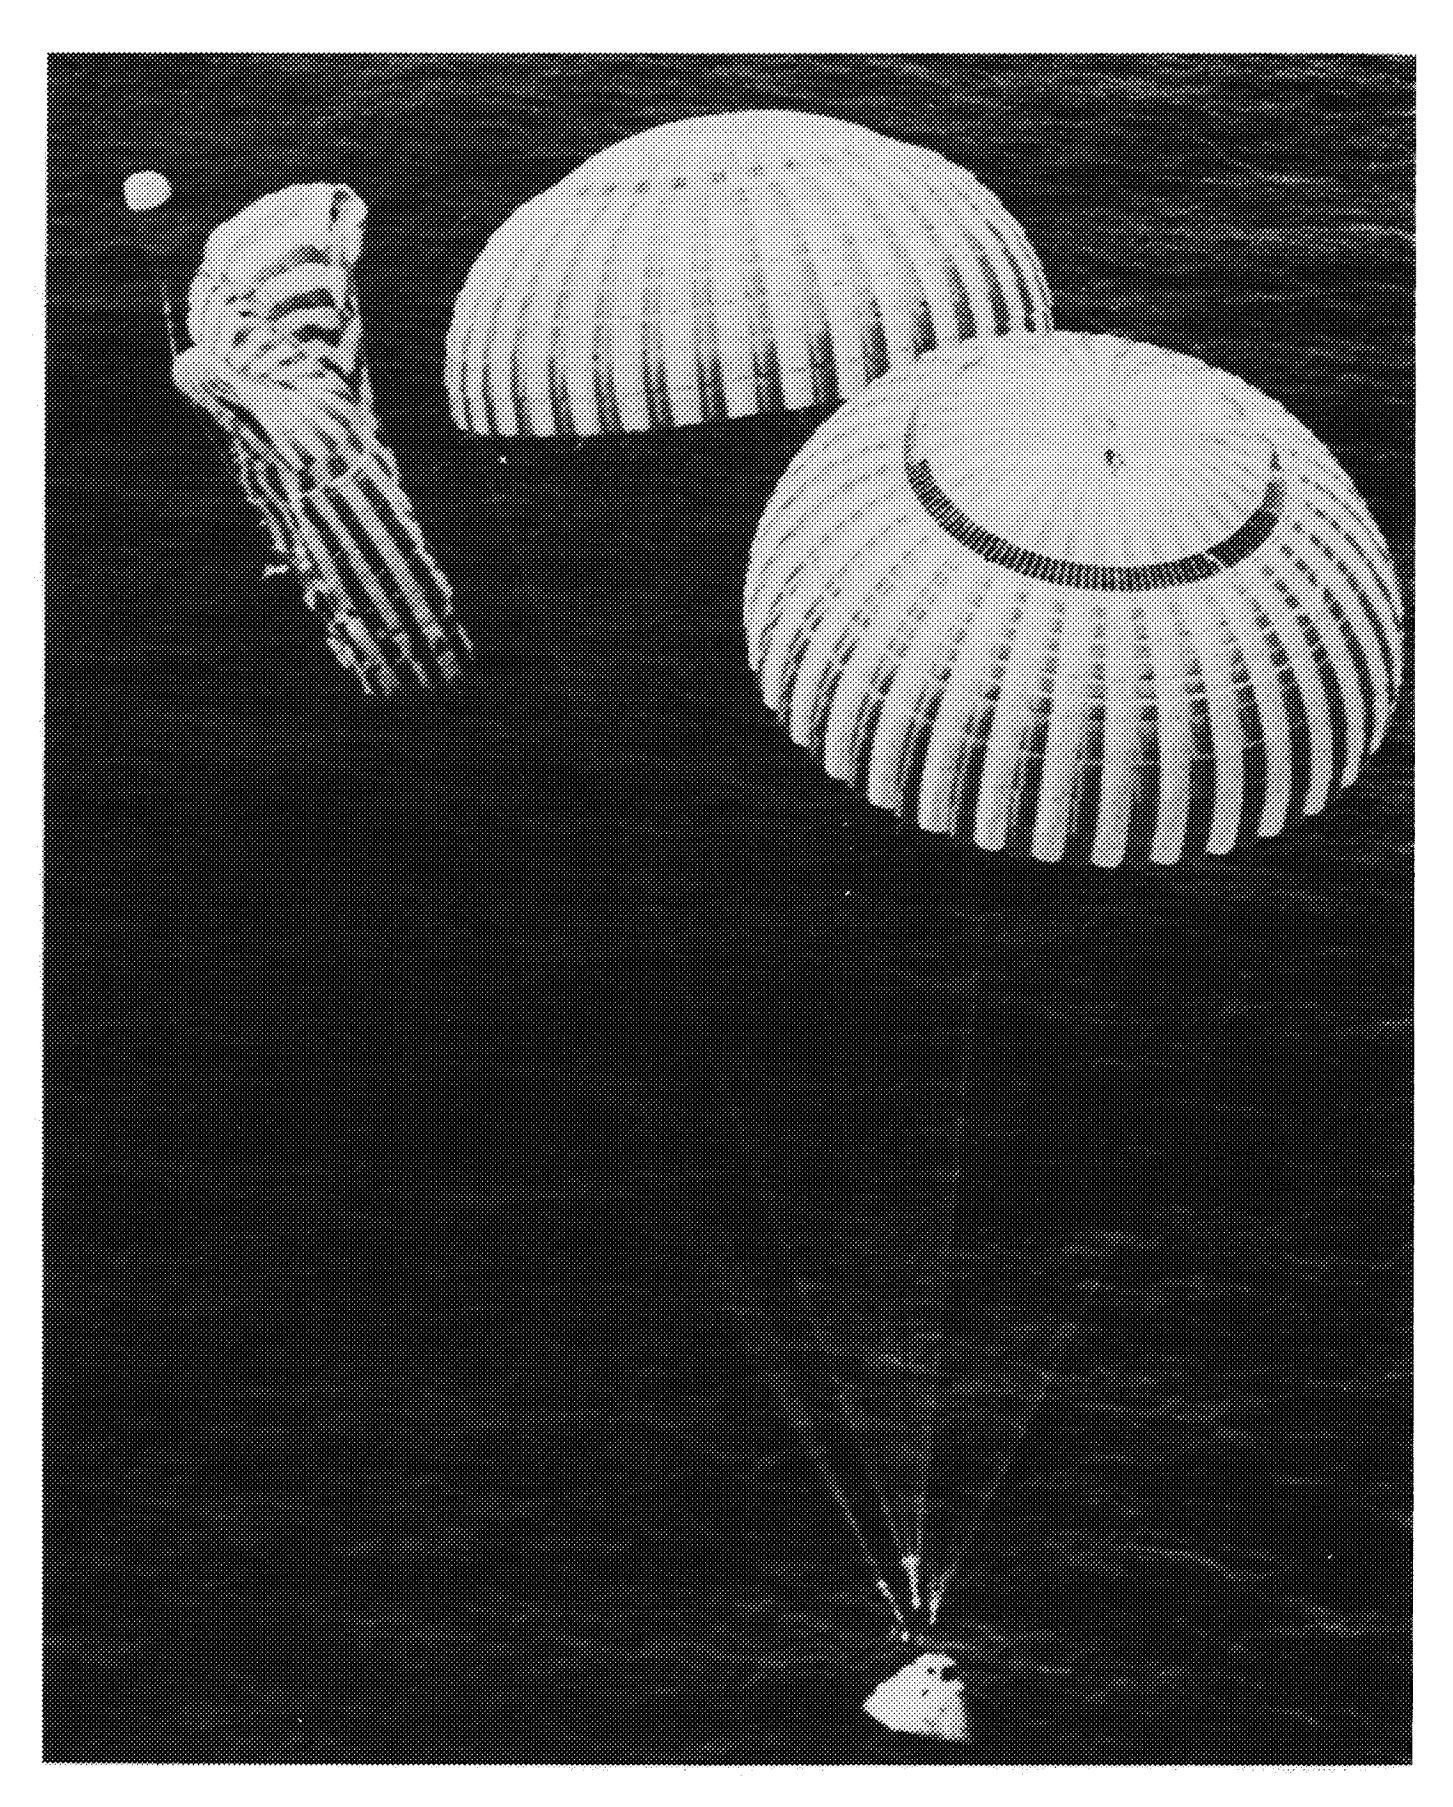
The three main parachutes of the Apollo 15 spacecraft deployed and inflated properly at approximately 3050 meters altitude. Films show that all three parachutes disreefed and opened fully in the proper sequence. The spacecraft and its parachutes were obscured by clouds at approximately 2135 meters altitude. On emerging from the clouds at approximately 1825 meters altitude, one of the three main parachutes was deflated,

as shown in figure 1. The spacecraft and parachute system descended in this configuration to water landing. The three parachutes were disconnected and one of the good main parachutes was recovered.

Figure 1. - Spacecraft descending with one main parachute failed.

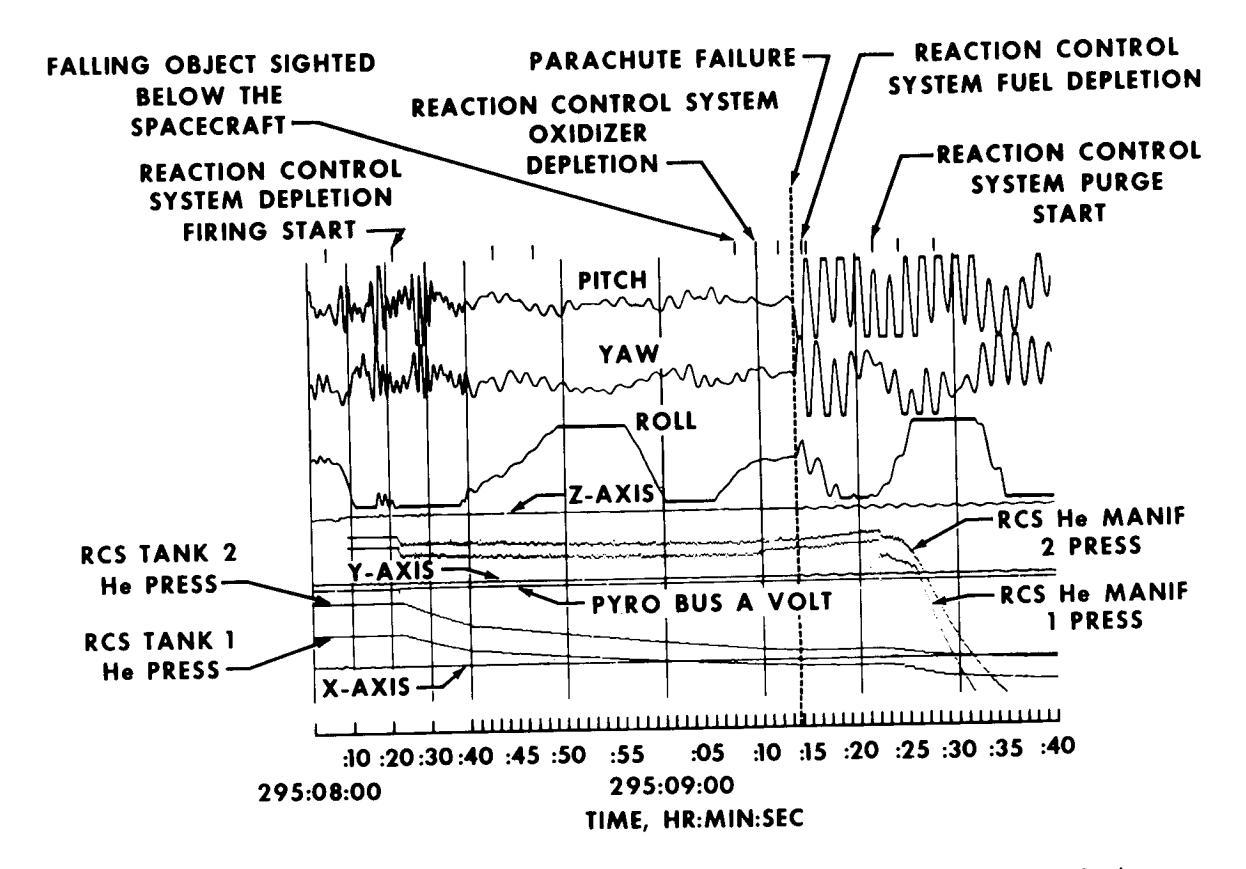
The initial efforts of the investigation team were concentrated on accumulating and assessing the spacecraft data, evaluating the photographic and television coverage, and inspecting the recovered parachute and the forward heat shield. The spacecraft data and the associated events are shown in figure 2. The time of the anomaly was determined from the X, Y, and Z accelerometer data and the associated rapid rate changes. The data show that the command module reaction control system depletion firing was completed approximately 3.5 seconds before the anomaly, as determined from an abrupt rise in the reaction control system manifold pressure. This change occurs when the pressure regulators abruptly close, as a result of the reaction control system tank bladders being collapsed. The completion time of the fuel (monomethyl hydrazine) dump that follows the depletion firing was determined by calculating the amount of fuel remaining at the end of the depletion firing (approximately 2.72 kilograms, using the known flow rate of the fuel through the engines). The 4.7-second duration of the fuel dump overlaps the time of the anomaly occurrence. The start of the reaction control system purge occurred 8.3 seconds after the anomaly, as determined from the spike in the pyrotechnic bus voltage and the immediate decreases in the reaction control system pressures.

According to these results, two connector links must fail simultaneously to satisfy the abrupt load change calculated from the data of figure 2. It is highly unlikely that this situation occurred because of the low-load condition at the time of failure (35 percent of the opening shock load). Assuming that the collapsed parachute did have two failed links, load still would have been carried by the fractured links. This fact was demonstrated by testing of the recovered failed link in which the link withstood two complete mission load cycles.

Figure 2. - Sequence of events during descent on the main parachutes.

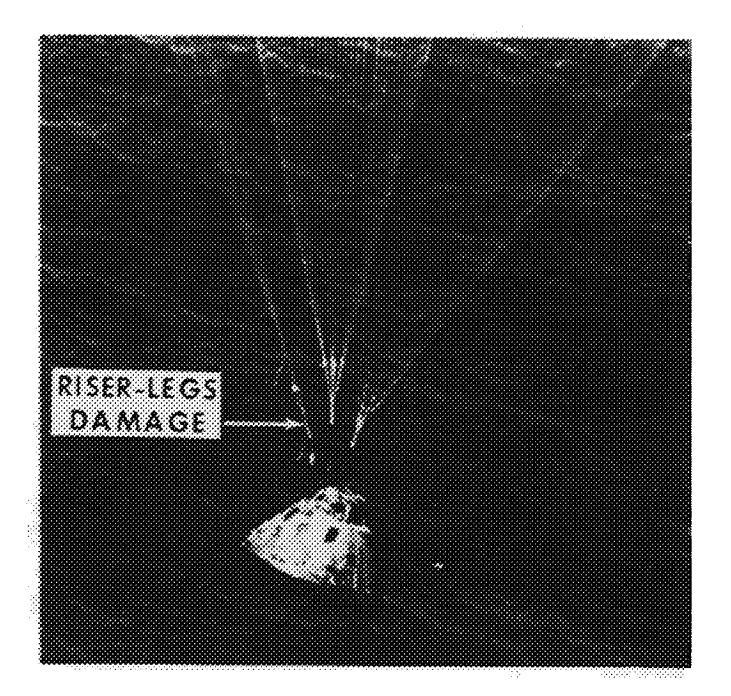
The two most significant items of photographic data obtained were the television tape, which indicated that the forward heat shield was in the vicinity of the spacecraft at the time of the anomaly, and the photographs shown in figures 1 and 3, which show the spacecraft parachute system damage when the spacecraft was relatively close to landing. The photographs show that

- 1. Three of the risers are taking the load.
- 2. There is no evidence of flailing suspension lines.
- 3. Two of the damaged riser lines appear to be full length.
- 4. Approximately two-thirds of the suspension system appears to be missing.
- 5. No significant canopy damage is visible.

Figure 3. - Parachute-riser damage during final descent.

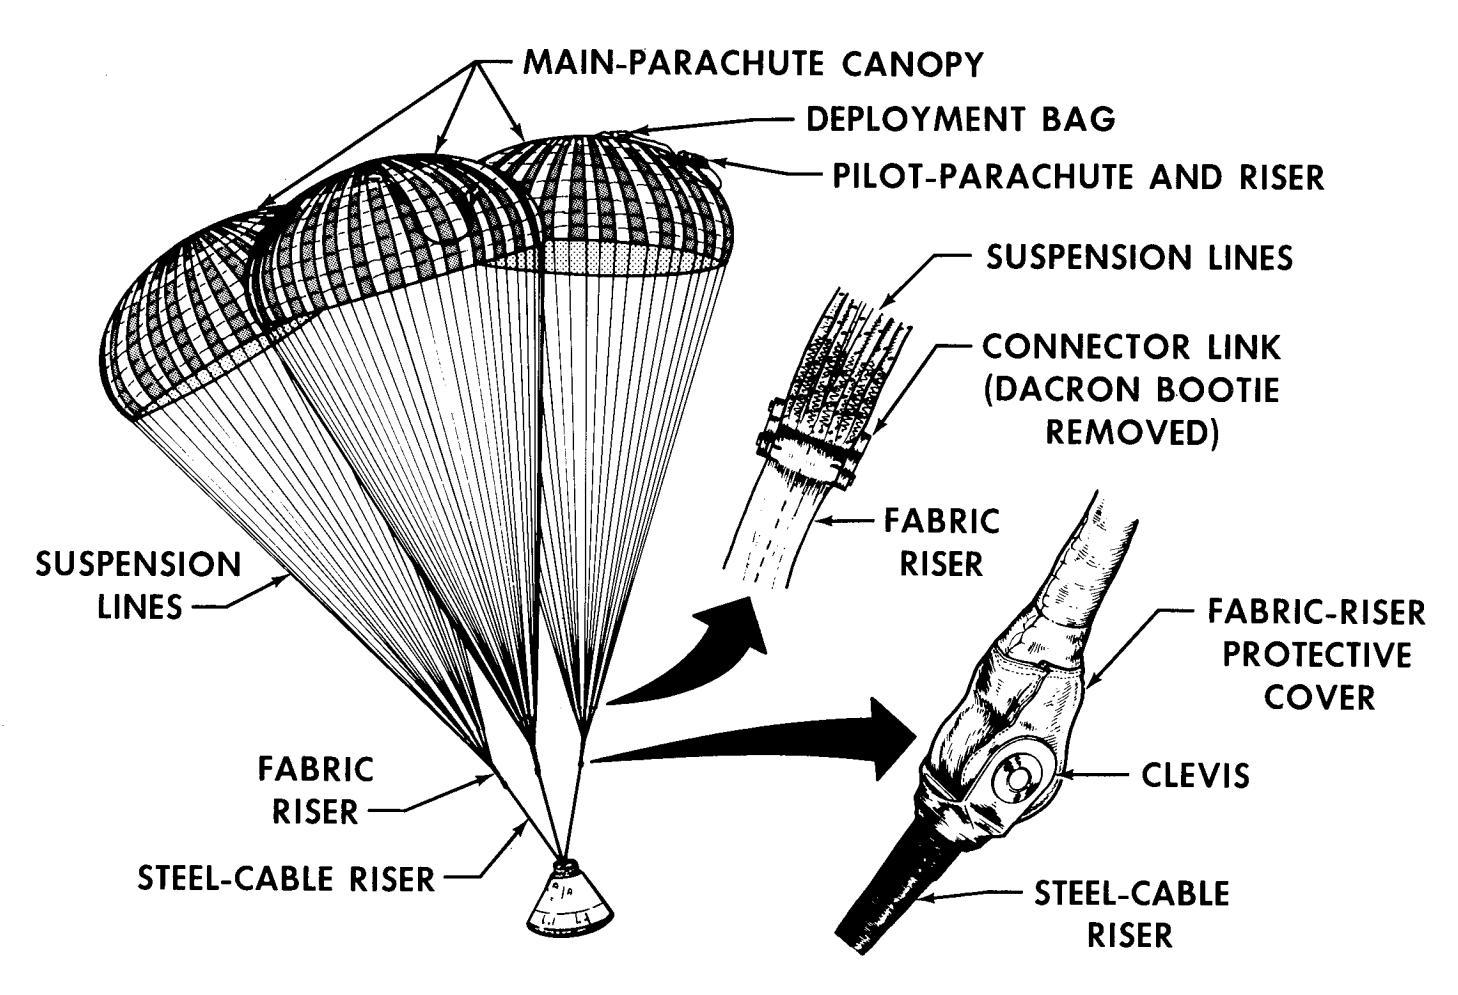
The inspection of the forward heat shield revealed no damage that could be attributed to contact with the parachute system or the spacecraft. The initial inspection of the recovered parachute showed only that it was not the one that had collapsed. Approximately 1 week after the first inspection, a second inspection was conducted, and a broken riser/suspension-line connector link was found after the Dacron bootie that protected it had been removed. Two to 3 weeks later, a closer examination of the Dacron riser protective cover (fig. 4) and the Dacron connector-link booties showed evidence of heat.

Figure 4. - Parachute system configuration.

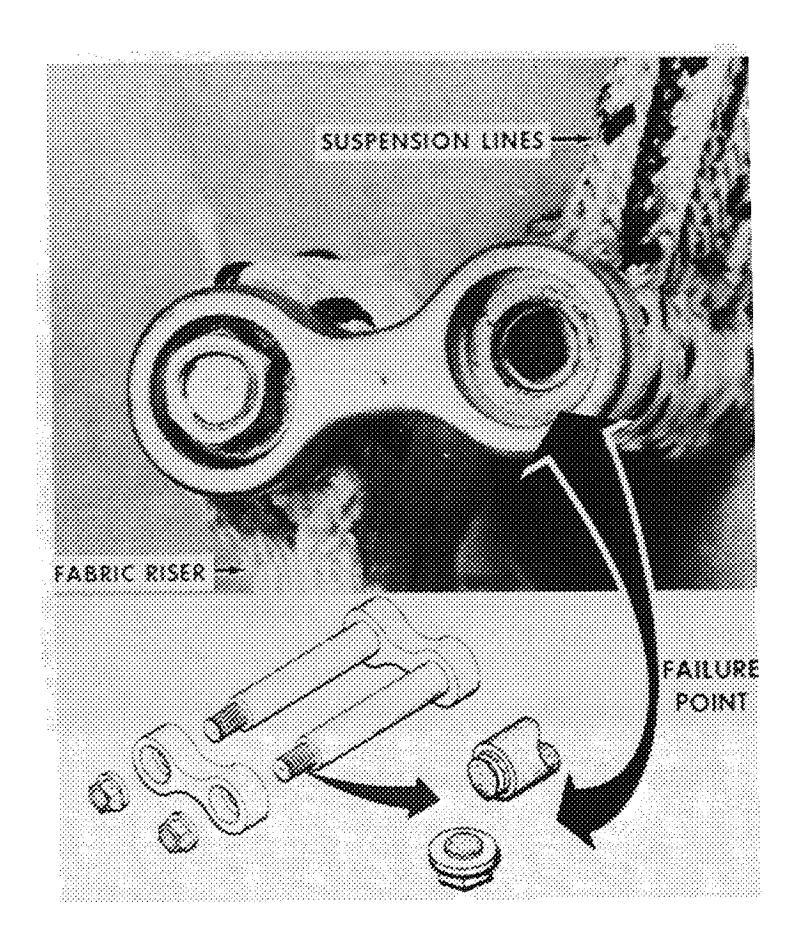
The discovery of the failed link on the recovered parachute (fig. 6) resulted in an extension of the investigation in order to identify the process that caused the connector link to fail and to determine if such a failure could have occurred and resulted in the parachute failure observed during the Apollo 15 landing. Microscopic inspection of the broken stud (fig. 7) indicated that stress corrosion or hydrogen embrittlement may have caused the link failure, or that it may have been caused by some other indeterminate means. The material used in the studs (4130 steel alloy) is susceptible to cracking when it is highly stressed and immersed in salt water. This process can cause stress corrosion. Hydrogen embrittlement can occur in the plating operation during the manufacturing process. The plating produces hydrogen that causes the embrittlement if the subsequent heat treating is improper.

Tests were performed on the connector links in an attempt to determine if either stress corrosion or hydrogen embrittlement was the process that caused the link failure. These tests included sustained-load tests to determine if hydrogen embrittlement was present; stress-corrosion tests to determine if salt-water corrosion could have induced the failure; over-torque tests of the studs to determine if tolerance buildup of stresses could have caused the problem; and hypergolic propellant exposure to determine if propellant exposure could have caused the observed flaws. The results of the tests and the metallurgical examinations performed were inconclusive in isolating the failure mechanism.

The failure of a single connector link has little effect on the load-carrying capability of a parachute and was not the cause of the parachute collapse.

Figure 6. - Main-parachute connector-link failure.

Corrective actions for the reaction control system include landing with the propellants on board for a normal landing and biasing the propellant load to provide a slight excess of oxidizer. Thus, for the low-altitude abort land landing, burning the propellants when the parachutes are deployed will subject the parachutes to some acceptable oxidizer damage but will eliminate the dangerous burning-fuel conditions. The suspension-line connector-link material has been changed to Inconel 718 to eliminate the requirement for plating, and the link-stud threads are rolled rather than machined to improve the metallurgical properties of the material.

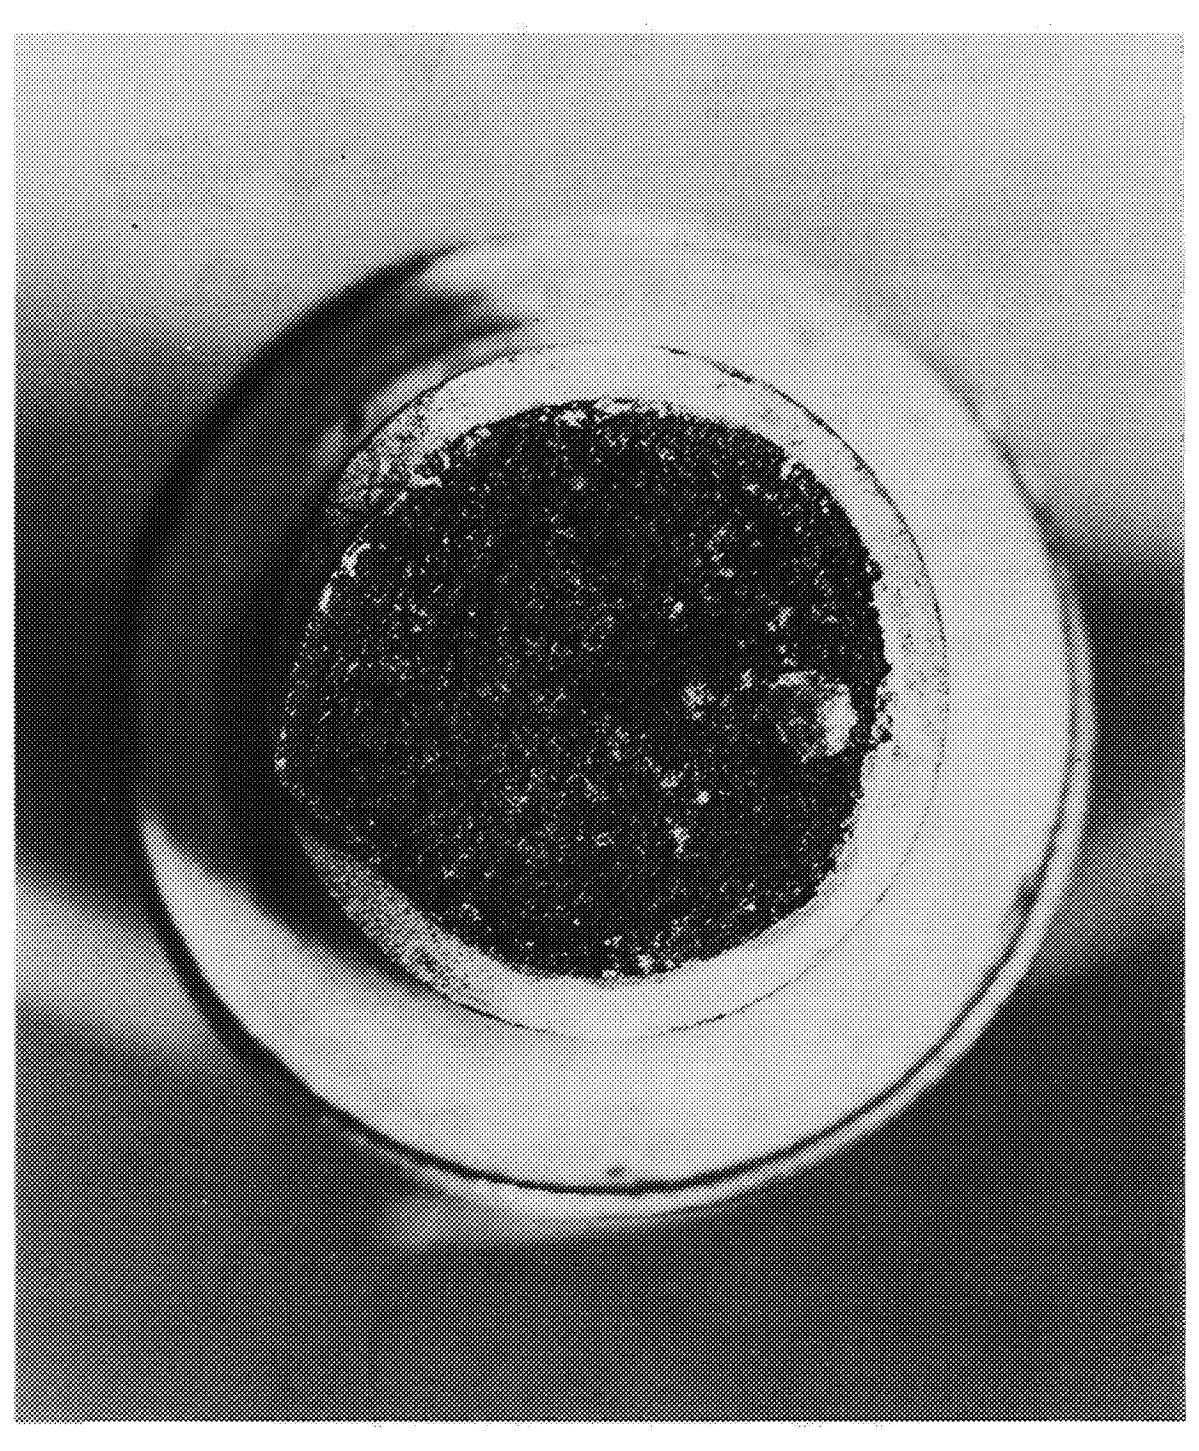
Figure 7. - Enlarged view of broken stud.
