**NASA TECHNICAL  
MEMORANDUM**

**NASA TM X- 62,428**

**THE EFFECT OF A PLANETARY SURFACE PENETRATOR ON THE  
SOIL COLUMN SURROUNDING THE IMPACTING BODY**

**Maxwell B. Blanchard  
Ames Research Center  
Moffett Field, Calif. 94035**

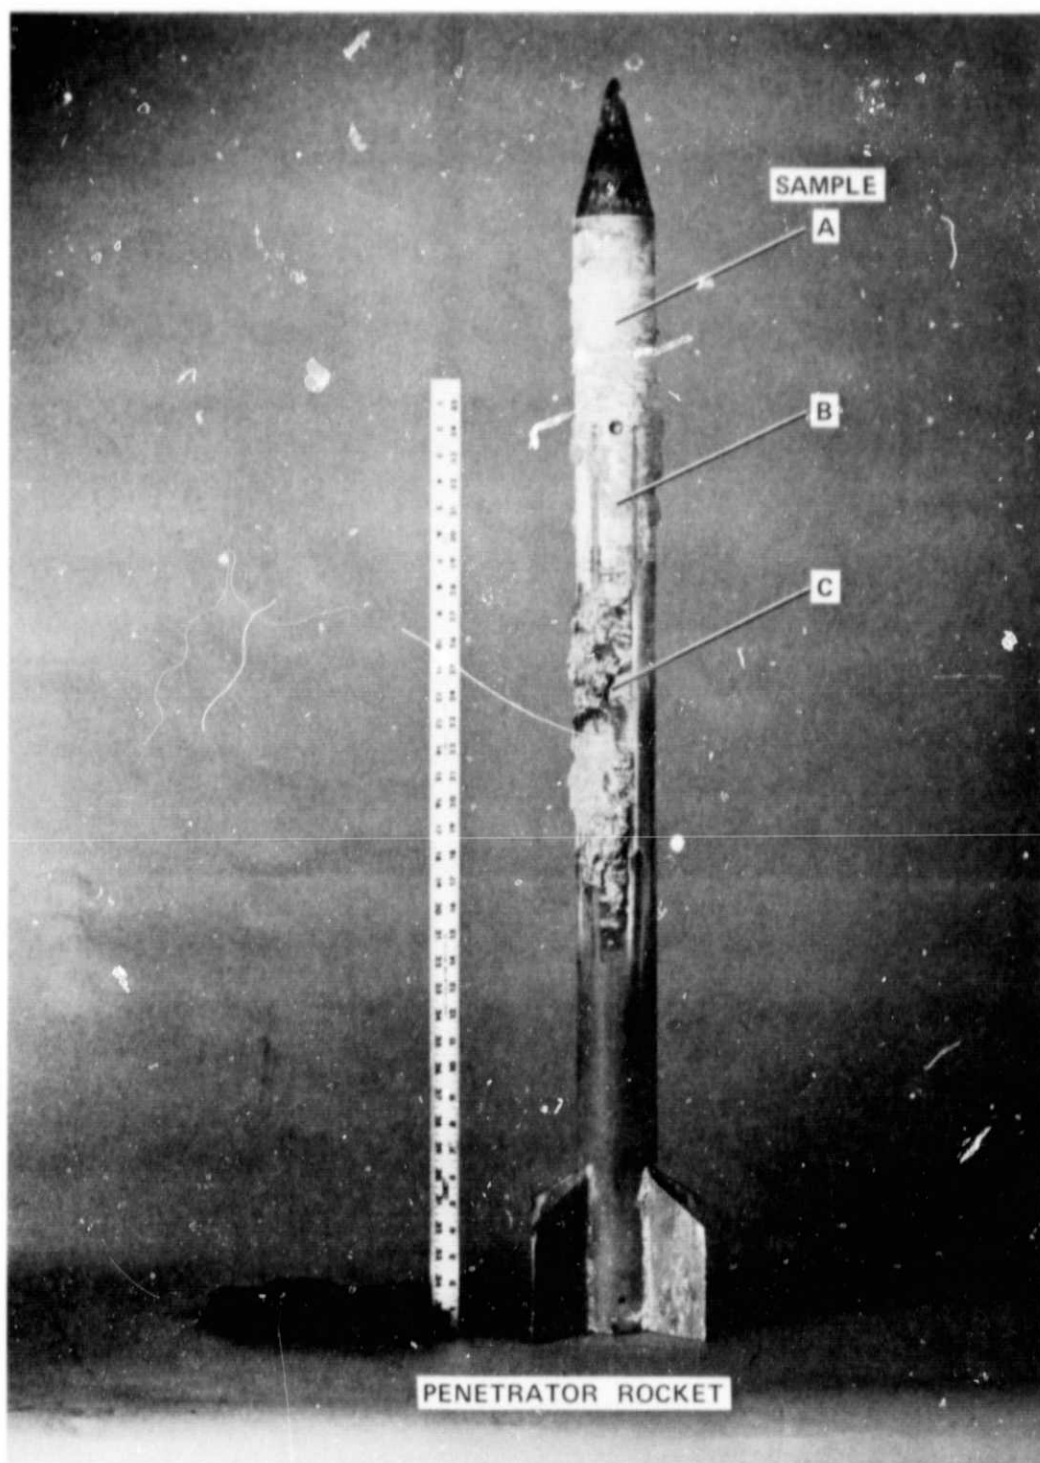
Soil samples immediately adjacent to the penetrator casing were carefully removed from several sites, as shown in figure 1. Selected fragments of paint and casing material were also removed for examination. Optical microscopic examination of the soil samples showed that much of the soil surface adjacent to the casing was coated with red paint (fig. 2). The paint came from the outer surface of the penetrator casing. Not so apparent was a white paint covering parts of the soil surface as well as part of the red paint. The white paint was evidently a primer placed directly over the metal of the penetrator casing before the red paint was added. The soil surface in direct contact with the casing was very smooth and striated. The paint had been smeared in parallel streaks that were thicker in some places than others. The larger soil grains were usually not fractured by impact. Instead, they appeared to be pushed back into the softer matrix material. Some shiny particles of abraded metal could be seen adhering to larger soil grains. The metallic particles represent portions of casing metal that had been scoured off as the impactor penetrated the soil column. Figure 2 shows a surface where paint has built up over the soil and some metal has scraped off the casing.

Figure 1.— Penetrator casing after impacting into dry lake bed. Samples of soil were removed from penetrator surface at locations A, B, and C for analyses. Also, material was scraped from the penetrator casing to compare with the samples.

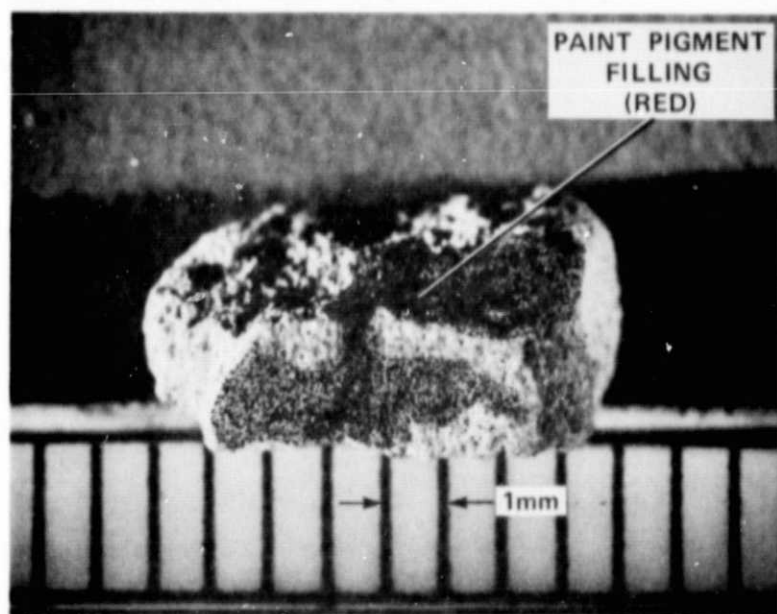
Cracks in the soil ~~perpendicular~~ perpendicular to the penetrator's entry axis were common. These cracks are caused by the rebounding soil after the compression wave formed during the penetrator's entry into the soil. Frequently the paint pigment (figs. 3(a) and (b)) migrated into these cracks where it coated and/or completely filled them. Thus, the paint pigment appears to be mobile during the penetration: it smears off the penetrator's metal casing and coats

Figure 3.— Photomacrograph of the soil immediately adjacent to the penetrator's casing showing the cracks caused by the rebounding soil after the compression wave formed during the penetrator's entry into the soil. During the time of formation, these cracks were filled by the mobile point pigment which came from the protective coating on the exterior of the penetrator's casing. View A is looking directly at the face between the casing and soil boundary. View B shows paint that migrated into a crack.

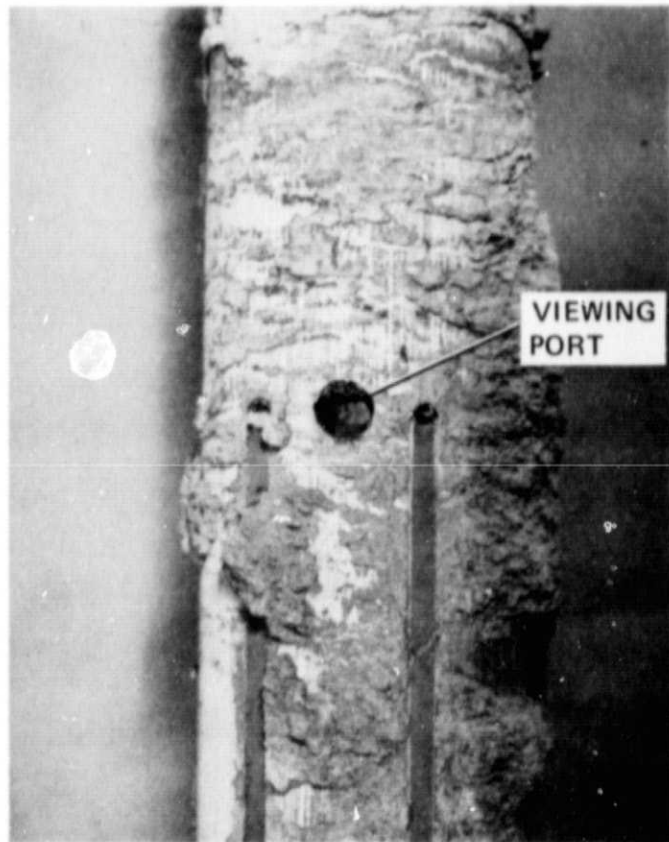
the adjacent soil surface as it passes through the soil column. The smeared paint pigment has also partially covered one viewing port on the side of the impactor, as shown in figure 4. The port was set back from the skin line, thus allowing the abraded debris to build up. Occasionally, portions of smeared paint show a vesicular texture (fig. 5). This texture indicates sufficient heat was generated during penetration to melt the paint.

Figure 4.— Photo of penetrator casing showing the buildup of debris smeared over the viewing port.

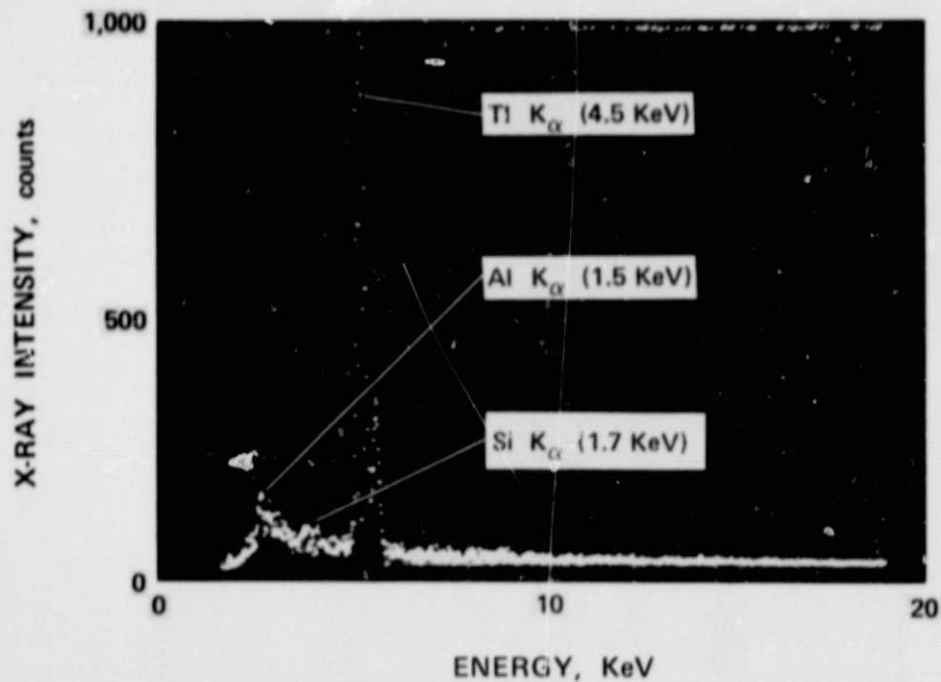
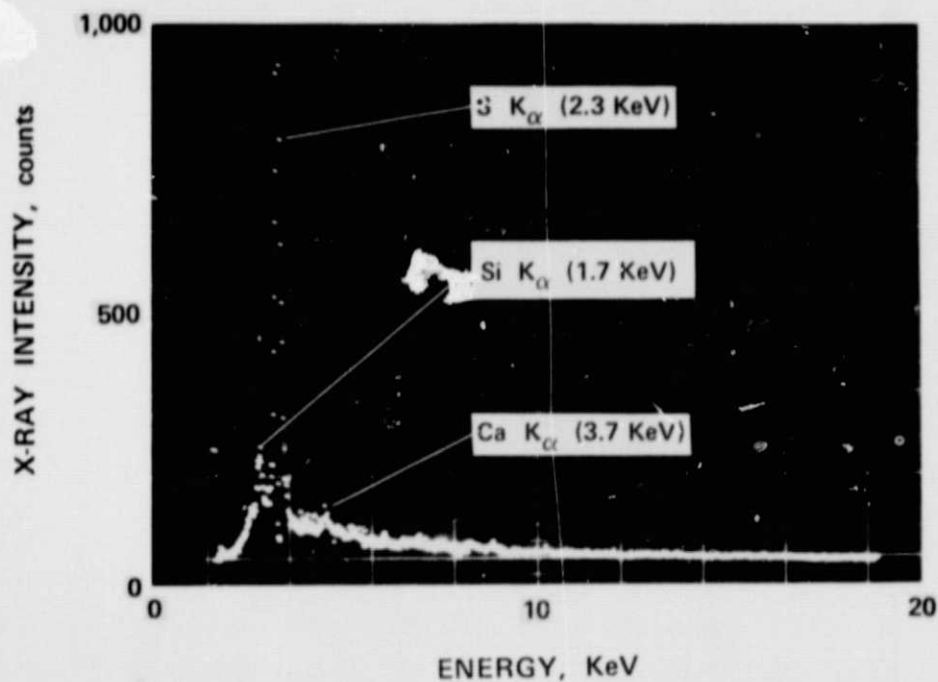
(a) Identifies elements Al, Si, and Ti, which are in the pigment for the white paint.

(b) Identifies elements Si, S, and Ca, which are in the pigment for the red paint.

Figure 6.— Photos of CRT display delineating the number of X-ray photons counted from the paint sample in 200 sec time and the energy of the emitted X-rays.

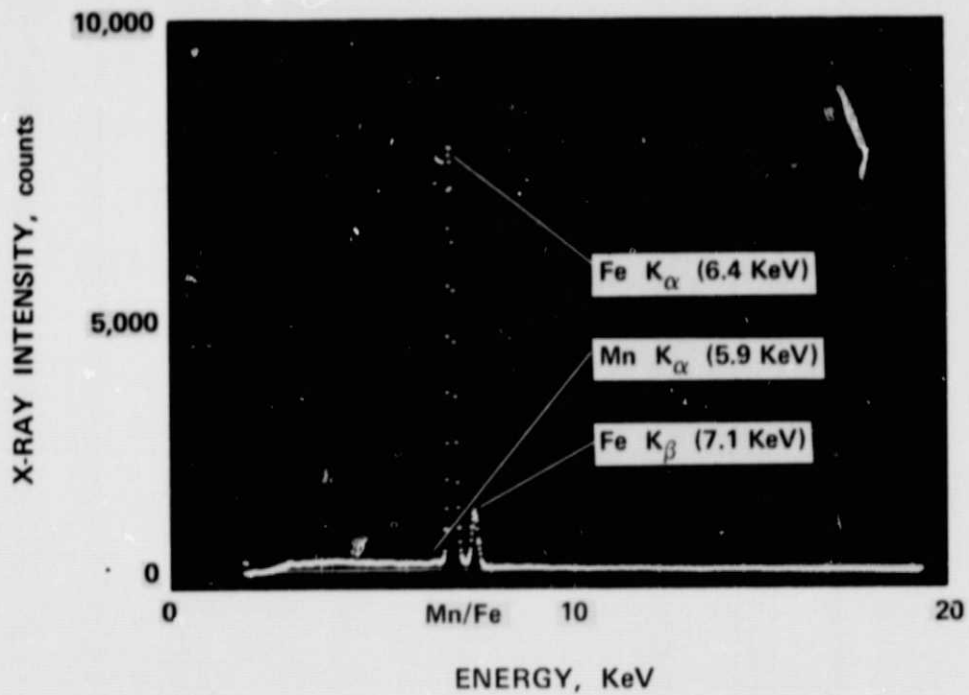
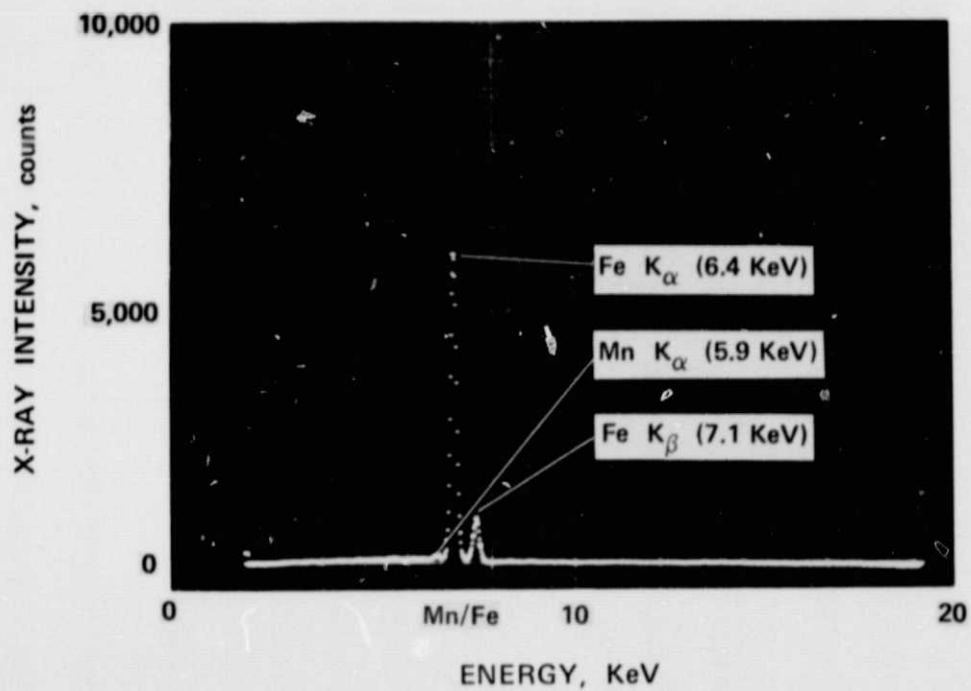
Figure 7.— Photos of CRT display delineating the number of X-ray photons counted in 100 sec time and the energy of the emitted X-rays of the metal chips for the penetrator housing.

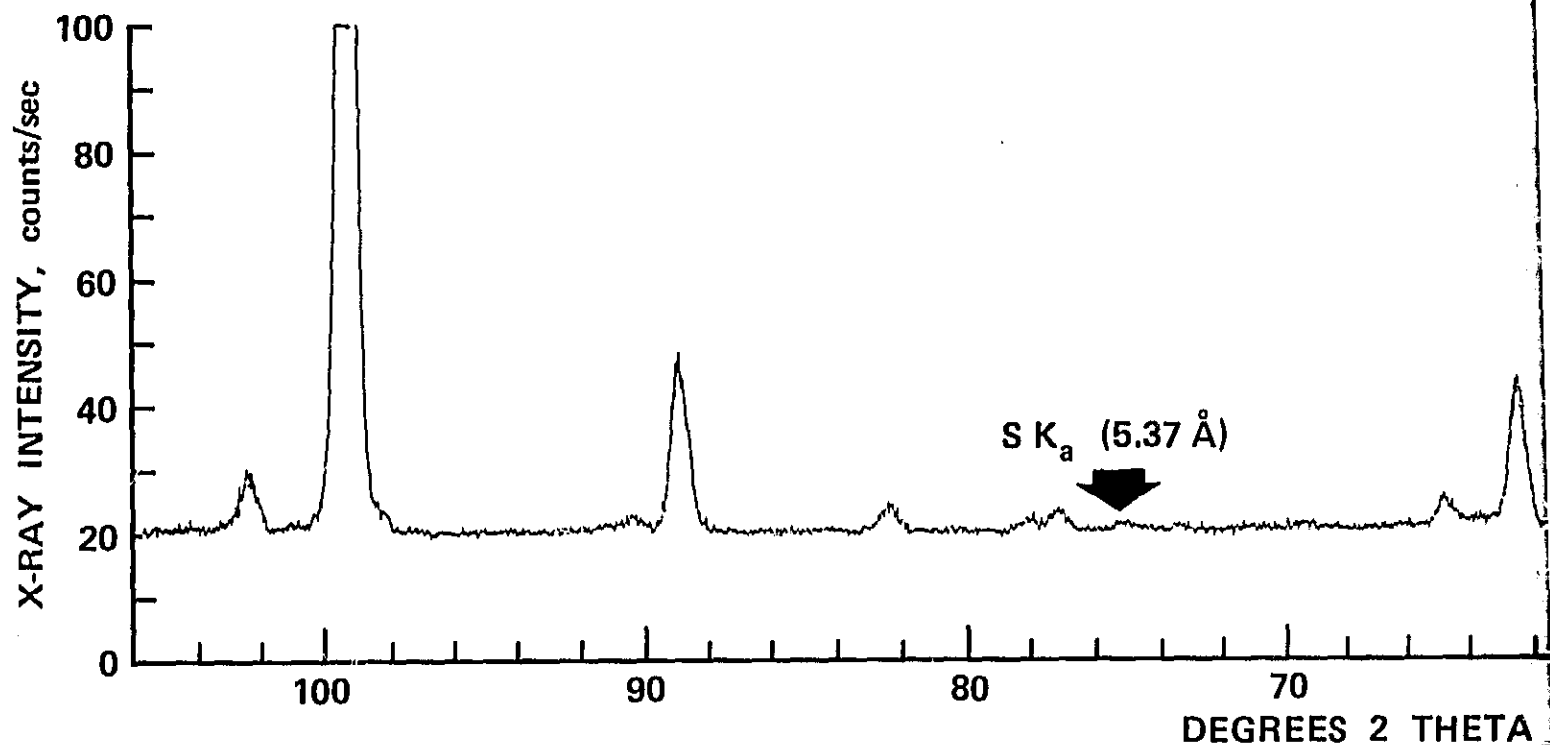
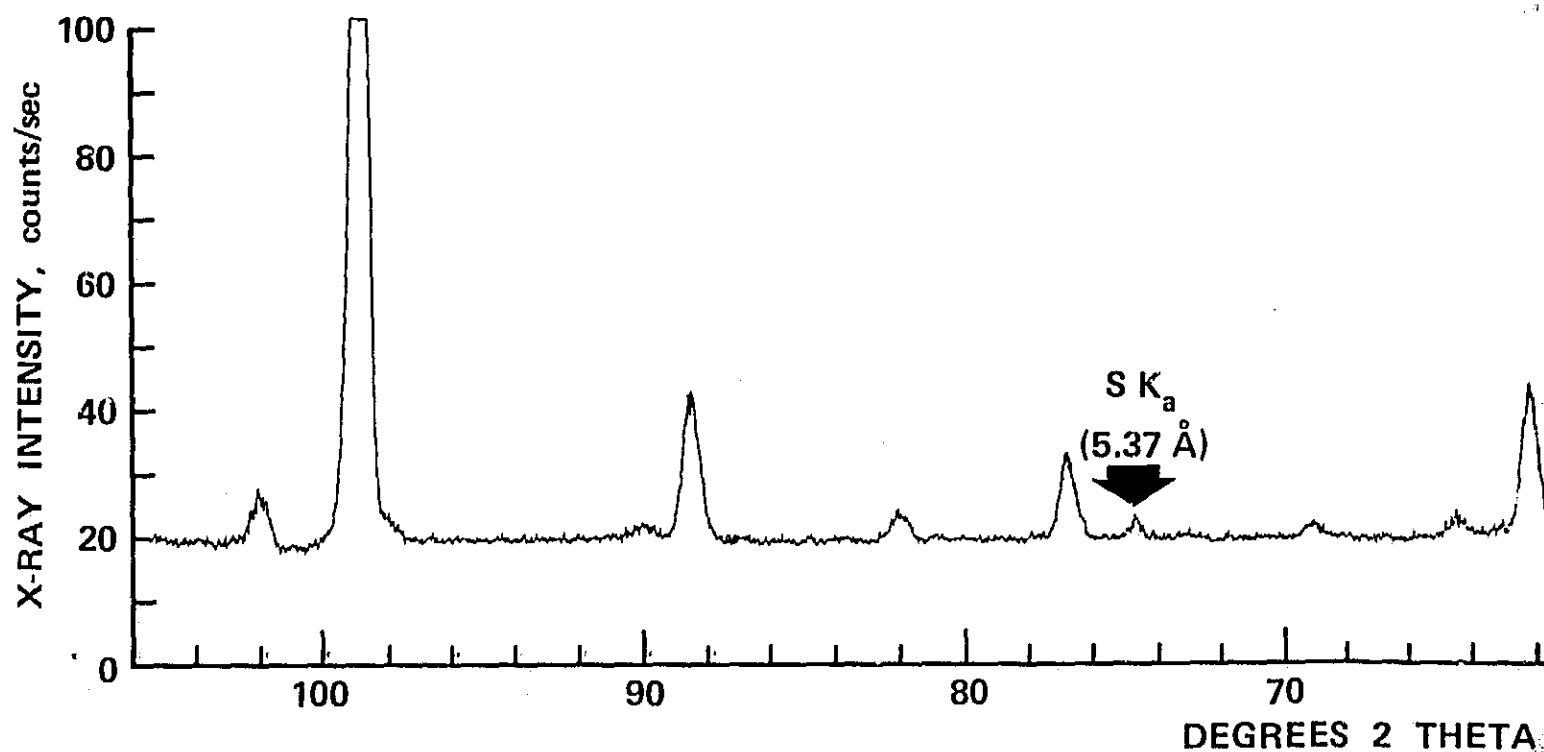
Figure 8.— Portion of strip chart from X-ray fluorescence analysis showing the increased concentration of S and Ti for the bulk soil samples tested.

This study suggests that great care be taken in the use of coating materials and the metal alloys selected for the penetrator's exterior casing. Otherwise, the accuracy of any experiment requiring an uncontaminated *in situ*

sample will be seriously affected. Future design and testing of penetrator configurations should be accompanied by careful analytical studies. The studies should include both the penetrator casing surface and the soil attached to the casing.
