**NASA TM-73700**

**FRACTURE SURFACE CHARACTERISTICS OF OFF-AXIS COMPOSITES**

by J. H. Sinclair and C. C. Chamis  
Lewis Research Center  
Cleveland, Ohio 44135

TECHNICAL PAPER to be presented at the  
Fourteenth Annual Meeting of the Society of Engineering Science, Inc.  
Bethlehem, Pennsylvania, November 14-16, 1977

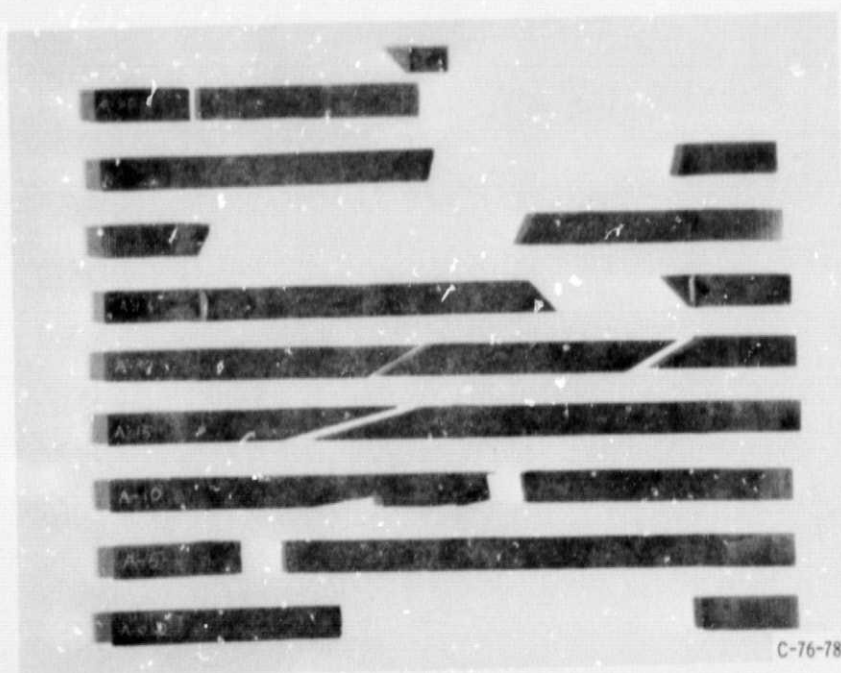
Figure 4. - Fractured tensile specimens.

Fractured surfaces from each tensile specimen shown in figure 4 were observed by scanning electron microscope, and typical photomicrographs were made to illustrate fracture modes.

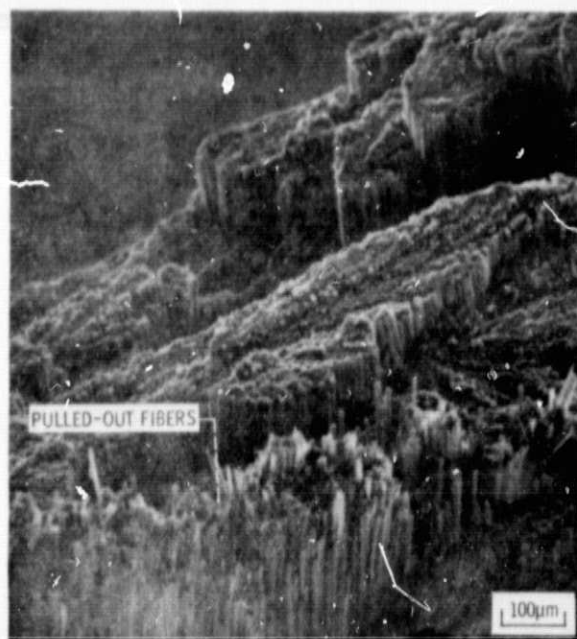
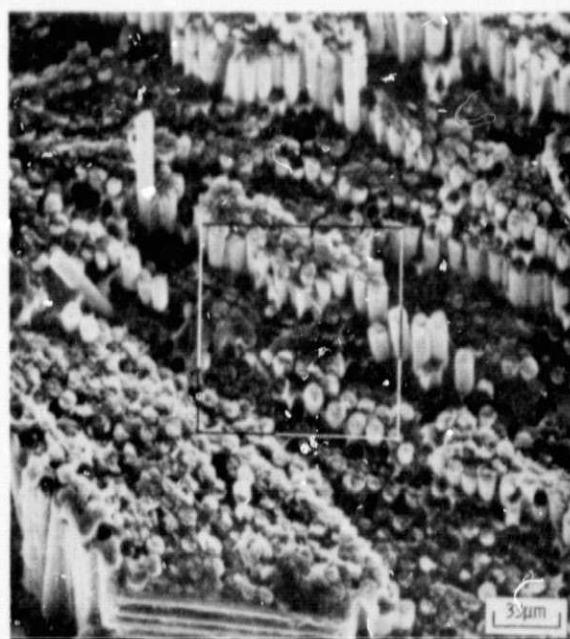
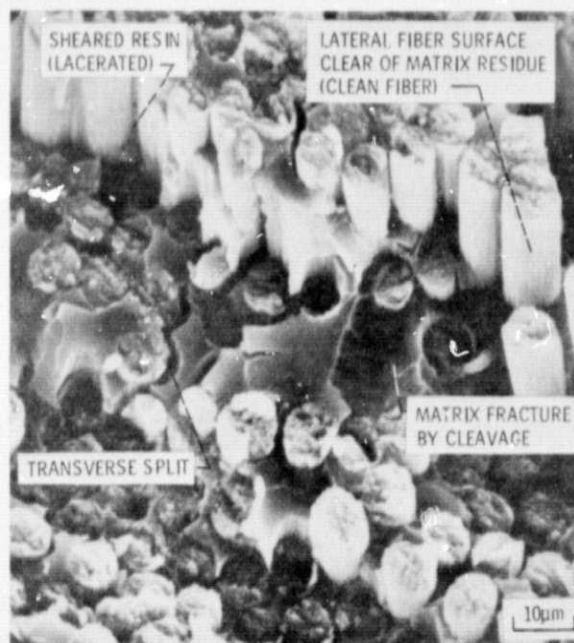
Figure 6. - Scanning electron photomicrographs of fractured surface of MOD V/Epoxy composite [D]g tested parallel to the fiber direction.

The fracture surface of the  $0^\circ$  specimen is shown in figure 6. As can be observed, in figure 6(a) the fracture surface is irregular. An area replete with pulled-out fibers that broke off at varying lengths can be observed in the left foreground of figure 6(a). This type of

fracture suggests poor bonding between matrix and fibers. The remaining areas of figure 6(a) show irregularly shaped tiered or stepped surfaces that are typical of the fracture surface of specimens tested in longitudinal tension. At some regions, fibers over relatively large areas fractured at approximately the same level, and they show little fiber pull-out. This is the type of fracture surface shown in figures 6(b) and (c). There was strong bonding between the fibers and matrix in these areas. The fracture mode of the resin was cleavage (fig. 6(c)). Lateral fiber surfaces of these stepped zones show some evidence of sheared resin lying between the fibers as seen in the upper left of figure 6(c).

The fracture surface in figure 6(c) reveals several distinct features. These features and some significant implications following therefrom are as follows:

1. The fiber fracture surface is irregular but appears to be symmetric from the perimeter towards the center. This type of fiber fracture surface morphology will be considered to be typical of tensile fracture.
2. The matrix fracture surface between fibers at the same level is smooth indicating tensile brittle fracture by cleavage.
3. The matrix fracture surface between fibers at different levels is lacerated indicating fracture by tear which will be considered to "fracture by intralaminar shear."
4. The surface of fibers that pulled-out appears to be clear of matrix residue, in general. This indicates weak interfacial bonding which may be construed to imply that "the interfacial bond is predominantly mechanical."
5. The transverse split in the left foreground is probably caused by the elastic energy release after fracture "back-lash."

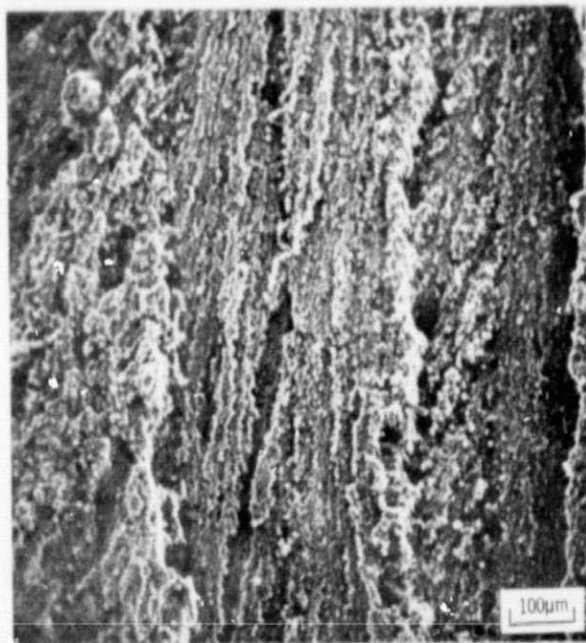
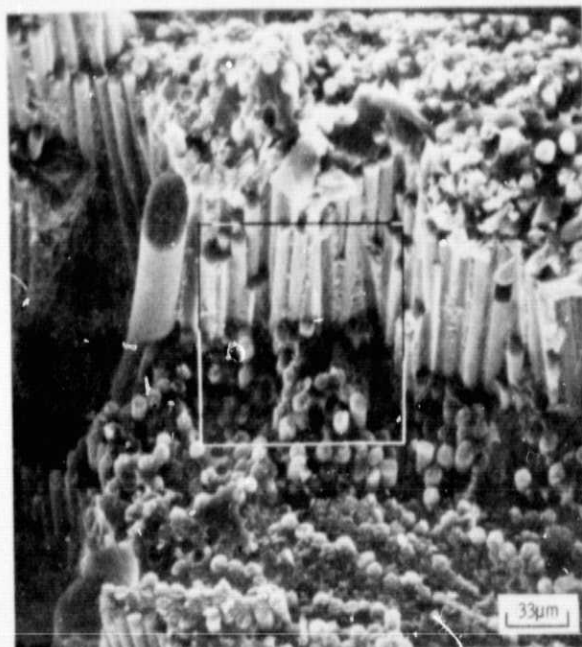
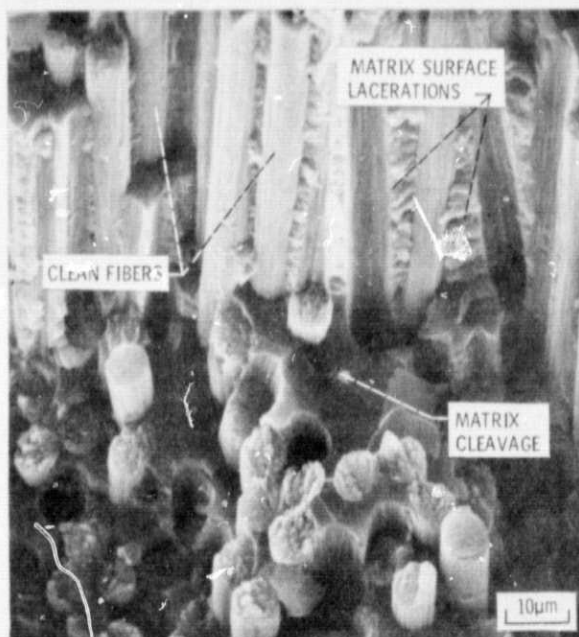
Figure 7. - Scanning electron photomicrographs of fractured surface of MOD V/Epoxy composite [0] g tested at 5 degrees to the fiber direction.

The fracture surface of the 5° off-axis tensile specimen, figure 7, reveals the following features:

1. Surface tiering (fig. 7(b)) and matrix cleavage (fig. 7(c)) both of which are indicative of tensile fracture.
2. Extensive matrix surface lacerations indicating substantial fracture by intralaminar shear.
3. Fiber pull-out and surfaces free of matrix residue indicating weak interfacial bonding. Recall that all of the above features were observed in the fracture surface of the 0° tensile specimen.

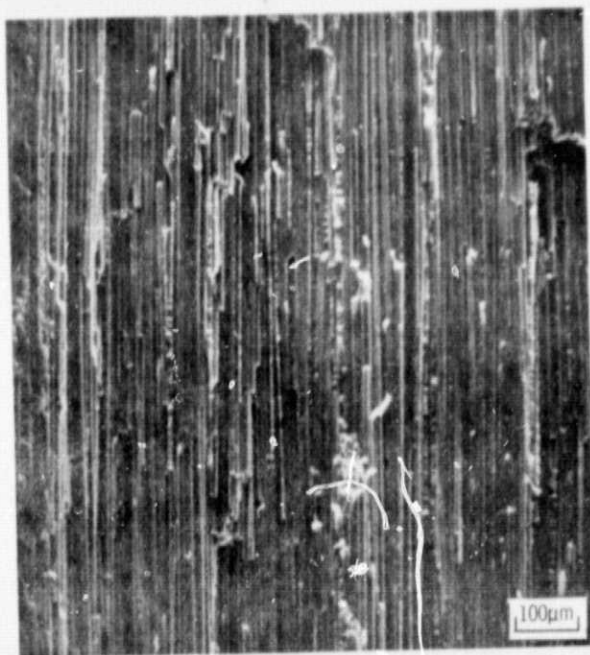
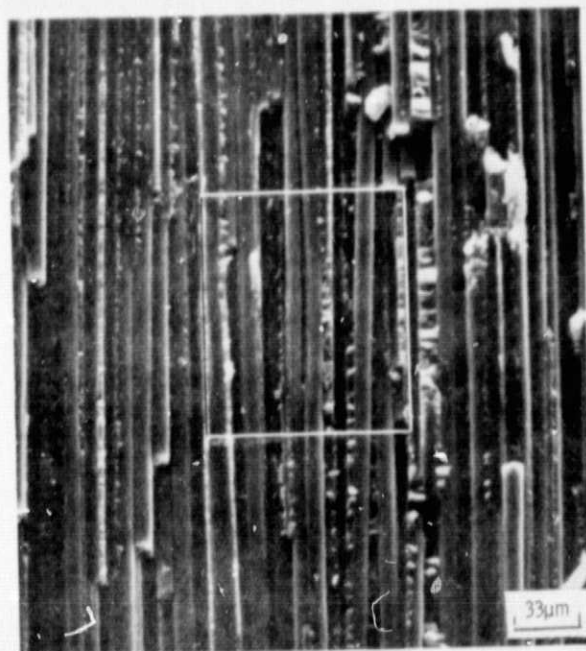
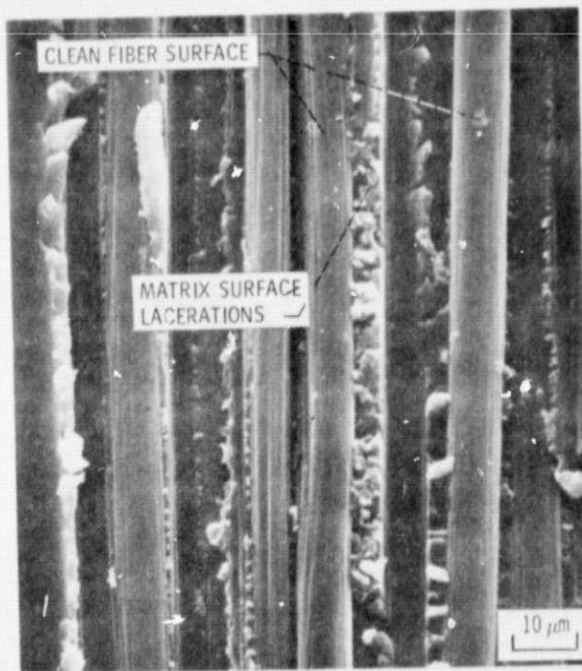
Figure 8. - Scanning electron photomicrographs of fractured surface of MOD V/Epoxy composite [0] <sub>g</sub> tested at 10 degrees to the fiber direction.

The fracture of the 10° off-axis tensile specimen of figure 8 reveals: (1) matrix surface lacerations and (2) fiber surfaces free of matrix residue. Both of these features indicate that the intralaminar shear fracture mode became dominant between the 5° and 10° off-axis loadings. We will consider this angle range to fracture by intralaminar shear stress. This observation as well as certain theoretical considerations not covered herein led to the recommendation that: "The 10° off-axis tensile specimen is suitable for intralaminar shear characterization of unidirectional fiber composites [2]."

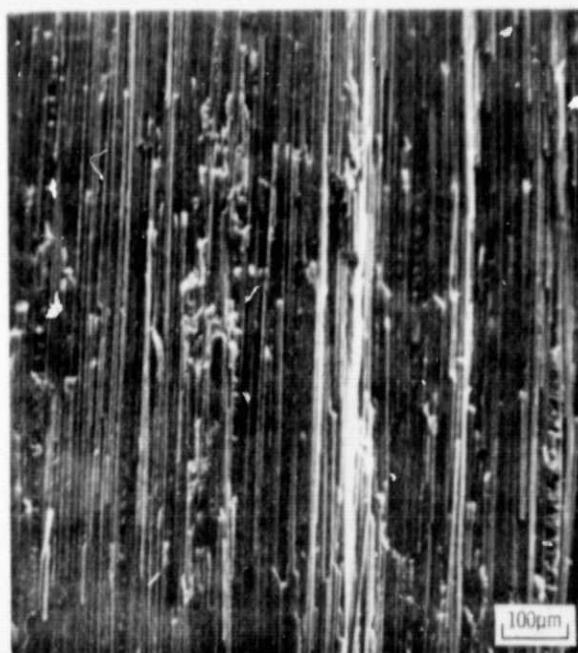
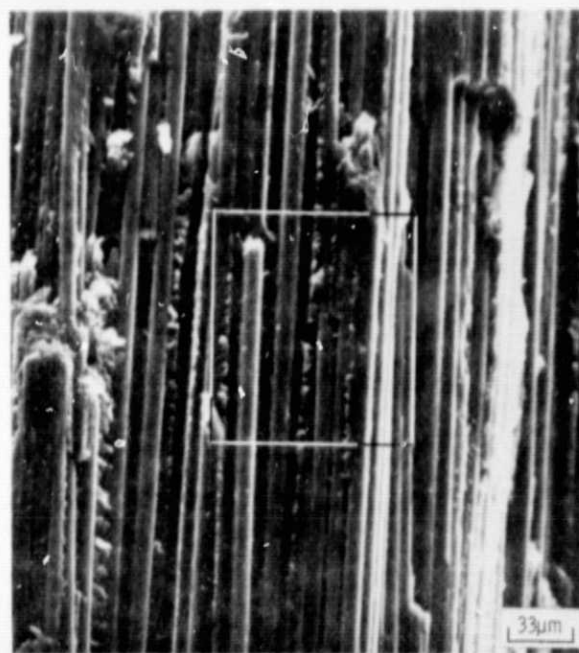
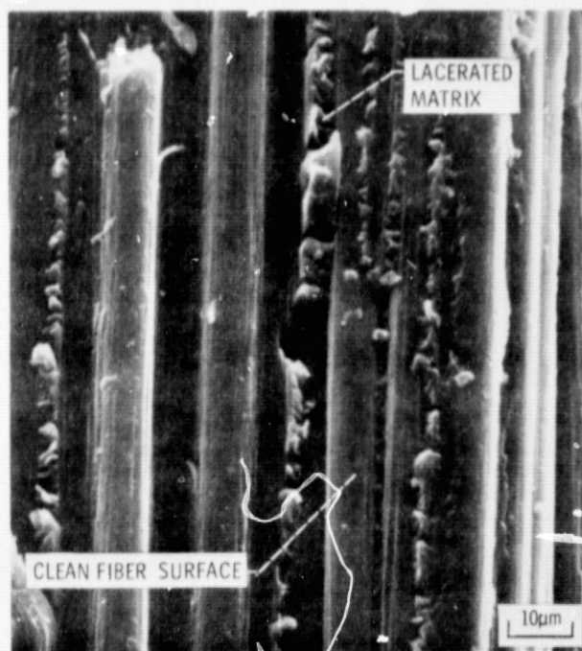
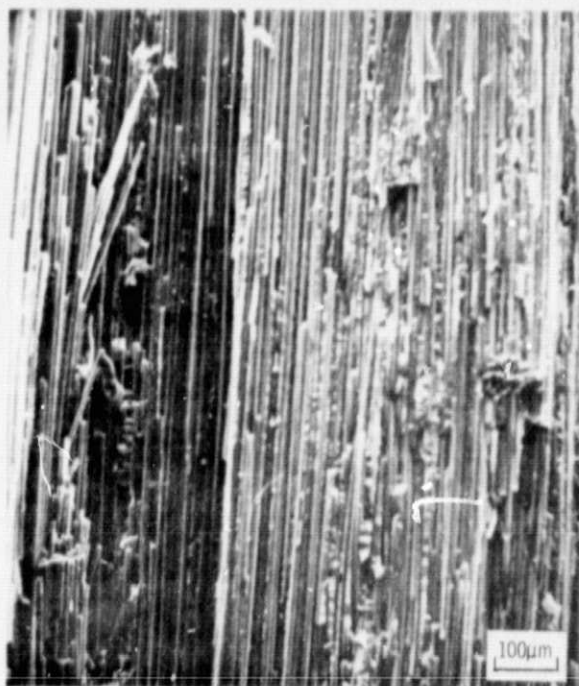
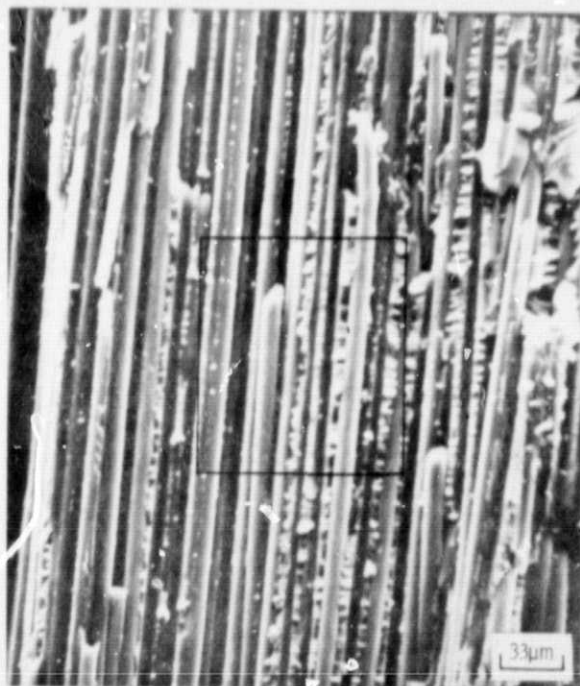
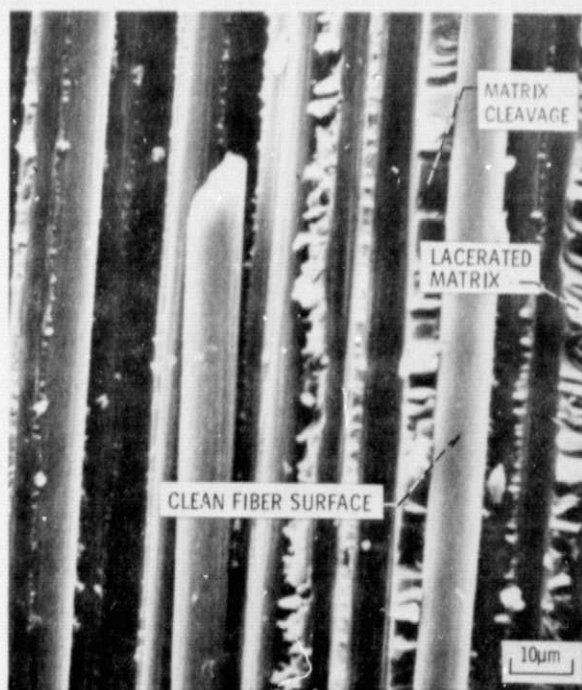
The fracture surfaces of the 15° and 30° off-axis tensile specimens figures 9 and 10 reveal similar features to those of the 10° off-axis tensile specimen. These surfaces, too, indicate that fracture was induced mainly by intralaminar shear stress.

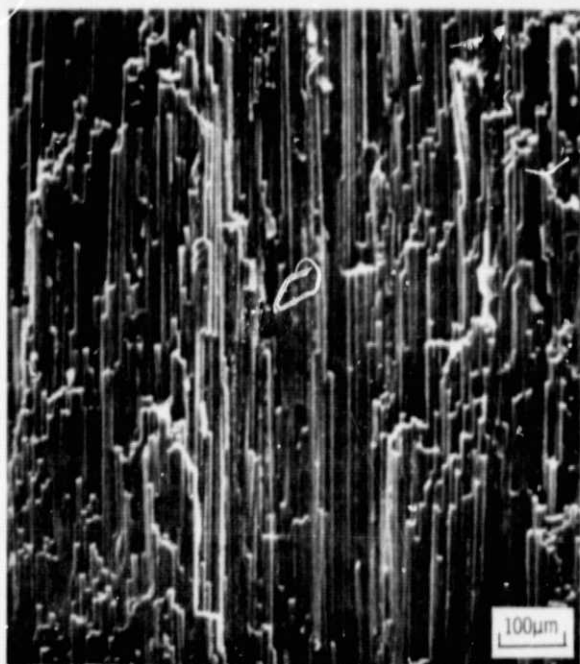
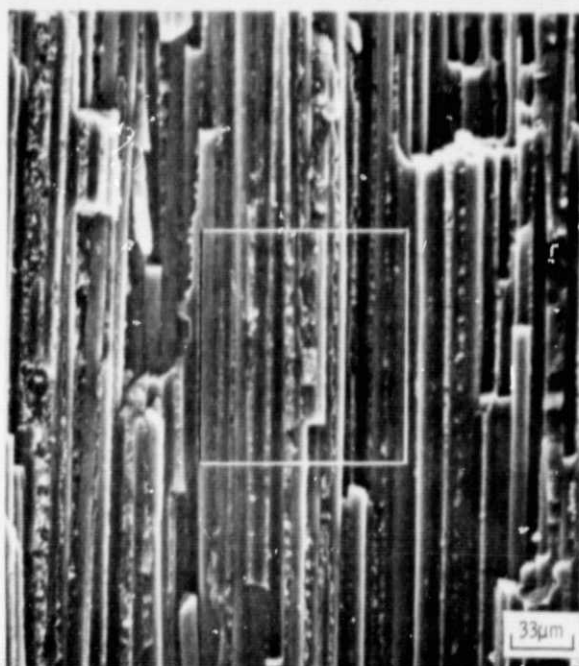
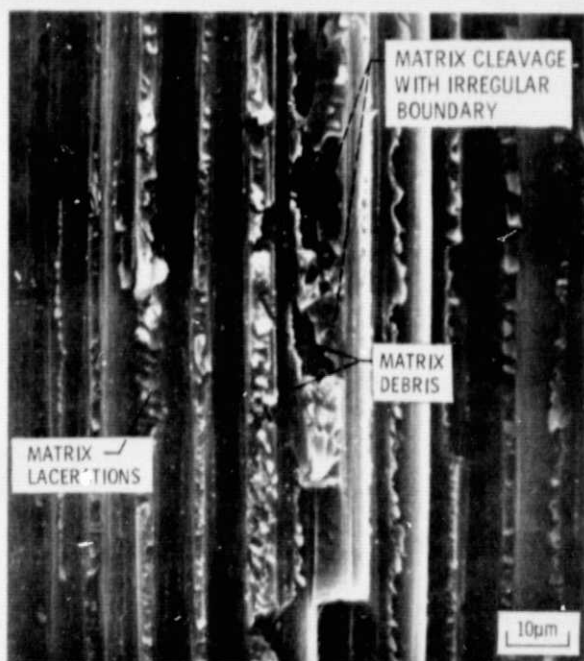
Figure 11. - Scanning electron photomicrographs of fractured surface of MOD I/Epoxy composite  $[0]_g$  tested at 45 degrees to the fiber direction.

The fracture surface of the 45° off-axis, figure 11, tensile specimen reveals the following features:

1. Matrix cleavage with irregular boundary indicating some transverse tensile fracture.
2. Matrix debris resulting probably from tensile matrix fracture.

3. Some matrix lacerations indicating some intralaminar shear stress fracture interaction.

The above surface fracture features show that another fracture mode becomes active somewhere between a load angle of  $30^\circ$  and  $45^\circ$ . This mode will be construed to be induced by the transverse tensile stress.

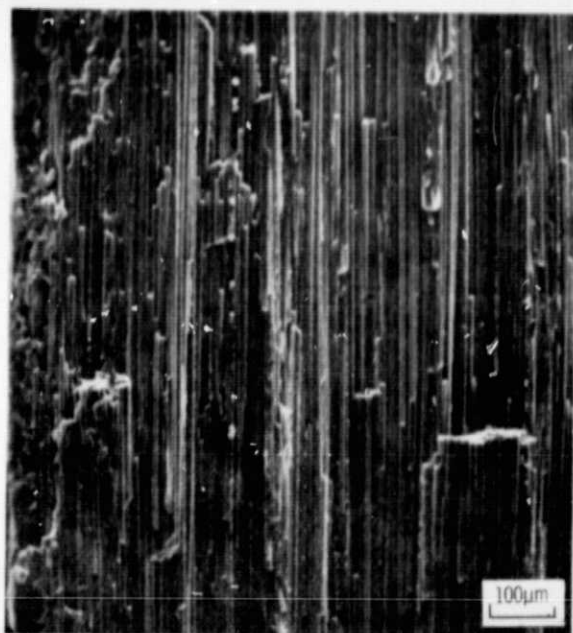
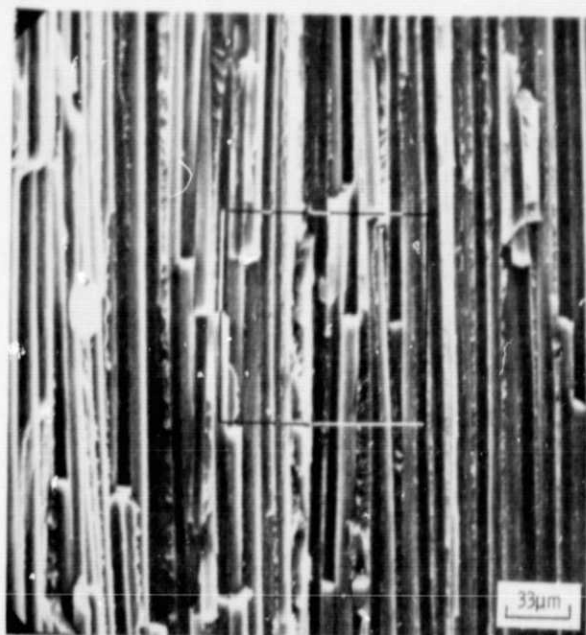
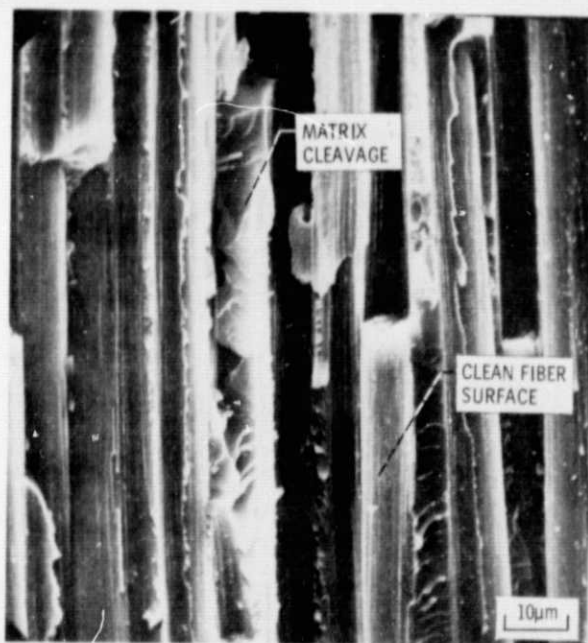
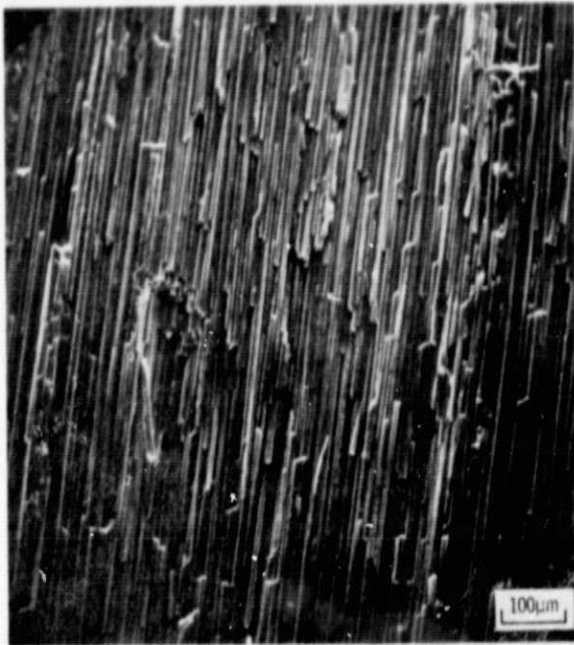
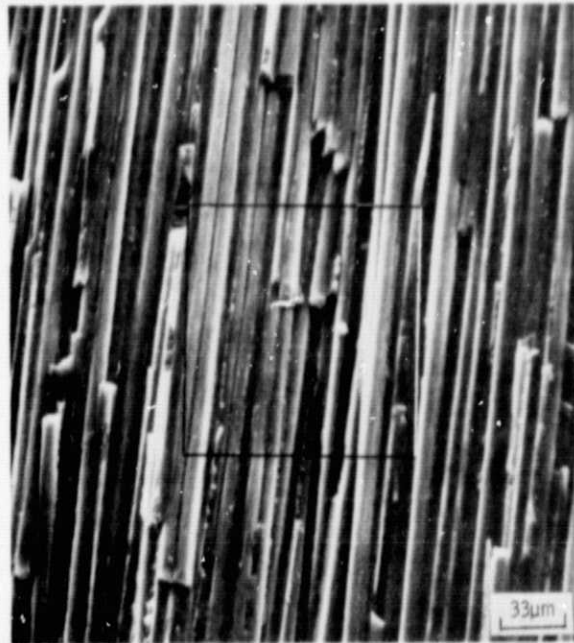
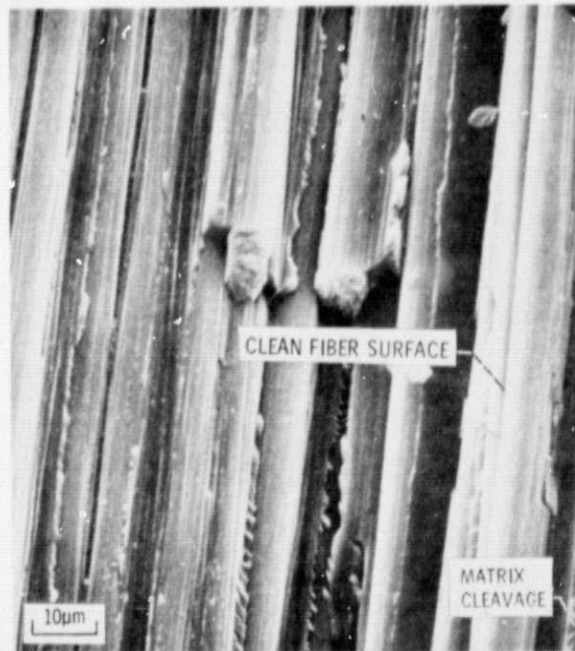
The fracture surfaces of the  $60^\circ$  off-axis tensile specimen, figure 12, and the  $75^\circ$ , figure 13, reveal mainly matrix cleavage and some fiber surface free of matrix residue; both of these features indicate that fracture was induced by transverse tensile stress.

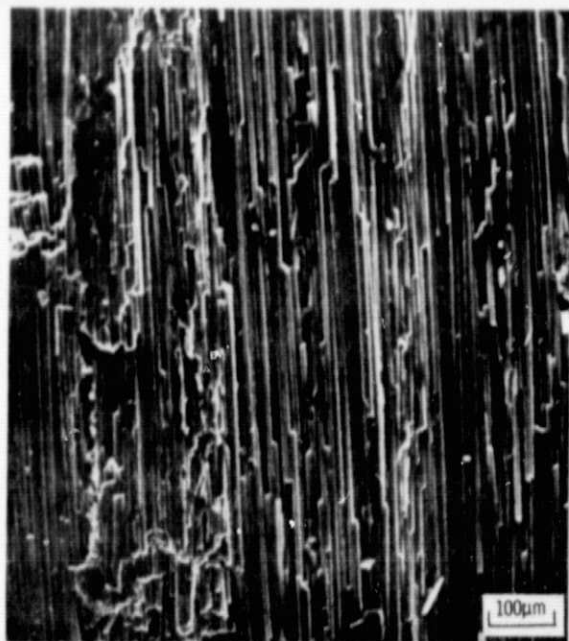
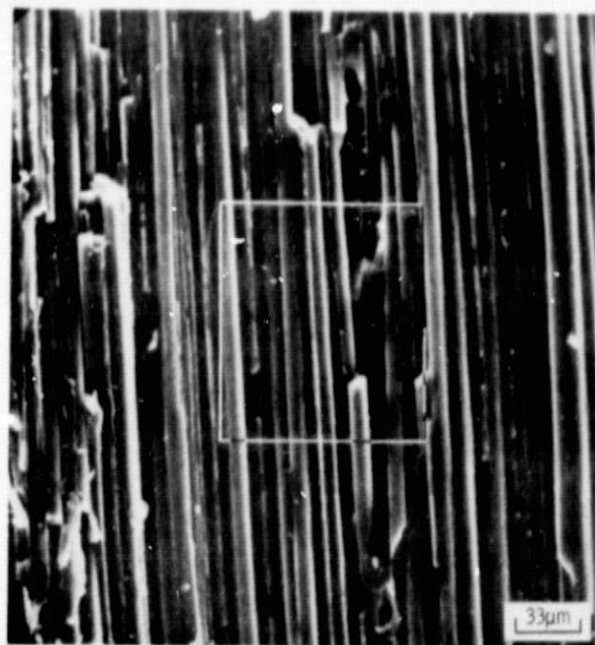
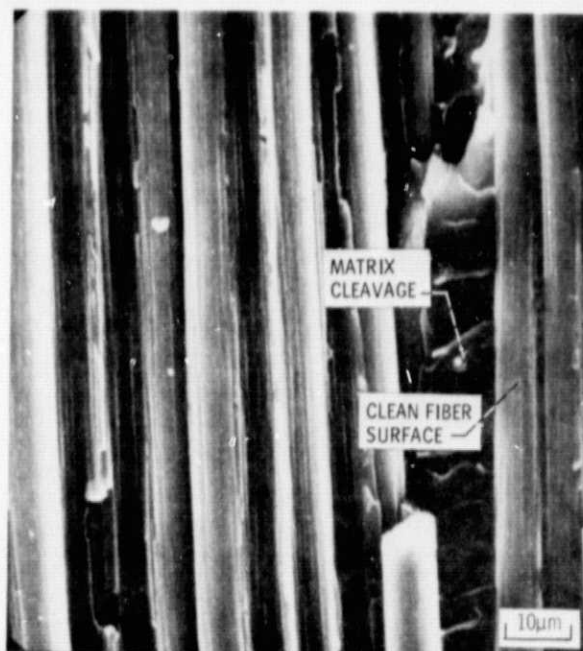
Figure 14. - Scanning electron photomicrographs of fractured surface of MOD I/Epoxy composite  $[0]_g$  tested transverse to the fiber direction.

The fracture surface of the  $90^\circ$  tensile specimen, figure 14, reveals the following features:

1. Matrix cleavage indicative of tensile fracture of brittle materials

2. Fiber surfaces free of matrix residue indicative of weak interfacial bond as was already mentioned.

The above features indicate that transverse tensile stress produces fracture surfaces characterized by: (1) matrix cleavage and (2) fiber surfaces clear of matrix residue.
