SATELLITE APPLICATIONS TO A COASTAL INLET STUDY CLEARWATER BEACH, FLORIDA

UFL/COEL-77/026

Report Submitted to City of Clearwater, Clearwater, Florida

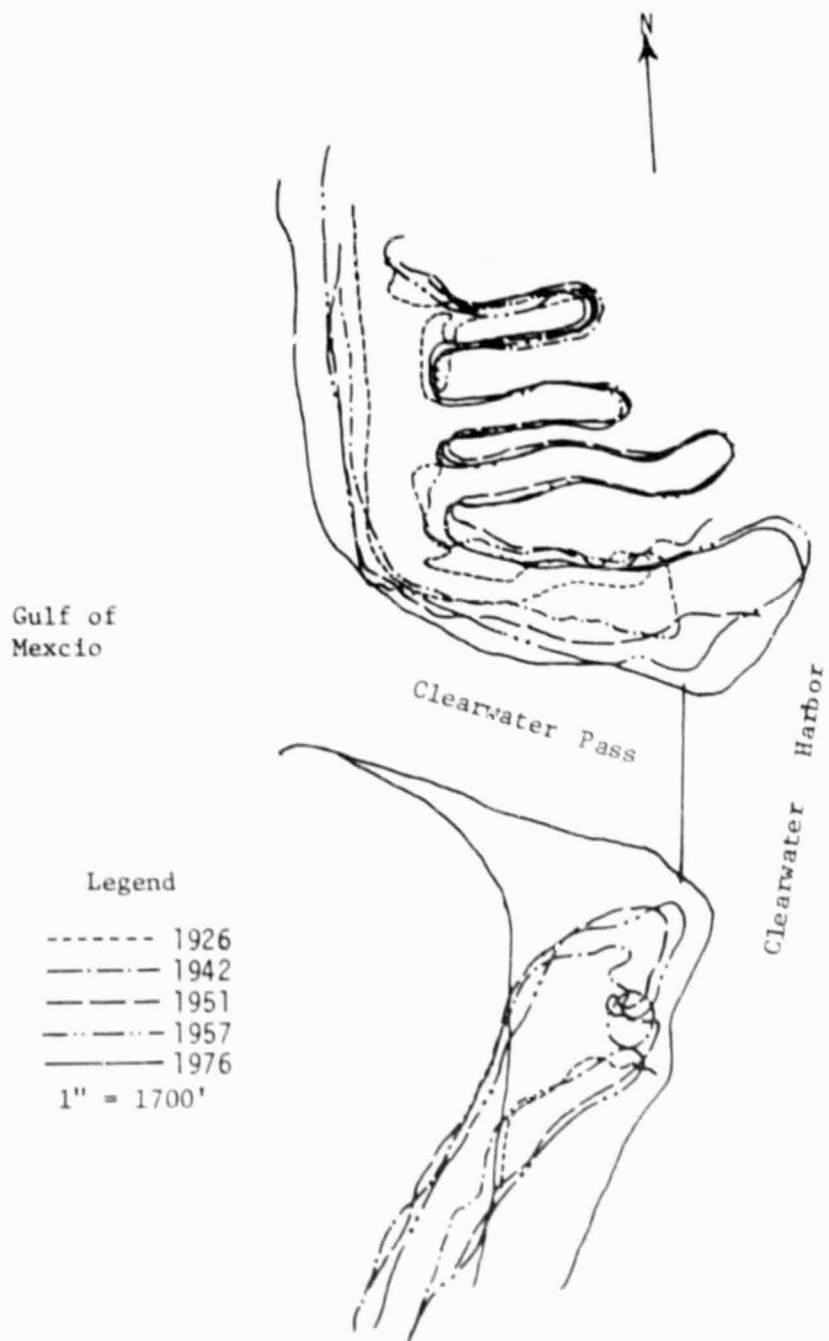
Figure 5. Superposition of Aerial Photography, 1926-1976
Clearwater, Florida

1. Historical Boundary Changes: Superposition of aerial photograph, 1926-1976, Figure 5, shows that the width of the inlet has narrowed from

approximately 4400 feet in 1926 to 3200 feet in 1942. Further decrease of the inlet width to approximately 2500 feet is noted by the year of 1951. Between 1951 and 1970, the inlet maintained its width. In the early 1970's, the northern tip of Sand Key started to accrete, further narrowing the inlet. In 1973, a jetty was constructed to stop the northward migration of Sand Key.

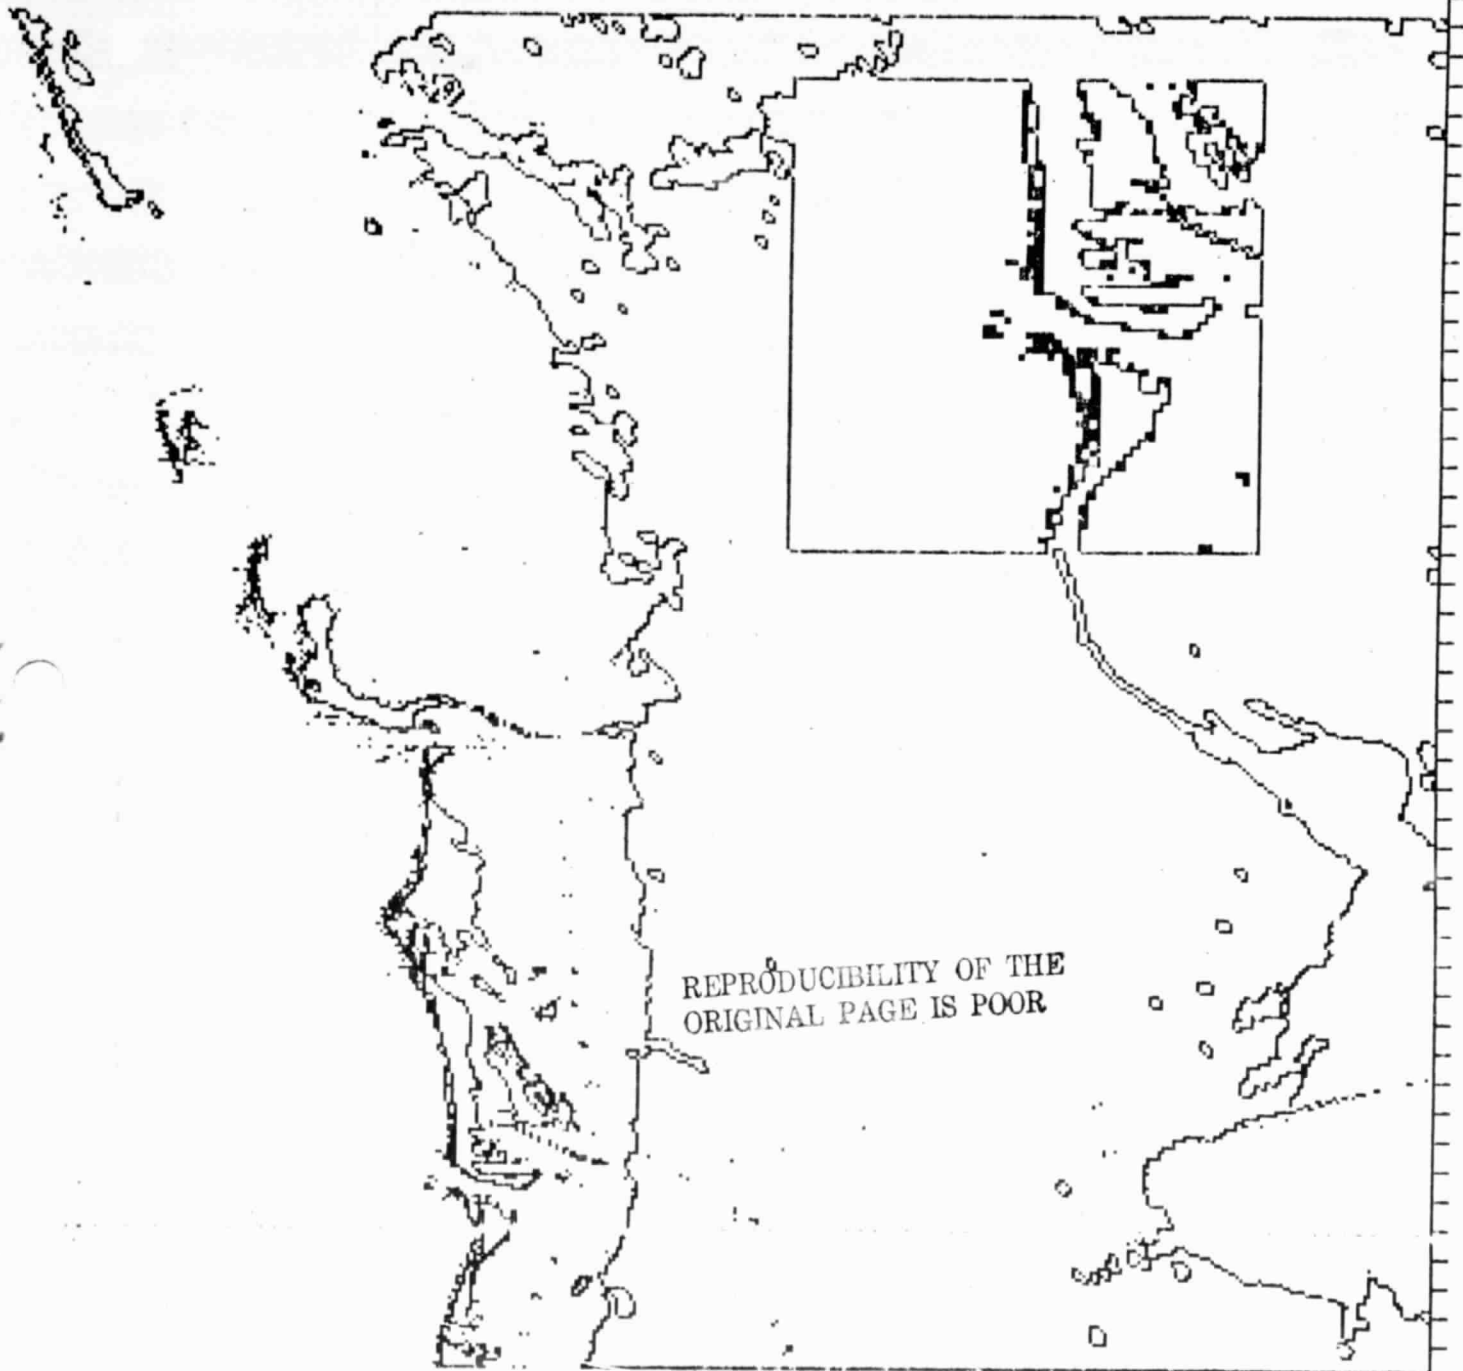
Figure 6. Golay Cluster Rendition of Extremely Shallow Area and Outer Bars

3. Location of Shoals: The outer bars and extremely shallow region, such as the bathing zone and the second bar parallel to shoreline, are identified by the shaded regions in Figure 6. These regions correspond well with the area identified on the aerial photos. The identification of the bar location at the inlet mouth has helped reveal the need for realignment of the navigational channel for the following reasons: (1) the existing dredged navigational channel turned towards the outer bar and cut through the middle of the outer bar; this means the dredged channel may be filled with sand more rapidly and therefore will require more frequent dredging, (2) the 35° turn that the channel made at the inlet mouth would create navigational hazards, since the current at the inlet mouth is strong and the wave field is variable there, particularly in bad weather, (3) since the bar location is known, the realignment of the navigation channel should be chosen in such a way that a straighter course cutting through the trough between two shoaling areas is possible.

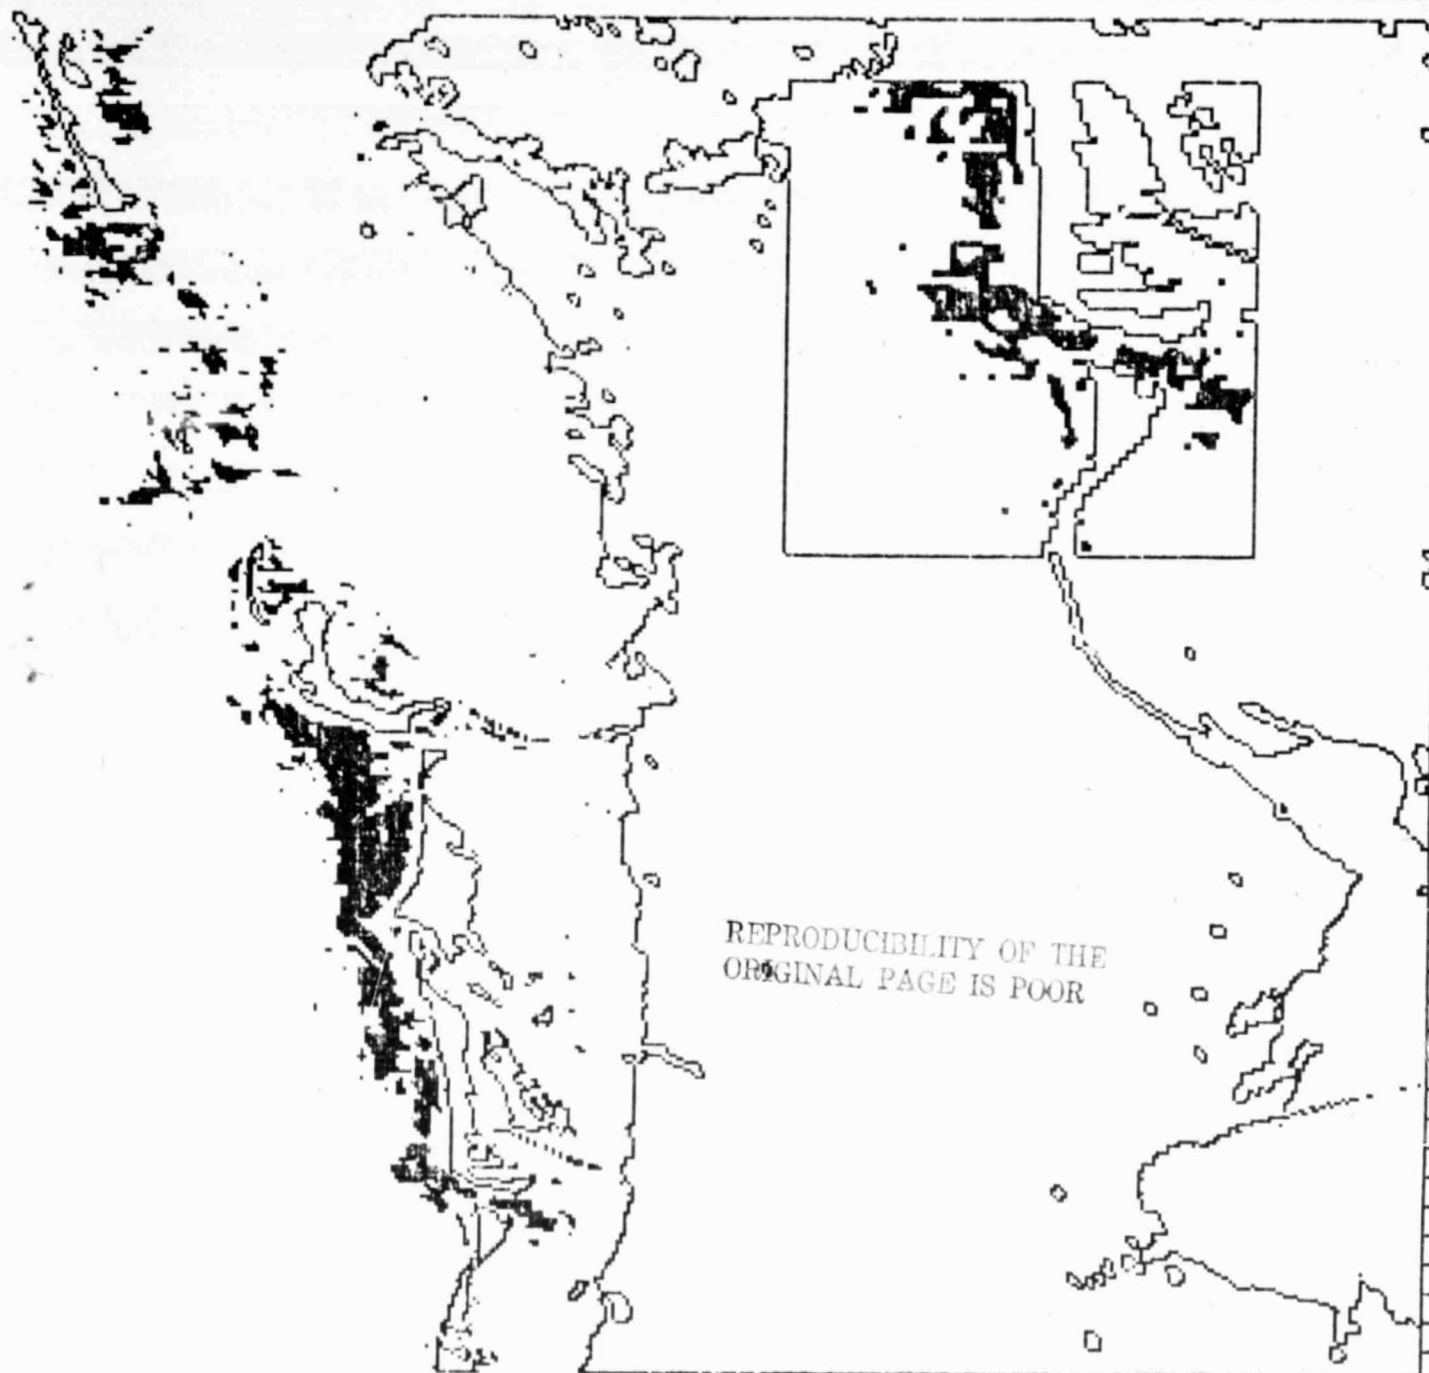
Figure 7. Golay Cluster Rendition of Areas Four to Ten Feet in Depth

The shaded regions in Figure 7 correspond to a shallow water depth area ranging between four and ten feet deep. The "empty holes" within the shaded

regions correspond to the shoals which have an approximate submerged depth of four feet or less. This helps to identify the inner bar location in the bay area. This is important with regard to the future dredging practice in connection with the inlet stability problem. (1) The inner bar region slows down the flow by increased bottom friction. As a result, the bay flow pattern is concentrated in two streams near the inlet throat. One is along the east bay shore where the bay navigational channel is maintained, the other is parallel to the west bay shore between the bridge and the toll booth, (2) this flow concentration pattern focuses its momentum on one part and is weakened in other regions of the inlet channel. Therefore it is responsible for the scouring at the bridge pier and silting along the south jetty.

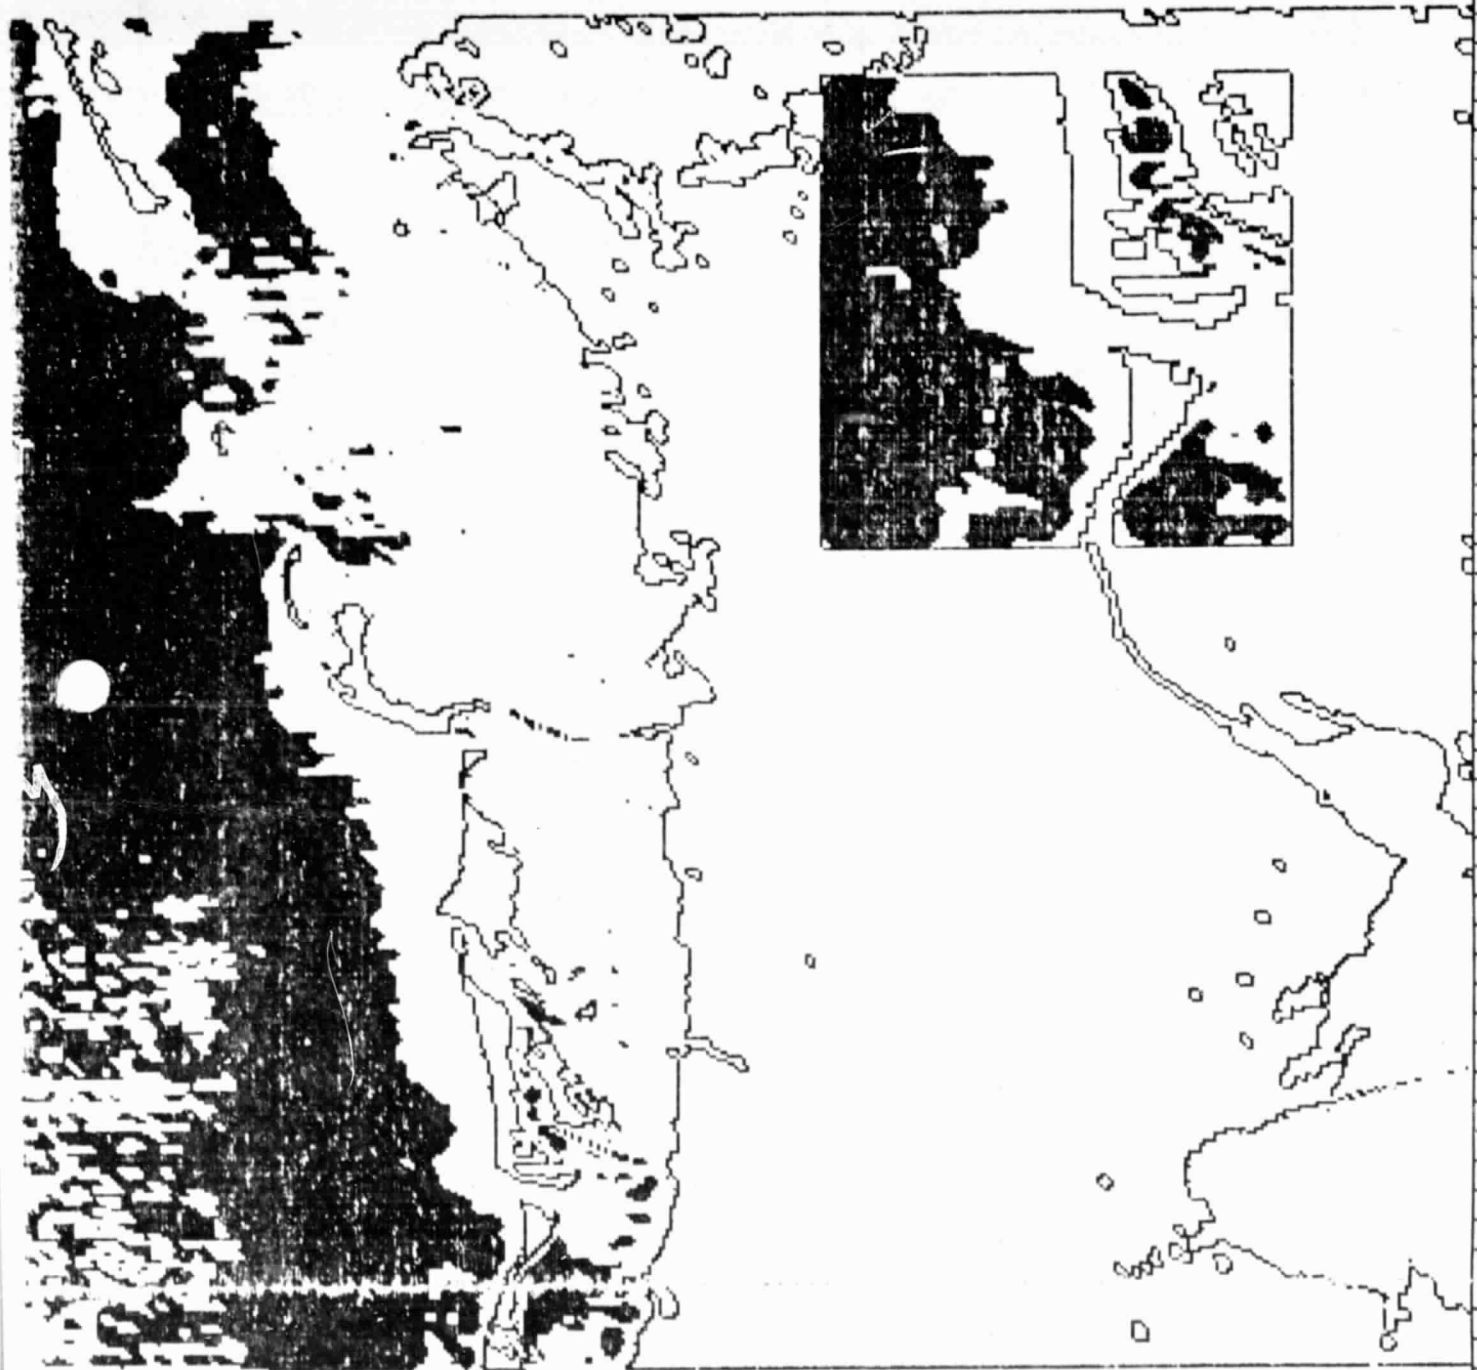
Figure 8 . Golay Cluster Rendition of Areas Greater than Ten Feet in Depth

The dark areas in Figure 8 represent the deep water region, say, approximately ten feet or deeper.

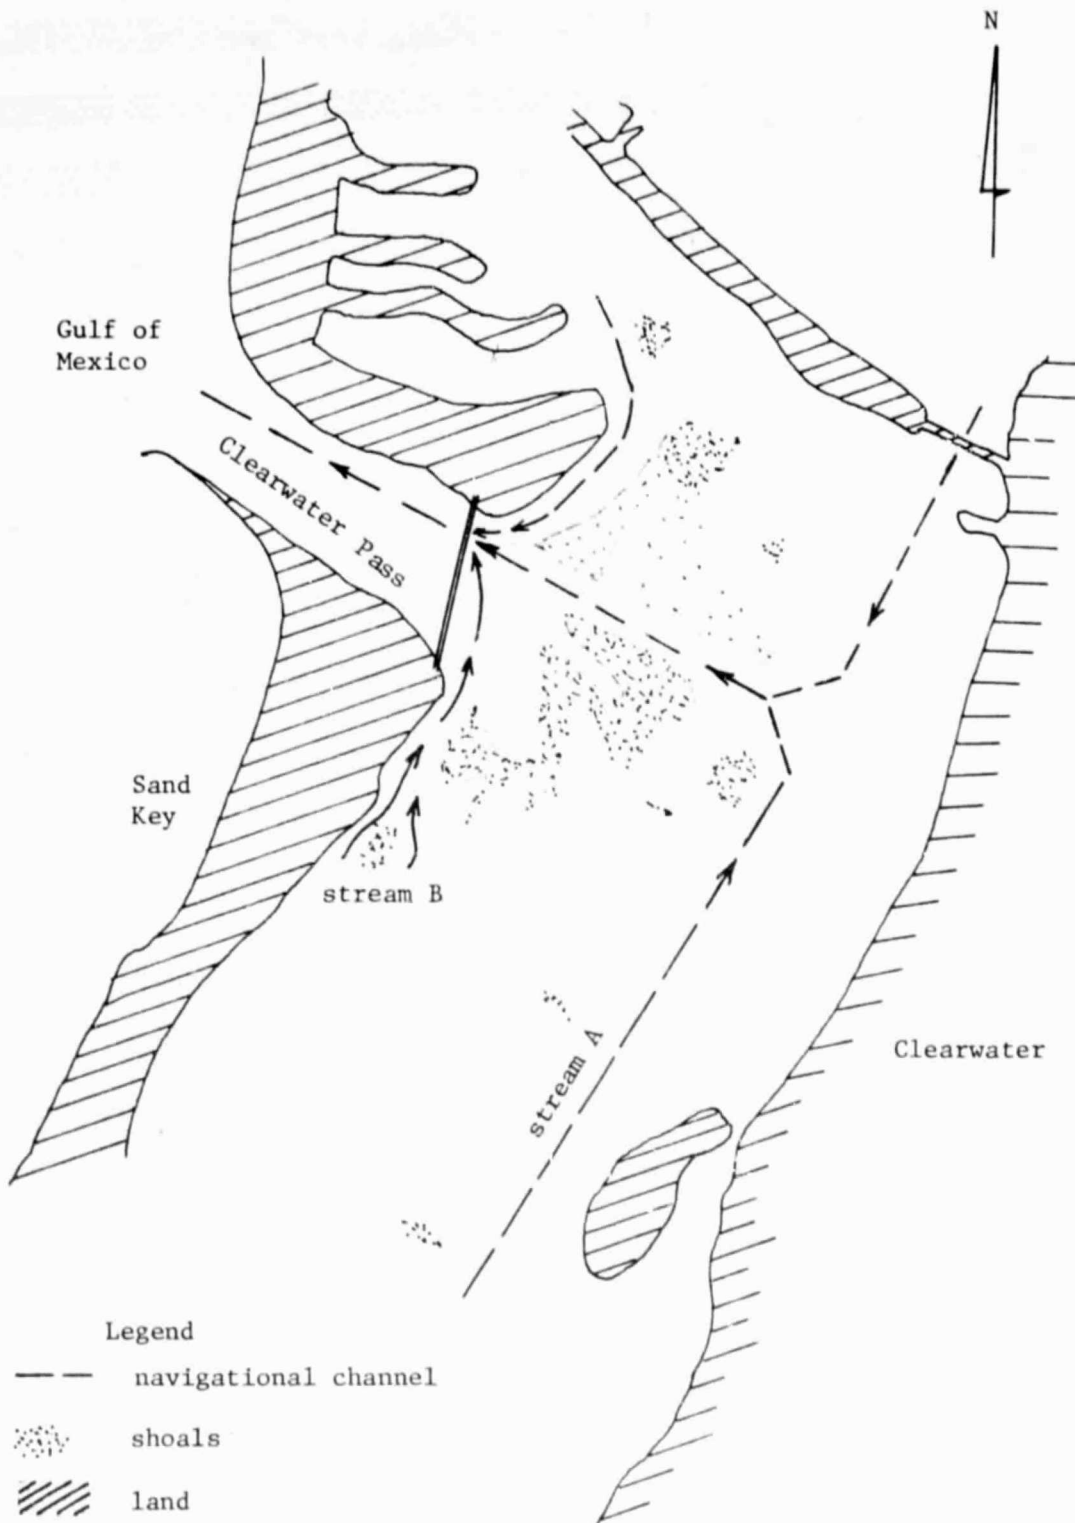
Figure 10. Inner Shoal Locations with Subsequent Stream Flow Patterns

3. The Inner and Outer Shoals: Identifying the location of the inner shoals revealed the reason why the flood/ebb flows concentrate into two major streams. Stream A (Figure 10) flows along the navigational channel parallel to the east bay shoreline; it makes a 90° turn westward to the inlet channel. The stream B is parallel to the eastern shoreline of Sand Key between the inlet bridge and the toll booth. The two streams merge at the deep portion of the inlet channel.

Suppose the inlet channel is dredged to a uniform depth across its entire width, then, the existing concentrated flow patterns of streams A and B would have the tendency to restore the dredged inlet cross section to the present configuration. That is to say, a narrow and deep channel along the north bank, and accretion and silting along the south jetty would occur. As a result, scouring of bridge pier in the deep channel section would take place with potential erosion along the north bank, particularly, along the west end of the north bank where the strong ebb current exists. Silting along the south jetty would further narrow and deepen the inlet channel close to the north bank. The idea of dredging the inlet channel to a uniform depth to eliminate the flow concentration in one area and silting in another area will be significantly weakened if the inner shoals remain at their present identified locations.

2. The inner shoals should also be dredged when the dredging operation of the inlet is undertaken. Dredging of the inner shoals would smooth out the concentrated flow pattern in the bay, if the uniform inlet outflow produced by inlet dredging could be enhanced and maintained. Otherwise, the existing flow concentration pattern will have a tendency to restore the inlet cross section to its present configuration, i.e., scouring and deepening near the north bank, and silting and accretion along the south jetty.
