NASA Technical Memorandum 81903

STRUCTURAL TESTS ON SPACE SHUTTLE THERMAL PROTECTION
SYSTEM CONSTRUCTED WITH NONDENSIFIED AND DENSIFIED
LI 900 AND LI 2200 TILE

January 1981

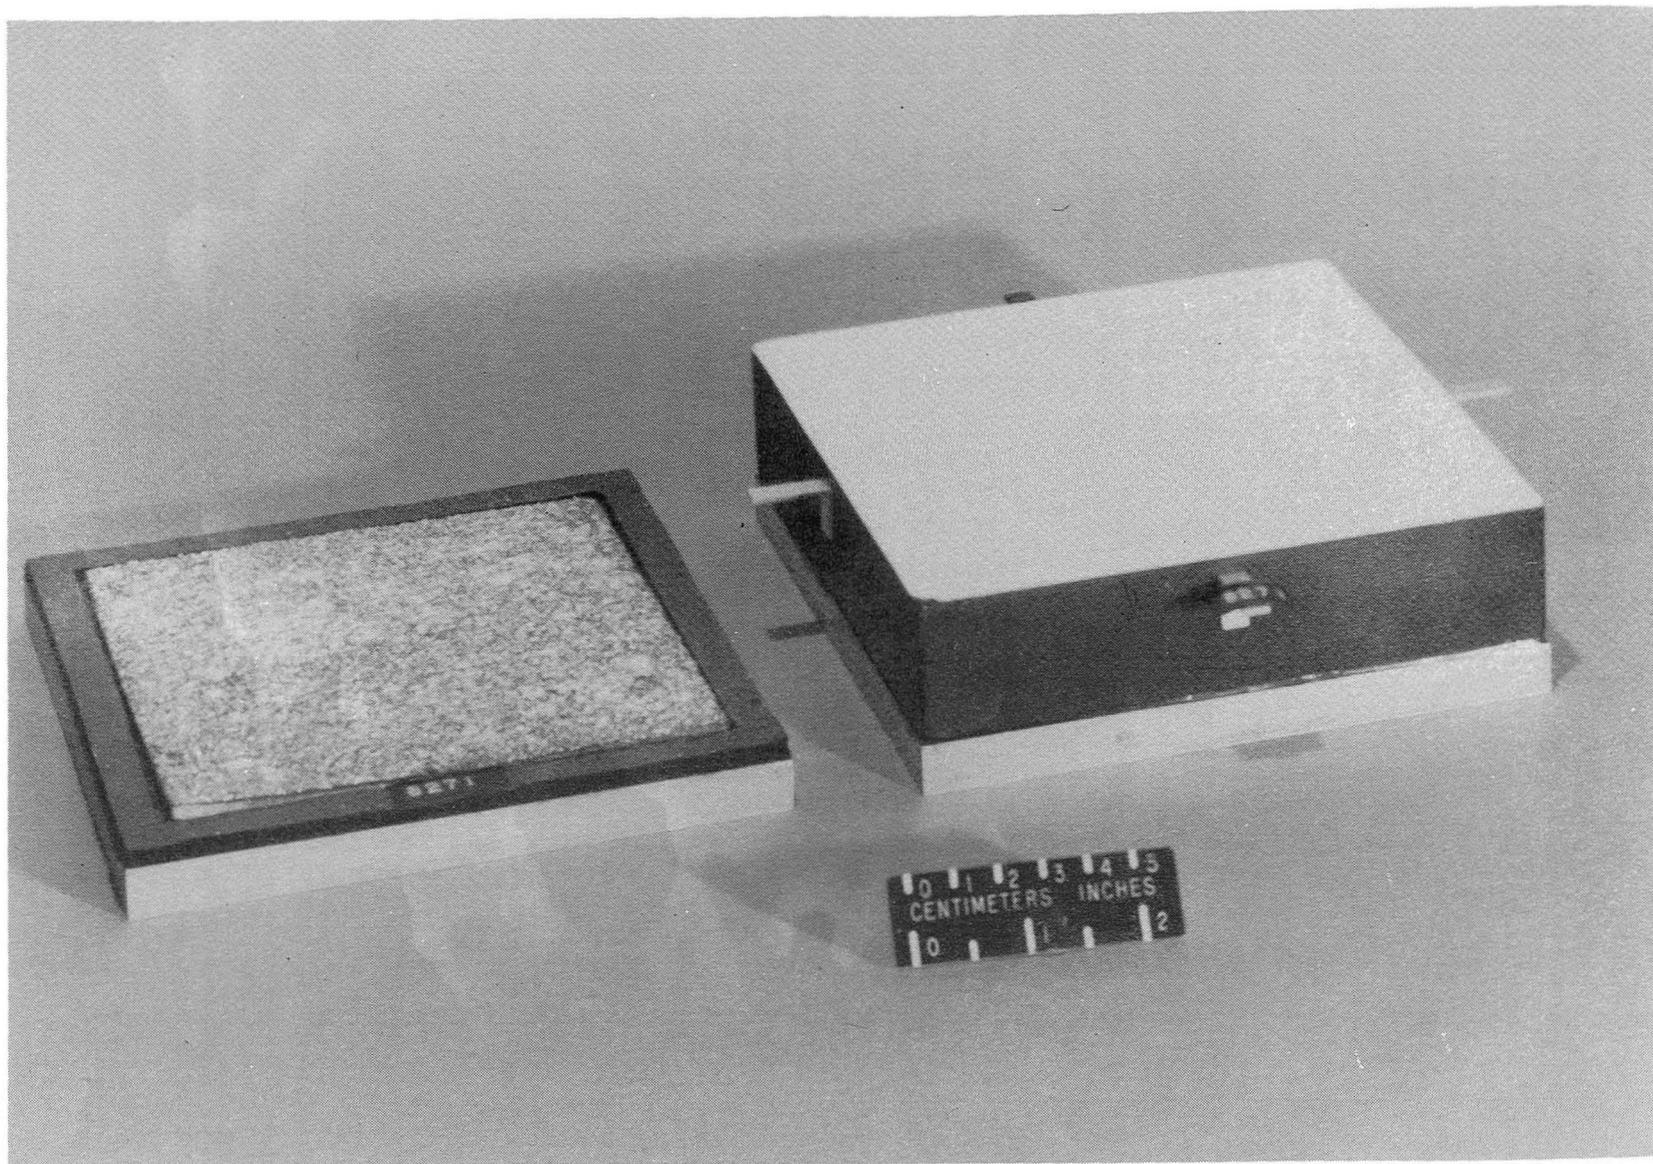
No significant differences in results were observed between specimens in which load was introduced through a metal plate bonded to the tile top surface and in which load was imposed by reducing the pressure on the top surface of the tile. The typical failure mode for LI 900 specimens loaded in tension is illustrated in Figure 10. The failure occurred in the bond between the tile and the SIP in which small particles of the tile remain distributed over the silicone rubber surface. The tile thickness of one specimen loaded through pressure was only 0.97 cm (0.38 in.). This specimen at failure carried an average stress of 84.1 kPa (12.2 PSI). Failure for the 0.97 cm (0.38 in.)-thick tile loaded by pressure initiated at one corner in the typical peel mode

Figure 10. - Typical failure mode for LI 900 specimens.

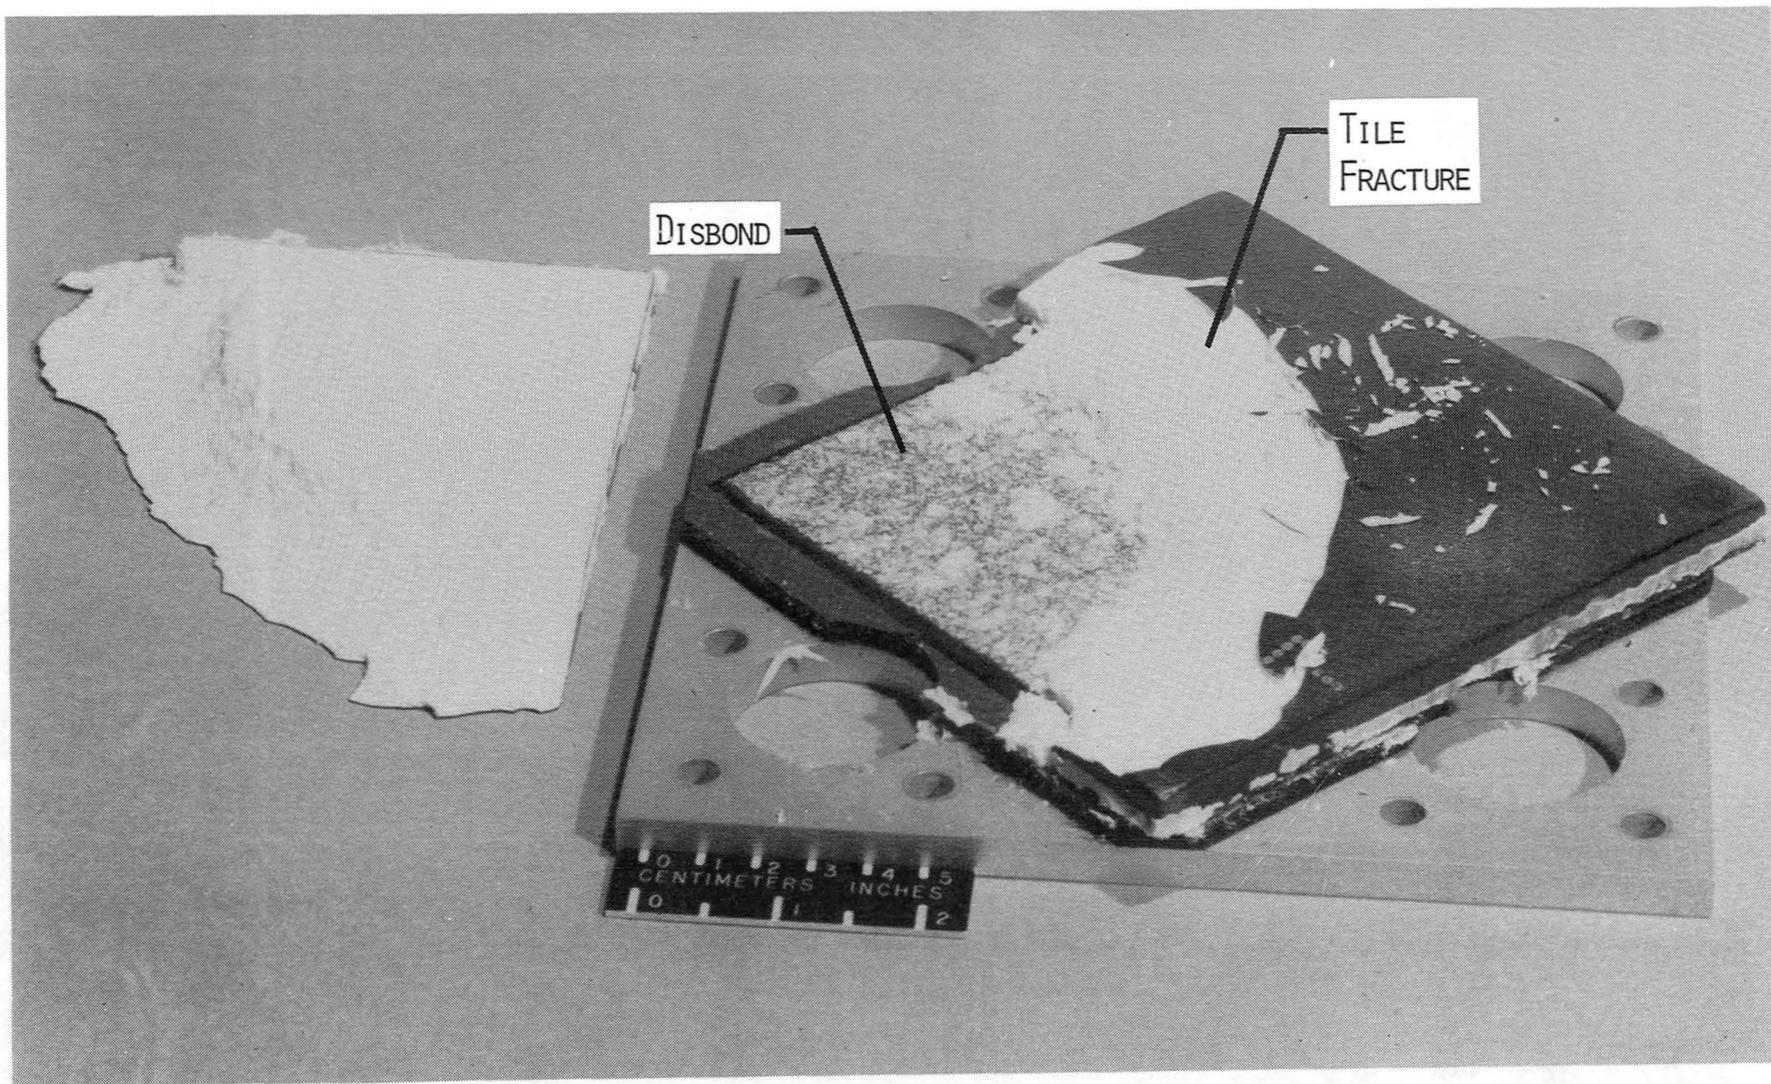
and propagated until the bending stresses on the thin tile were sufficient to cause the tile to fracture in the manner shown in Figure 11.

Figure 11. - Thin tile fracture following peel disbond at one corner.

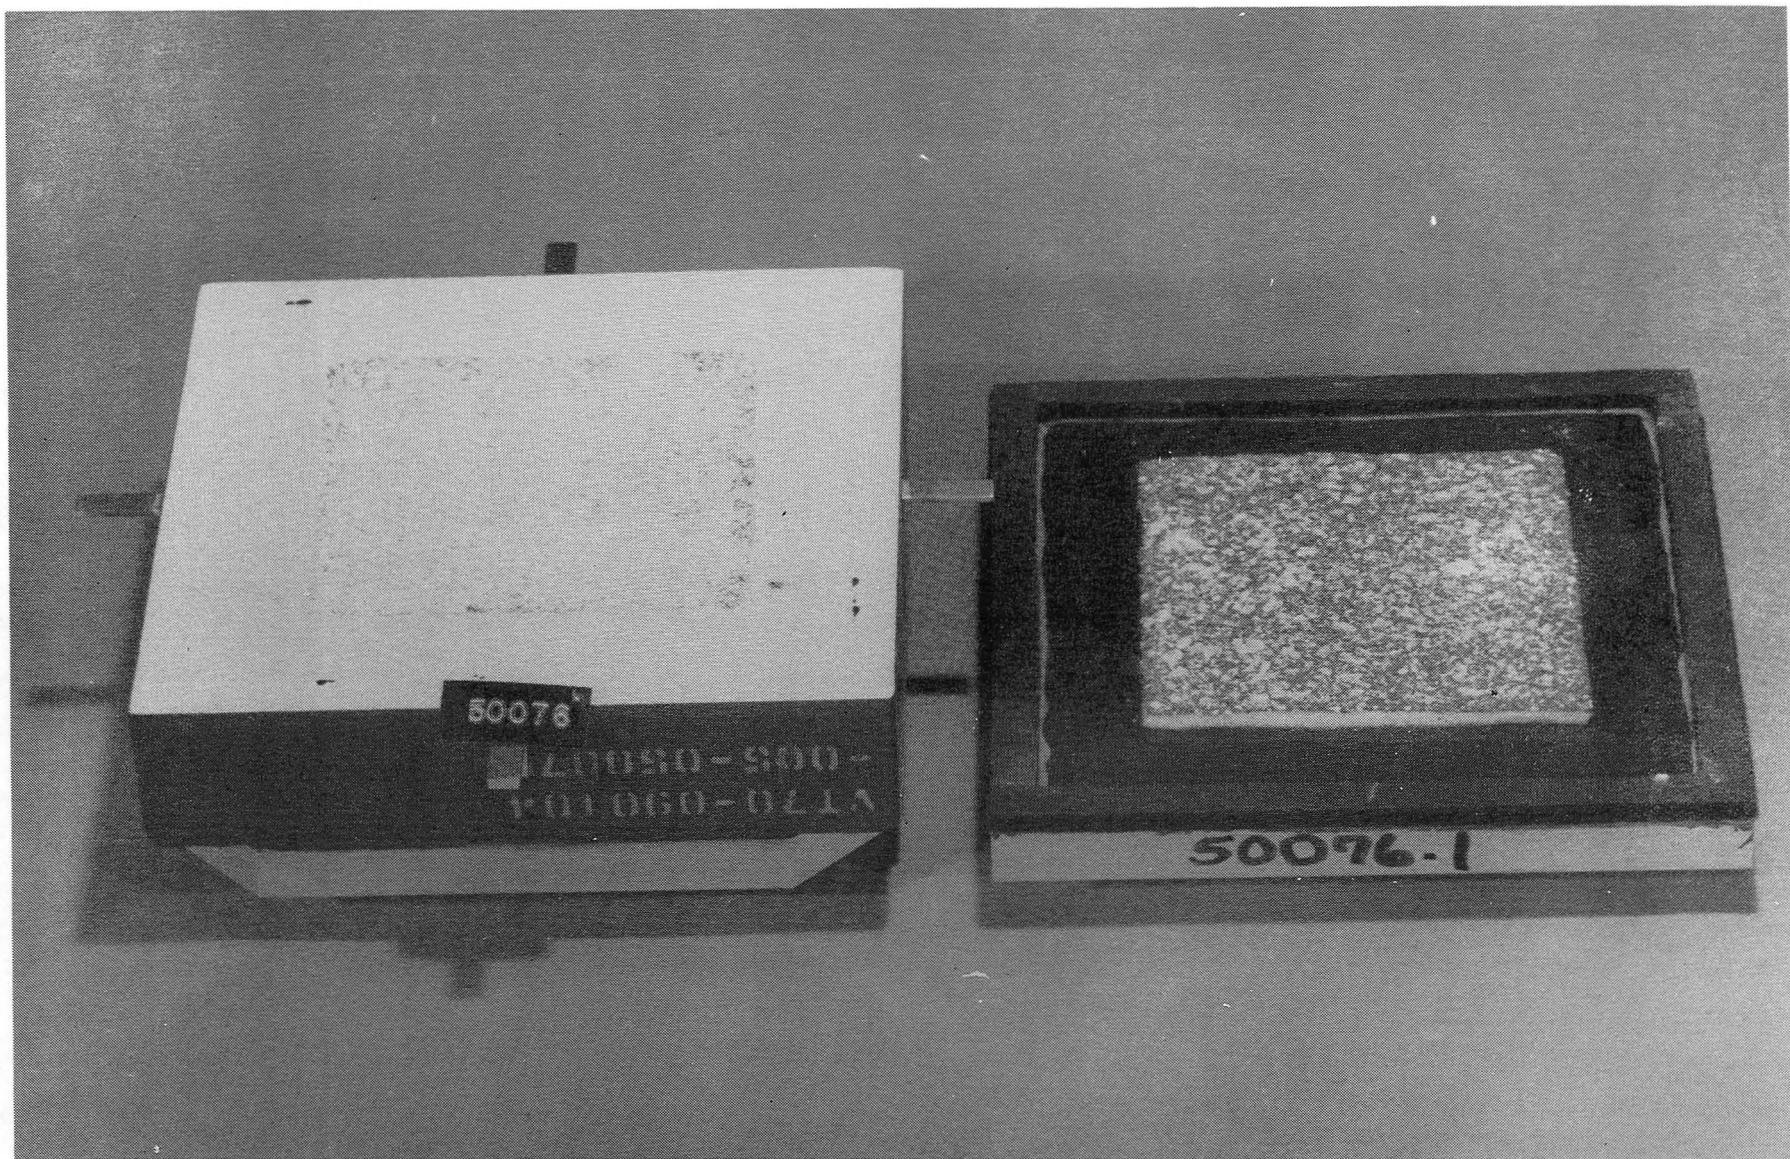
A set of tension tests were also conducted in which the SIP size was varied. These tests designed to address the effect bond area has on the specimen failure stress had SIP area ranging from 161 cm^2 (25 in^2) to 40.3 cm^3 (6.25 in^3). Results are listed in Table II. For the range of sizes considered, reducing the SIP area did not significantly change the average stress at failure. The failure mode was also unchanged as seen by comparing the failure surface for one of the reduced SIP area specimens (Figure 12) with that for the 161 cm^2 (25 in^2) SIP (Figure 10).

Figure 12. - Failure surface of LI 900 tile with reduced SIP area.

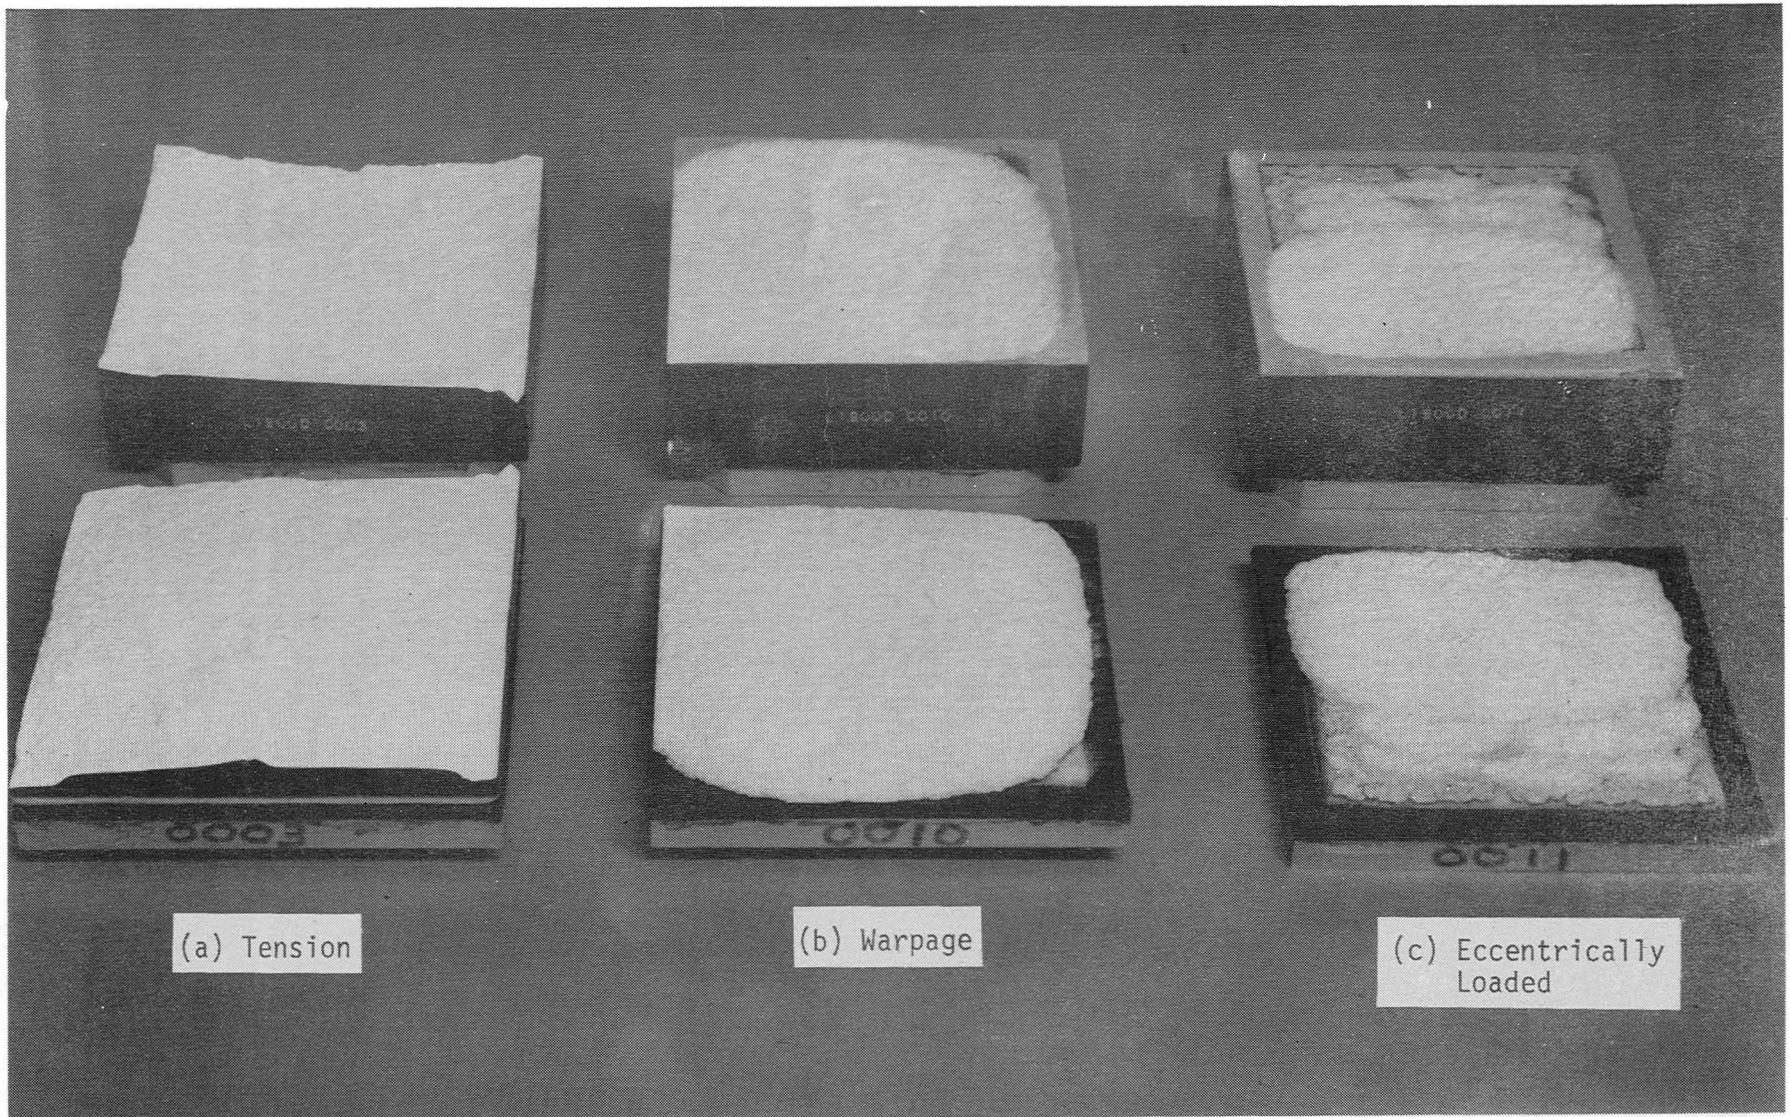
LI 900-Densified - The average SIP stress at failure was 179 kPa (25.9 PSI) for one LI 900-densified specimen loaded in tension and 171 kPa (24.8 kPa) for one specimen with a 2.29 m (90 in.) radius spherical imperfection mismatch. Beyond the 27.6 kPa (4 PSI) stress level, tension stress as a function of tile displacement response is almost linear as shown in Figure 7. Failure occurred totally within the tile above the densified region as shown in Figure 13.

LI 900-Densified - The displacement response for an LI 900-densified specimen loaded in tension with a 3.18 cm (1.25 in.) load eccentricity is presented in Figure 21. The load at failure was 1.67 kPa (375 lb.). A photograph of the failure surface is presented in Figure 13. Failure was by instantaneous fracture of the tile in which a cavity developed on the half of the tile loaded by maximum tension.

Figure 13. - Typical failure modes for LI 900-densified specimens.

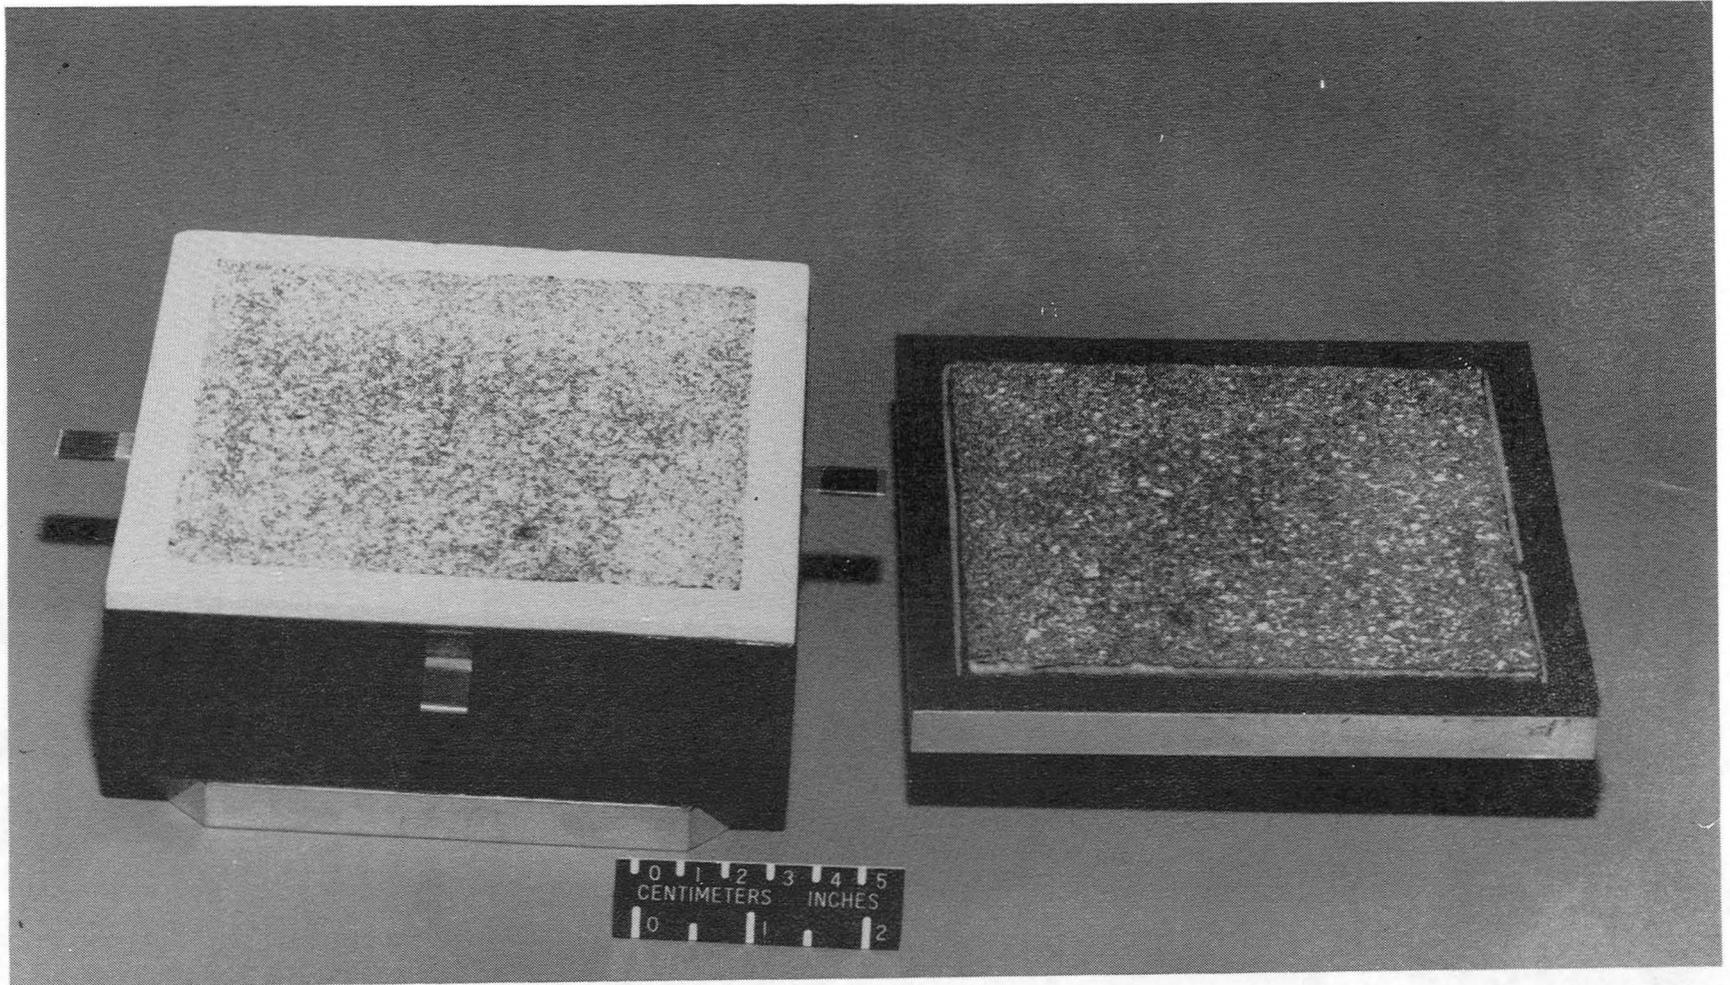
LI 2200 - The average SIP stress at failure was 170 kPa (24.6 PSI) and 175 kPa (25.4 PSI) for two LI 2200 tension specimens and 136 kPa (19.7 PSI) for one specimen with a 2.29 m (90 in.) radius spherical imperfection mismatch. The stress versus displacement response for the mismatch specimen plots between the response for the two tension specimens (Figure 8). The failure mode for LI 2200 specimens involved peel separation at the tile/SIP bond surface similar to that experienced by LI 900 specimens as illustrated in Figure 14.

Figure 14. - Typical failure mode for LI 2200 specimens.

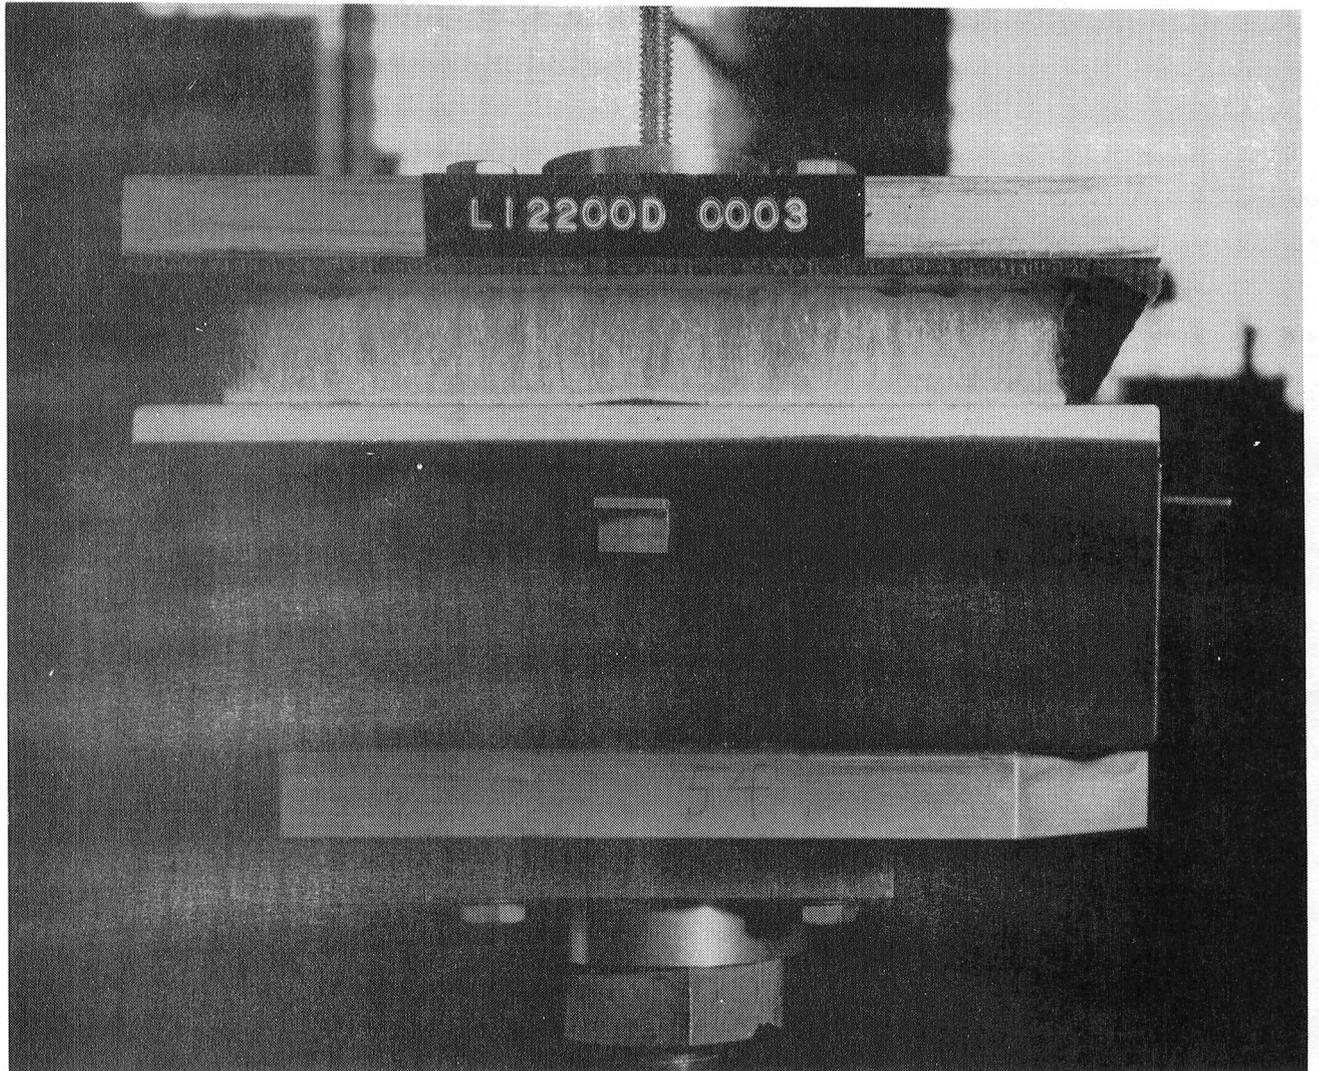
mismatch. The stress versus displacement response curves are highly nonlinear especially near the ultimate load (Figure 9). This response is related to the mode of failure illustrated by the photograph in Figure 15. As the specimen load approached the ultimate, the SIP fibers adjacent to the aluminum plate experienced large deformations leaving most of the SIP attached to the tile.

Figure 15. - Typical failure mode for LI 2200-densified specimens.

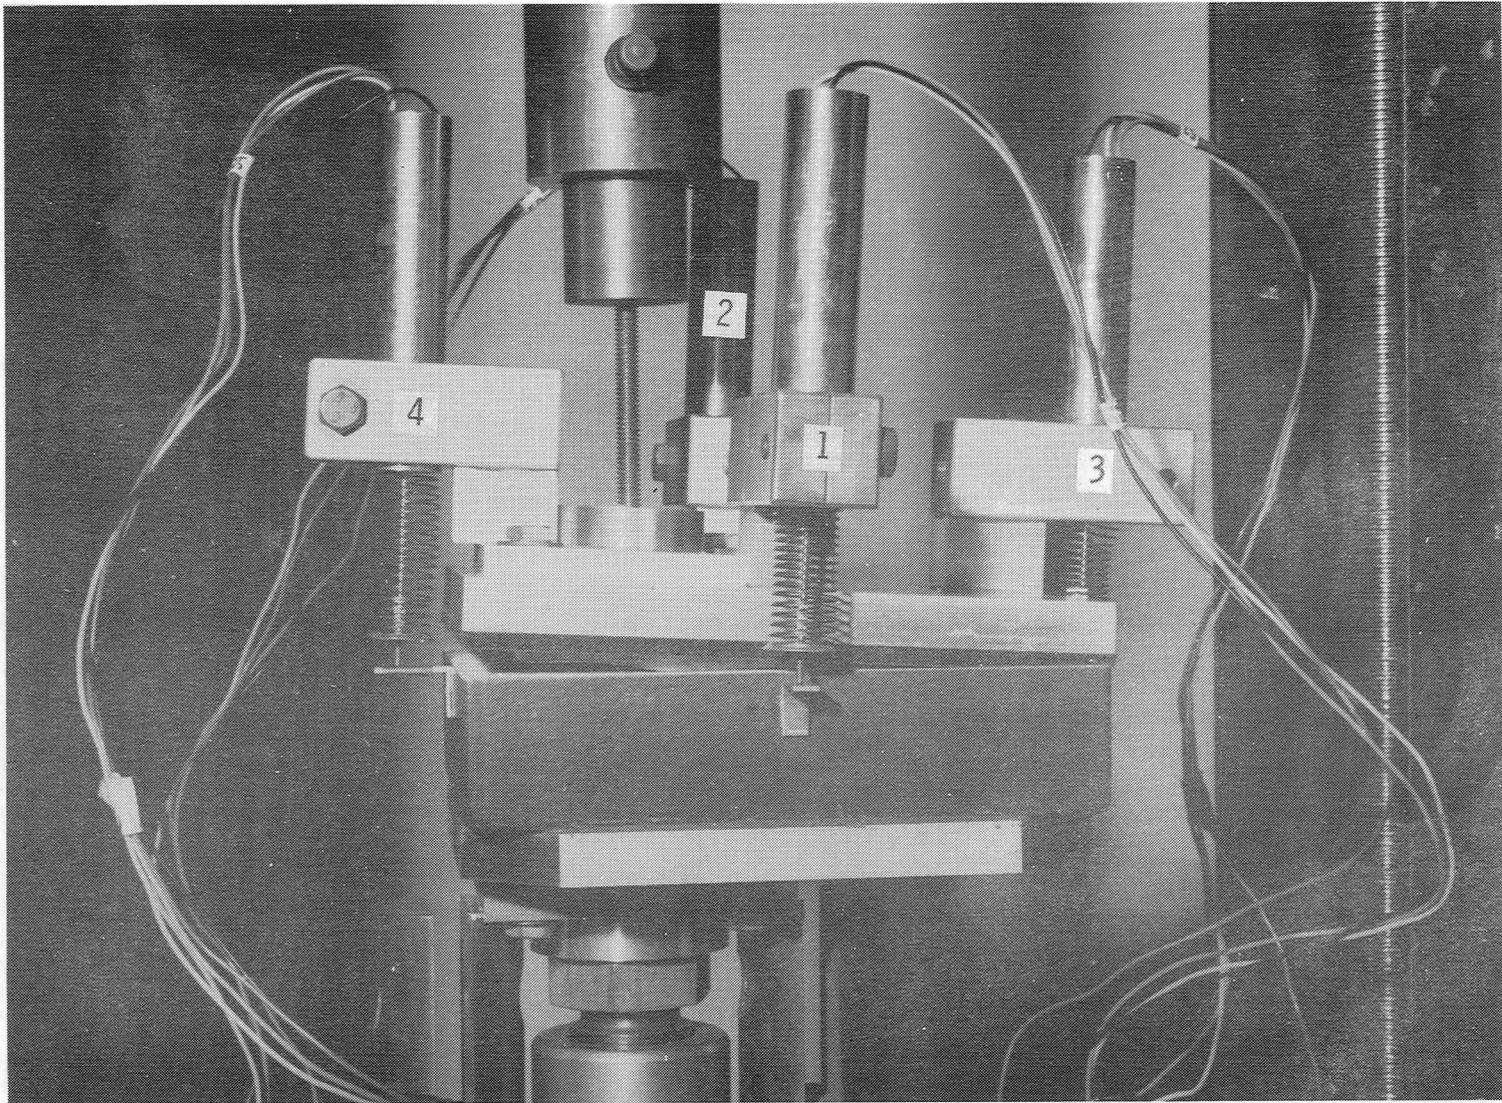
Failure for eccentrically loaded LI 900 specimens initiated in the region of maximum tensile stress and propagated by peeling of the tile-SIP interface until complete separation resulted. A photograph showing the rotation of the plate and disbond failure of the SIP to tile in this region is presented in Figure 19. The appearance of the failure surface was similar to that observed

Figure 19. - Photograph illustrating tile rotation and failure in region of maximum stress under eccentrically applied tension loading. LI 900 specimen.

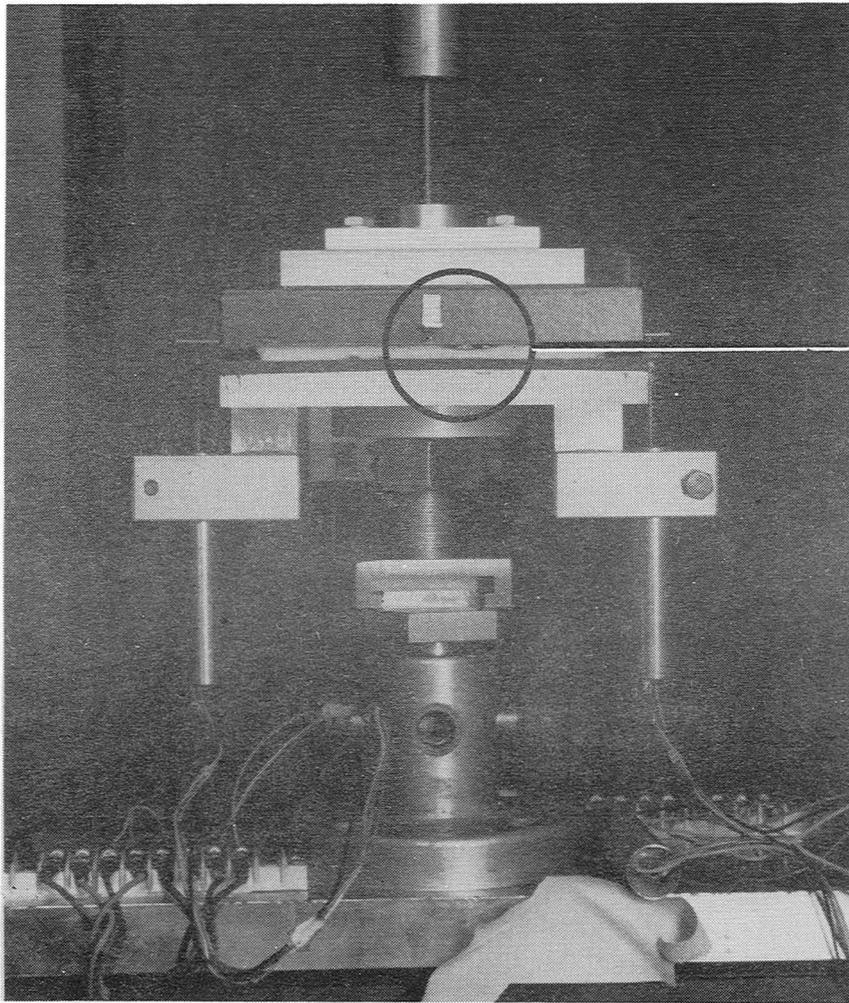
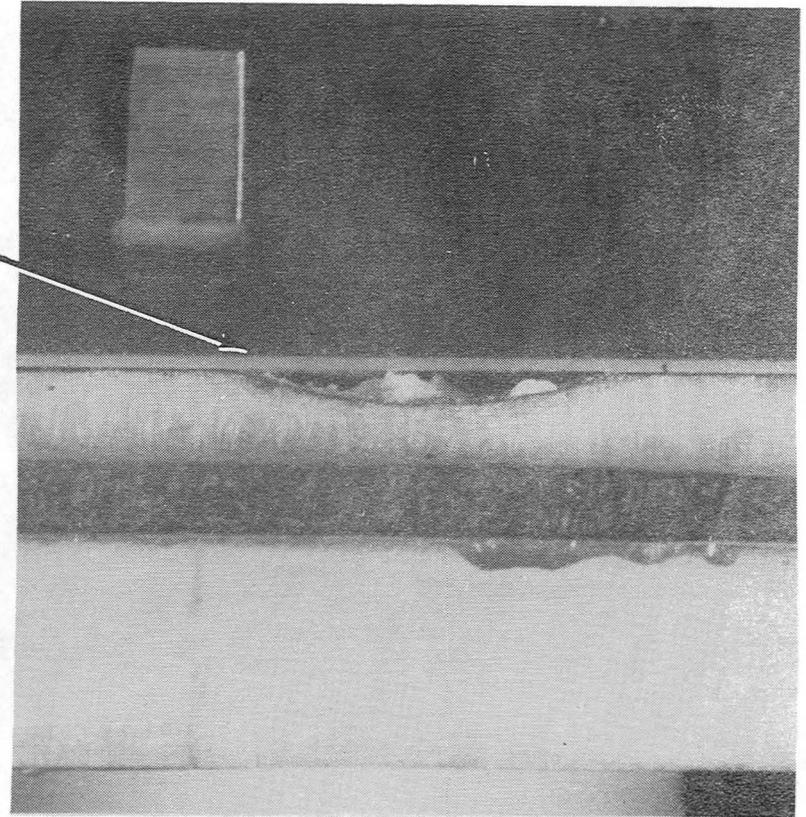
for pure tension tests. Failure for specimens with mismatch and load eccentricity occurred initially near the center of the edge of maximum tension as illustrated in Figure 20 rather than at the corners of this edge where the maximum warpage displacement amplitude occurs.

Figure 20. - LI 900 specimen with warpage showing initiation of failure near the center of the edge of maximum tension.
