DOE/JPL
Distribution Category UC-63
Report #7

EBIC AND HVTEM STUDIES OF RTR SILICON RIBBON

April 1981

B. Cunningham, H. Strunk* and D. Ast

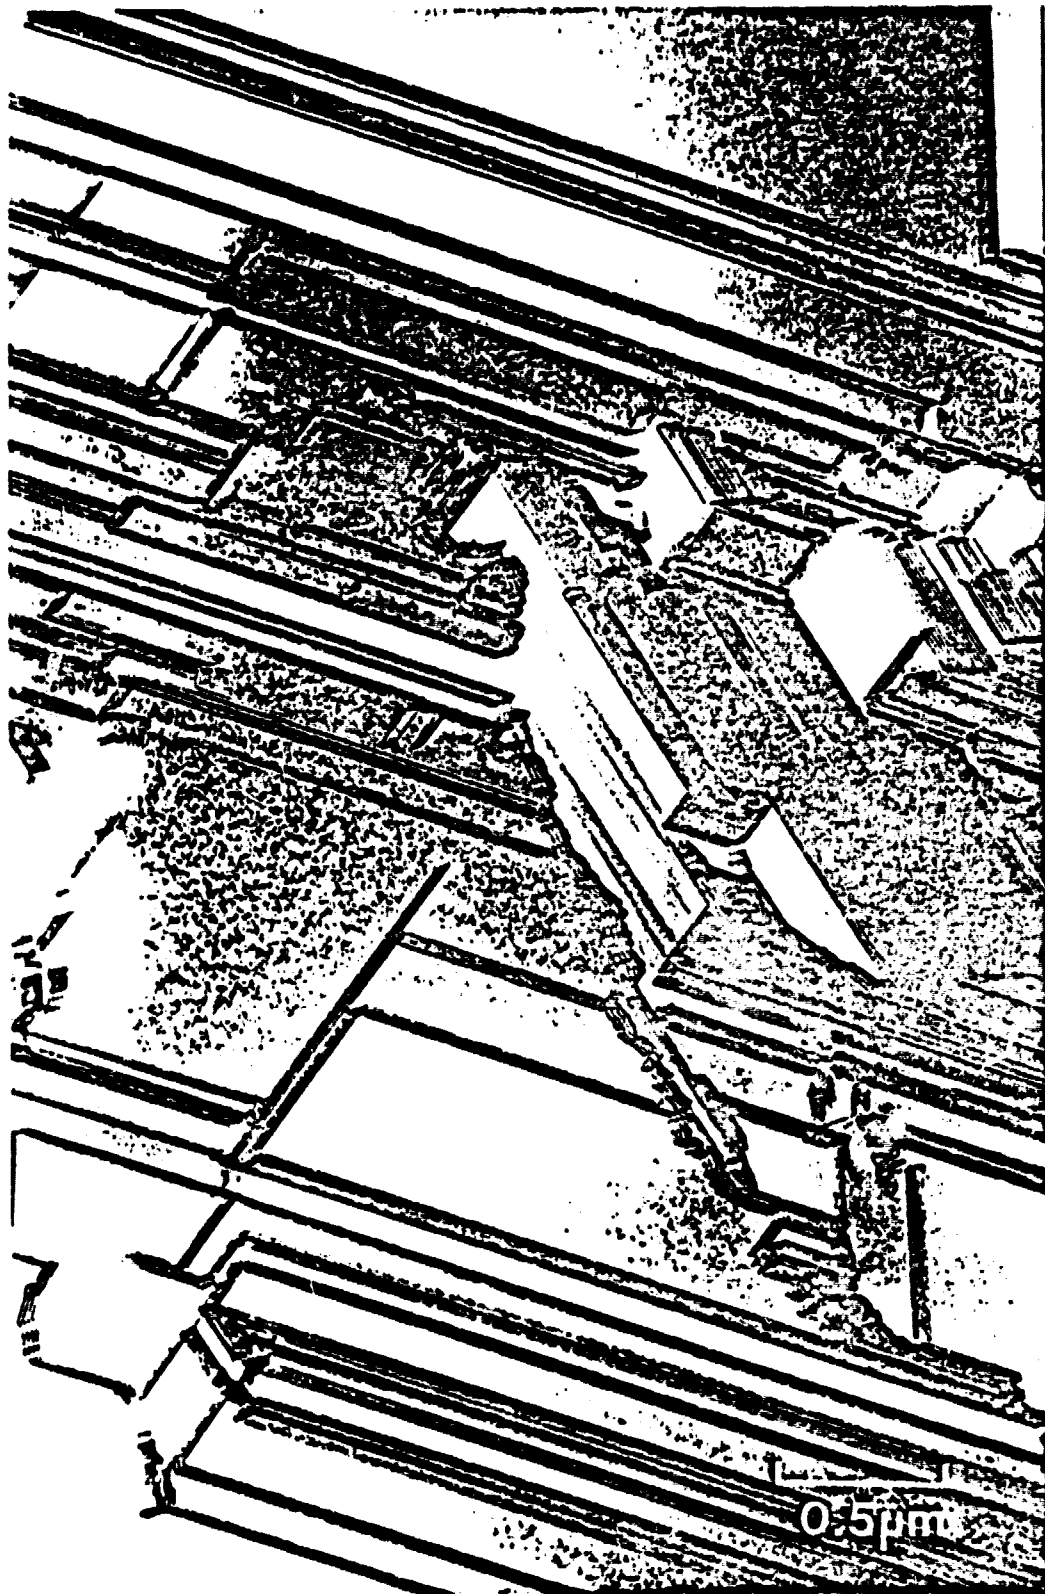
Figure 1 shows a typical micrograph of the CVD silicon substrate. A large number of closely spaced twin and grain boundaries is observed but only a few lattice dislocations. The most significant observation is the absence of precipitates. The polycrystalline silicon is deposited on a molybdenum substrate which is known to introduce large quantities of Mo into the silicon /4/. This effect should be pronounced in the material used in the present study since no SiO_2 or Si_3N_4 diffusion barrier was used between the Mo substrate and the silicon.

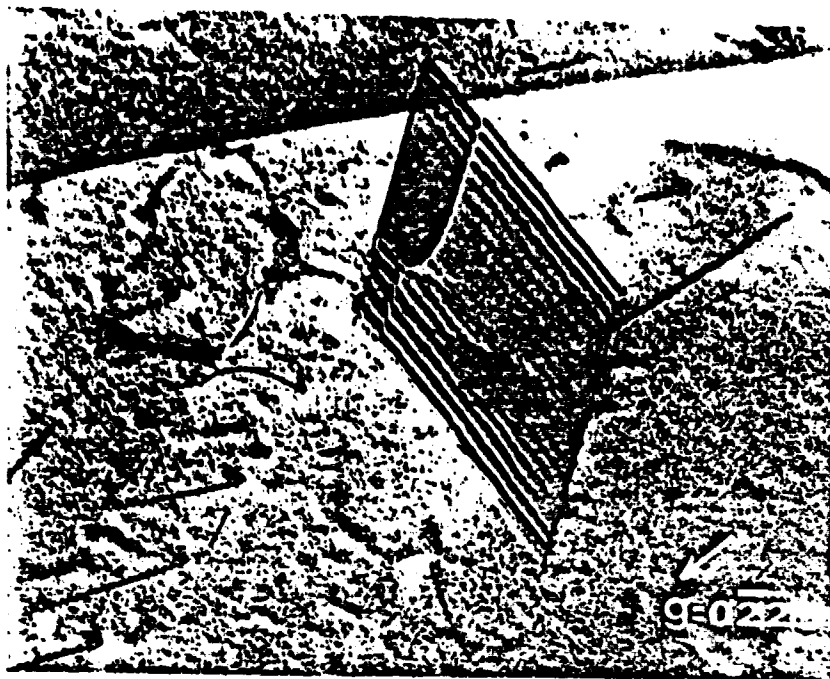
Figure 6 shows HVTEM micrographs of stacking faults connecting the two twin boundaries. The stacking faults are out of contrast in Figure 6(b) and the bounding dislocations can be seen. Although the overlapping fringes from the two faults makes it difficult to determine their nature it seems likely that one is intrinsic and one extrinsic. This arrangement preserves the stacking sequence on either side of the faults. Figure 7 is an EBIC micrograph of "pairs" of active defects along the twin boundary imaged in Figure 6. In view of the HVTEM results we propose that the "pairing" is caused by stacking faults between the twin planes and that the contrast is due to the active partials which bound these stacking faults.
