INTERNAL HYSTERESIS EXPERIENCED ON A HIGH

PRESSURE SYN GAS COMPRESSOR

F. Y. Zeidan Qatar Fertiliser Company Umm Said, Qatar

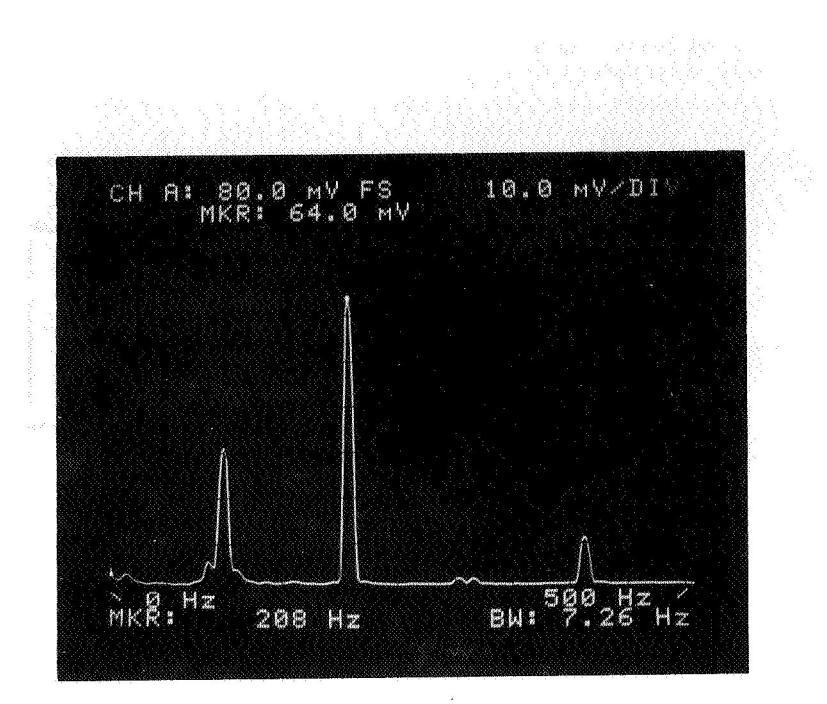
Figure 3. - High-pressure compressor 3101; location, A-II compressor house; date, 28/4/1981; 8 V; 50 mV rms/div.; 200 mV/mi1; frequency range, 0-500 Hz.

The normal vibration spectrum for the rotor obtained after an overhaul always contained a subsynchronous component approximately equal to 50% of the running speed frequency. As seen in figure 3 it was bounded, and the synchronous component due to residual unbalance was the dominant component in the baseline spectrum. Figure 4 shows the unfiltered orbit which agrees with the information designated by spectrum analysis, where the subsynchronous component forms an internal loop and is smaller in magnitude compared to the synchronous component. However, after being in service for some time, we always noted an increase in vibration. Figure 5 shows a spectrum of the same rotor taken 7 months later where the subsynchronous component became the dominant frequency. The orbit analysis also confirmed this fact. As noted in figures 4 and 6, the subsynchronous component has increased and predominates the total motion masking the effect of unbalance. Gunter (ref. 2) describes investigations which produced results similar to what we have experienced.

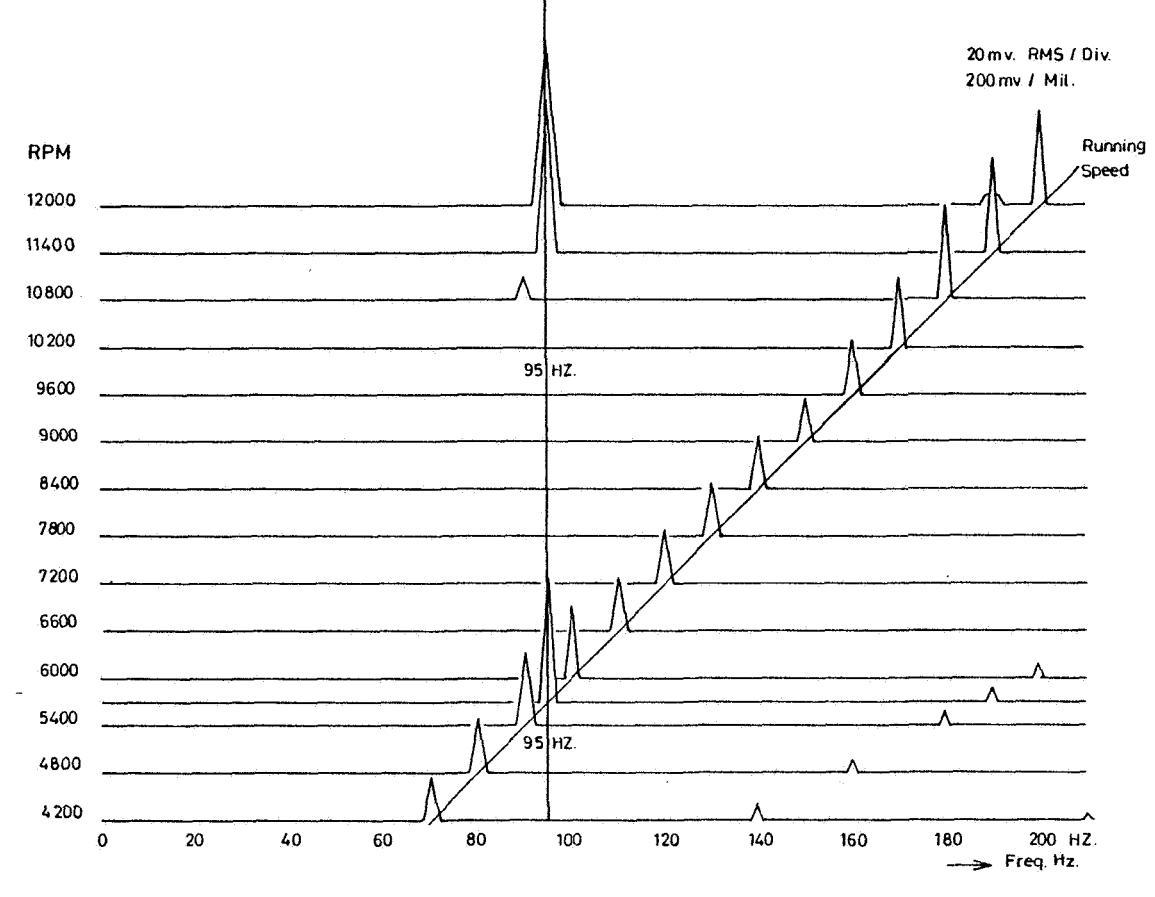
Figure 7. - High-pressure compressor runup.

Through the use of a tape recorder, transient data were obtained and further confirmed our previous findings. Figure 7 shows the run-up data of a newly overhauled rotor that was installed during an annual turnaround. At a speed of 5700 rpm (95 HZ), we noted a peak in amplitude of the synchronous component indicating the critical speed of the rotor. The synchronous component continued to be the only apparent signature until the rotor crossed the threshold speed and a subsynchronous component appeared at exactly 50% of running speed frequency. The subsynchronous component traced the running speed frequency until it reached the critical speed frequency and locked on it. At this point, changes in the running speed did not affect the instability which remained locked on to the rotor's first critical speed.

This verification eliminated the possibility of oil whirl in the seals as being the exciting force, since the seals were also replaced during the annual turnaround and could not have been locked-up at this stage. We have had the seals lock-up after several months of operation, and noticed that the vibration characteristics in such a case are quite distinct from what we witnessed here. Fig. 8 shows a frequency spectrum display of the rotor with a subharmonic component at 72 HZ which amounts to about 40% of running speed frequency. This was the result of the seals locking-up and acting as a sleeve bearing.

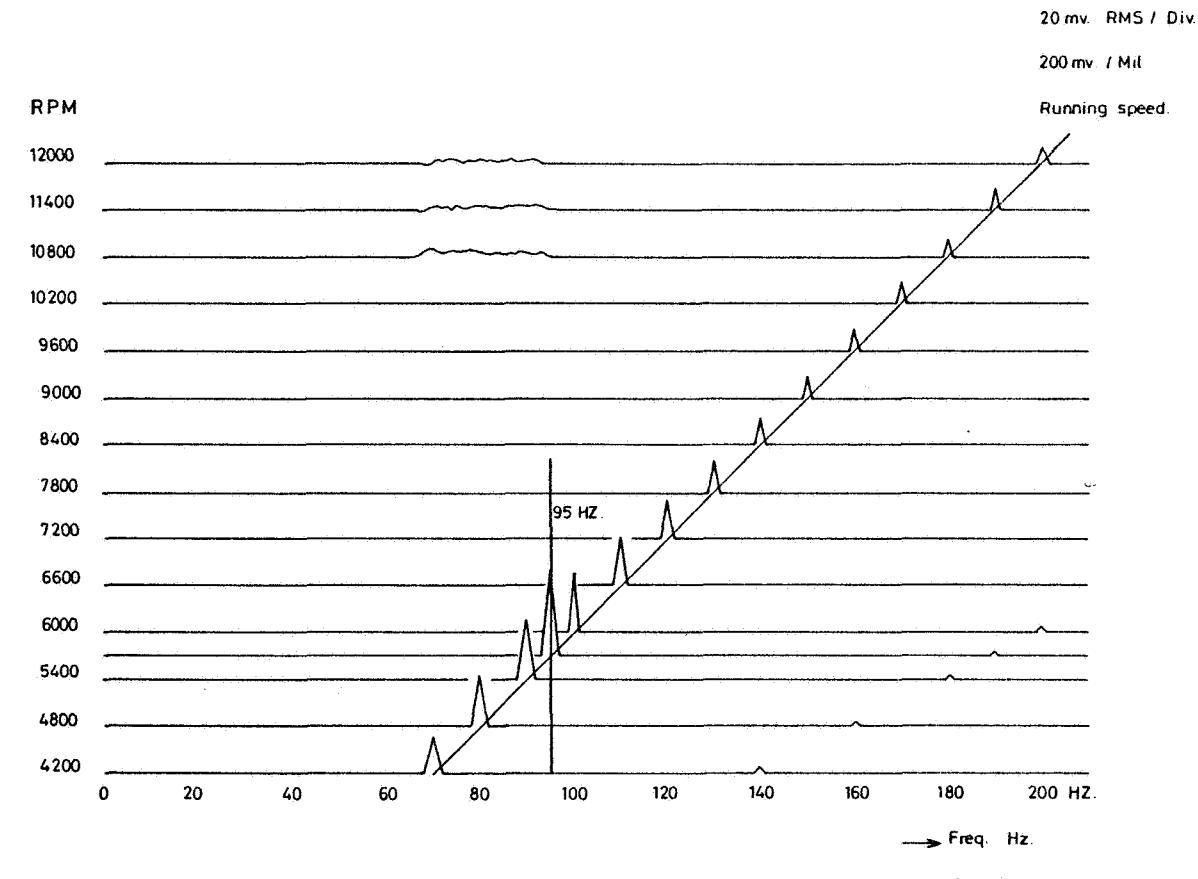
Figure 9. - High-pressure compressor runup with shrink fit improved.

Figure 9 shows a cascade spectrum of a rotor that had the shrink fit improved by plating the shaft 1 mil oversize. No appreciable subsynchronous vibrations were observed throughout the speed range of the compressor. What is also apparent in Figure 9, and of interest to note, is that the rotor's first critical speed was still around 95 HZ. The unit was operating at a very low vibration level allowing the plant to run at loads as high as 125%, a level never before achieved.

The objective here was to determine the most economical way to make the machine run smoothly and reliably. It was apparent that increasing the shrink fit by plating the shaft about one mil oversize should be the first step in such a solution, since it requires a minimum of expenditure. This solution was sound since it does not have an adverse effect on material strength, cause stress concentrations or stress corrosion, and will not exceed the yield strength of the material.
