## WEAR CHARACTERISTICS OF BONDED SOLID FILM LUBRICANT UNDER HIGH LOAD CONDITION

Naofumi Hiraoka, Akira Sasaki, Noritsugu Kawashima\* and Toshio Honda\*\*

#### ABSTRACT

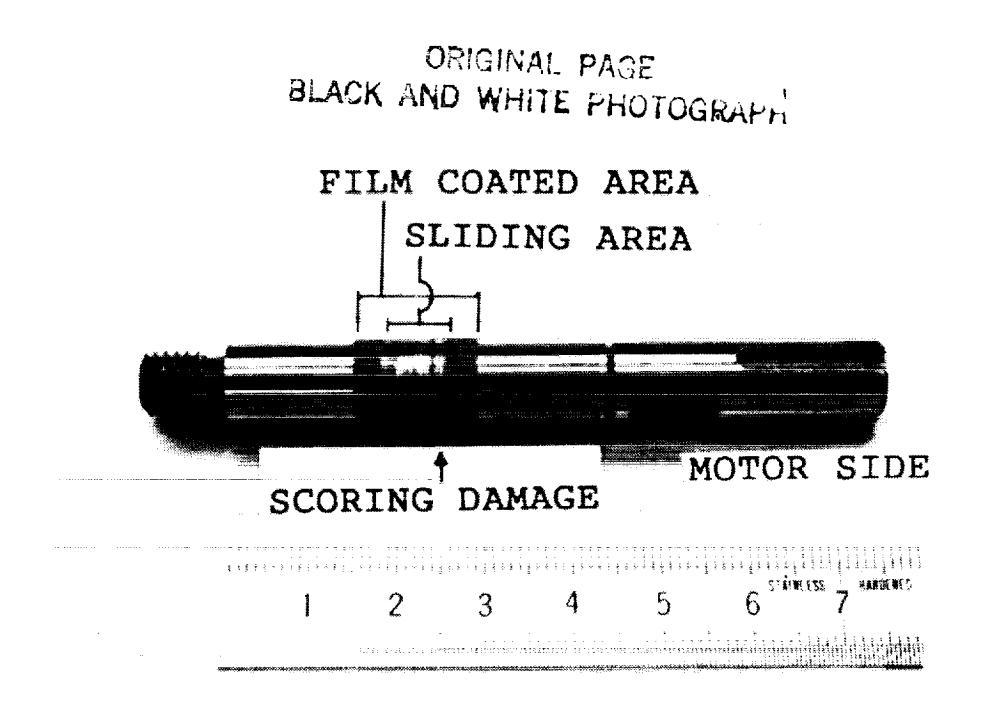
Figure 3. No Longer Usable Bearing Shaft

Figure 2 shows a typical measured frictional torque trend for the bearings. The torque was large in the beginning and decreased to a steady level (Fig. 2-a). At the end of the test duration, the torque increased suddenly. This point was regarded as the wear-life for the bearing (Fig. 2-b). All the life-ended bearings had scoring damages and the damages positioned on the motor side end of the bearings, as shown in Fig. 3. That was probably caused by a peculiar misalignment of the tester.

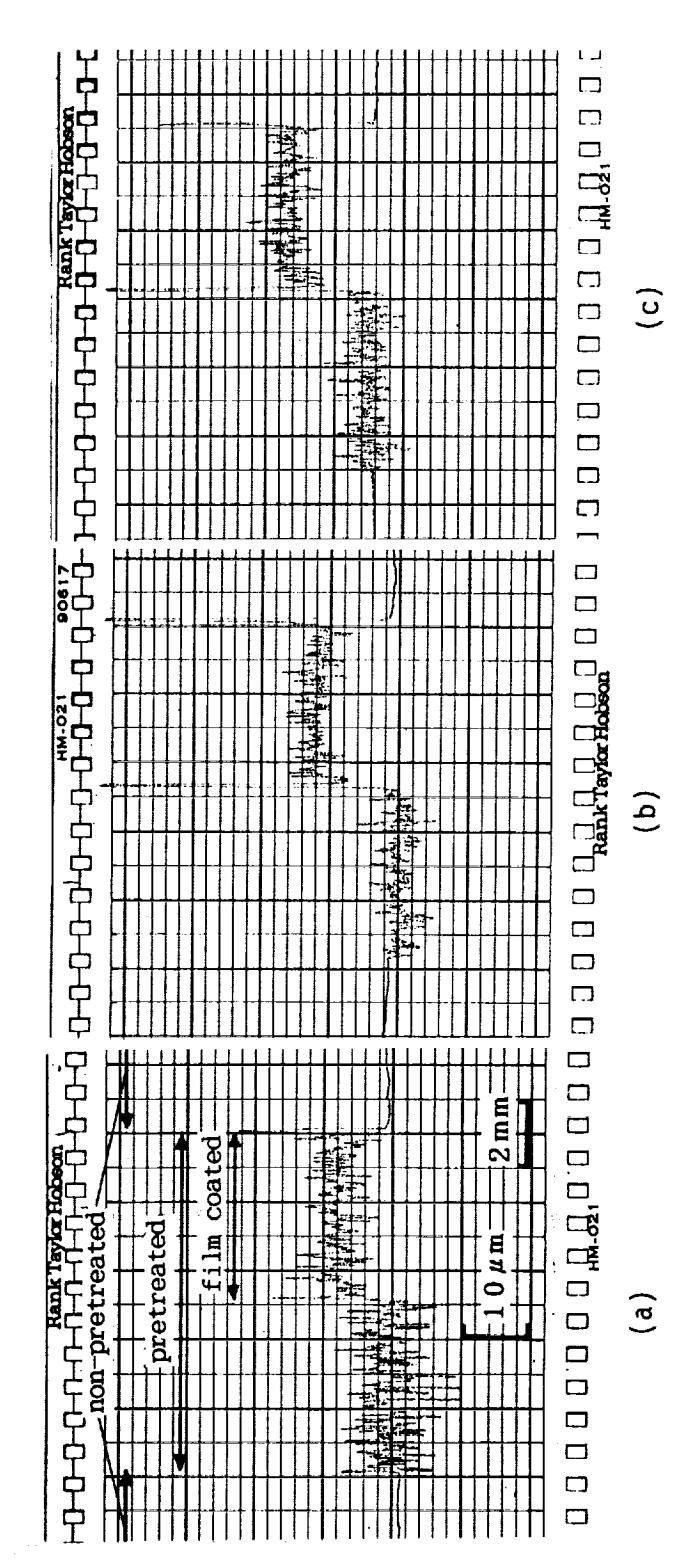
Surface Profiles for Pretreated Surface Specimens
(a): 2017 Aluminum Alloy, (b): 440C Stainless Steel, (c): 304 Stainless Steel Figure 7.

Figure 7 shows surface profiles for the specimens measured with TALYSURF. Corresponding numerical data are shown in Table 3. The aluminum alloy pretreated surface (Fig. 7-a) indicates a large degree of roughness, owing to sand-blasting. Heights of some peaks are comparable to lubricant film thickness, which means that films on such peaks had only a slight thickness, or even that there was no film on them. This is probably the most important reason for the short wear-life for the aluminum substrate bearing, besides low mechanical toughness of

aluminum alloy. The sand-blasting of the aluminum was the same as that for stainless steel, but this observation suggests that lower pressure or finer particles would be recommendable for sand-blasting aluminum alloy.

The pretreated surface of 440C stainless steel (martensitic stainless steel) in Fig. 7-b exhibits lower roughness height, on the average, than non-pretreated surface. This is because material was removed from the surface by sand-blasting. On the other hand, the pretreated surface of 304 stainless steel (austenitic stainless steel) in Fig. 7-c retained about the same height, on the average, as that for a non-pretreated surface. This is because plastic deformation was predominant, compared to material removal in sand-blasting on 440C stainless steel.

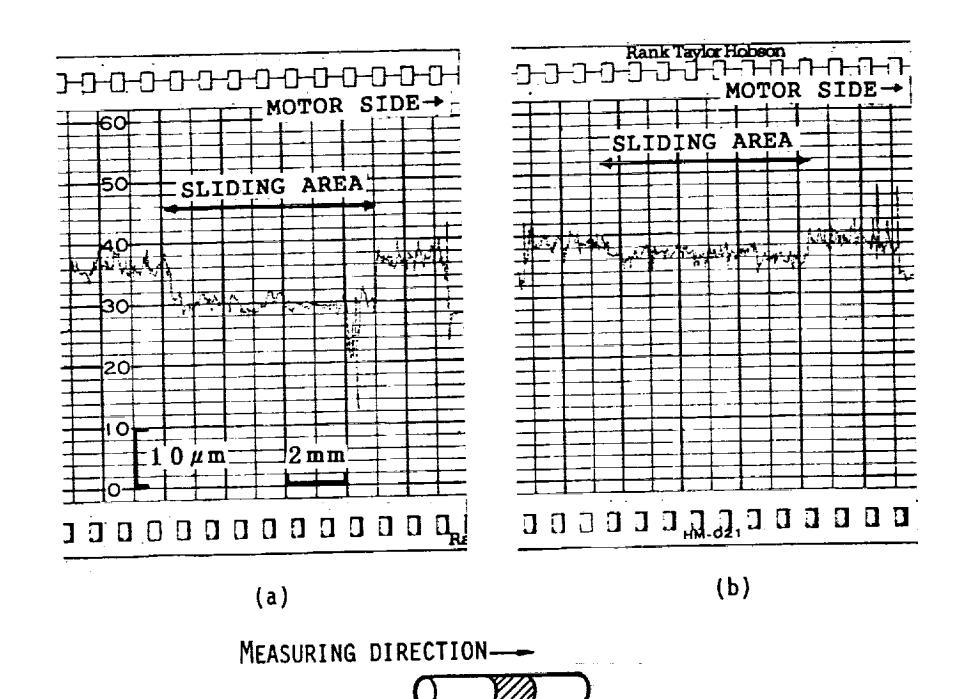
Figure 10. Surface Profiles for Worn Film on 304 Stainless Steel Shaft (a): No Longer Usable (b): After 1.27 x 105 Oscillations

Figures 9 and 10 show the worn film surface on a 304 stainless steel shaft and its profile. Figure 9 indicates many pits around flat surface. The width scale for these pits is on the order of a hundred microns and corresponds to that for profile's valleys of the corresponding area shown in Fig. 10a. Pits several microns in depth appear in the figure. In pertinent literature(10)(11)(12), 'blisters' were observed under much larger velocity conditions, but it is not clear whether the pits have anything in common with the blisters mentioned in the literature or not.

Figure 10-b shows the worn film surface profile for the shaft at approximately a half of the number of oscillations for the life-ended bearings. A wide, deep groove is observed on the motor side end of the worn surface. Figure 12 shows a microscopic image of this groove. The groove appears not to be the trace of abrasion, but to be an aggregation of pits or a trace of flaking in Fig. 12. Thus, the pitting or flaking wear is considered to dominate the film decrement.

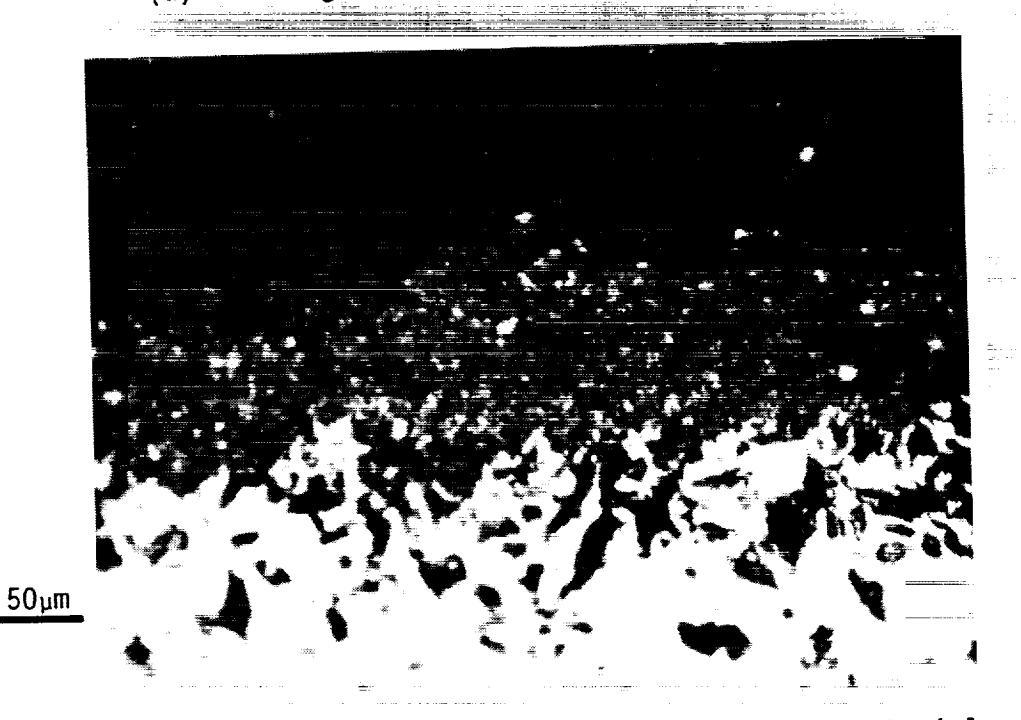
Figure 11. Cross Section View, Film Coated Surface for 304 Stainless Steel Pretreated Surface Specimen. Cut at 10° Inclination.

The pits are not considered to originate from the inherently existing voids in the film, according to the observation of the film cross section, which is shown in Fig. 11. They were also not considered to be the blisters produced by frictional heat, because higher angular velocity did not decrease the wear-life under 50 deg./s, as mentioned above. This means frictional heat did not increase the film damage, such as the pits, in this sliding velocity range. Thus, the pits were estimated to be traces of partial debonding of the film materials from the film caused by fatigue entailed during the sliding process.

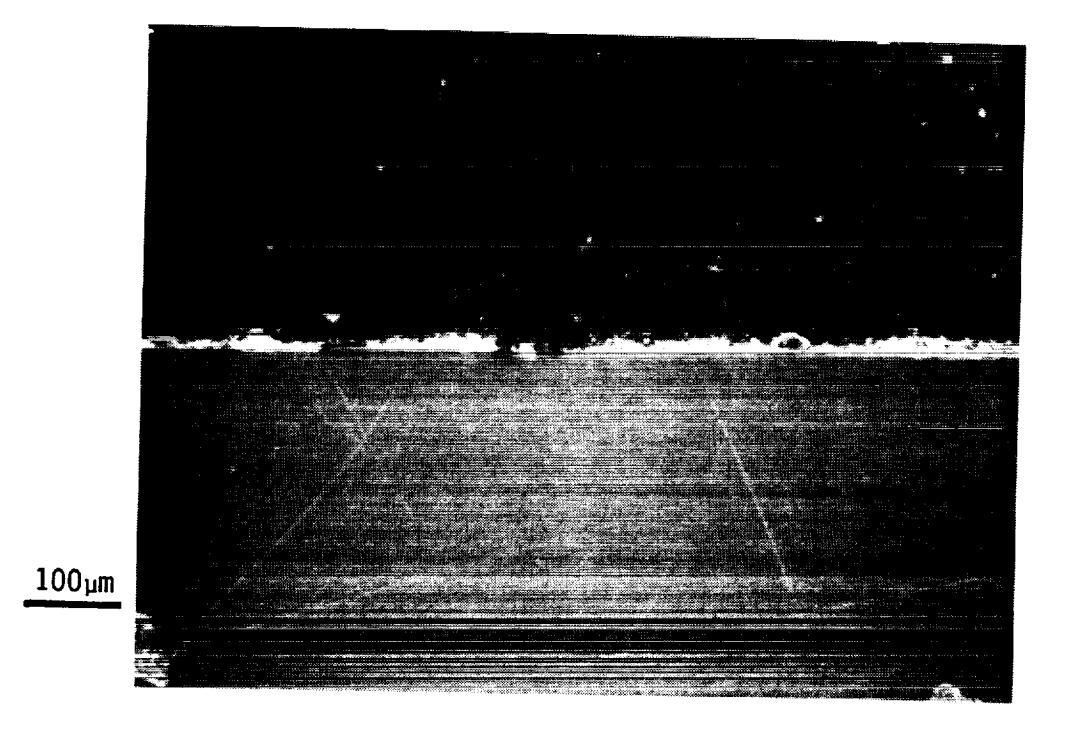
Figure 13. Cross Section of Ring Specimen

Figure 13 shows a cross section of the film coated ring specimen, which was used in the block-on-ring wear test in nitrogen gas in another study(13). A deep wear groove was observed, including ring material between thick remaining films. This could be considered the trace of abrasion of the film wear particles to the ring material, as stated above.
