## **C-COUPON STUDIES OF CMCS: FRACTURE BEHAVIOR AND MICROSTRUCTURAL CHARACTERIZATION**

Frances I. Hurwitz, Anthony M. Calomino  
NASA Glenn Research Center  
Cleveland, OH 44135

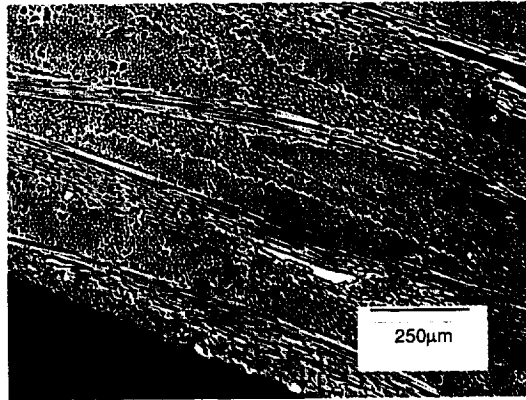
**Figure 2. Microstructure of 5 HS specimen, lot 0253-01-007 showing good infiltration and well spread tows.**

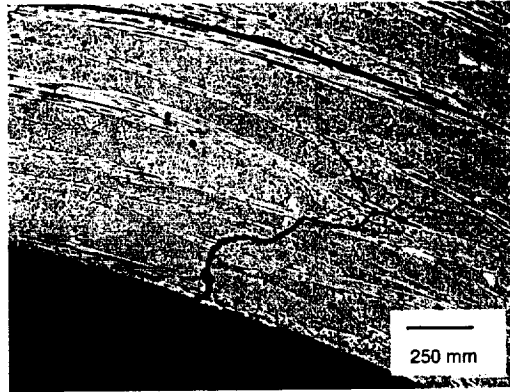
shown in Figure 3. Delamination fractures propagated in the hoop direction. These occurred between multiple ply layers in several specimens, and may represent successive fracture as loading continues. Cracks initiating on the tensile surface propagated radially and often branched. Because these samples were tested in load control, and continued to be loaded after failure, fractures due to hoop stresses are expected to have occurred subsequent to ILT fracture.

The observed damage is consistent with the finite element analysis, which shows the maximum hoop stress at the tensile surface, and maximum radial stress midway through the thickness, tapering off at  $40^\circ$  to  $45^\circ$  on either side of the specimen centerline. Older batches of the baseline material having poorer microstructure (i.e., tighter tows and many more voids), failed at significantly lower stress levels, and exhibited delamination failures only.

Figure 3. Typical fracture observed in 5 HS specimen, room temperature test.

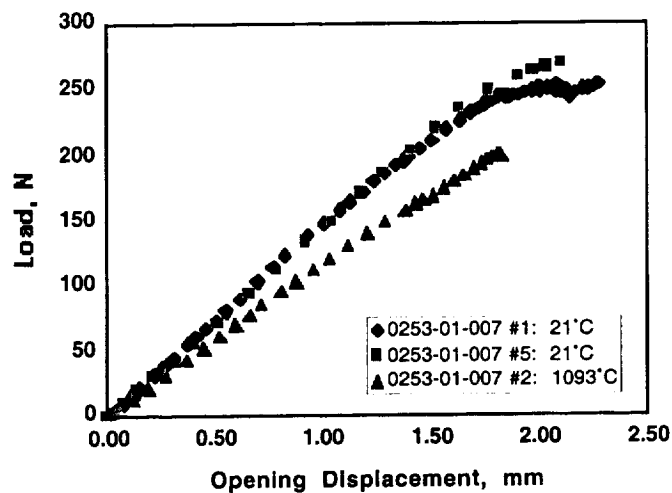
Representative load-displacement curves for the 8 ply 5 HS Lot 0253-001-007 EPM C-specimens are shown in Figure 4. Testing was conducted in load control, so that no load drop which can be attributed to initial cracking is seen. Based on finite element analysis

Figure 4: Load-displacement curves for 8 ply, 5HS composite at ambient and elevated temperatures.

of radial stress as a function of  $h/r_m$ ,<sup>7</sup> room temperature fracture occurred at a radial stress of 29-30 MPa and a maximum hoop stress of 420-450, close to the ultimate tensile strength of the 9/99 material. Therefore, for these samples, mixed mode fracture cannot be ruled out.

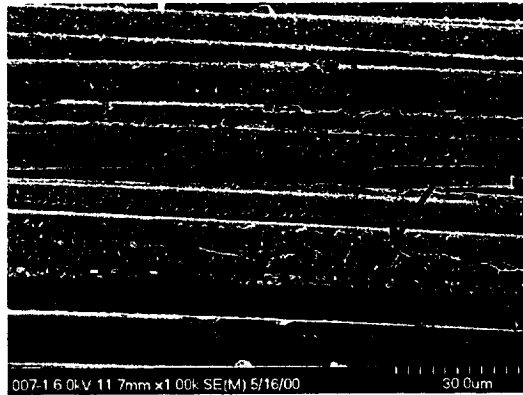
Fracture surfaces from room temperature tests exhibited "saw tooth" patterns characteristic of shear failure, as shown in Figure 5. The majority of the delaminations occurred between the BN interphase and the SiC overcoat, as shown in Figures 6 and 7, although occasional bare fibers also were seen (Figure 7). The BN interface possessed a

**Figure 5** Fracture surface of 5 HS coupon showing indication of shear. Failure appears to have occurred between the BN and CVI SiC layers.

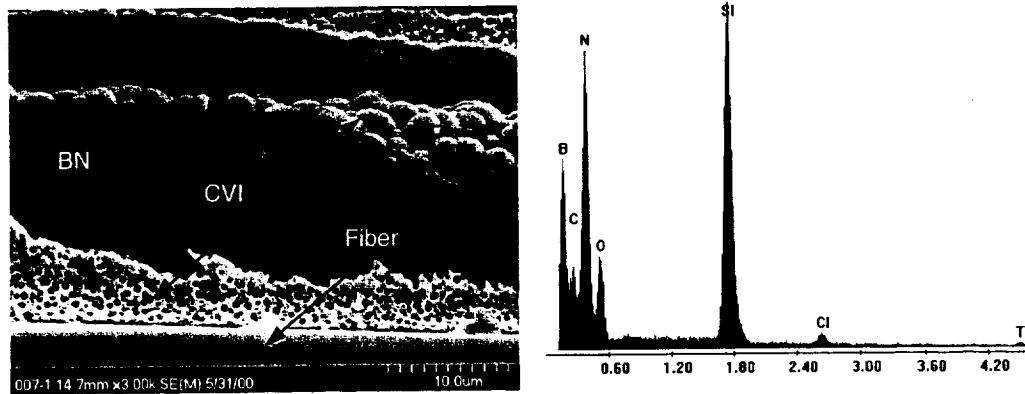
"bumpy" appearance (Figure 7), which, though not typical of the Sylramic™/MI CMC, has occasionally been observed in other lots of material outside of the present work. The "smooth" BN coating shown in Figure 8 is more typical of the majority of material lots, and had a higher percentage of fracture between the fiber surface and the BN. The "bumpy" BN coating was found by EDS at 6 kV to contain Cl (Figure 7), not observed in the smooth BN (Figure 8), and relatively less C. (The Ti arises from the Sylramic™ fiber.) Whether the Cl and C incorporation alone explains the difference in BN morphology is not understood at this point, but adds to the evidence of lot to lot material variations.

**Figure 7. Fracture surface, SHS specimen with "bumpy" BN interphase coating. EDS spectra of BN coating at 6 kV is at right.**

It is interesting to note that fracture occurred between the BN and CVI SiC layers, at least for samples with "bumpy" BN morphology; this might serve as an area of focus for improving interlaminar properties.

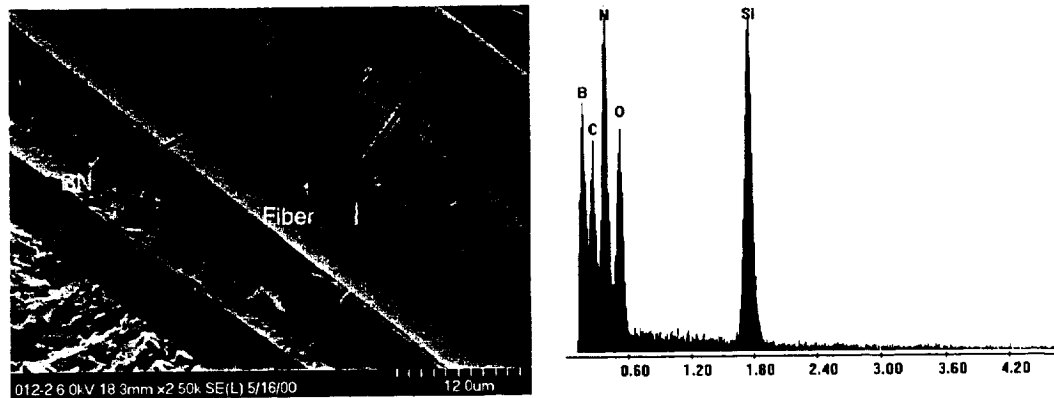
**Figure 8. Elevated temperature fracture of specimen with smooth BN interphase coating. EDS spectra of coating at 6 kV is at right.**

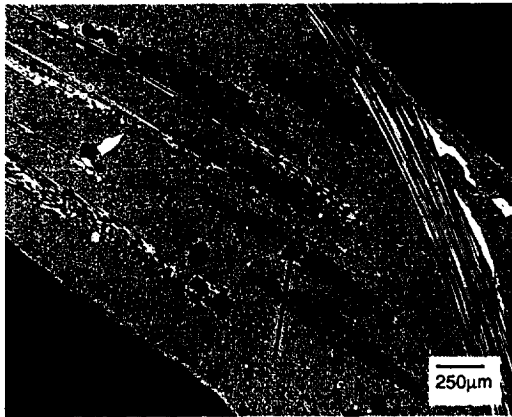
broken fibers due to high stiffness, (nominally estimated as 400 GPa), necessitating modifying the weave so that the Z fiber crossed two tows rather than the usual one in turning. The resulting weaves also proved to present challenges for matrix infiltration and specimen consolidation. The orthogonal (Figure 9) and angle interlock specimens had rather low fiber volume fractions, as well as non-uniform fiber spacing, resulting in matrix rich regions and numerous voids. Fiber misalignment also occurred because weaving was performed on flat material which was then formed to the curved C. Maximum loads at failure were 113-129 N for the angle interlock, and 64-125 N for the orthogonal weave, as compared with 200-268 N for the baseline 8 ply 5 HS layup.. The fracture patterns for these specimens displayed the same mixed mode failure patterns observed in the baseline material.

**Figure 9. Orthogonal weave tested at room temperature. Arrow indicates fracture.**
