# **ACOUSTIC EMISSION DETECTION OF IMPACT DAMAGE ON SPACE SHUTTLE STRUCTURES**

WILLIAM PROSSER<sup>1)</sup>, MICHAEL GORMAN<sup>2)</sup> and ERIC MADARAS<sup>1)</sup>

1) Nondestructive Evaluation Sciences Branch, NASA Langley Research Center,  
MS 231, 3 E. Taylor St., Hampton, VA 23681, USA

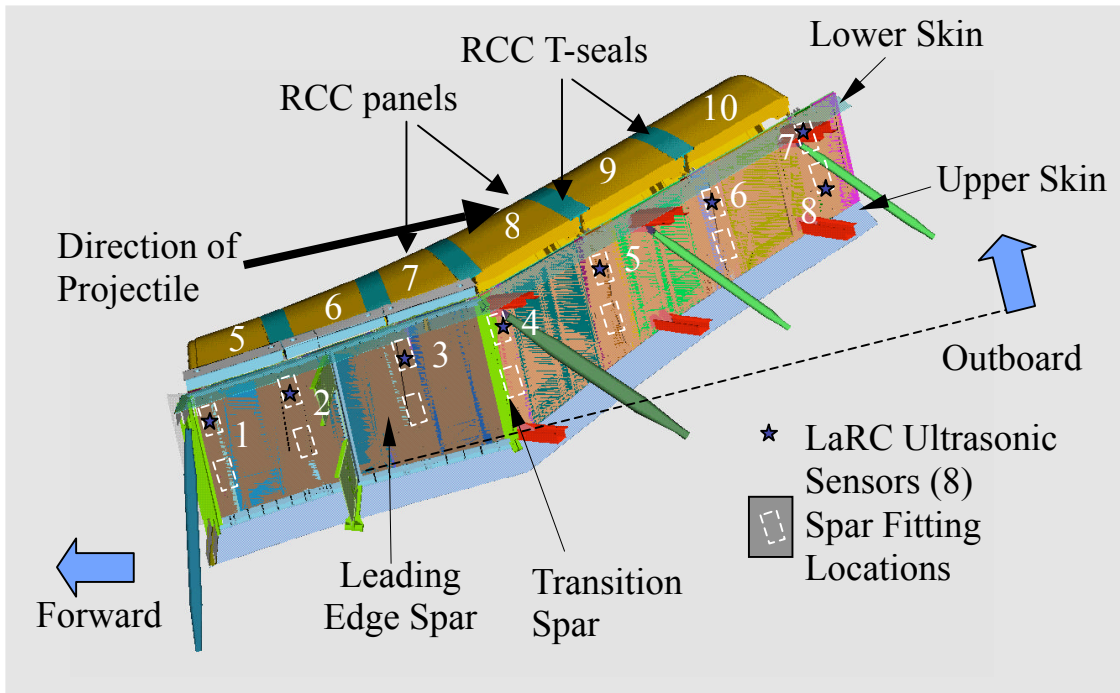
For the defining test of the investigation, a foam block weighing 1.67 lbs. was launched at a velocity of 237 m/sec, striking panel 8 as indicated in Figure 1. This impact produced a significant hole in the RCC panel providing conclusive evidence for the Columbia Accident Investigation Board in determining the cause of the accident [4]. The AE signals that were detected from this foam impact event are shown in Figure 2. Only 6 dB of gain was applied to the signals from the AE sensors. As would be expected, the largest signal, arriving earliest in time was that from sensor 5, which was nearest the impact site. Decreasing arrival times and amplitudes of signals from sensors located further away from the impact point were observed. Although not noticeable in this figure as all signals are plotted on the same scale, signals were detected all the way down to the location of sensor 1, suggesting that impact events can be detected by sensors mounted several RCC panels away, a distance of more than 1 m. Examination of the arrival times for signals from sensors 7 and

8 showed that the impact site could be localized with respect to the upper and lower surface of the leading edge.

Figure 1. Leading Edge Support Structure with RCC panels 5-10 and T-seals shown. The locations of the AE sensors 1 through 8 are indicated with black stars.

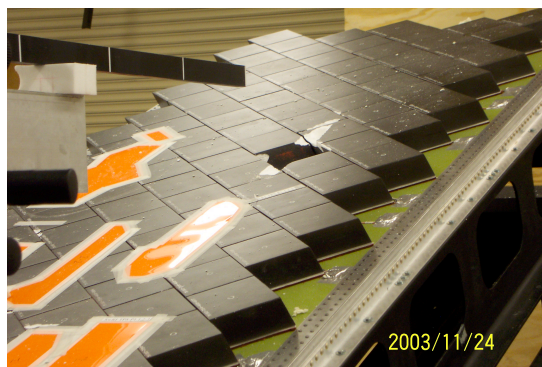
Foam impact tests were also performed on lower wing specimens representative of regions on which the thermal protection material is tile. Specimens from this region of the wing also included a main landing gear door. Representative damage for a wing specimen impacted by foam at approximately 259 m/sec is shown in Figure 4 in which a hole formed by a tile that was broken away by the impact can be observed. Signals were again readily detected by AE transducers for all impact conditions studied. Although the signals were very complex due to the complicated nature of the source and the complex structural geometry of the tile and wing specimen, source location could be determined using appropriate frequency filtering to selectively analyze the flexural mode of propagation.

Figure 4. A wing acreage tile test article showing the resulting tile loss due to a foam impact.

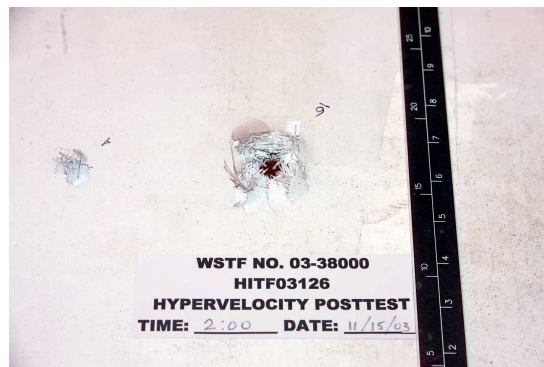
Hypervelocity impact tests are being performed to simulate micrometeoroid and orbital debris (MMOD) damage that can occur once the Shuttle is in orbit. Initial tests were performed on flat metal and fiberglass plates to develop a database to support modeling efforts as well as to determine appropriate instrumentation settings. Figure 5 shows typical damage resulting from two hypervelocity impact events at 6.8 km/s in a fiberglass plate. The smaller impact was created by a 1 mm diameter aluminum projectile while the larger was created by a 2 mm aluminum projectile, which fully penetrated the plate. Contrary to previous hypervelocity impact testing in graphite/epoxy composites plates [1], the AE signals in the fiberglass plates contained only extensional mode components with no flexural mode present. This is shown in the signals of Figure 6a. For comparison a lead break simulated AE signal near the impact site shown in Figure 6b clearly shows the extensional and flexural mode components. It is interesting to note in comparing these signals that there was 64 dB of attenuation applied to the signals from the hypervelocity impact as compared to 47 dB of gain for the lead break signal. There is a tremendous amount of energy in the hypervelocity impacts. Figure 7 shows the raw signal amplitude, after adjustment for the attenuation, from a series of hypervelocity impacts on a fiberglass plate as a function of impact energy. As shown in this figure, the raw signal amplitude increases with corresponding impact energy until it peaks at nearly 80 volts for an impact energy of nearly 100 J. For impacts exceeding 100 J, the projectile penetrates the plate and a decrease in AE signal amplitude is observed. Additional testing is ongoing to further understand this decrease in signal amplitude after penetration as this may be important in determining impact detection thresholds.

Figure 5. Fiberglass panel showing damage from two hypervelocity impacts.
