## Ballistic Impact of Braided Composites with a Soft Projectile

## Abstract

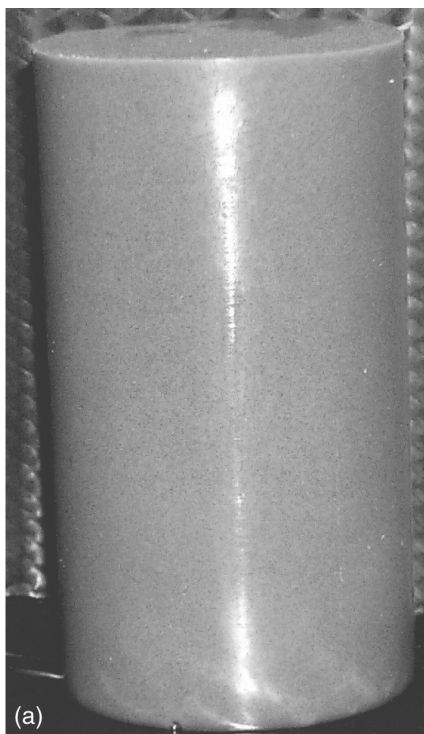
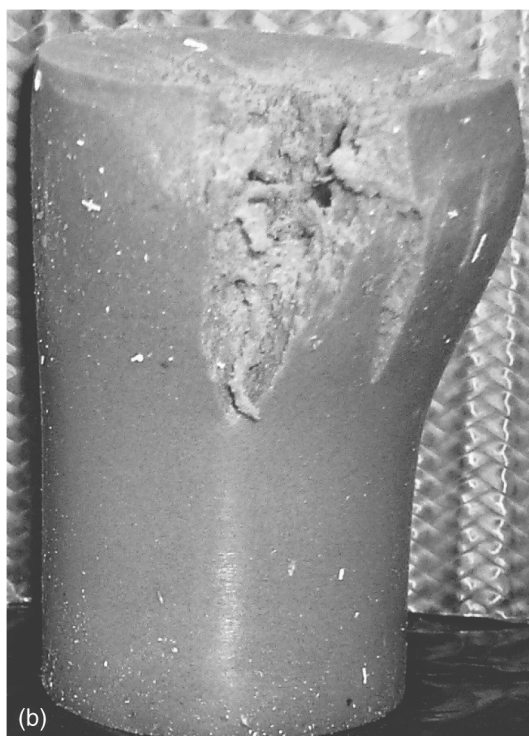
The soft projectiles used in the impact tests were made using a mixture of gelatin and microballoons with a density of  $960 \text{ kg/m}^3$ . The mixture is cast in the shape of a cylinder 12.7 cm (5 in.) long and 7.0 cm (2.75 in.) in diameter. Figure 3 shows an example of a projectile before and after impact. For impact testing a projectile is mounted in a sabot and shot into a target using a 20.3 cm (8 in.) diameter gas gun. The axis of the cylindrical projectile is aligned along the line of flight, so that the flat end of the cylinder makes first contact with the target. Impact velocity is measured digitally using a high speed video camera with a view perpendicular to the line of flight. During a test the projectile initially flattens into a disk approximately 25.4 cm (10 in.) in diameter before rebounding to the “after impact” shape shown in Figure 3(b). At low velocities the projectile can be recovered in the form shown in Figure 3(b), but at high velocities the projectile is disintegrated into small pieces.

Fig. 3. Gelatin projectile. (a) Before impact. (b) After impact.

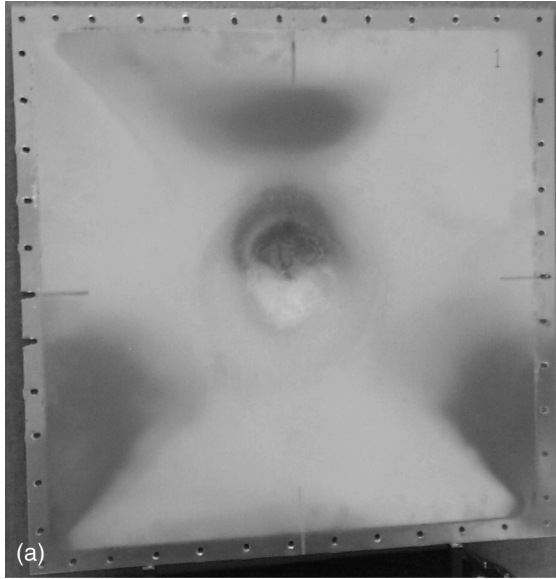
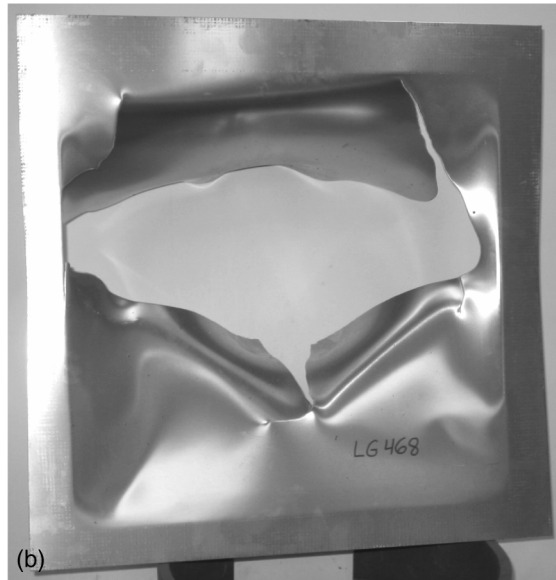
An initial set of 4 tests were done on aluminum plates using the 55.9 cm (22 in.) frame opening and impact velocities ranging from 156 m/s (513 ft/s) to 235 m/s (770 ft/s). In this test configuration the clamped area is only one inch wide, and even the use of pins through the plate was insufficient to prevent slipping of the edges out of the frame. Figure 6(a) shows the plate tested at 156 m/s (513 ft/s). Some tearing of the pin holes resulting from slipping is evident in the left edge of the plate in Figure 6(a). The type of damage that occurred was similar for all 4 plates, except that the extent of deformation and the amount of slipping from the frame were much more severe at the higher velocities. Each of the 4 plates had a circular region of extensive plastic deformation at the center that is about the size of the initial contact area and less extensive plastic deformation in the region between the initial contact area and the edges of the plate. The four folds beginning at the corners of the plate and directed at 45° toward the center of the plate are an artifact of the stress field imposed by the square boundary conditions. It was somewhat surprising that the aluminum plates were not penetrated with an impact velocity of 235 m/s (770 ft/s). In order to determine if penetration would occur if the edges of the plate were held tightly in place, two more tests were done on the remaining plates using the new frame with the 50.8 cm (20 in.) opening. This frame allows for a 5.08 cm (2 in.) clamping width at the edges of the plate. A plate tested at 226 m/s (743 ft/s) in this frame is shown in

Figure 6(b). With the edges of the plate now held more tightly in place, penetration did occur along with extensive cracking of the plate. High speed video of the impact event clearly showed crack initiation near the initial contact area and dynamic crack propagation toward the boundaries. Figure 6(b) illustrates the effect of having a high strain energy density in the plate at the onset of failure. A second plate tested at 199 m/s (654 ft/s) was not penetrated by the projectile. However, some slipping occurred at the boundaries, even though the new test frame was used. Further testing would therefore be needed to determine the penetration threshold in a test where the boundaries are held completely fixed.

Fig. 6. Aluminum panels after impact. (a) 156 m/s (513 ft/s). (b) 226 m/s (743 ft/s).

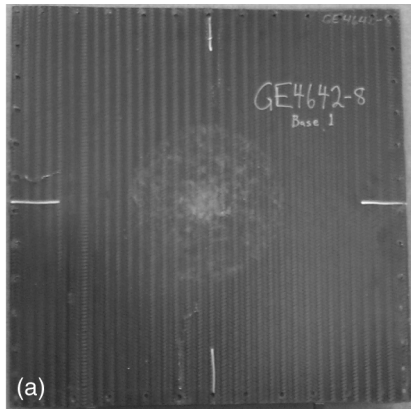
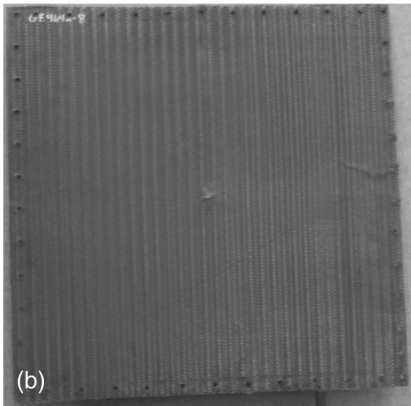
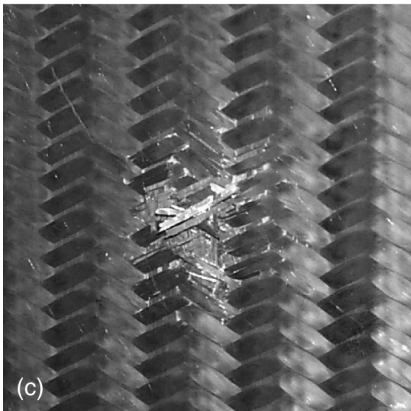
Eight composite plates were tested with impact velocities ranging from 103 m/s (338 ft/s) to 198 m/s (648 ft/s). The failure mode for the composite plates differed from that for the aluminum plates in several ways. First, when tested at velocities below the penetration threshold, the composites did not have a permanent deformation analogous to the plastic deformation in the aluminum plates. Second, the penetration threshold was lower for the composite plates. Third, when tested above the penetration threshold, the damage did not propagate beyond an area approximately the size of the initial contact area. Slipping at the edges of the plates was a problem in the initial tests using the frame with the 55.9 cm (22 in.) opening and only the bolts around the edges to hold the plates in place. Addition of pins through the steel frame and the composite plate reduced the slipping considerably. However, elongation of the holes in the composite and cracks emanating from the holes in some tests indicated that slipping was probably not completely eliminated. Using data only from tests in which the slipping appeared to be very small, the penetration threshold was determined to be between 150 m/s (491 ft/s) and 161 m/s (528 ft/s). Figure 7 shows the front and back surfaces of the composite plate tested at 150 m/s (491 ft/s). In Figure 7(a) the small whitened circular region at the center of the plate is the initial contact area. The larger, less distinctive, whitened area is the region over which the gelatin projectile was spread when it was completely flattened into a disk before rebounding. There is no visible damage on the front side of the plate. However, in Figure 7(b) there appears to be a small circular region of fiber tensile failure at the center of the back side of the plate. A magnified view of this damage is shown in Figure 7(c). This type of damage in the back ply is reasonable since the maximum strain should occur at this point. Fiber fracture also occurred on the back of other composite plates tested at velocities well below the penetration threshold. It was not possible to determine the threshold velocity for the onset of this failure mode because of the limited number of

plates available and because the test results can not be considered to be reliable in tests where slipping occurs at the boundaries. A lower bound for this threshold can be estimated from results of one test at 103 m/s (338 ft/s). There was no visible damage in this plate after the test. However, high speed video showed the projectile to be misaligned and partially torn before impact. Further testing would be needed to establish a threshold for onset of detectable damage.

Fig. 7. Composite flat panels after impact at 150 m/s (491 ft/s). (a) Front. (b) Back. (c) Back, close-up.

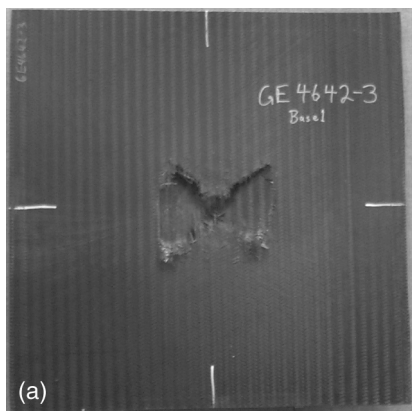
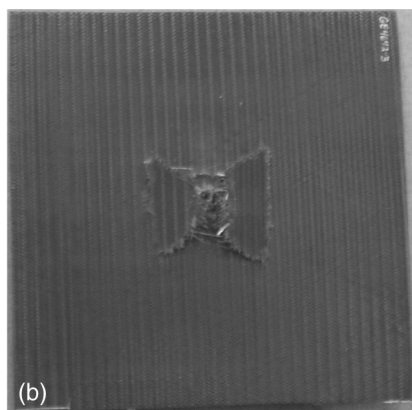
At impact velocities of 161 m/s (528 ft/s) and above, the projectile perforated the composite plates with the damage pattern shown in Figure 8. The plate in Figure 8 was tested at 192 m/s (629 ft/s). Penetration is initiated at the center of the plate where fiber tensile failure has occurred on the back ply. Cracks then propagate along the  $\pm 60^\circ$  bias fiber directions. When these cracks extend beyond the initial contact area, triangular flaps fold back along  $0^\circ$  axial fibers. Two remarkable results are that the cracks do not propagate far from the initial impact area and that there is no apparent delamination between plies. It was anticipated that these damage modes would be present and would have to be controlled by the use of buffer strips or other methods. The damage tolerance demonstrated in these tests suggests that such methods for limiting crack growth may not be needed in fan case structures. A possible contributing factor to the damage tolerance is that the interlaminar stresses available to induce damage are small because the triaxial braid is quasi-isotropic within each ply. This issue is currently being investigated both experimentally and by analysis.

Fig. 8. Composite flat panels after impact at 192 m/s (629 ft/s). (a) Front. (b) Back.

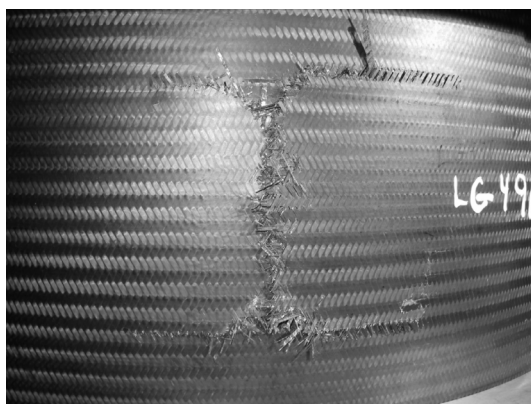
Two half-rings were tested using the fixture shown in Figure 5. The half-ring composites were fabricated so that the  $0^\circ$  fibers are oriented circumferentially in the fixture. The damaged region after a test at 150 m/s (492 ft/s) is shown in Figure 9. Because the damage is localized around the initial contact area, it is possible to perform three separate impact tests on each half-ring. Slipping of the edges out of the fixture was not a problem in any of these tests. The penetration threshold was between 133 m/s (436 ft/s) and 138 m/s (454 ft/s). This is lower than the range of 150 m/s (491 ft/s) to 161 m/s (528 ft/s) determined for the composite flat plates. The penetration thresholds are not expected to be the same for the flat plates and the half-rings because the stress state induced in the composite by impact is different for the different geometries. Some of the failure modes observed in the flat plates also occurred in the half-rings. For velocities below the penetration threshold, a small circular region of fiber fracture occurs in the back ply directly behind the center of the initial impact area. Similar to the flat plates, this region of fiber fracture is the initiation site for crack propagation when the impact velocity exceeds the penetration threshold. However, in the half-ring tests the cracks initially propagate from the initiation site in a direction transverse to the  $0^\circ$  fibers rather than along the  $\pm 60^\circ$  fibers. As the cracks reach a location near the edge of the initial impact site, each of the transverse cracks split into two cracks that travel a short distance along the  $\pm 60^\circ$  directions. These cracks then turn again to travel along  $0^\circ$  fibers. Square flaps then open by folding along a line transverse to the  $0^\circ$  fibers. Similar to the flat plates, the damaged area is only slightly larger than the initial contact area.

Fig. 9. Composite half-ring after impact at 150 m/s (492 ft/s).
