Current Space Station Experiments Investigating Component Level Electronics Repair

Prepared for the
Space 2009 Conference and Exhibit
sponsored by the American Institute of Aeronautics and Astronautics
Pasadena, California, September 14–17, 2009

Abstract

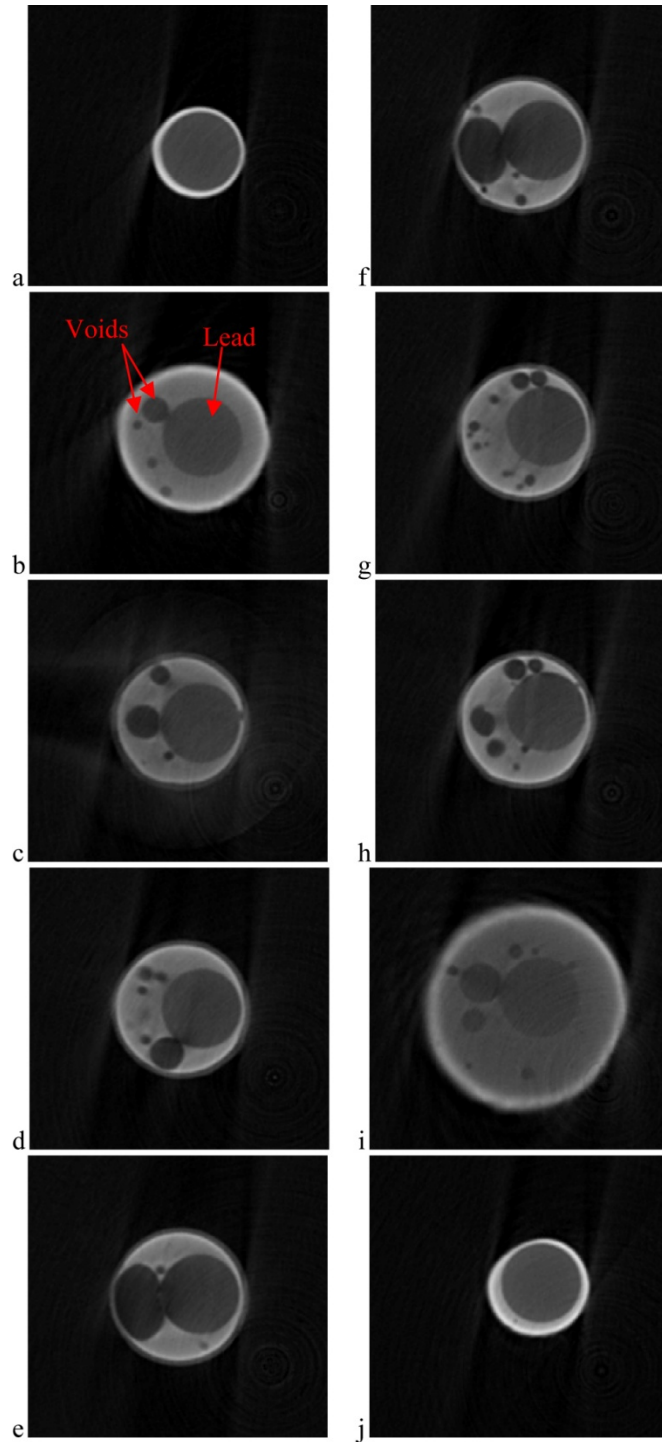
Figure 5.—Sequence of images describing the interior of a solder joint. The images show the lead and voids within the equally spaced images. Images a and b are taken from the soldered fillet, images c through h from the annular region, and images i and j from the flowed fillet. Image b demonstrates the lead and typical voids.

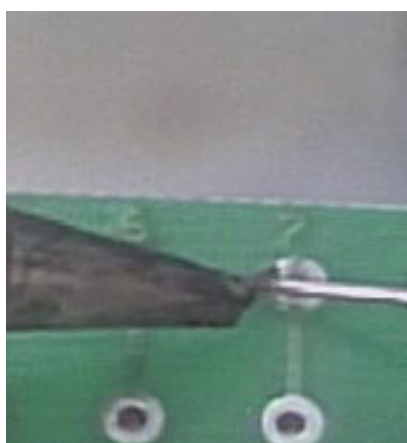
Figure 7.—Close-up image of the ISS Solder Kit soldering iron tip. The bent section of the tip is in contact with the solder wire, component lead, and circuit board plating.

The video record showed a problem with the ISS Soldering Iron Kit tip that was not expected by the SoRGE team, and may have negatively impacted the performance of the operator. As seen in Figure 7, the soldering iron tip used was curved, with a bend at the approximate middle of the tip. The ISS Soldering Iron Kit does not include any soldering iron tips with a bend; all provided tips are straight. This indicates that the soldering iron tip was damaged prior to use on the SoRGE experiment. The damaged soldering iron tip has a number of implications in terms of effectiveness for both the SoRGE experiment and general use during other ISS operations. First, the bend could indicate a change in tip temperature. The soldering iron tip is resistively heated, and the action that caused the tip to bend may have damaged the electrical connection between the tip and the soldering iron, connections between layers of material in the tip, electrical connections within the tip, or any combination of these effects. The change in tip shape could also affect the contact between the soldering iron tip and the circuit components—the resistor leg and circuit board through-hole or land—in a way that reduces the rate of heat transfer from the soldering iron tip to the joint area. While the tip used did provide enough heat to melt the solder wire and form solder joints, the potential reduction in performance of the tip may have made the astronaut's task more difficult than expected, and adversely affect the results of the experiment.

NASA should also improve the tools and facilities provided to the crew for electronics repair work. One area for improvement is the U.S. Soldering Kit. A new soldering iron should be improved to provide a hotter iron tip (at least 700 °F) with better temperature control. The hotter soldering iron tip will allow for operations with multilayer circuit boards which could not be done in the CRE-1 work and are more common in industry and in flight avionics. The higher temperature tips are more common in general use, and for this reason more shapes and sizes of the higher temperature tips are available, expanding the types of components that may be worked as well as making work currently possible easier to perform and more reliable. In addition to the soldering iron, other hand tools should be included. CRE-1 provided a number of small hand tools for use with the experiment, and they remain in the ISS tool kit for future use by the crew. The number and types of tools provided should be expanded, providing tools for manipulating smaller components or performing other tasks such as forming and inserting component legs in a circuit board to repairing damaged circuit traces and lands on a circuit board.

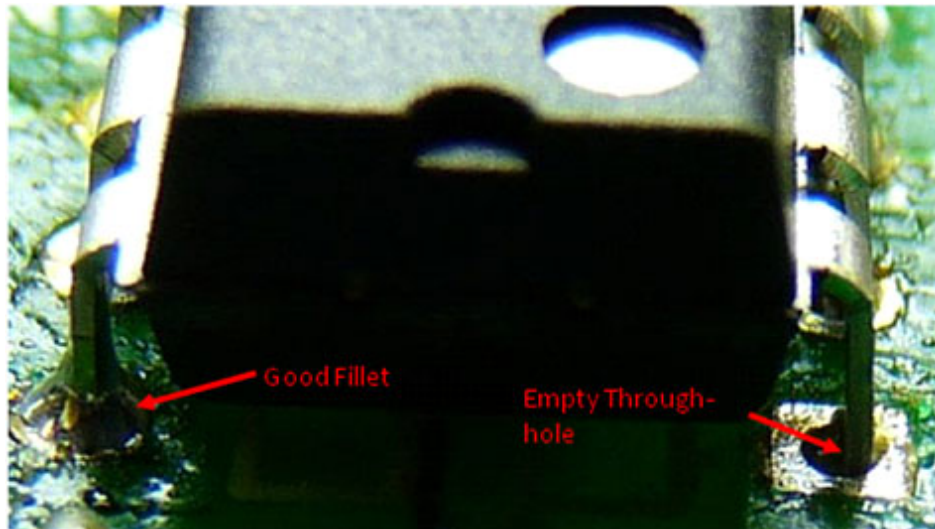
Figures 8 through 10 show some of the soldering issues found in the initial inspection. Figure 8 shows both a good solder joint, and a solder joint that failed inspection and would require rework. The good solder joint shows a fillet on the top side of the circuit board, wetting the leg of the component. The second solder joint does not have sufficient solder filling the plated through-hole; in practice, this solder joint would require rework to ensure proper wetting of the solder and a functional circuit, but is functional as-is.

Figure 8.—A replacement U2 component on a CRE-1 circuit board. The image shows a joint which passes the NASA standard as well as one joint that does not pass because the board through-hole is not filled with solder, but is functional.

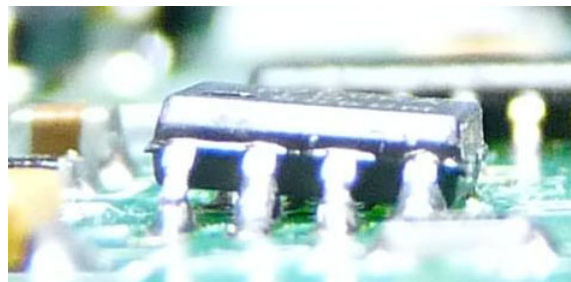
Figures 9 and 10 show an issue found in working with U4, a surface mount device. In many cases, the new component is not flat on the circuit board. This requires solder to flow between the bottom of the chip leg and the circuit board pad, which does occur in the case shown in Figure 9. In other cases, such as that shown in Figure 10, the solder does not wet both the raised chip leg and the circuit board pad, leading to an open circuit and faulty installation. This would require a repeat attempt to complete the repair, which the crew were instructed not to do as part of the experiment design.

Figure 9.—A replacement U4 on a CRE-1 circuit board. This image shows the component not resting flat on the board surface. The joints do not pass NASA standard, but are functional.

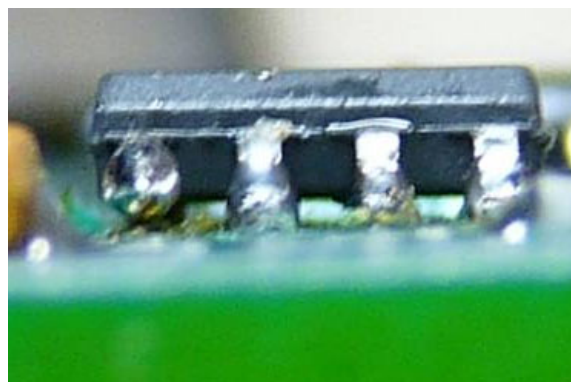
Figure 10.—A replacement U4 on a CRE-1 circuit board. In this case, the first leg is not soldered to the circuit board, requiring rework.
