#### JANNAF Lessons Learned Panel Selected Saturn V History

Skip Urquhart Jacobs – ESTS-Group NASA/Marshall Space Flight Center Huntsville, Alabama

May 2010

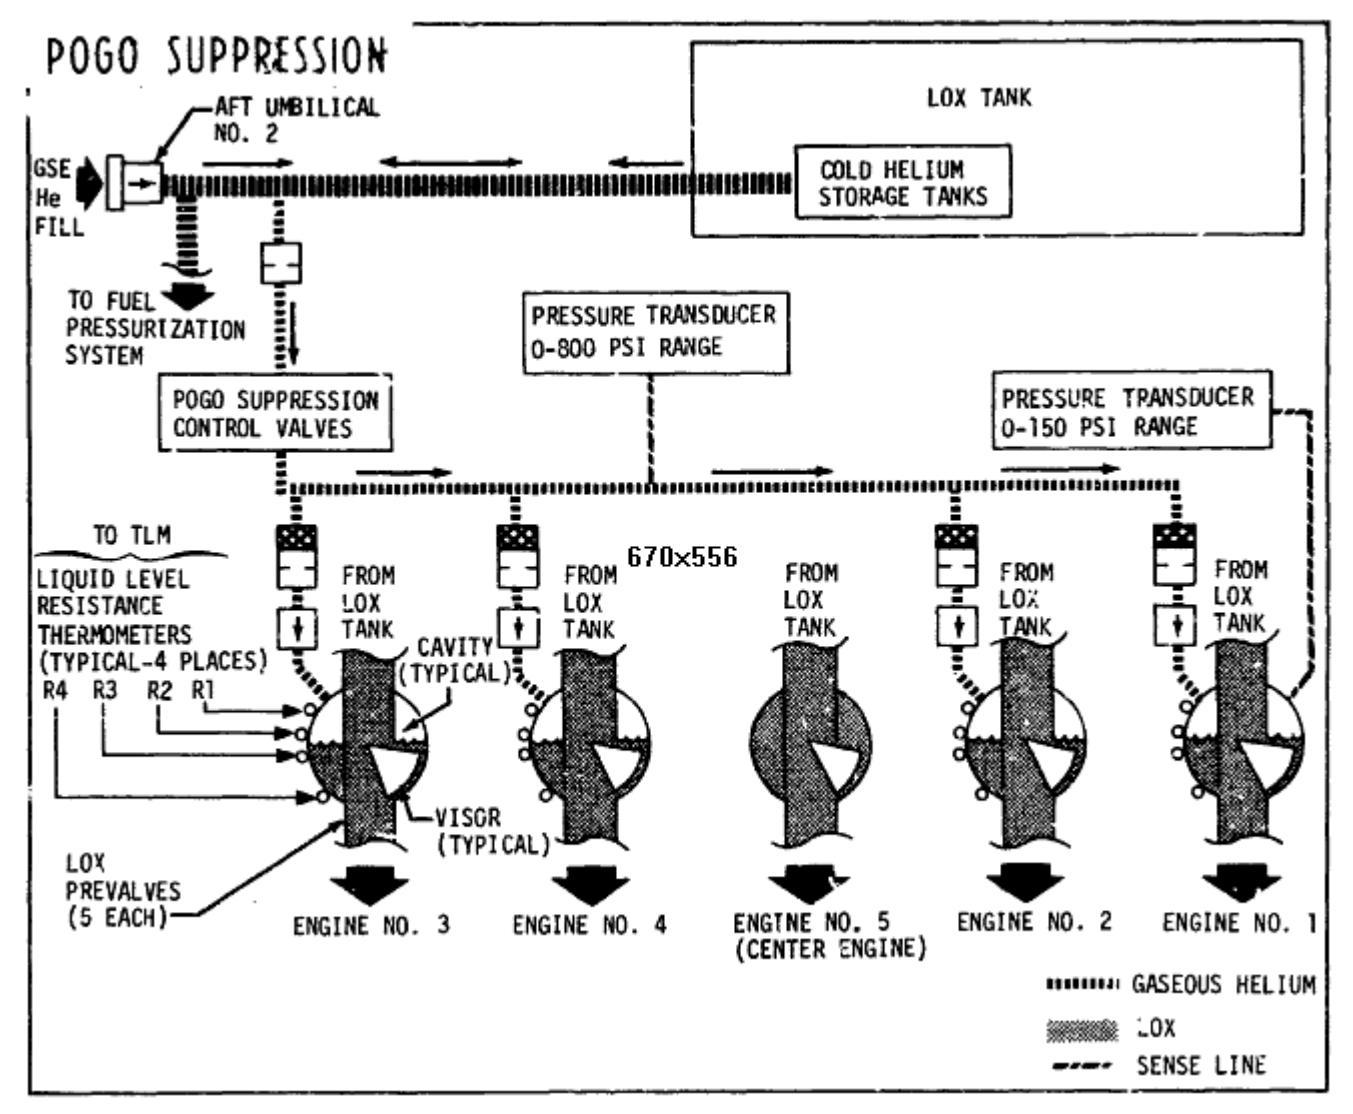
S-IC Pogo Suppression System (AS-503 & Subsequent)

- AS-502 S-IC experienced Pogo Vehicle first longitudinal structural mode frequency coupled with the engine response to the oxidizer suction lines resonant frequency from the 110 to 140 seconds.
- Oxidizer suction lines changed to rigid ducts between AS-501 and AS-502 because of manufacturing difficulties with flexible ducts.
- AS-501 did not experience Pogo, in part, because of more compliant oxidizer suction lines.

#### **S-IC Pogo Mitigation**

- Outboard prevalves redesigned to include helium cavities to provide compliance to the systems.
- POGO suppression system supplied helium gas obtained from the onboard fuel pressurization system. Four resistance thermometers in each prevalve determine the presence of gas or liquid in the prevalve cavity (see schematic).
- The POGO suppression system performed satisfactorily on AS-503 and subsequent flights.

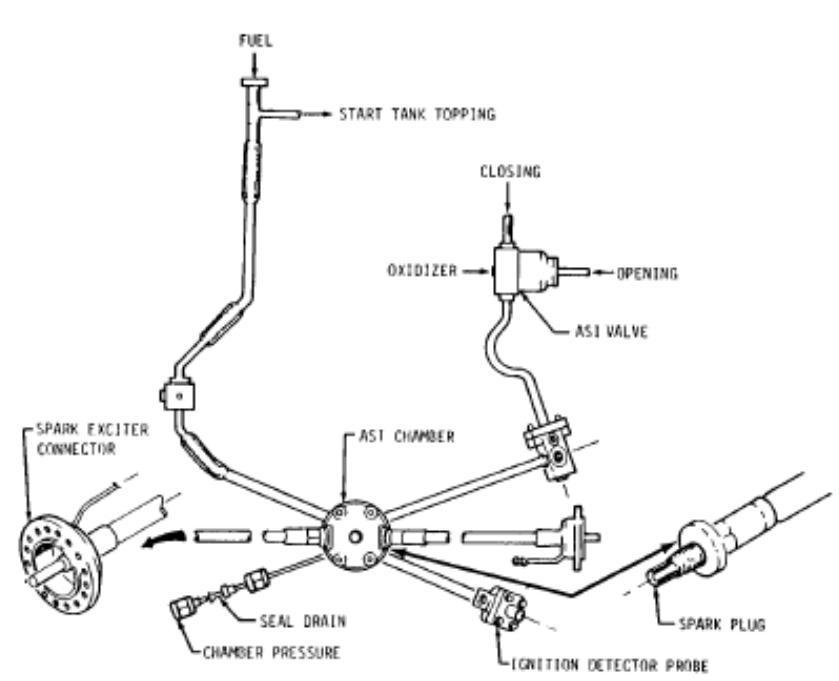
- The AS-502 S-IVB failed planned restart on orbit.
- All engine chilldown and preparations for restart were accomplished satisfactorily. However, the J-2 engine did not ignite due to leakage of ASI fuel line.
- Propulsion system met all operational requirements during first burn, cutoff transient, and orbital coast.

ASI is a small chamber which is center-mounted in the thrust chamber injector. Its purpose is to create and maintain a small ignition flame for thrust chamber ignition.

• ASI fuel line leakage resolved by redesign of the ASI propellant lines.

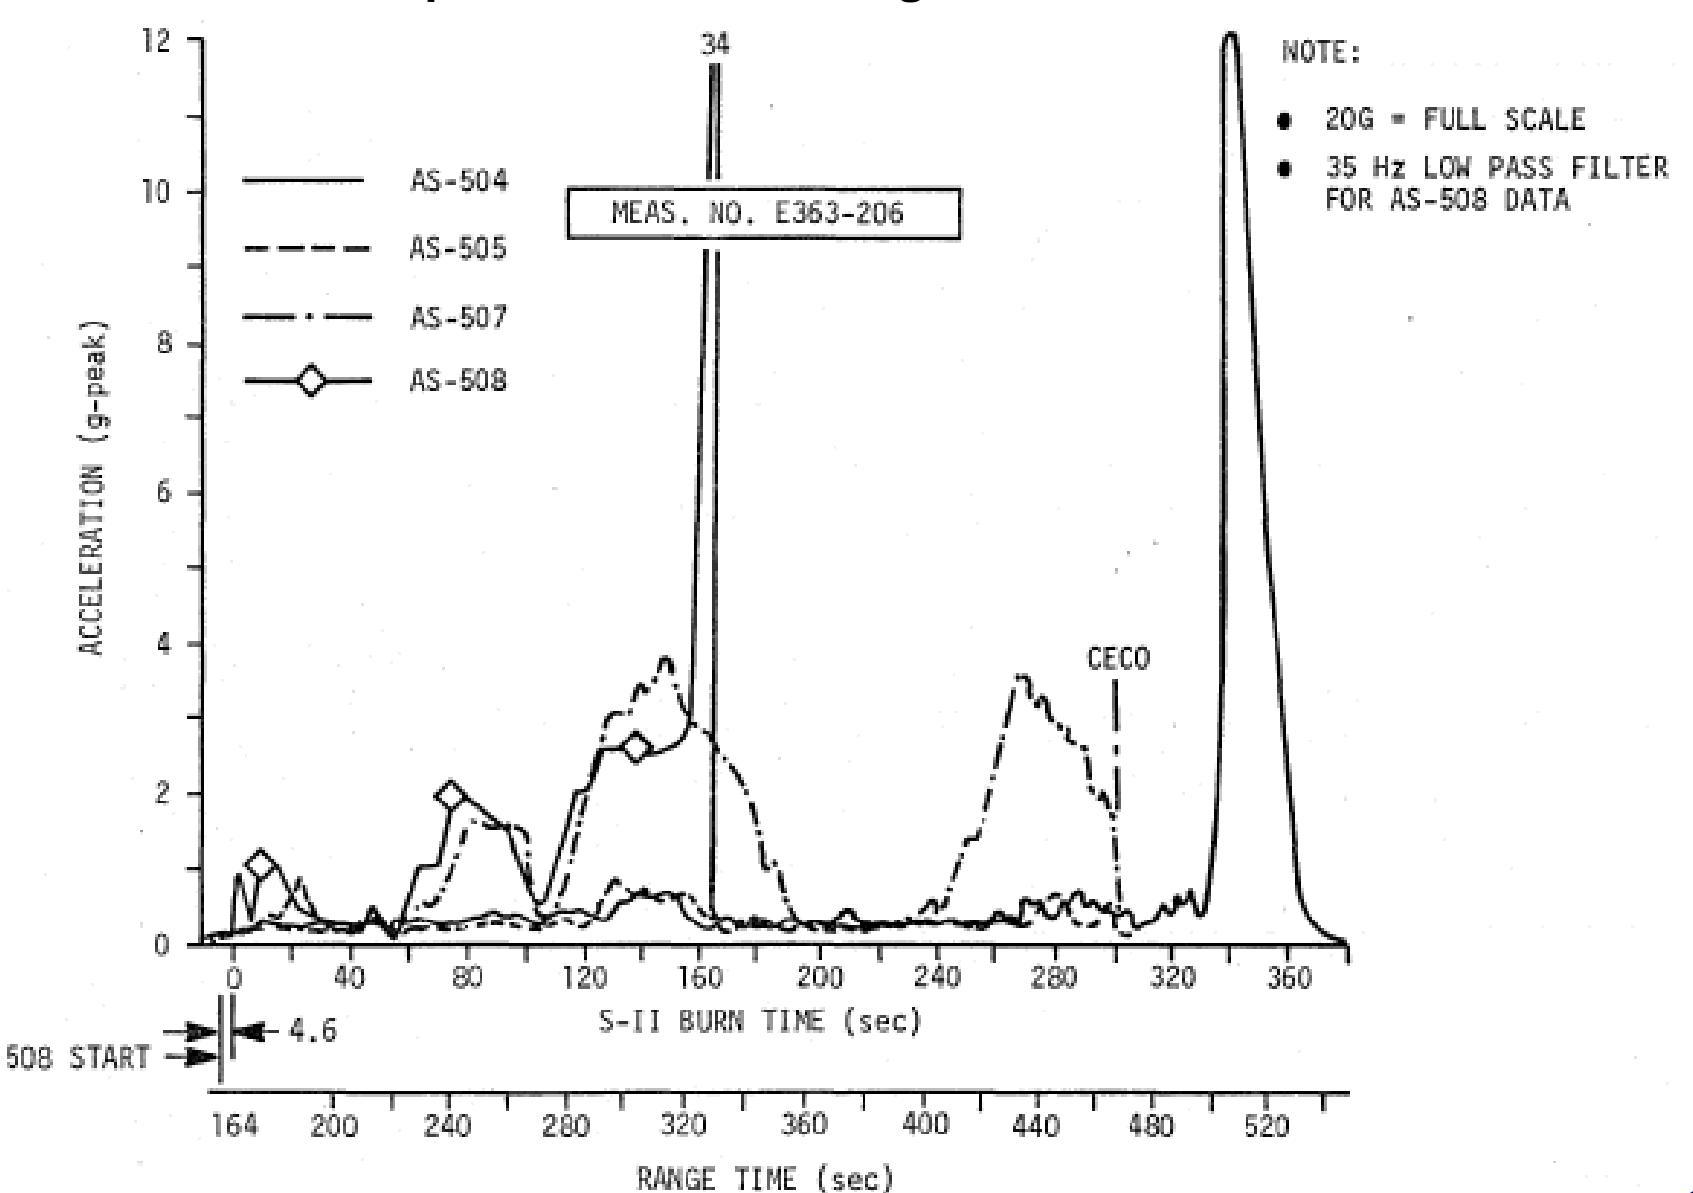
#### **Comparison of Center Engine Acceleration**

- AS-501 & AS-502 no S-II Pogo was observed. (limited instrumentation)
- AS-503 17 Hz oscillation near 480 seconds. Self limiting – local oscillation on center engine.
- AS-504 17 Hz oscillation near 500-540 seconds.
  12g's at center engine self limiting local oscillation.
- AS-505 & AS-506 No S-II Pogo was observed (limited instrumentation) Center engine cutoff approximately 60 seconds early as planned.
- AS-507 16 Hz near 120-180 & 240-300 seconds. Self limiting – local oscillation. Center engine cutoff approximately 60 seconds early as planned.
- AS-508 16 Hz near 120-160 seconds (24 g's amplitude) Pump cavitation caused early center engine cutoff
- AS-509 & subsequent flights no Pogo at 16 Hz.
  Center engine LOX line accumulator implemented.

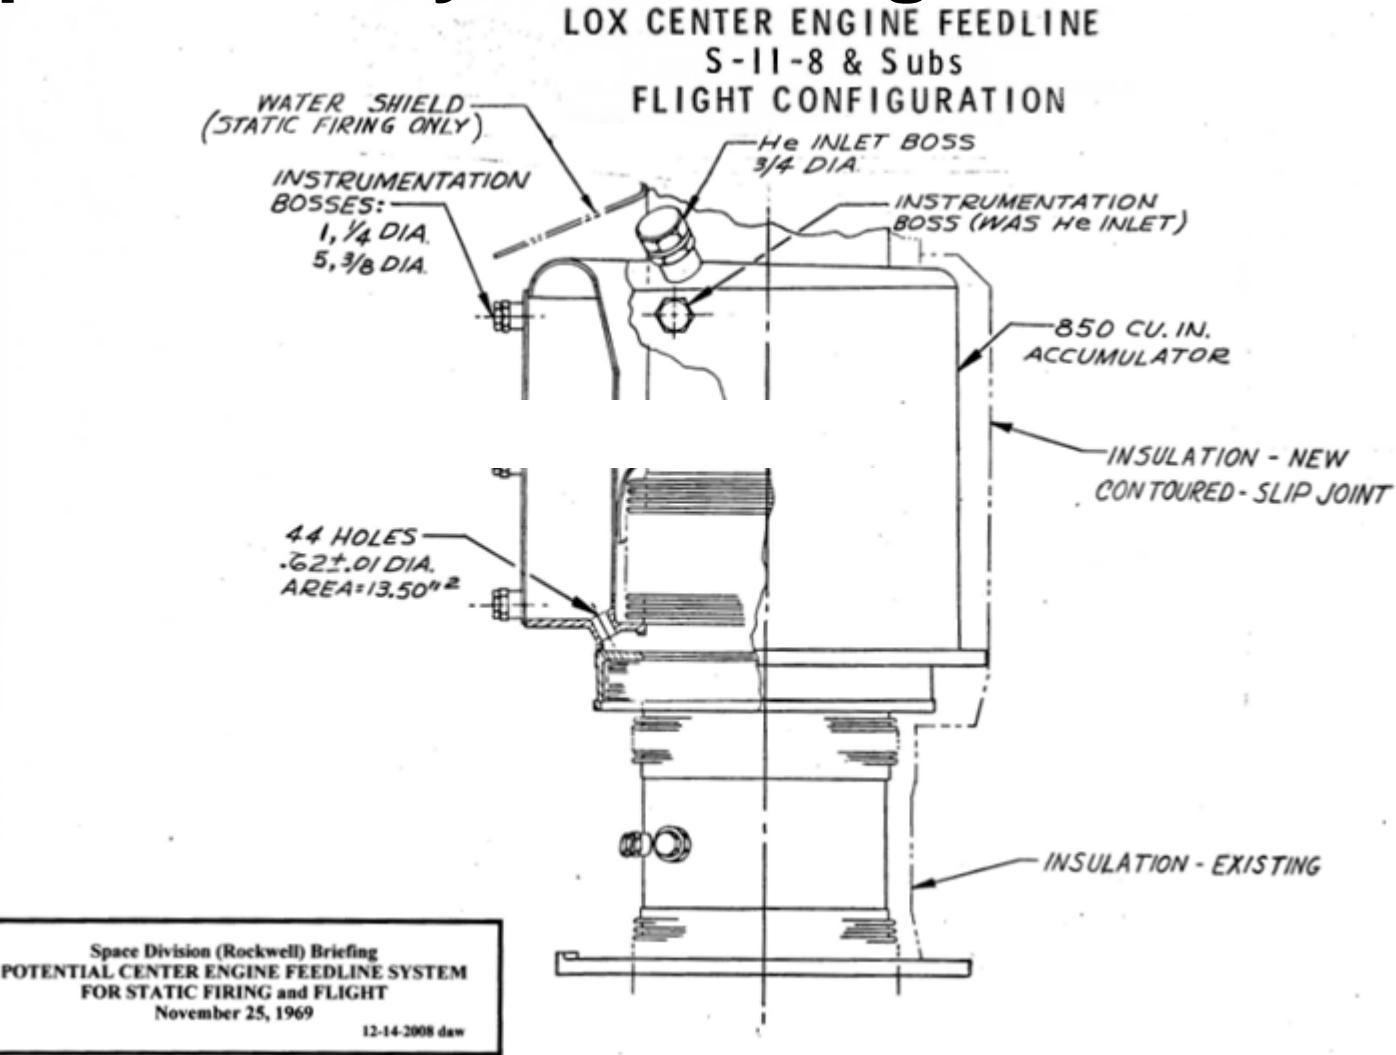
## **Suppression System Design**

- Before AS-508 (Apollo 13), S-II Pogo events were considered to be self limiting and local.
- Ironically, AS-508 (Apollo 13) was planned to incorporate a Pogo Suppression System. Stage contractor indicated that the change was to be made on S-II-8 and subsequent vehicles (see label on following schematic).
- Implementation was delayed.
- Pogo event on AS-508 (Apollo 13) forced an immediate change to incorporate a Pogo Suppression System.
