Surveys of Returned ISS Hardware for MMOD Impacts

Jim Hyde...... [Jacobs/CLG XI4] Eric Christiansen... [NASA/JSC XI4] Dana Lear.......[NASA/JSC XI4] Kornel Nagy........ [NASA/JSC ES2] Eve Berger........[Jacobs/CLG XI3]

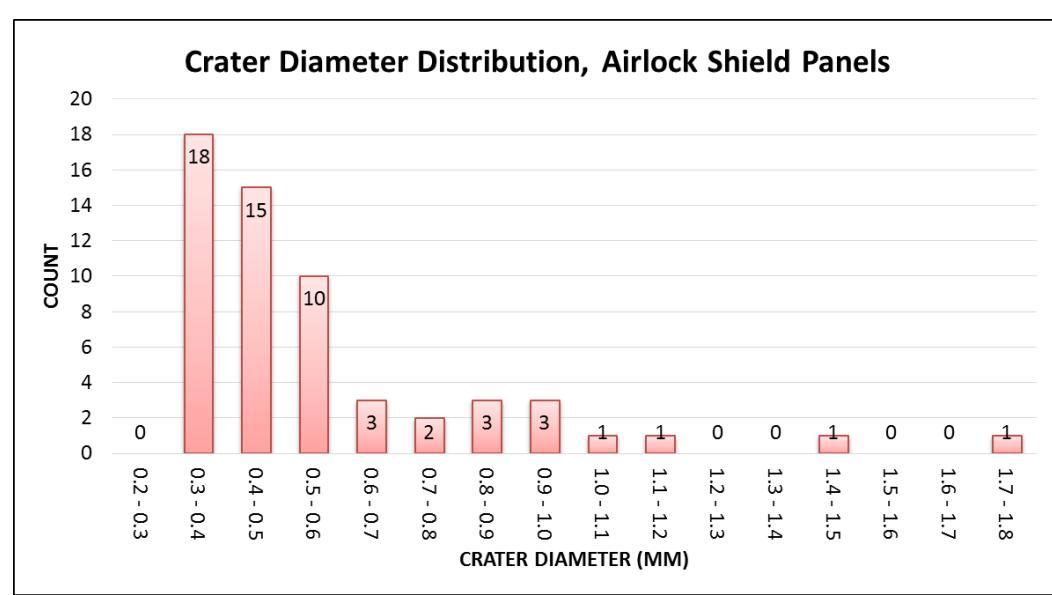
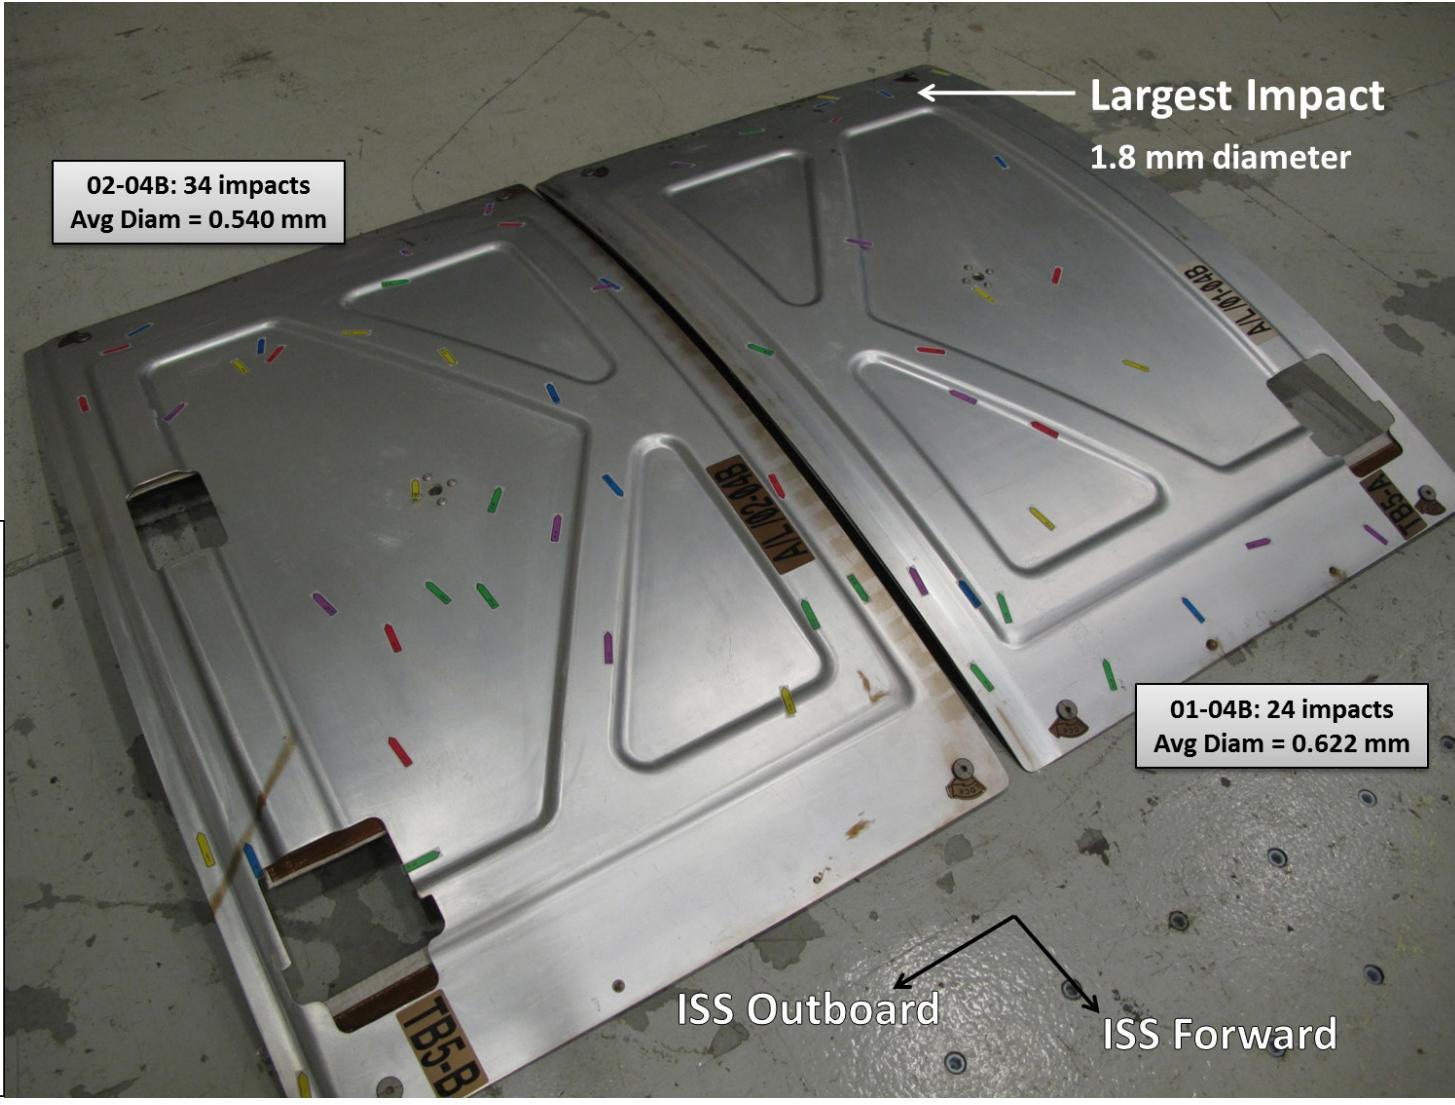
Post Flight Inspection Results

- 58 impact feature observed
- Max crater diameter = 1.78 mm
- Average crater diam. = 0.57 mm

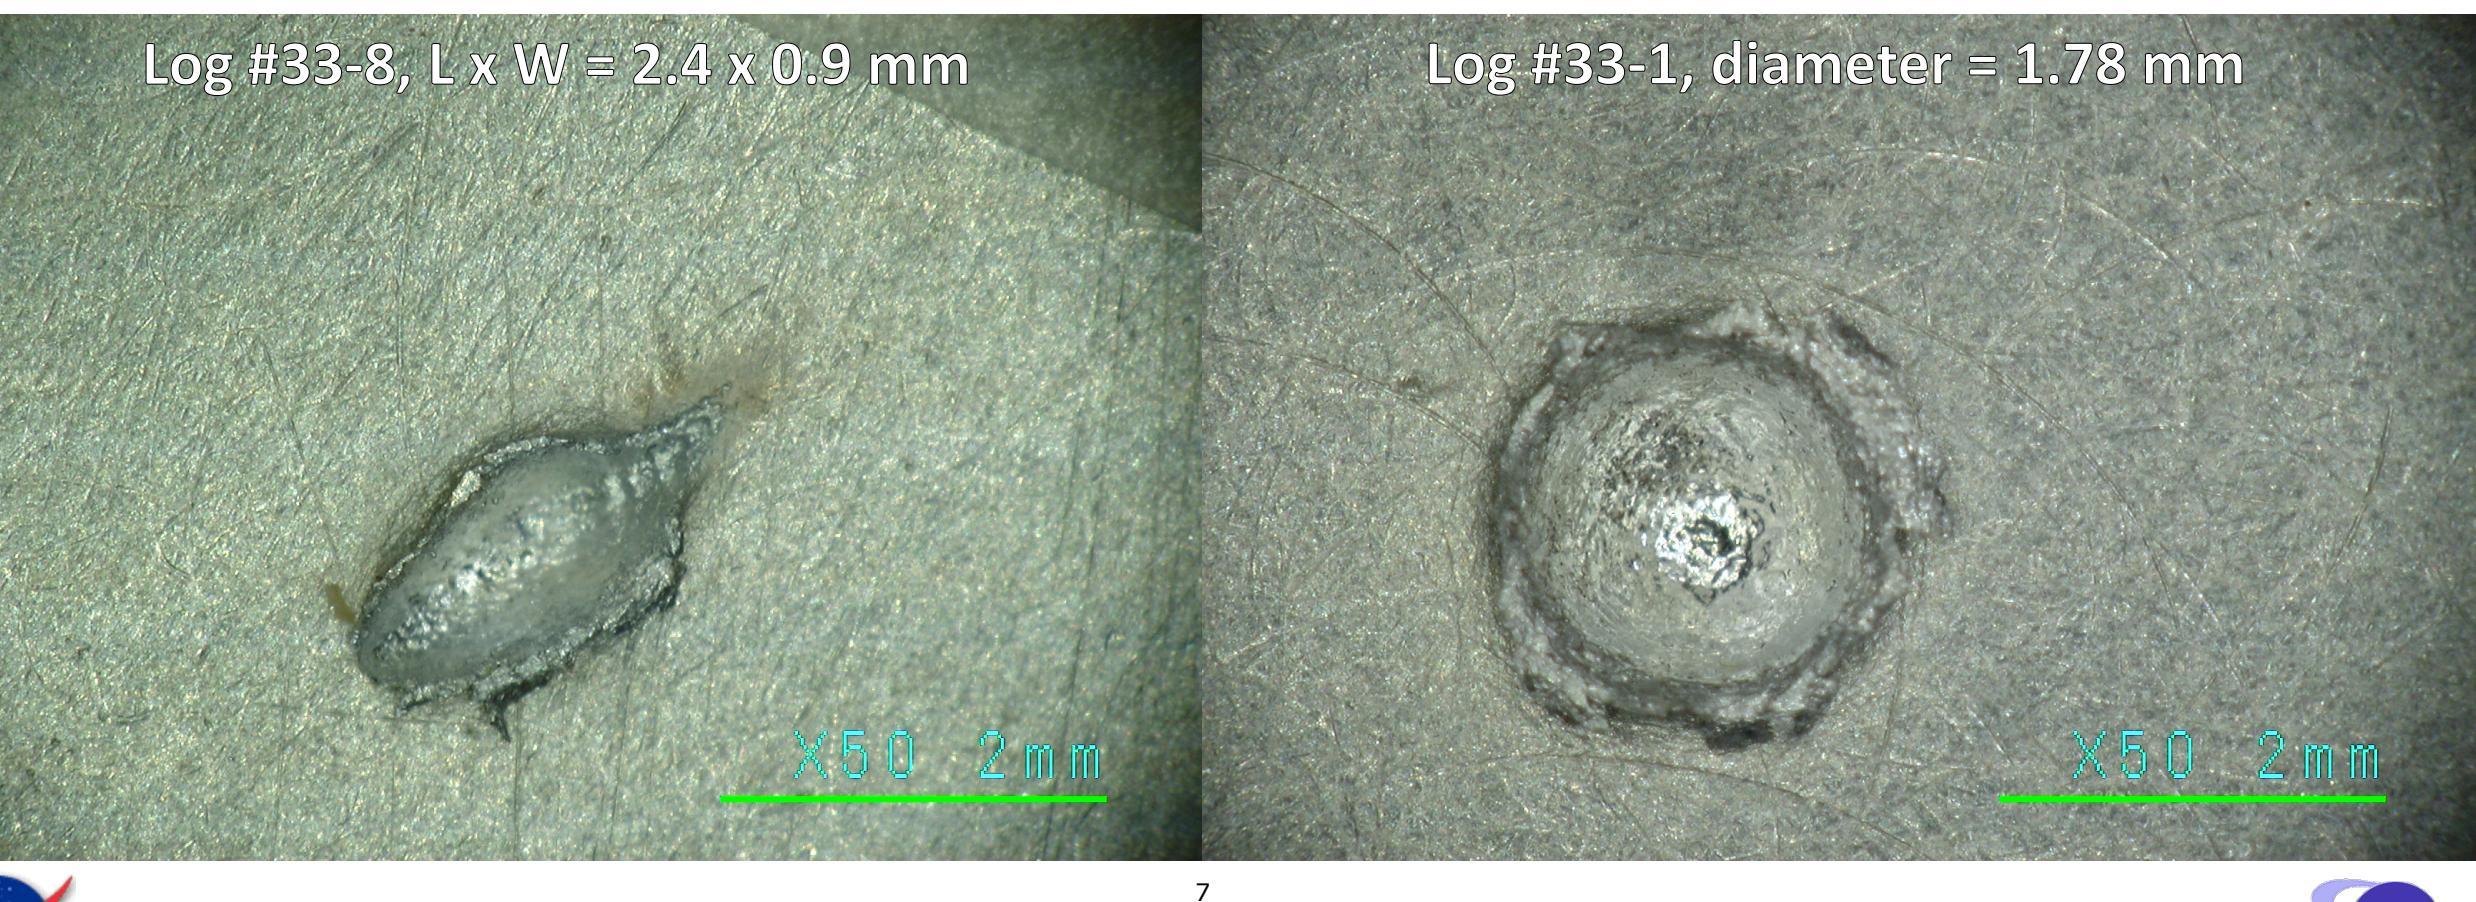
Sampling at Impact Sites

- Intact extraction of craters was not permitted
- Portions of the raised lips at 9 craters were removed for analysis

- SEM analysis revealed many areas with silica melted into the aluminum
- Instances of Fluorine and Carbon were also common

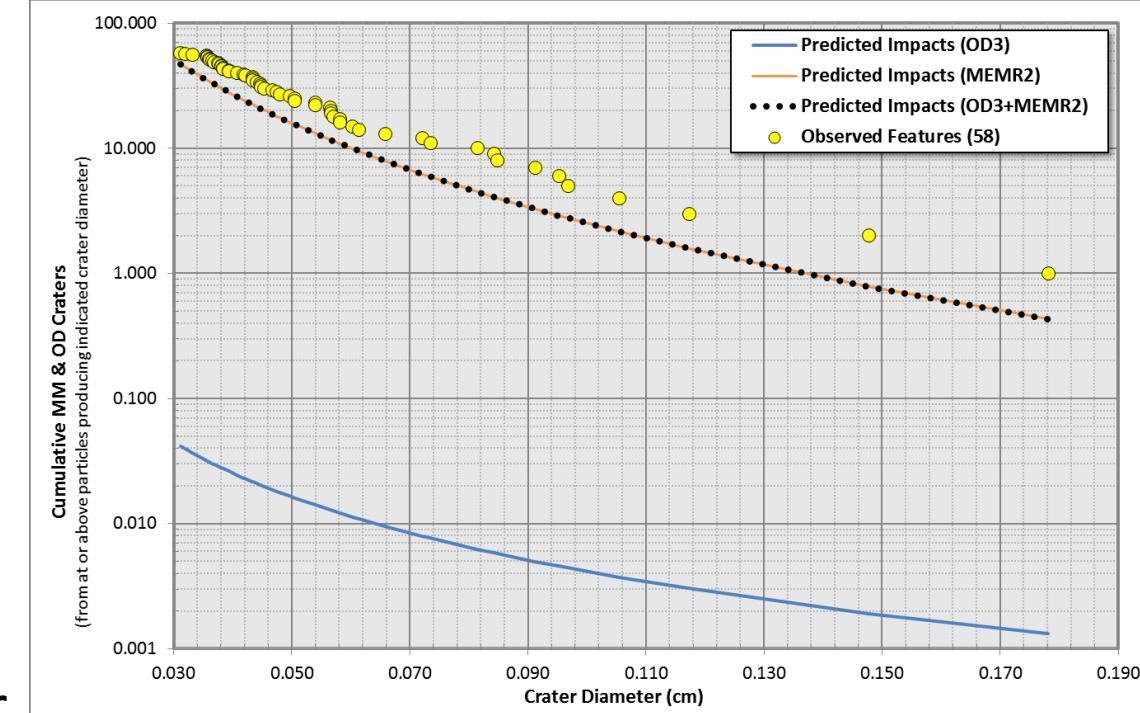
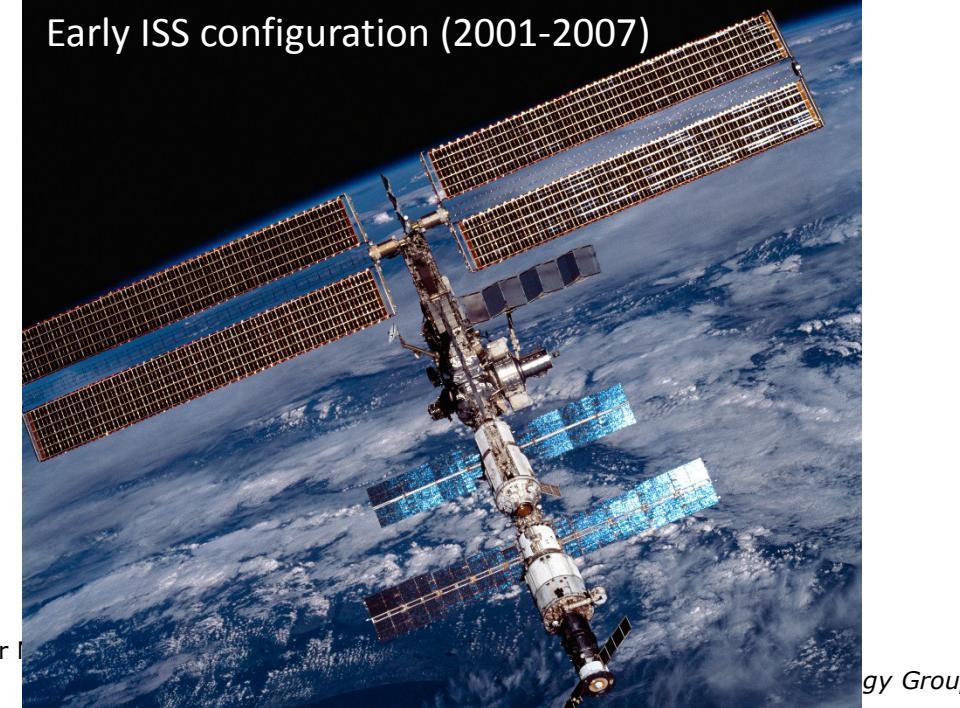
- Micrometeoroids are expected to account for nearly all of the craters
- Shield panels are oriented on the zenith/trailing side of the airlock
- The abundance of orbital debris impacts can be explained by the proximity of the ISS solar arrays wings and radiator
- Secondary debris (ejecta) from MMOD impacts on solar arrays and radiators is the suspected source
- SEM evidence supports the hypothesis, with an abundance of silica detected

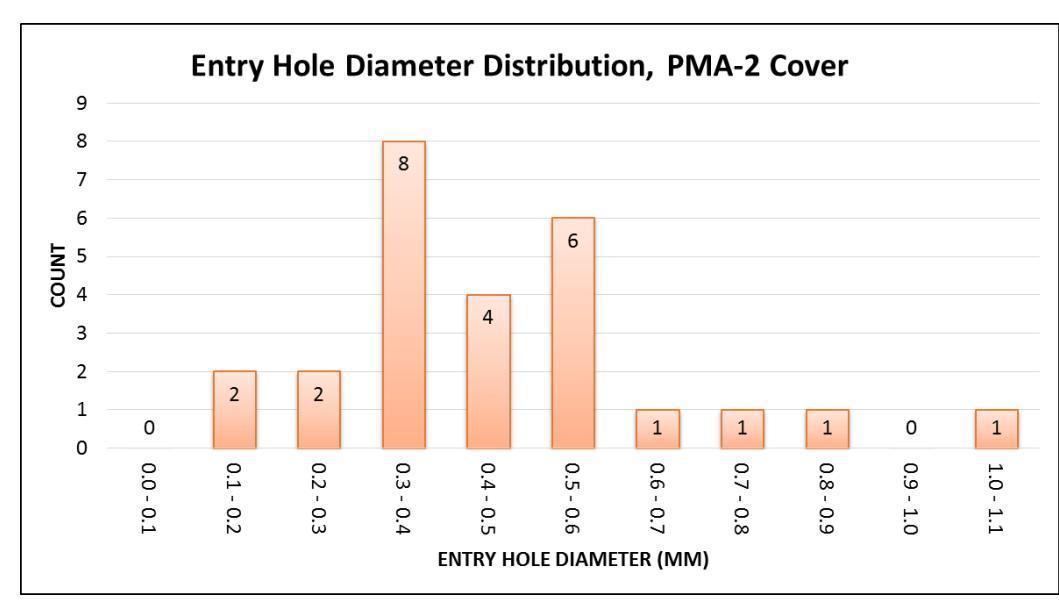
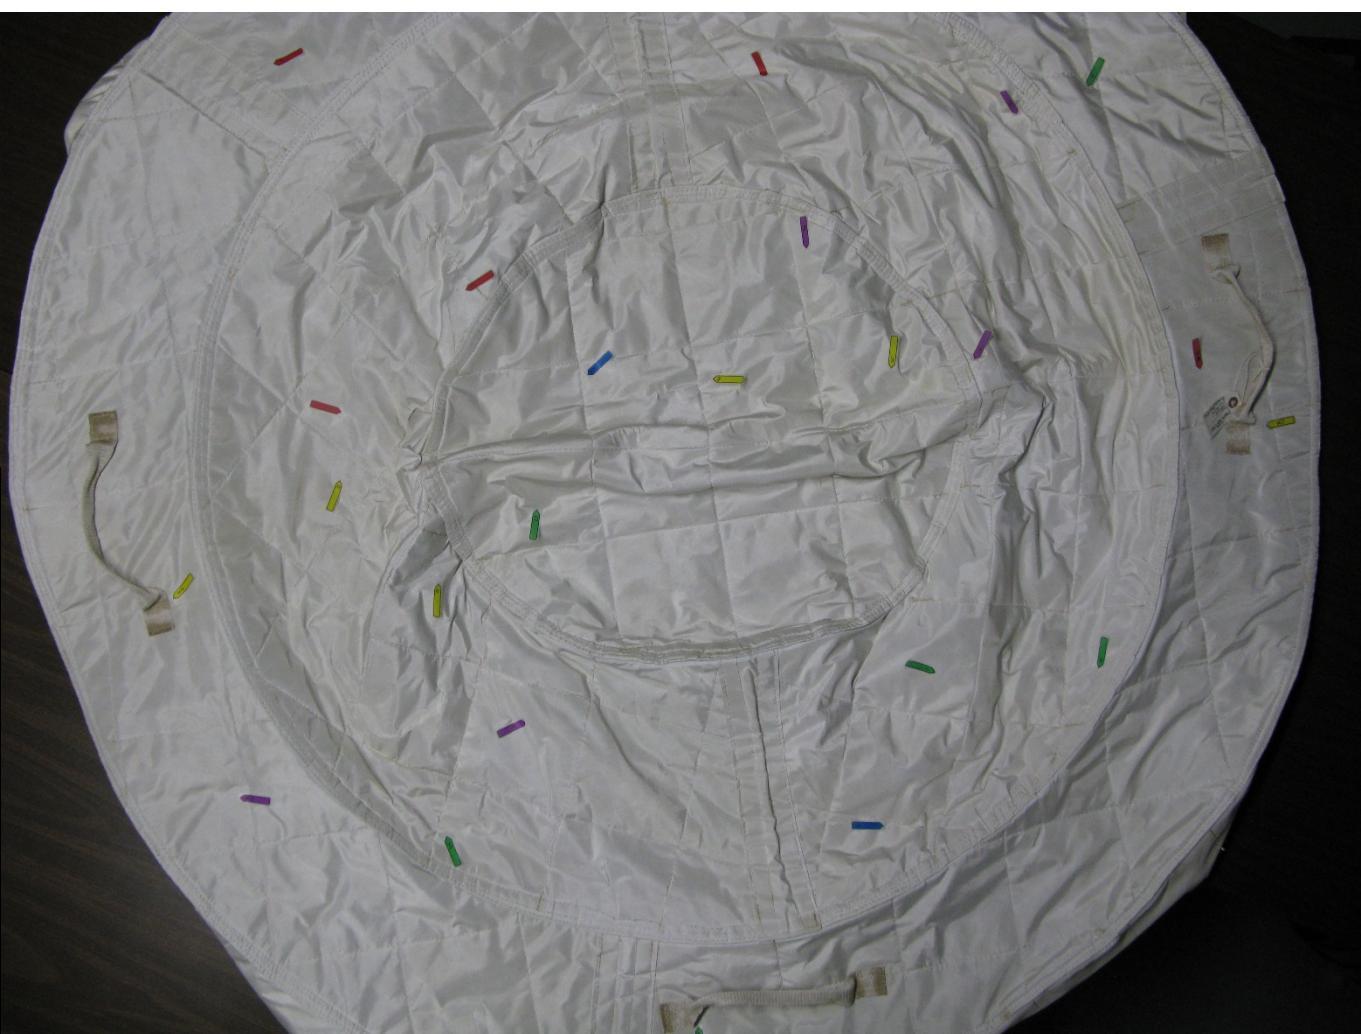
Post Flight Inspection Results

- 26 impact feature observed
- Max hole diameter = 1.01 mm
- Average crater diam. = 0.45 mm

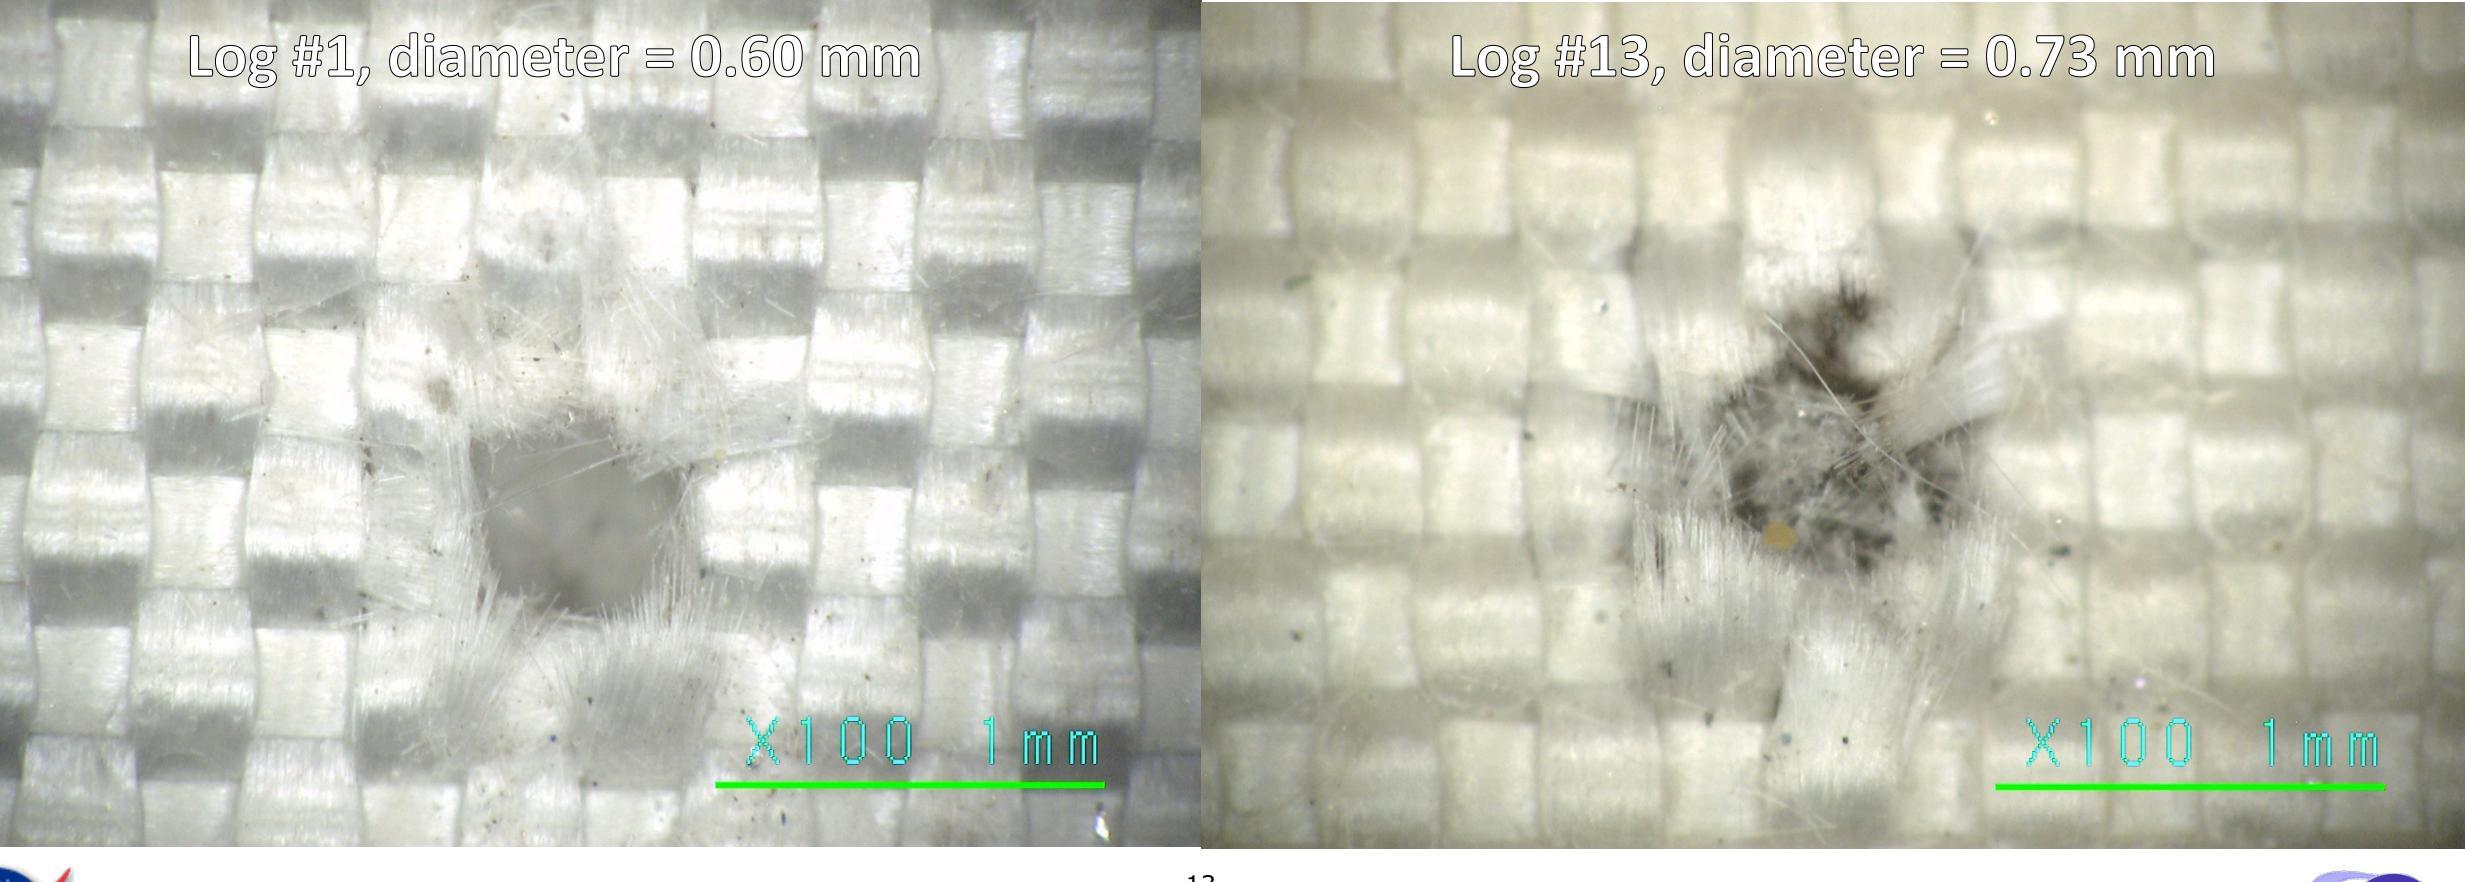
Sampling at Impact Sites

- Six samples were extracted intact using a "hole punch" technique
- Relative orientation of internal layers was preserved

Textural and compositional indications of high density orbital debris as the source in 4 of 6 samples

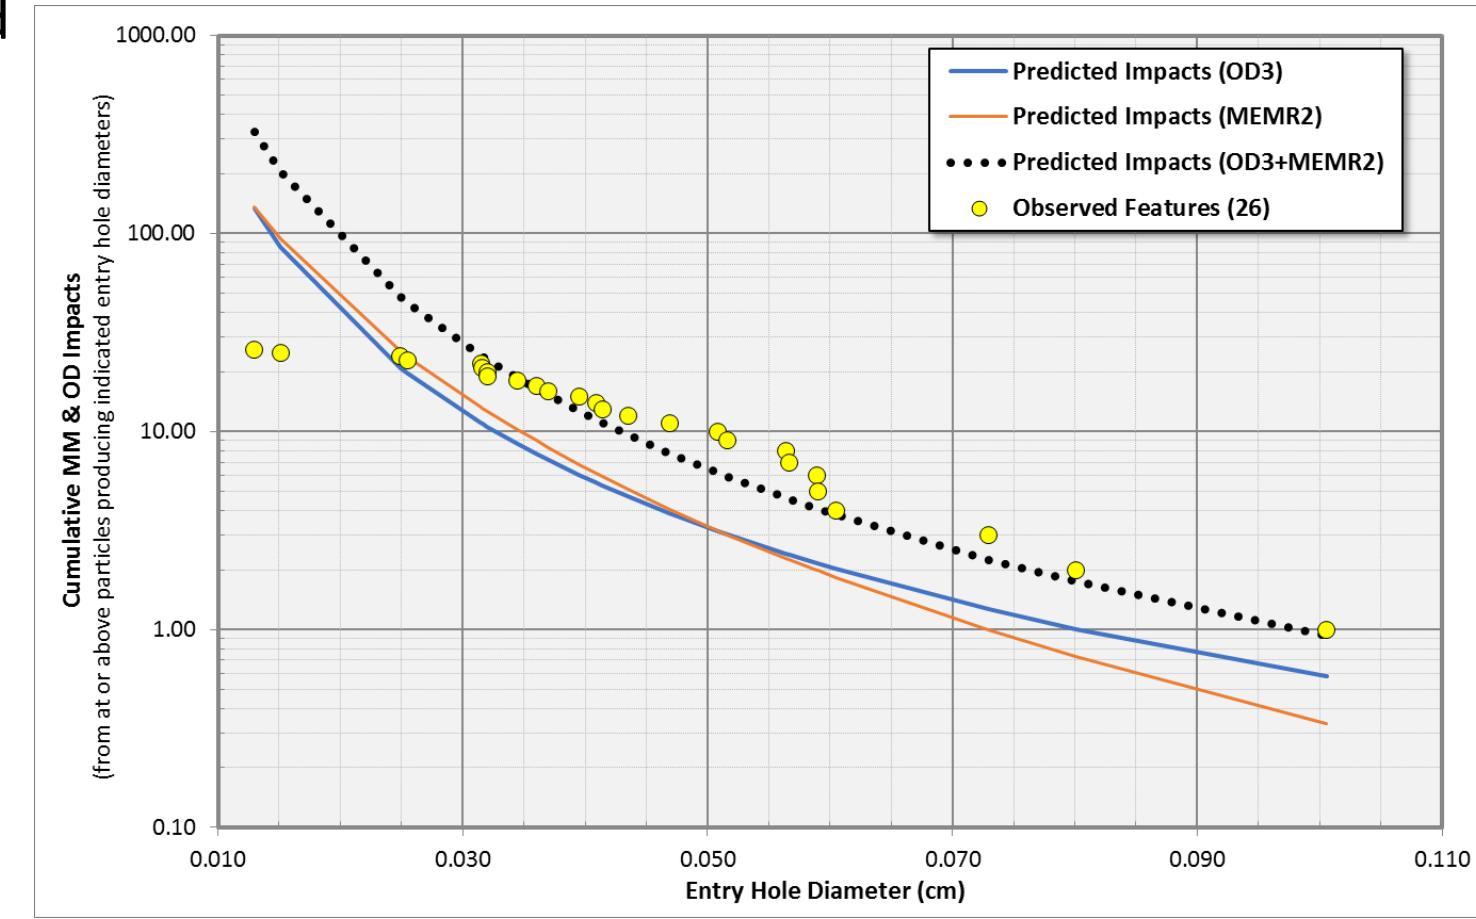
Bumper predictions for MM and OD are much closer to observations
