# Government Working Group

## Justification for Opposing Proposed Change to MIL-STD-883 Intended Seal Width Requirement

Presented at the JEDEC JC13 Task Group 15-02 X-Ray Seal Voids Meeting

January 24, 2017

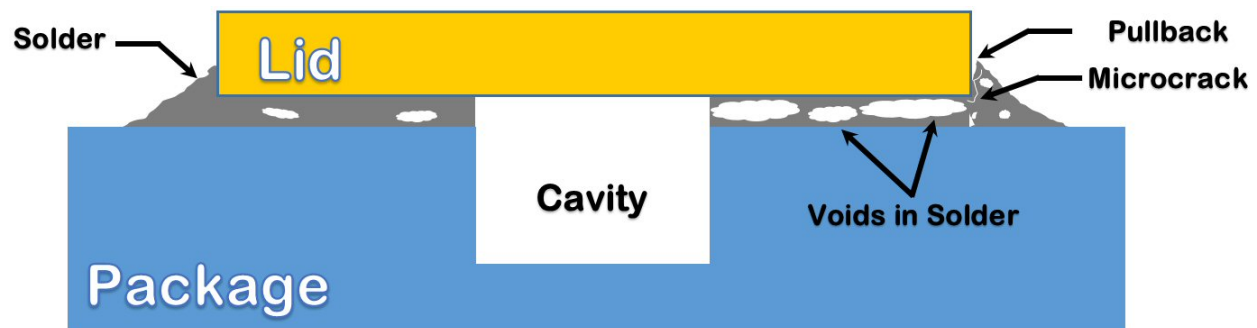
- DLA Land and Maritime has no history of why fillet was included in the seal width for MIL-STD-750 product (requirement inserted in TM2076 in 1/3/2012)
  - M750 has significantly tighter leak rates than M883 and some believe the fillet inclusion was a compromise since tighter leak rates and this change were made in the same timeframe.
- The fillet is not a design feature of the seal process.
  - Fillet width is not a controlled process.
    - Fillet forms when solder flows out from under the lid during the sealing process, and tapering of the fillet results in a non-uniform seal width (see figures on Slide 8).
    - Solder pullback severity can negate the seal effectiveness of the fillet.
    - Microcrack(s) not distinguished in x-rays may compromise seal integrity as they can propagate to a void area when part is placed on board or during box level and system level testing.

Figure illustrating voids, solder pullback, and microcrack in lid seal

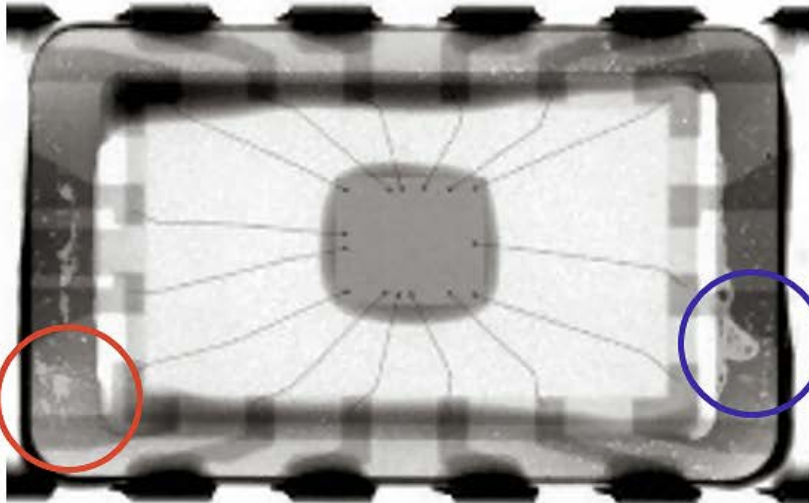
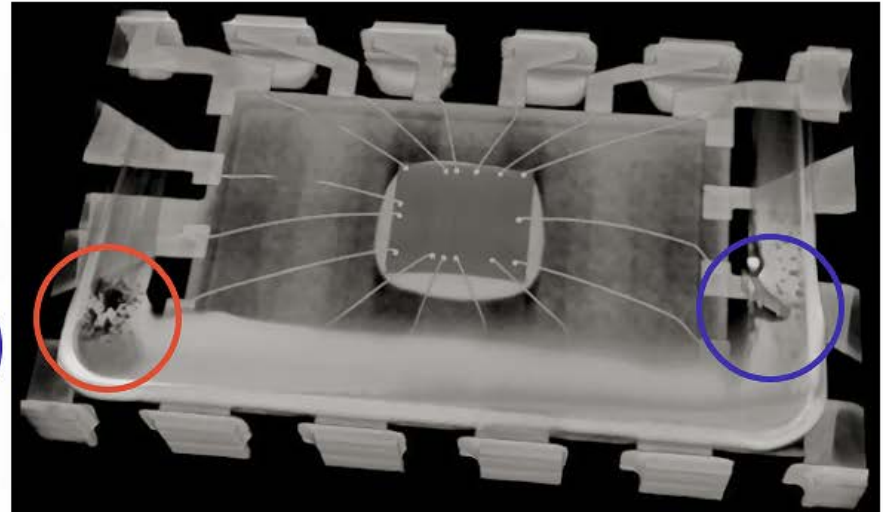
- Voids may reduce sealing width underneath the lid by more than 75% and also contact the fillet.
  - Microcrack(s), not distinguished in x-ray, may compromise seal integrity as they can propagate to a void area.
- The current lid seal requirements would fail this device, yet pass if the fillet is included in the intended seal width.

This part was a randomly selected sample and had this void issue. Because this part was randomly selected, it is highly probable that there are other parts with similar issues.

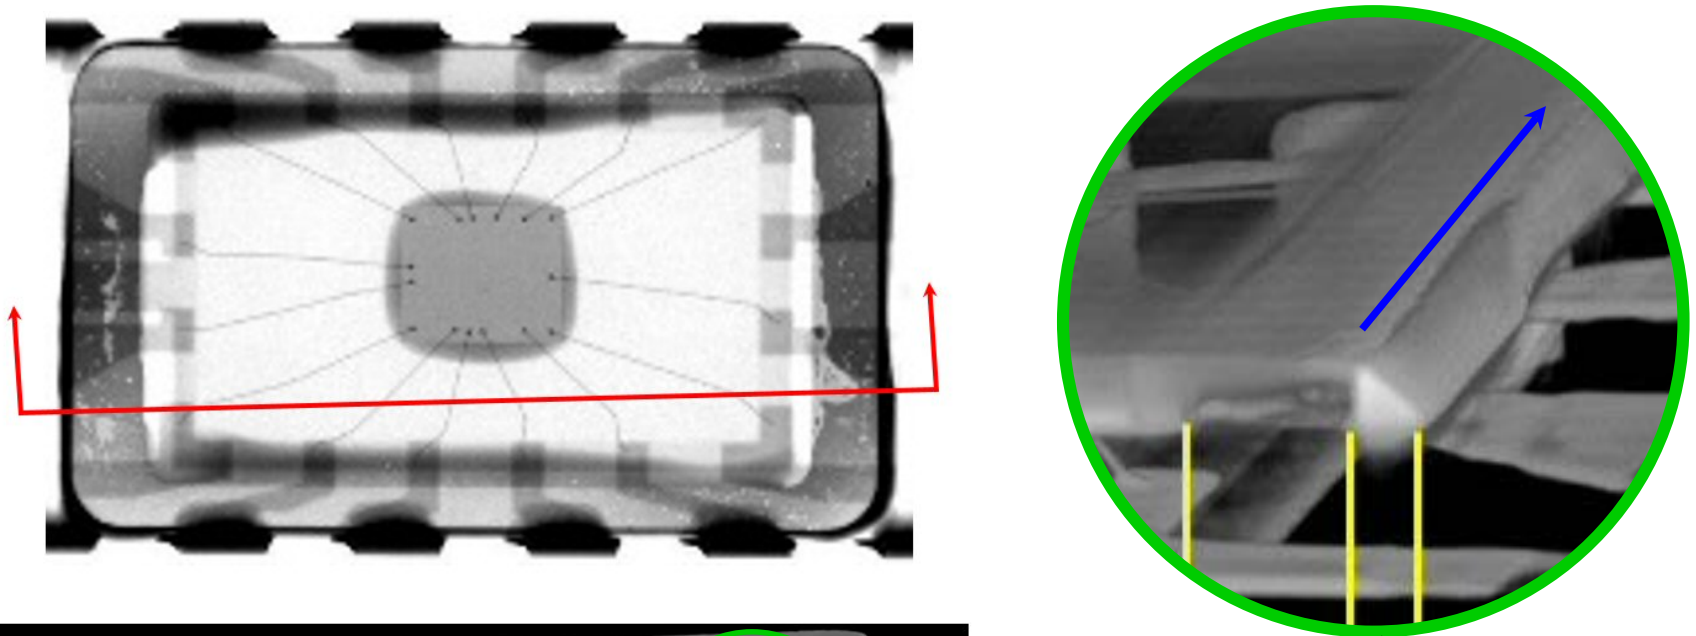
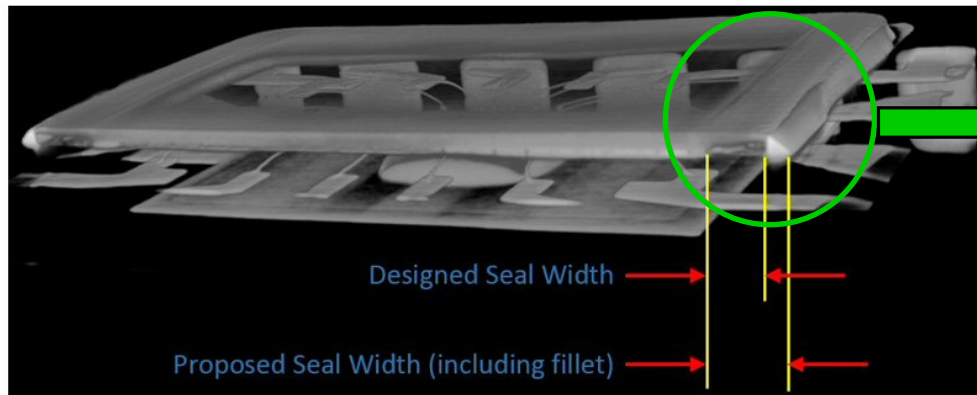
- **Example 1: Excessive Voiding Underneath Lid (continued)**
  - The current lid seal requirements would fail this device, yet it would pass if the fillet is included in the intended seal width.

Darkened areas in the designed seal width are voids and the fillet width tapers (blue arrow).

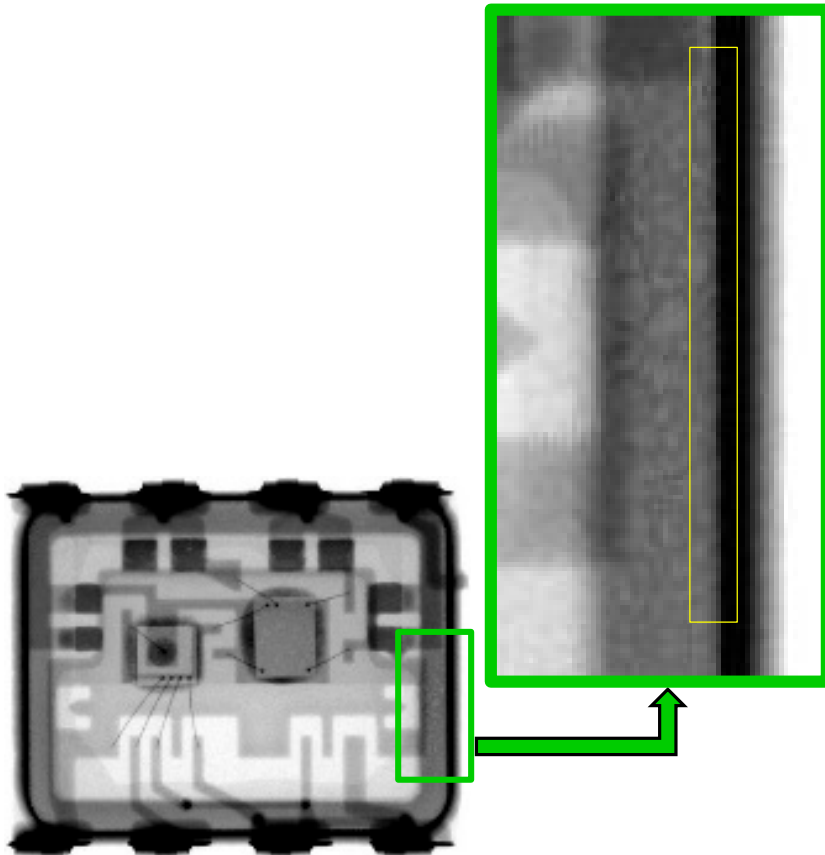
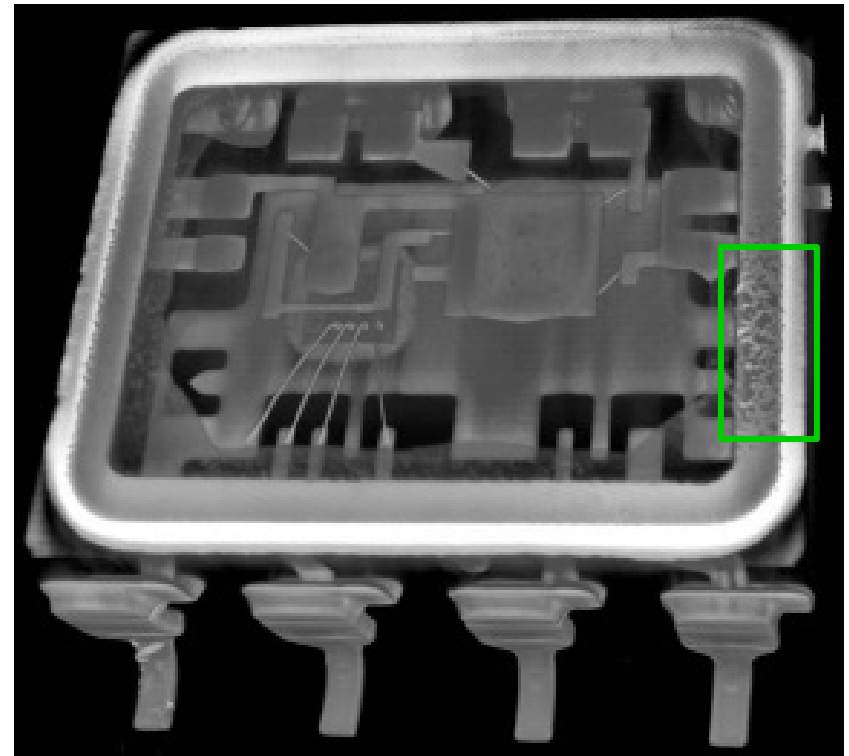
- Voids reduce sealing width underneath the lid by more than 75% and pinholes exist in fillet area next to the lid. Note that the pinholes are not clearly detected in the 2D x-ray image (yellow box) due to the thick, x-ray dense solder of the fillet.

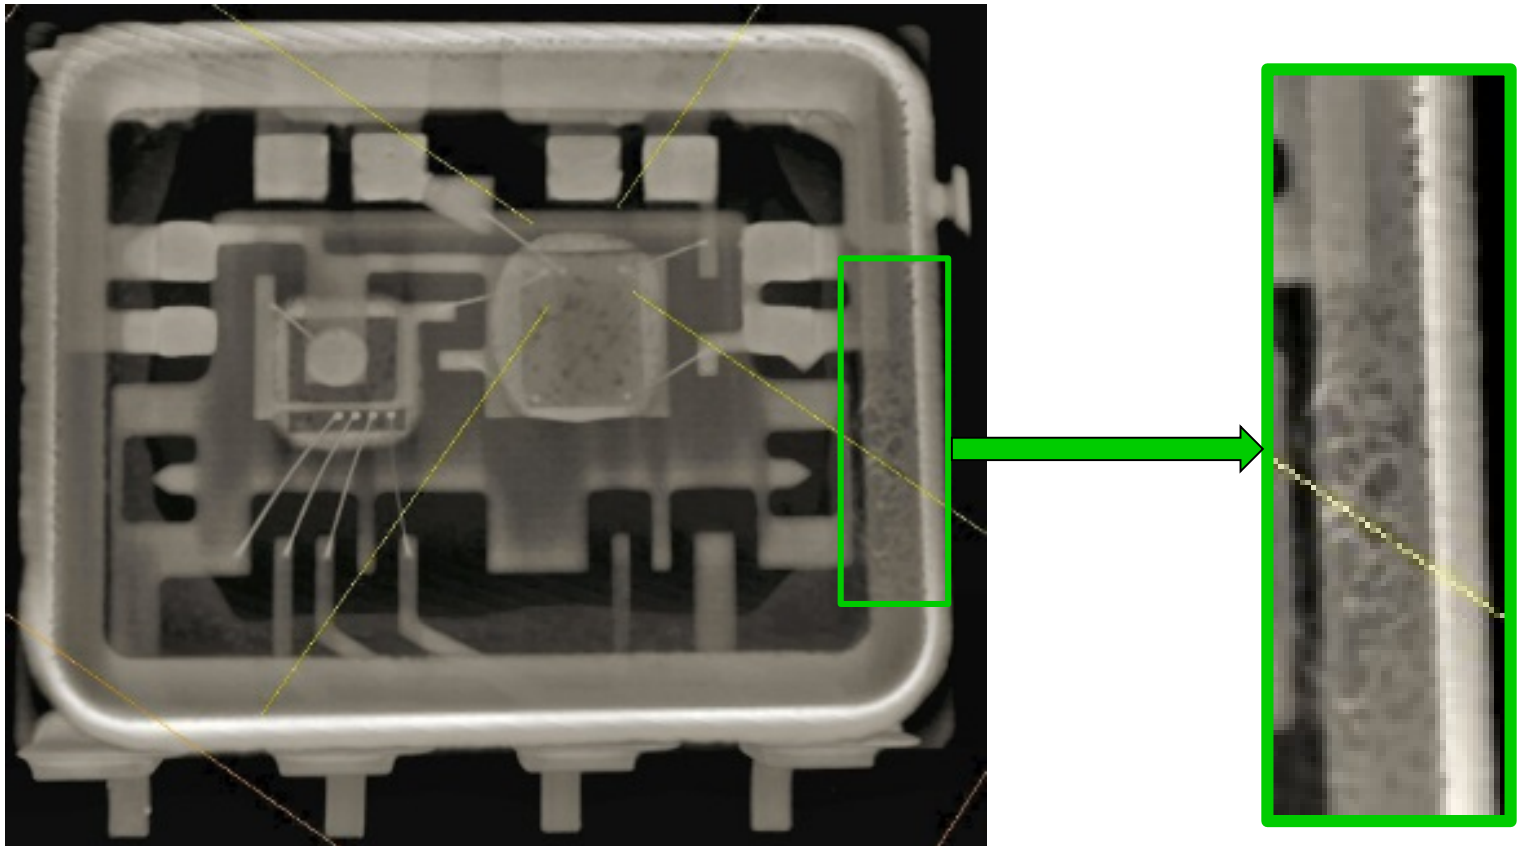
- **Example 2: Excessive Voiding Underneath Lid (continued)**
  - Another 3D-CT image of the device shown on Slide 9. This part would fail the current criteria, but would pass if the fillet was included in the design width. Note the pinholes in the fillet next to the edge of the lid, which provides a potential leak path.
