## Day of Remembrance

*By John Uri*

*NASA Johnson Space Center*

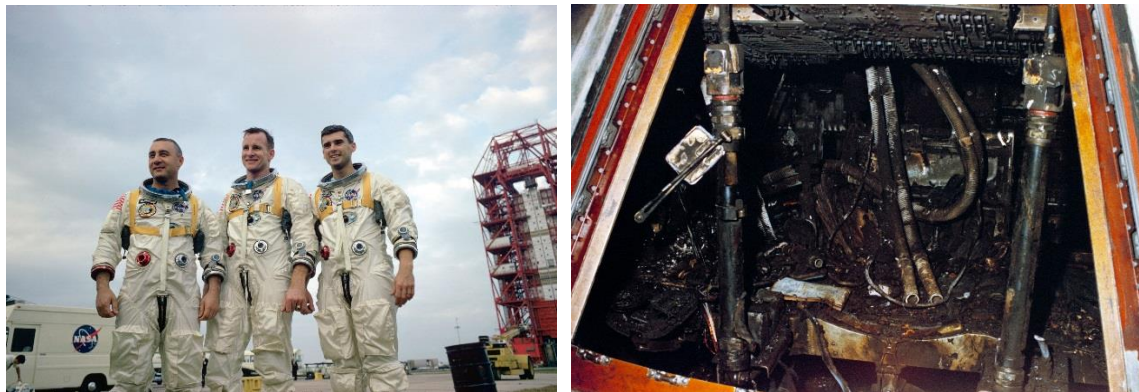
A small fire under Grissom's seat spread incredibly fast in the pure oxygen environment and the enclosed space of the capsule. The space suits they were wearing protected the crew from major burns, but the fire rapidly used up the oxygen and the various flammable items in the capsule gave off thick smoke. Within minutes all three men died of asphyxiation. The crew had valiantly tried to save themselves by trying to open the hatch, but the three-hatch design proved too much to overcome: the innermost hatch opened inward, and with the increased pressure caused by the fire the crew physically could not open it.

Immediately, NASA set up an investigation board to determine the cause of the accident. The exact source of ignition for the fire was not determined conclusively, but it was likely an electrical short that set some combustible material aflame. The pure oxygen atmosphere at high pressure and extensive use of flammable materials was an ideal environment for the fire to spread. Although in retrospect these conditions seem obviously hazardous, it was common practice in American aerospace and therefore accepted as safe because there had never before been an accident. Unknown to everyone in the US until decades later, a Soviet cosmonaut had died tragically in 1961 under similar circumstances during a ground test in an altitude chamber filled with pure oxygen, an accident the Soviets kept secret for

*Apollo 1 crew of (l. to r.) Gus Grissom, Ed White and Roger Chaffee (left); charred remains of the Apollo 1 capsule (right). Images courtesy of NASA.*

In response to the review, the contractor implemented many modifications to the spacecraft, including redesign of the wiring, a quick opening hatch, eliminating the use of a pure oxygen atmosphere during ground tests, and removal of many flammable materials. NASA improved its management and safety organizations with the establishment of an independent safety review organization. No American flew in space for 21 months until October 1968, when NASA deemed the Apollo system was again safe to carry crewmembers.

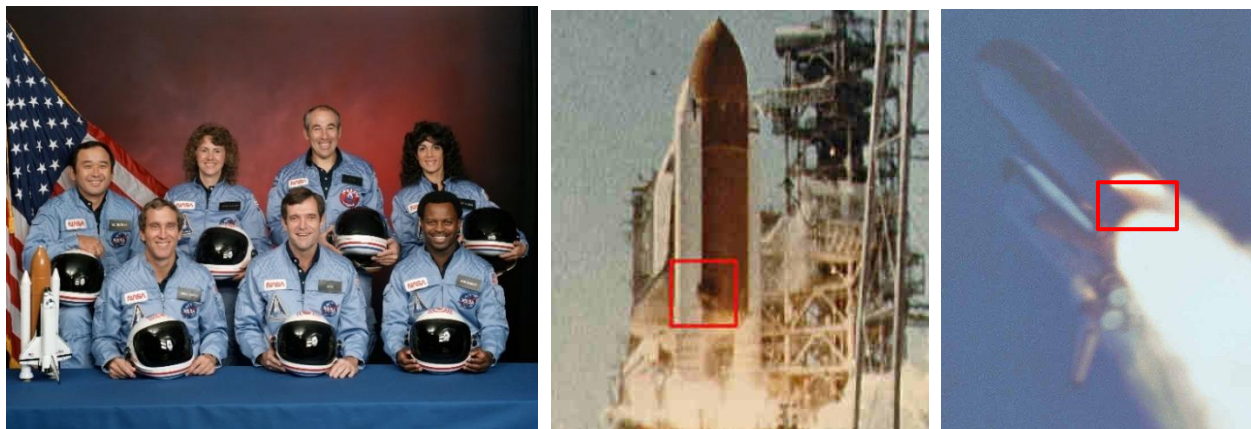
Unbeknownst to the crew and all watching the launch either in person or on TV, trouble started mere moments after liftoff. During the investigation, a puff of black smoke could be seen on video of the launch less than a second after liftoff, coming from the side of the right-hand SRB. This was the first sign that the O-rings were failing and hot gases were escaping. Within less than a minute, this had grown to

The independent Rogers Commission was empaneled to determine the cause of the accident and to make recommendations so the program could resume flying safely. The focus immediately turned to the O-rings in the joints of the SRM's. There had been issues with O-rings since the second flight in the program in 1981, but none had caused any real damage, and so the problem had become accepted as normal. But no data existed about how the O-ring material would behave at the low temperatures in which *Challenger* launched, although some engineers predicted it would become brittle and fail. In a simple test during the investigation, this was indeed proven to be true. What was more disturbing is that engineers had raised the issue of the O-rings before *Challenger's* launch and had recommended a delay, but management that had normalized the problem with O-rings and didn't fully appreciate the risk had overruled them.

*Crew of the Space Shuttle Challenger (left): (l. to r.) Ellison Onizuka, Mike Smith, Christa McAuliffe, Dick Scobee, Greg Jarvis, Ron McNair and Judy Resnik. The puff of black smoke from the right SRB moments after launch (center) and the growing plume of flame at about 1 minute (right). Images courtesy of NASA.*

The Commission made several recommendations, both to the Shuttle system and to NASA management. On the Shuttle side, the addition of an escape system would allow crewmembers to exit the vehicle during stable flight (but wouldn't have saved the *Challenger* crew), the use of full pressure suits was mandated, and the O-rings and SRM's were redesigned to prevent a repeat of the *Challenger* accident. More importantly, NASA changed its decision making process to allow for more open discussions of dissenting opinions and created a new independent safety organization. The modifications required 32 months to complete before the next Shuttle flew in September 1988.

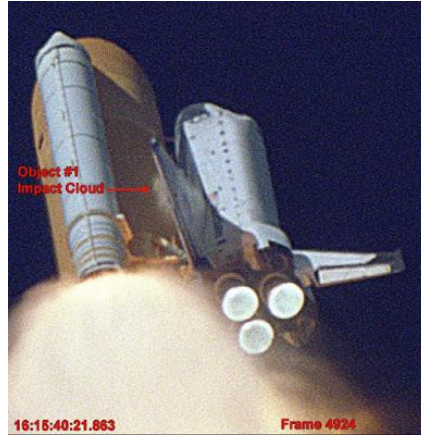
The *Columbia* Accident Investigation Board (CAIB) determined the proximate cause of the accident, and once again noted that there were management cultural issues that were significant contributing factors. NASA knew that 82 seconds after liftoff, a suitcase-size chunk of insulating foam (probably mixed with ice) had come loose from the Shuttle's large orange External Tank and struck the Shuttle's left wing. Imagery of the Shuttle during the flight using powerful ground-based telescopes didn't show any apparent damage, but the resolution was not optimal and some parts of the vehicle couldn't be properly observed. Concerned engineers repeatedly requested the use of other "national assets" to photograph *Columbia* at higher resolution but ultimately management rejected the requests. Based on the available data, therefore, management deemed the situation to be of no real concern, and provided this assessment to the crew. As it turns out, that chunk of foam had punched a hole in *Columbia's* left wing leading edge. The hole didn't cause any issues until the reentry 16 days later, when super-hot gases intruded into the wing's structure, melting the aluminum frame, eventually causing the wing to detach and the entire vehicle to then disintegrate at 200,000 feet and traveling at about 14,000 mph. The crew cabin rapidly depressurized, causing the crew to lose consciousness within seconds and expire shortly thereafter.

*Crew of the Space Shuttle Columbia (left): (l. to r.) Mark Brown, Rick Husband, Laurel Clark, Kalpana Chawla, Mike Anderson, Willie McCool, and Ilan Ramon. Foam debris at moment of impact during launch of Columbia (right). Images courtesy of NASA.*

The CAIB made several recommendations, and as after the *Challenger* accident, these focused on improving the safety and reliability of the Shuttle itself as well as making organizational and cultural changes to how NASA makes its decisions. Among the former, NASA instituted changes to how the insulating foam was applied and improved monitoring of any foam shedding, and mandated orbital inspection of the Shuttle thermal protection system as the vehicle approached the International Space Station (ISS). Engineers also evaluated methods for in-flight repair of any damage. As far as the latter, the commission again reiterated the need for more open discussions during decision-making meetings
