# **Fatigue Life of a NiCr-Coated Powder Metallurgy Disk Superalloy After Varied Processing and Exposures**

**1. NASA Glenn Research Center, 2. DVTI, Inc., 3. Vantage Partners, LLC**

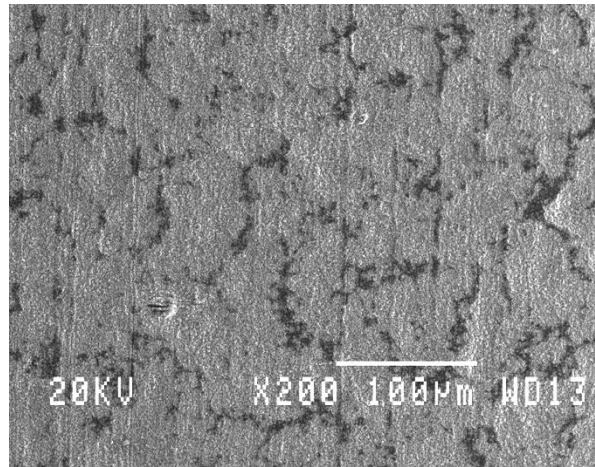
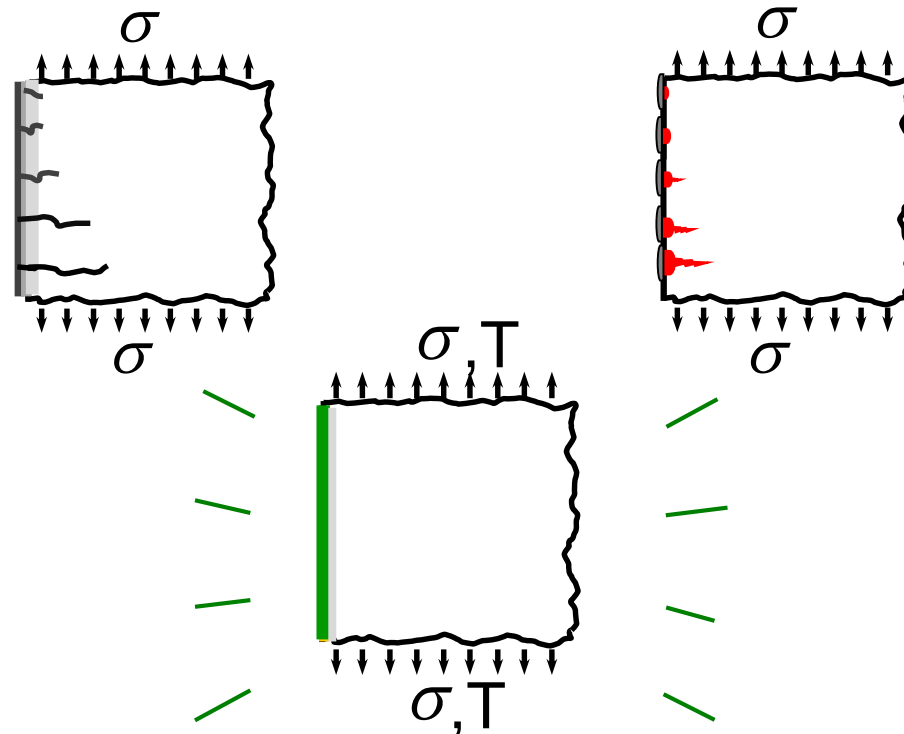
## Oxidation Attack

**Oxide Scales on Surface:  
Up to 98 % Reduction in  
Uncoated Fatigue Life**

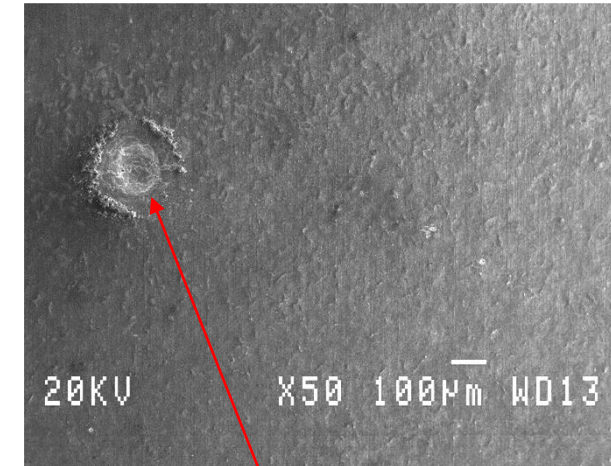
## Hot Corrosion Attack

**Corrosion Pit on Surface:  
Up to 98 % Reduction in  
Uncoated Fatigue Life**

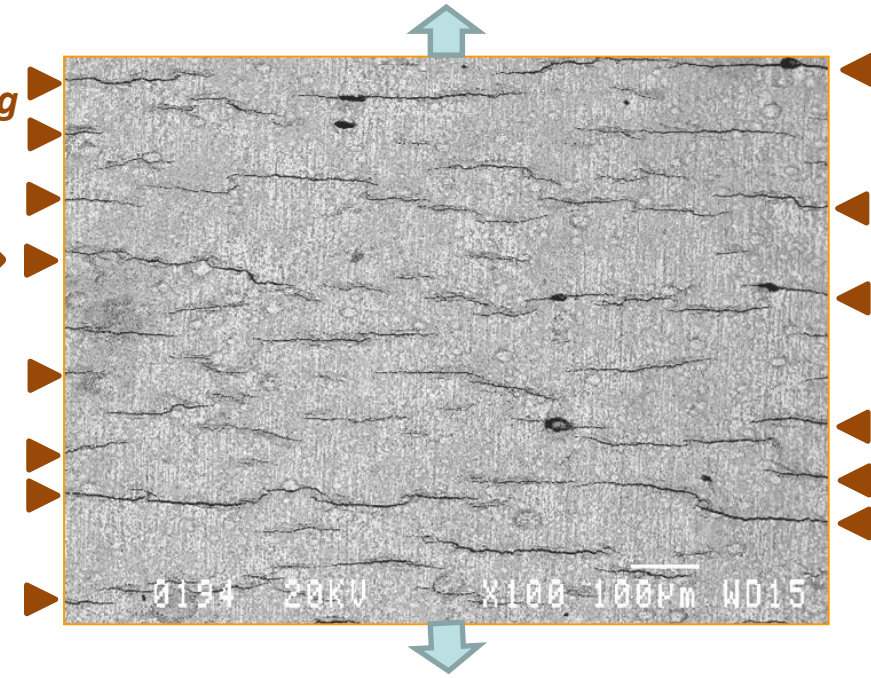
We evaluated a baseline coating process on a disk superalloy using grit blasting to roughen the surface, coating with a Ni45CrY  $\gamma + \alpha$  phase coating, shot peening plus heat treatment. In fatigue tests, this gave increased fatigue cracking at the coated surface.

Enhanced fatigue cracking

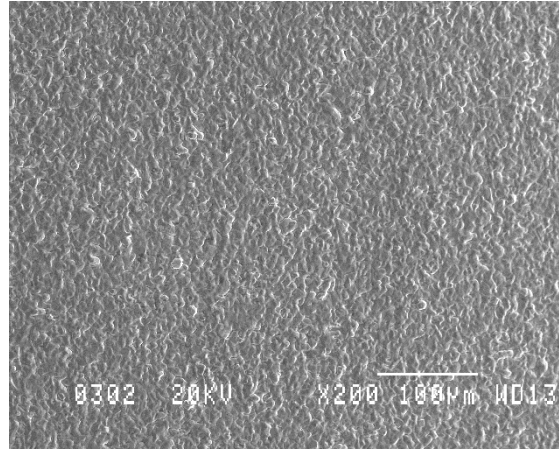
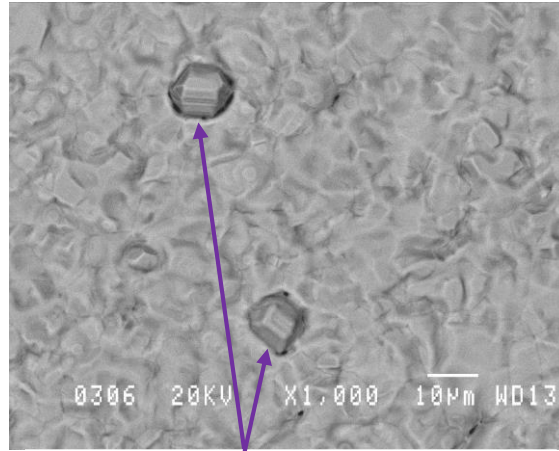
## Coated

**“Spit”**: Produced by occasional arcing event in the coating plasma

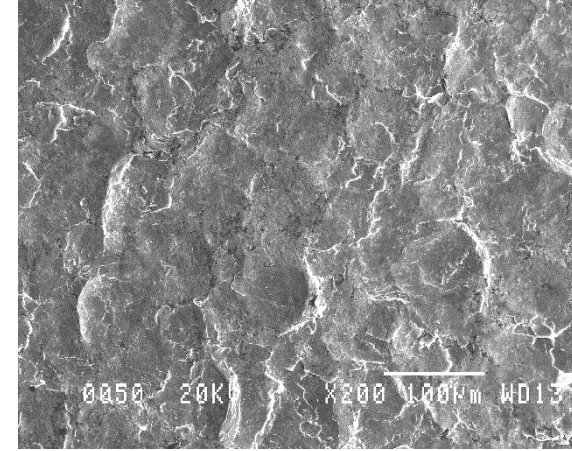
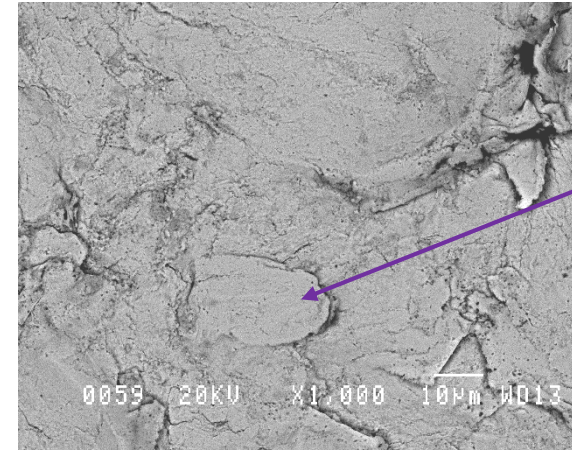
## Post-coating

**Lap**:  
Folded rim of dimple from shot impact

Dark particles  
are embedded  
alumina grit

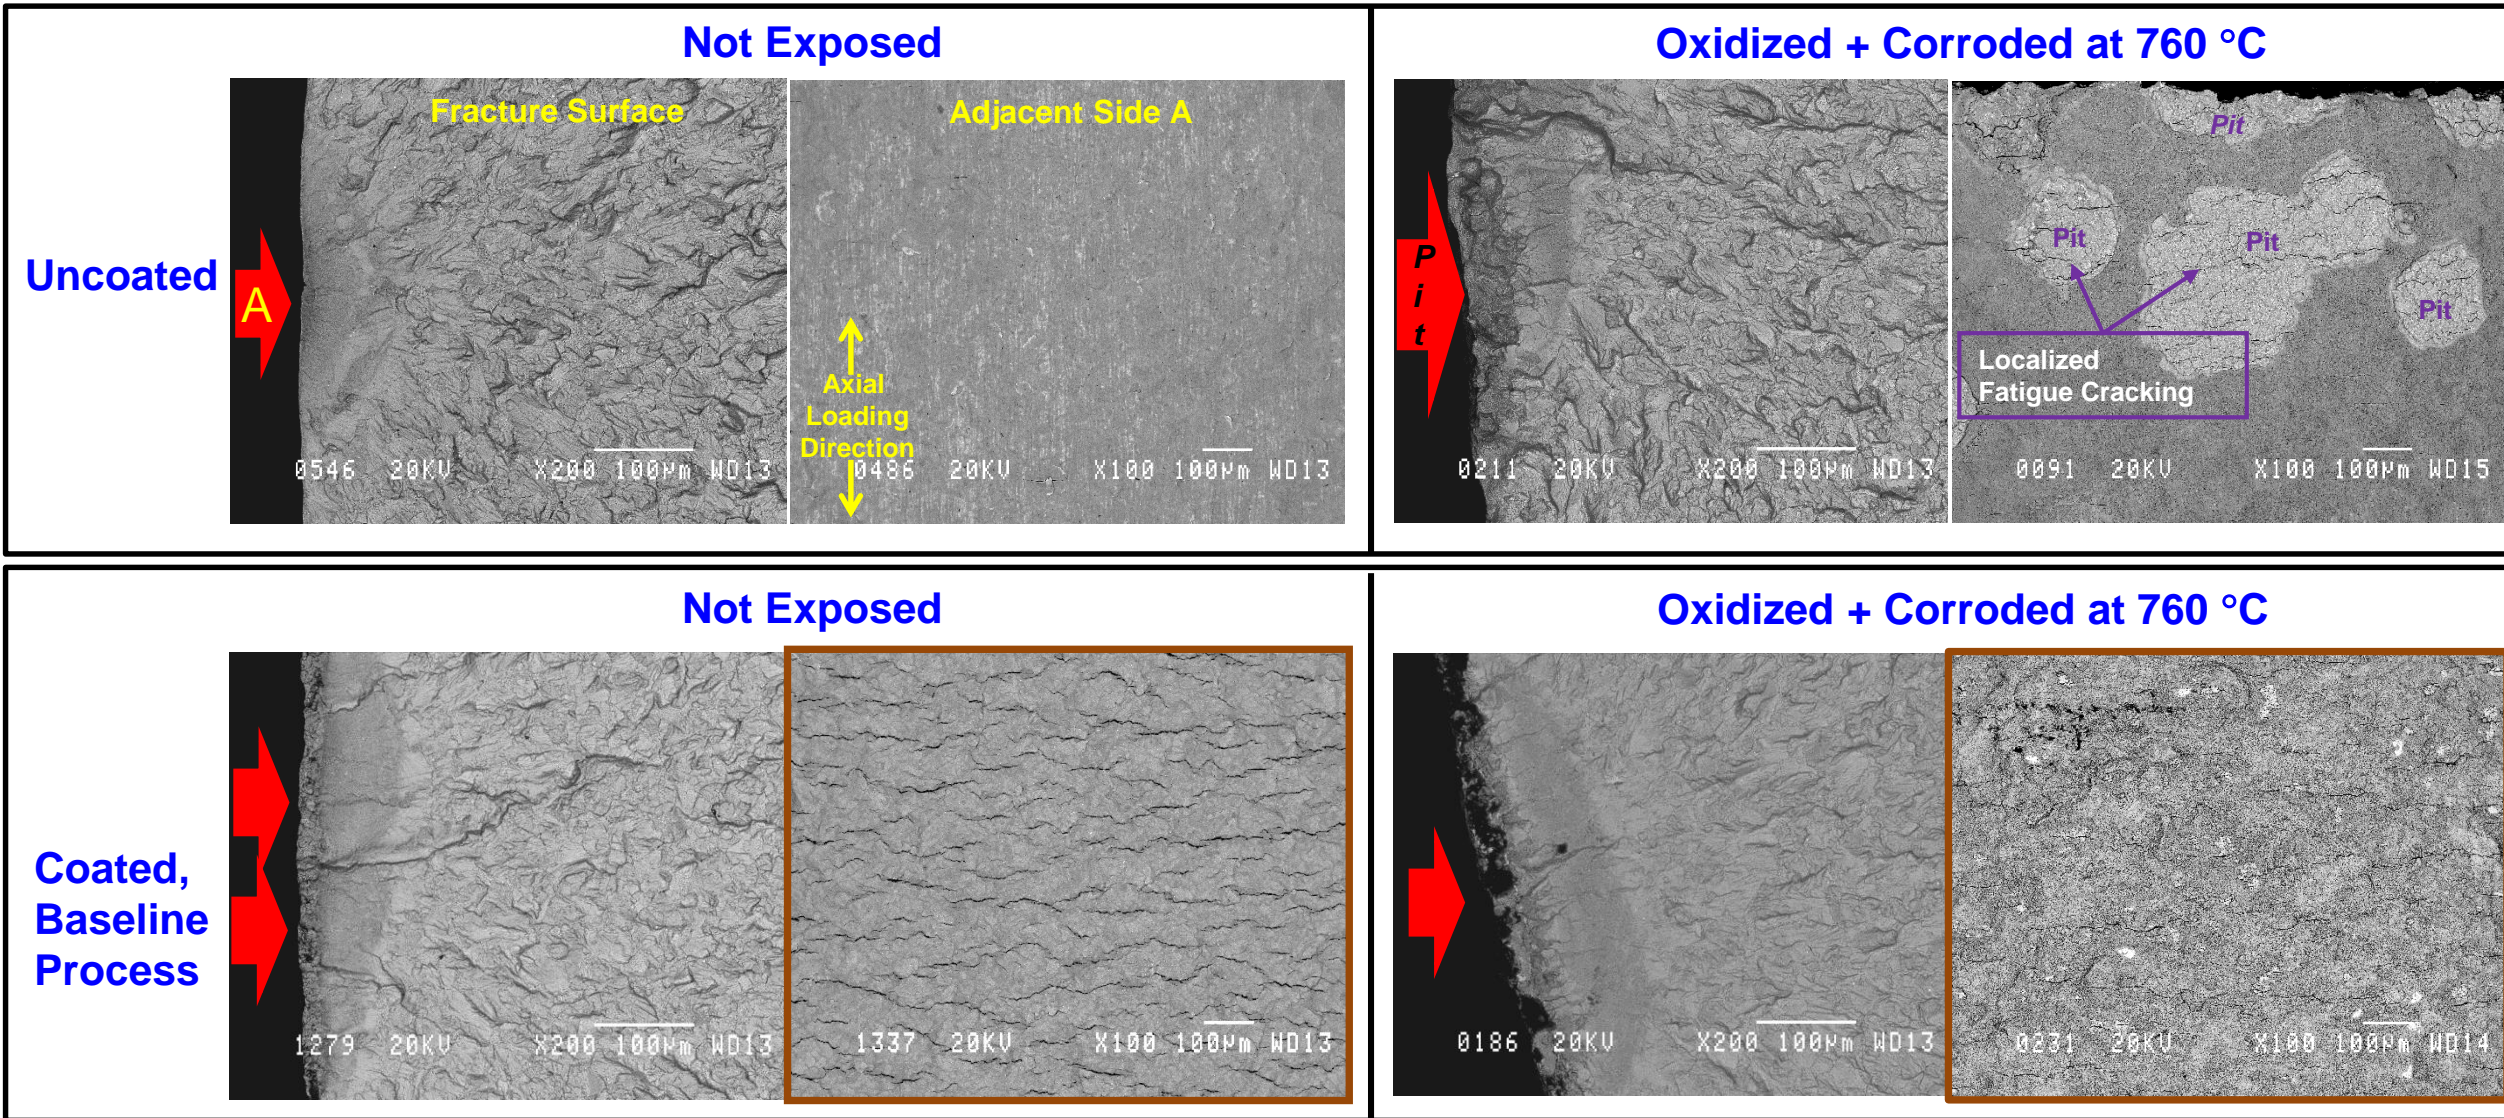
-Uncoated specimens had localized fatigue cracking at corrosion pits.

-The surfaces of coated specimens did not display distinct corrosion pits, yet had increased fatigue cracking, even without oxidation plus corrosion at 760 °C.

➤ A more ductile coating did not eliminate the increased surface cracking, at the coating.

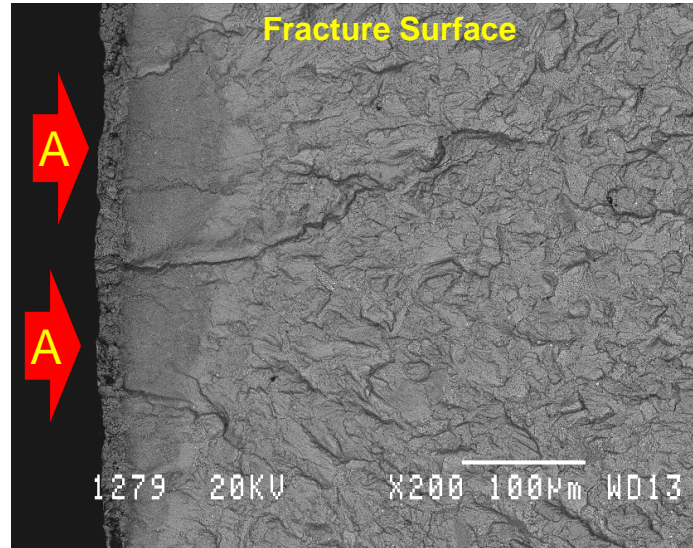
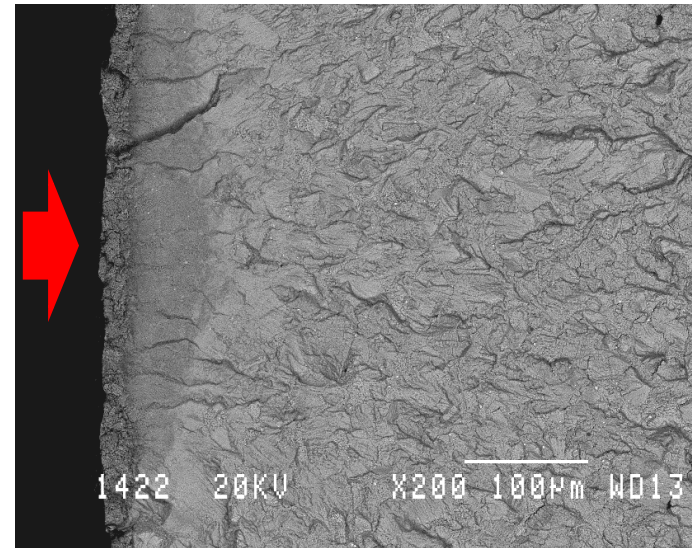
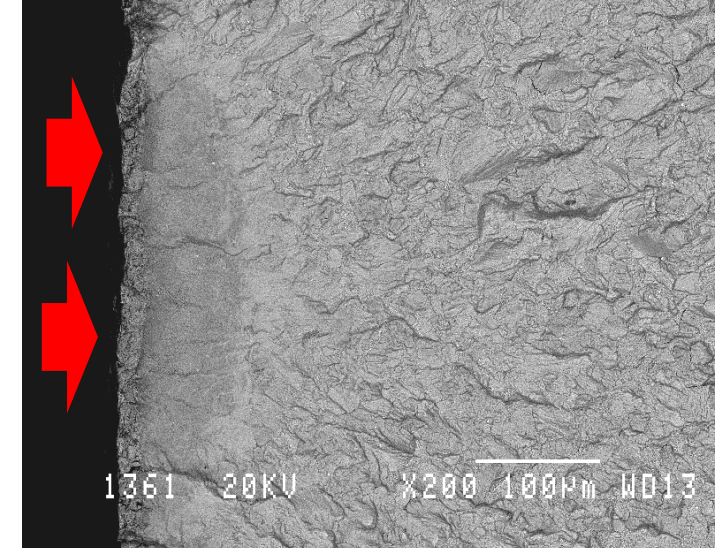
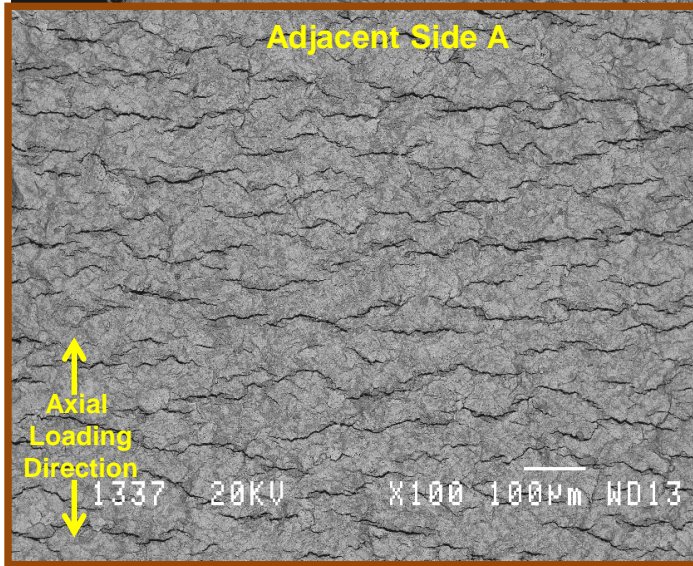
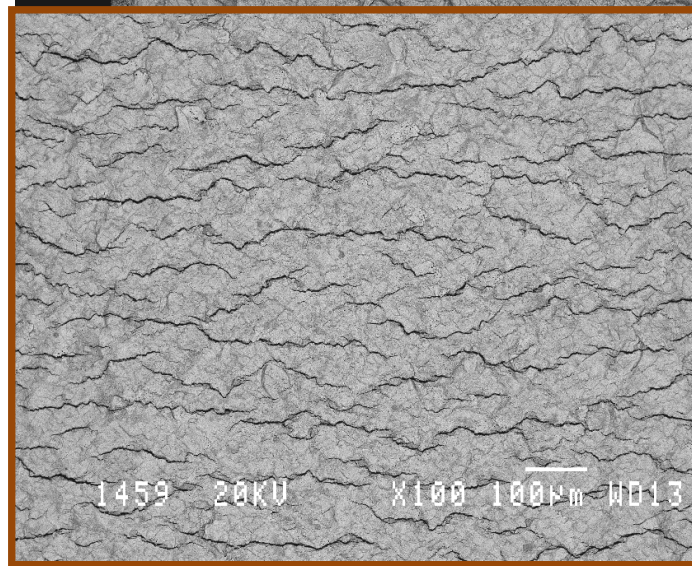
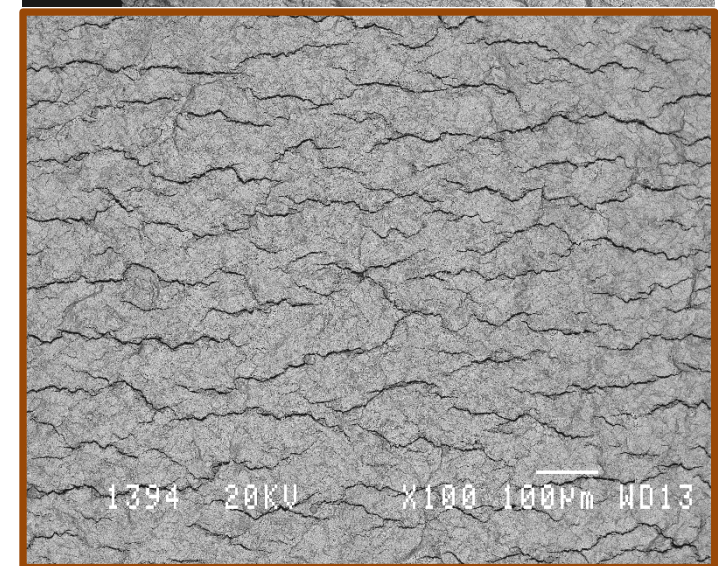
➤ Application of all pre-coating treatments still resulted in increased surface fatigue cracking, at the coating.

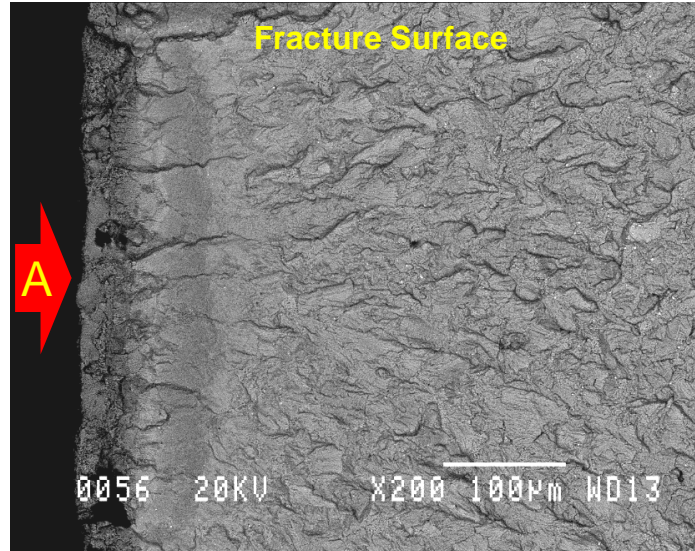
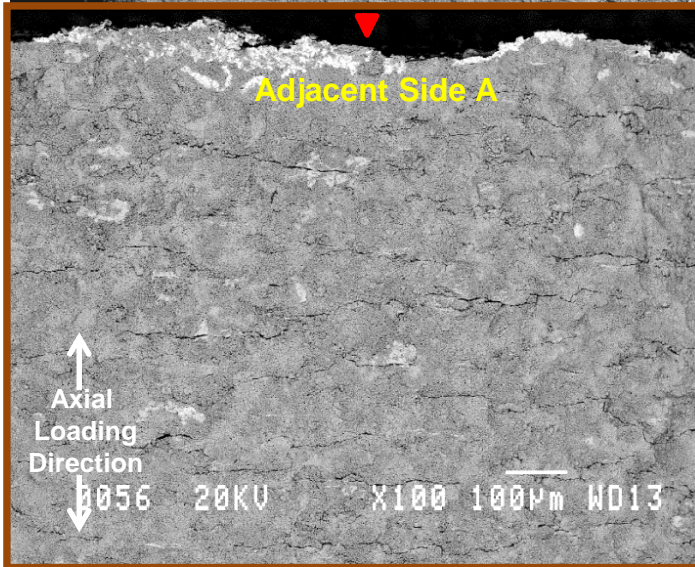
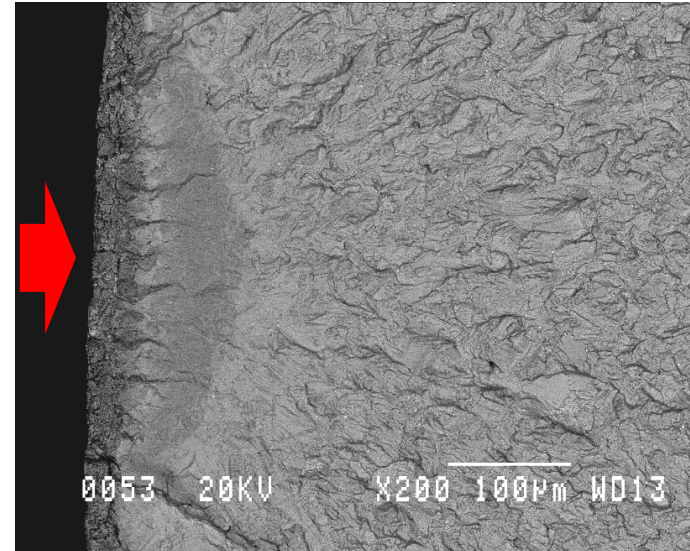
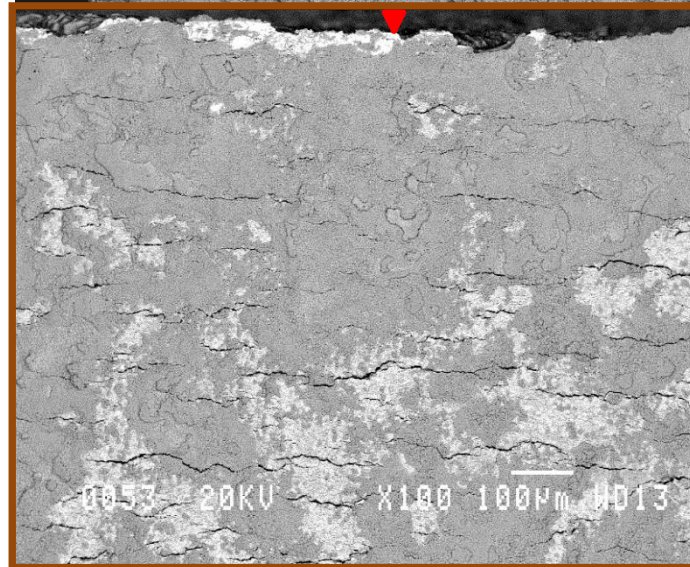
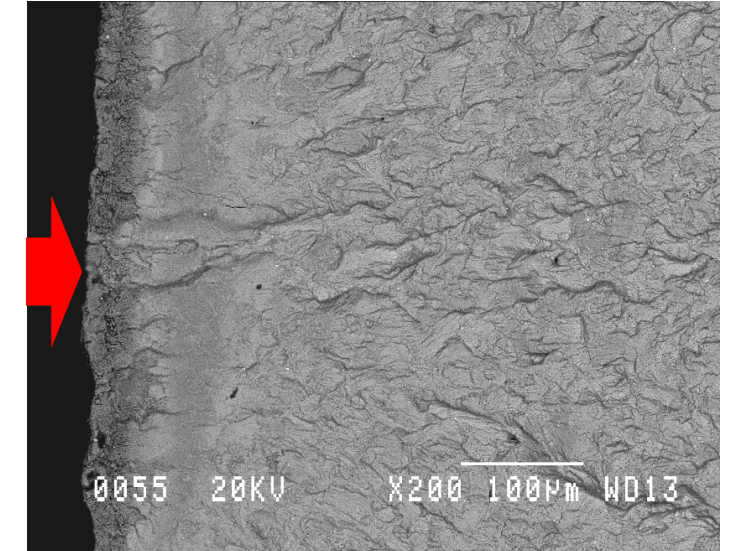
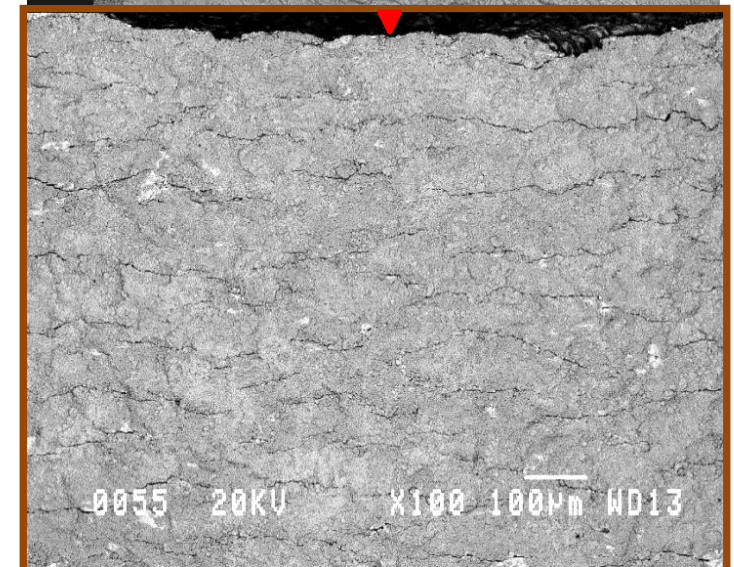
**➤ No, increased surface cracking of this ductile coating was still prevalent for all pre-coating treatments combined with a gentler post-coating shot peen treatment.**

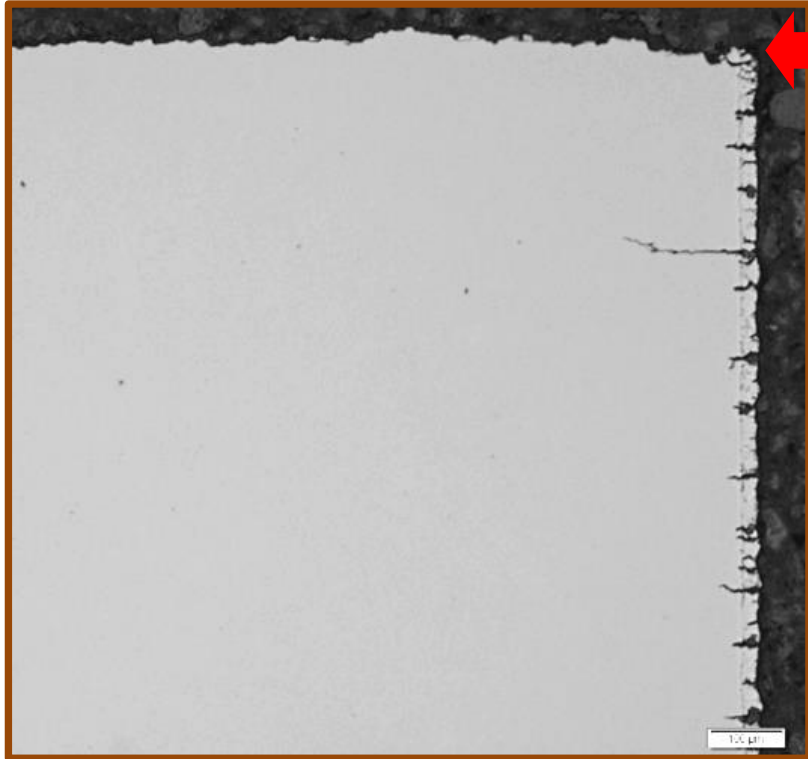
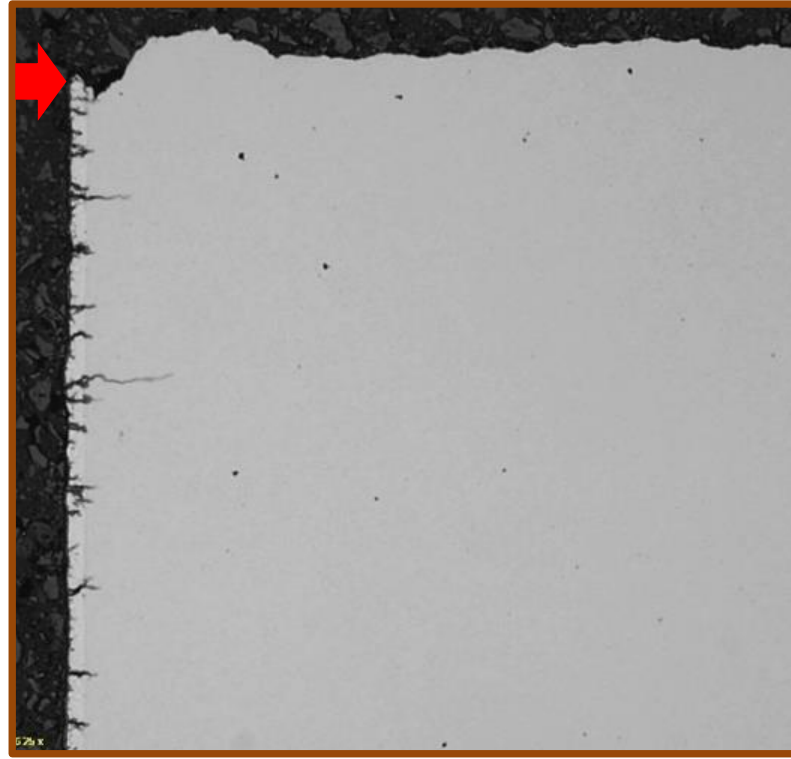
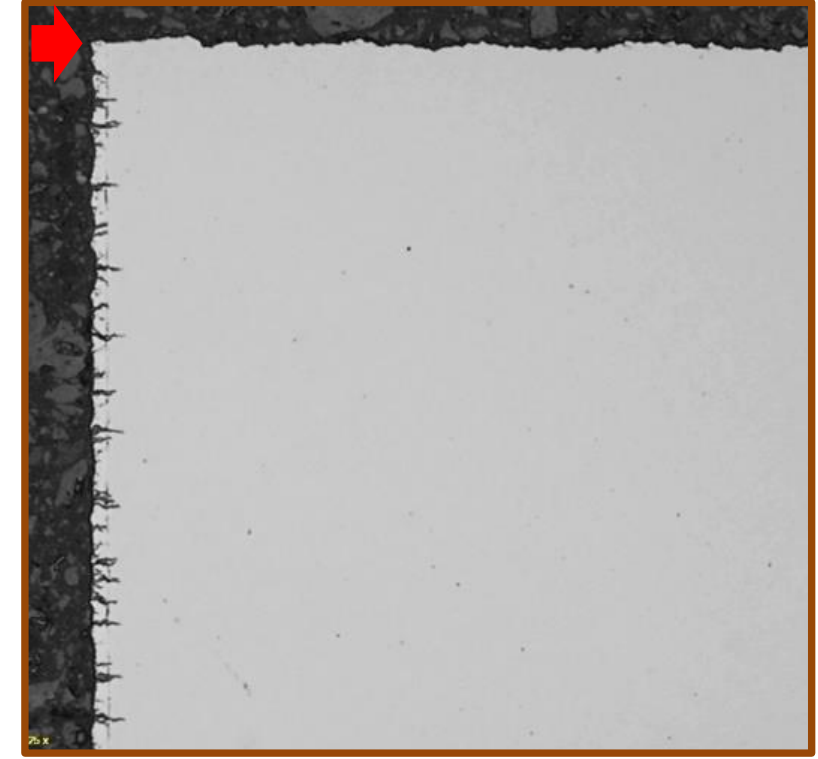
- Very many cracks are present at the coated surface.
- Yet, a majority of the coating cracks did not grow far into the superalloy substrate.
- *Very similar response had been observed for the Ni45CrY  $\gamma + \alpha$  phase coating on this disk superalloy.*

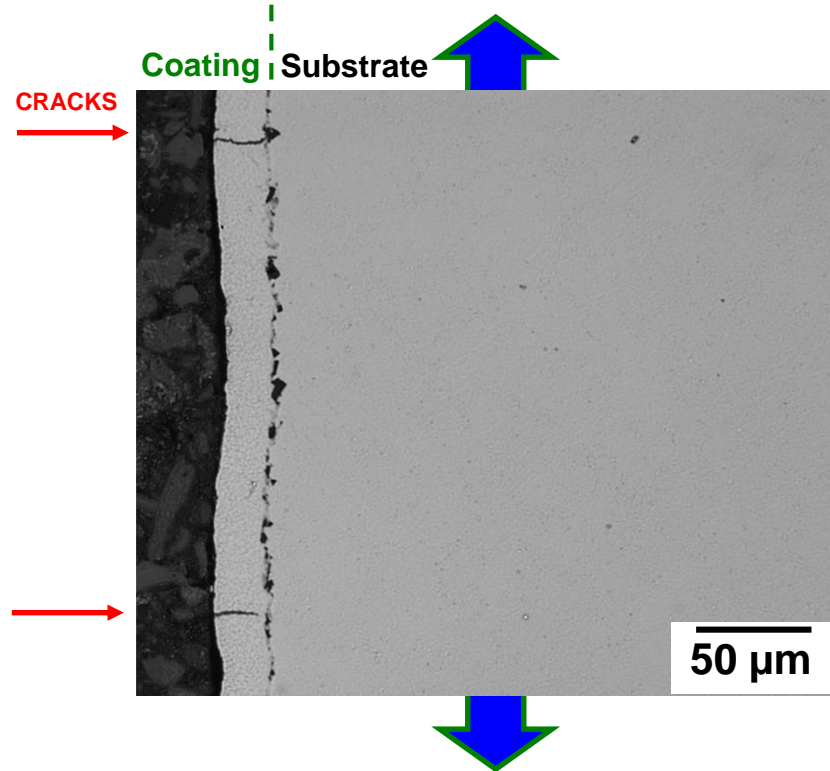
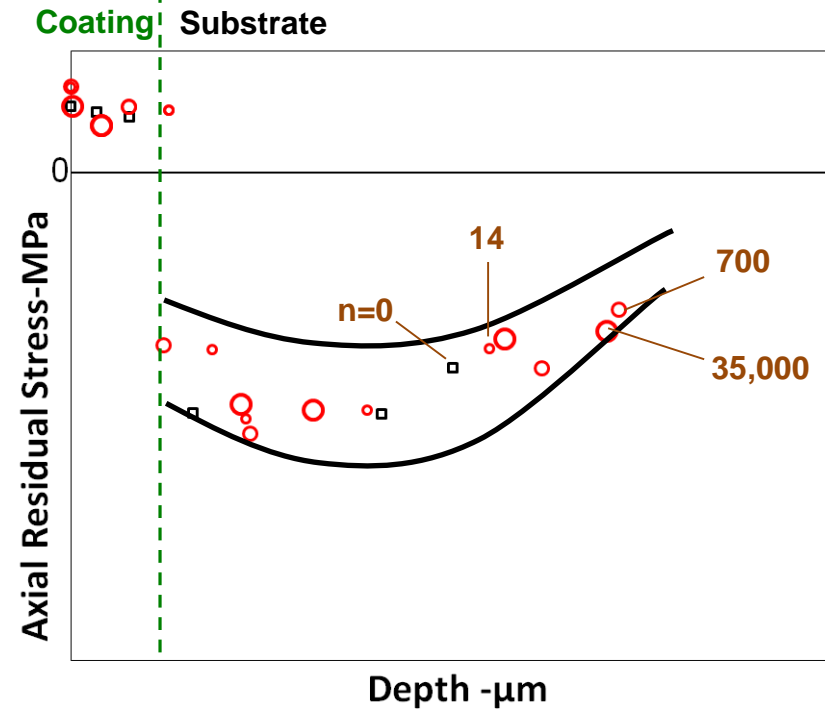
- Cracks can begin to form sooner in these weak coatings, where no compressive residual stresses from shot peening remain at 760 °C.
- Yet, the adjacent substrate can retain sufficient stable compressive residual stresses to resist most crack growth there, enabling good fatigue life.
