Dynamic Drop Testing of eVTOL Energy Storage Systems Part 1: Drop Test Data Summary

Justin Littell
Research Aerospace Engineer
NASA Langley Research Center
Hampton VA, 23681

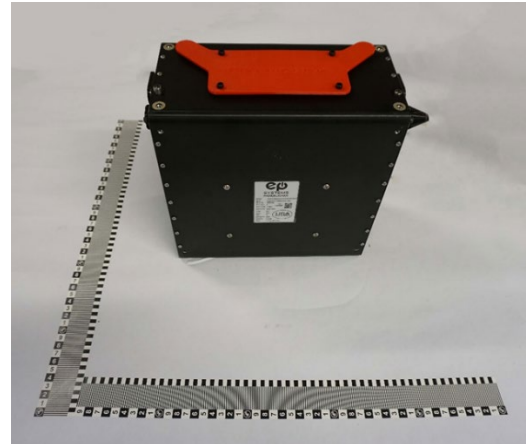
Figure 1. EPS EPIC ESS Module

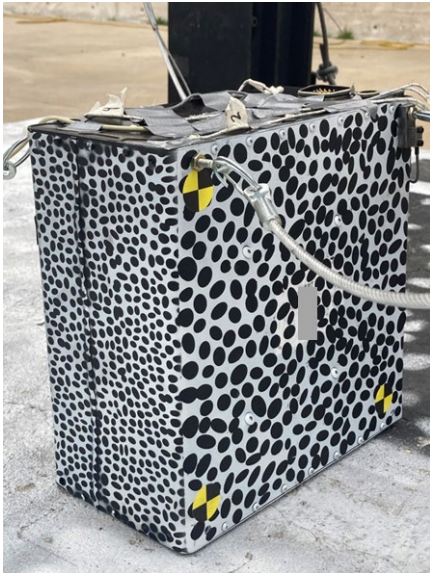
Figure 3 - Module paint for photogrammetry

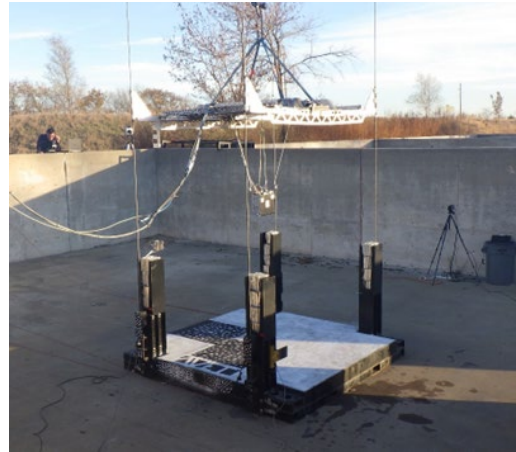
Figure 4 – Test article at beginning of lift

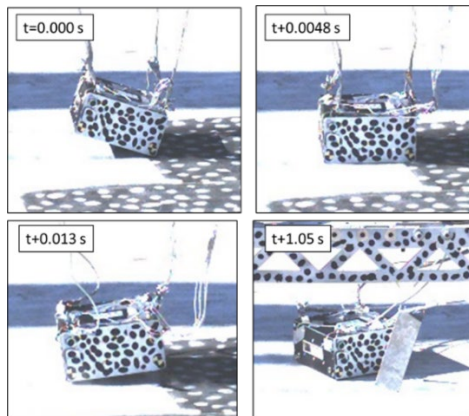
Figure 6. Test sequence - Flatwise orientation

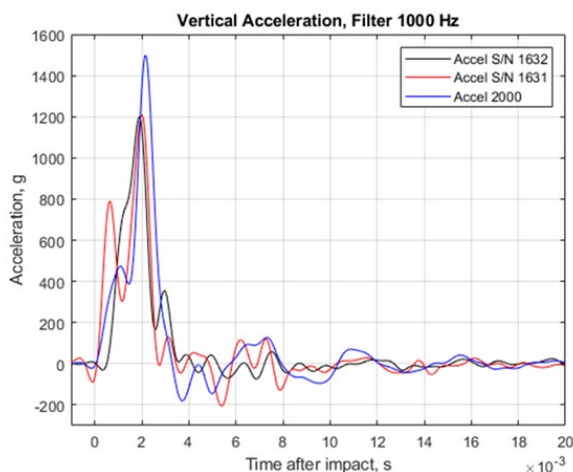
Figure 11 - Acceleration from right-side-up orientation

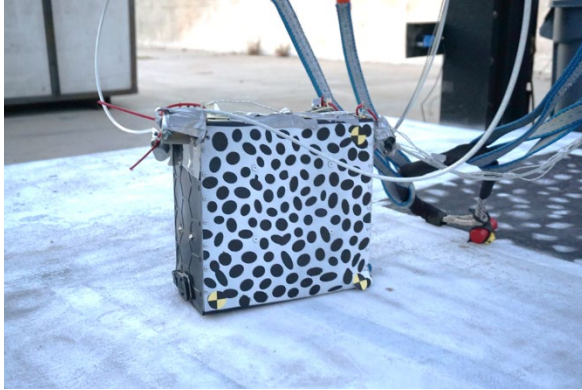
Figure 13 - Post-test position, Upside Down orientation

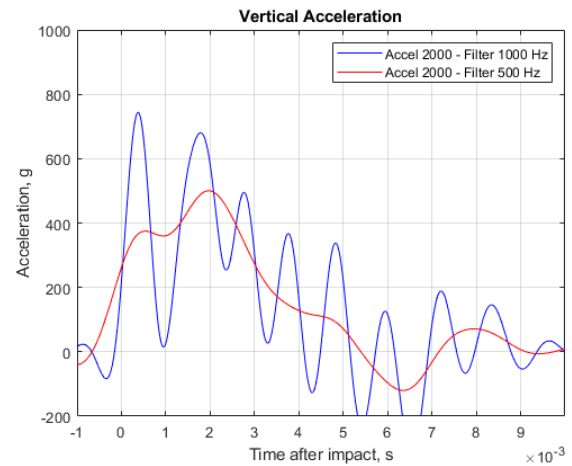
Figure 15 - Vertical acceleration from Accel 2000 using two cutoff frequencies

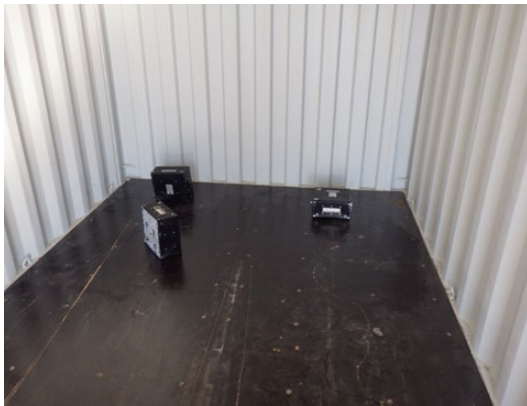
Figure 16 - Test articles in outside storage
Sideways Orientation

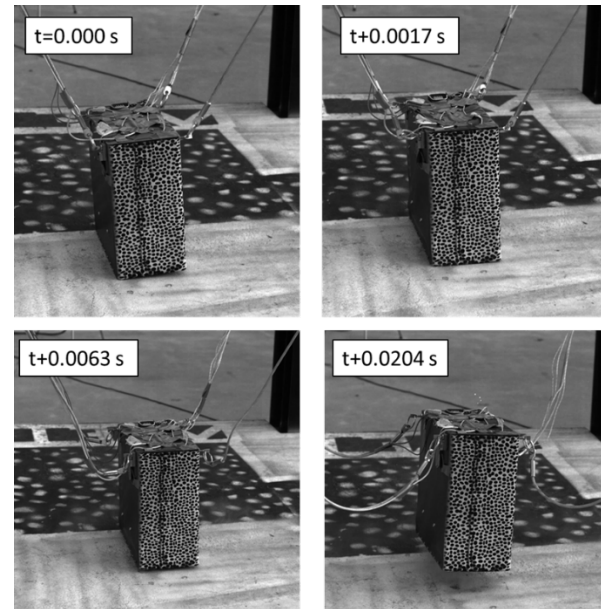
Figure 17 - Test sequence – Sideways orientation

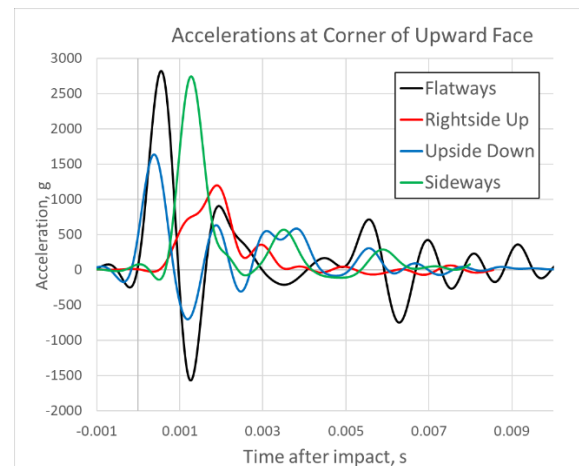
Figure 20 - All test acceleration, corner location

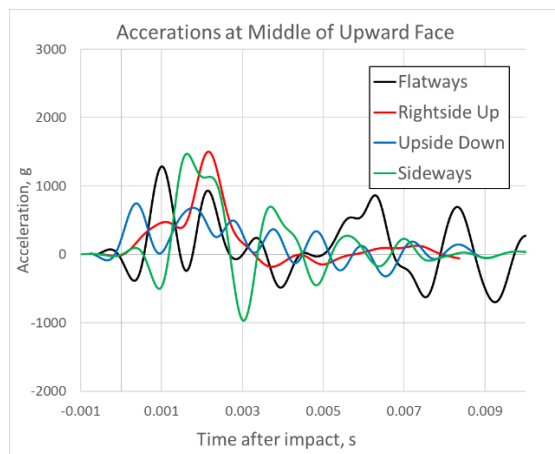
Figure 21 - All test acceleration, middle location
