NASA TM X-53728

November 7, 1968

FRACTOGRAPHY OF POLYTETRAFLUOROETHYLENE (PTFE)

By **B. H. Nerren**
Quality and Reliability Assurance Laboratory

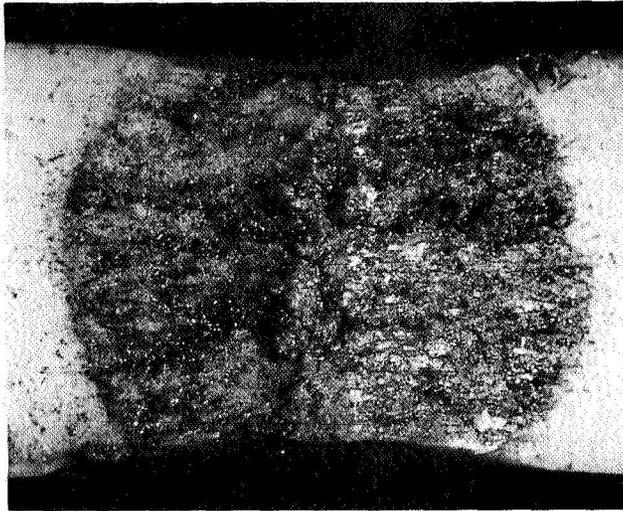
Figure 2. Macrograph of Notched, Ambient, Tensile Fracture

Basic observations revealed that the configuration of samples tested, either notched or unnotched, was the primary factor effecting the macrotopography of specimens fractured at ambient temperatures. In the case of notched sample, Figures 2 and 3, the area at the root of the notch and the area at the center of the specimen are distinguishable. It is felt that the areas at the root of the notch are zones where slow crack growth occurred prior to failure. The center area was formed during final, catastrophic failure of the specimen.

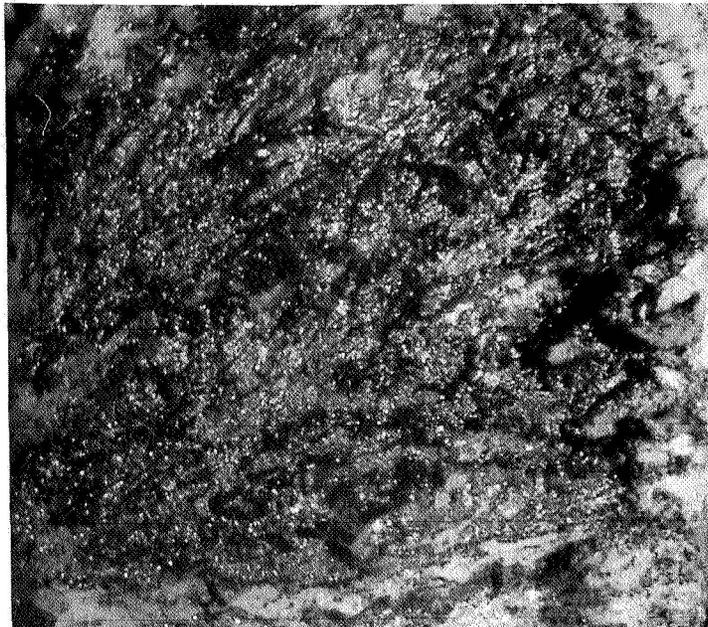
Figure 4. Macrograph of Unnotched, Ambient, Tensile Fracture

In the case of the unnotched specimens, the macroappearance of the fracture was the same at ambient temperatures (Figures 4 and 5). Under both tensile and cyclic loading the fracture was fairly flat with chevrons pointing to the origin of failure.

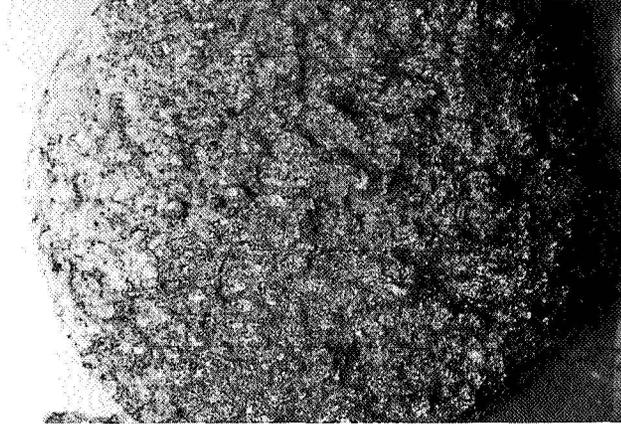
Figure 6. Macrotopography of Fracture at Cryogenics

The macrotopography of samples fractured at cryogenic temperature appeared to be unaffected by sample type or stress environment. All samples fractured at cryogenic temperatures exhibited the flat, fine grained texture shown in Figure 6.

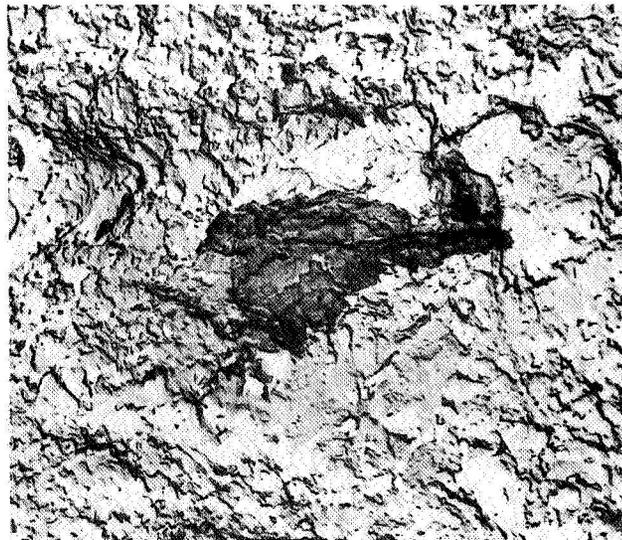
Figure 7. Electron Micrograph of Tensile Failure Exhibiting Dimples

Electron microscopy studies indicated that the microtopographical features were influenced primarily by the stress and temperature environments and were essentially independent of sample configuration. Notched and unnotched tensile failure exhibited dimple structure (Figure 7) on both ambient and cryogenic specimens.

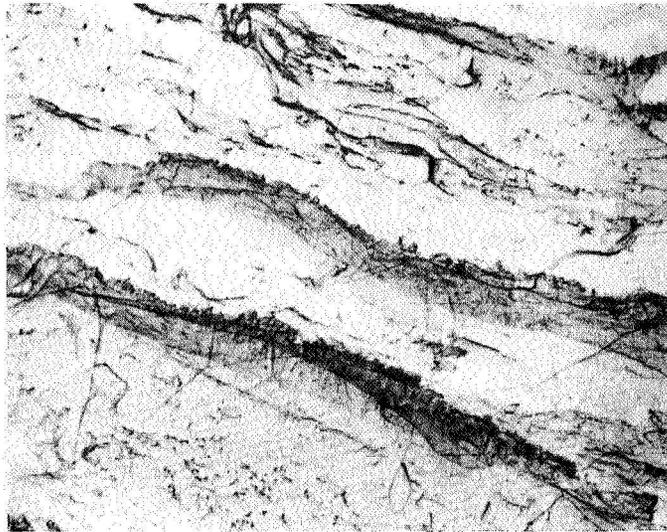
Figure 8. Electron Micrograph Illustrating Tear Ridges

The samples fractured under ambient condition also exhibited tear ridges (Figure 8) on the fracture face. These tear ridges indicate considerable local plastic deformation prior to fracture. The fact that these ridges are not found in the cryogenic tested samples indicates that a significant decrease in ductility occurs as the testing temperature is reduced.

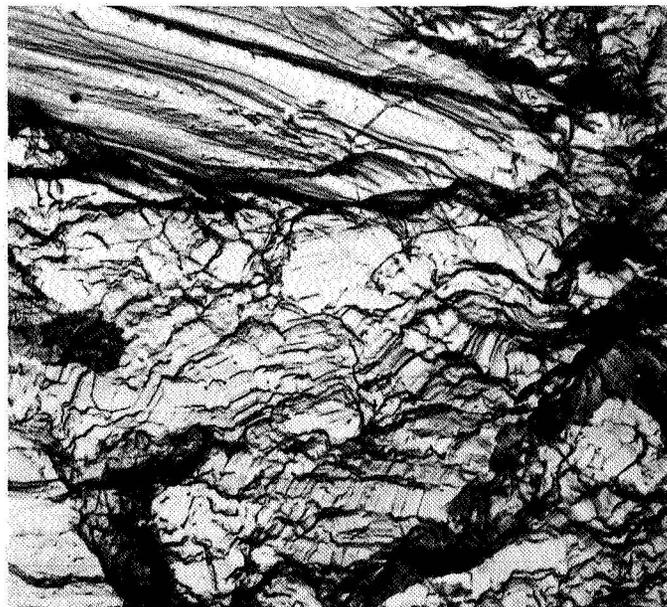
Figure 9. Electron Micrograph of Crystals

Crystals were also noted in samples fractured under cryogenic conditions (Figure 9).

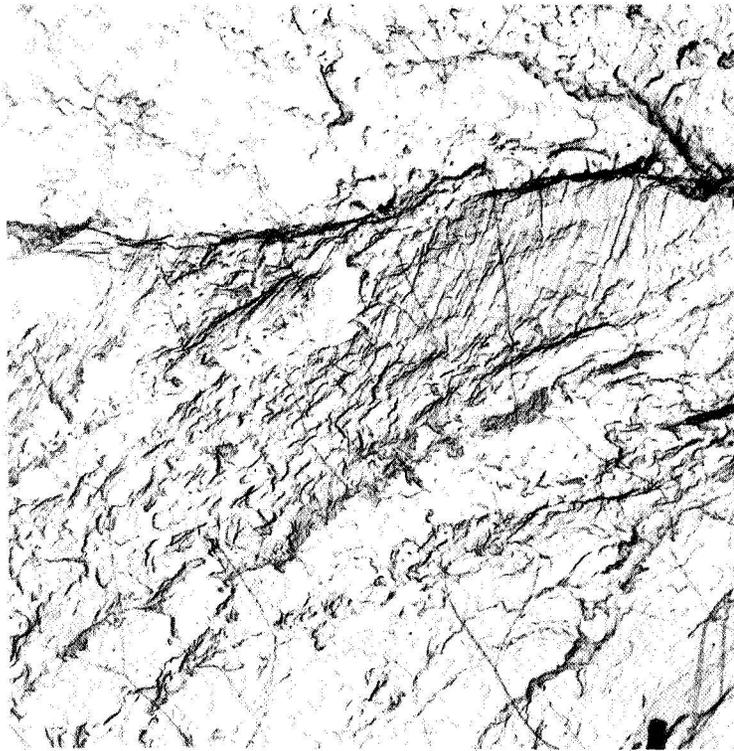
Figure 10. Electron Micrograph of Fatigued PTFE (Note Striations)

All samples which were fractured under cyclical loading exhibited striation (Figure 10). These striations are very similar to fatigue striations found on metal surfaces fractured under cyclical loading. These are probably crack arrest lines where crack propagation was momentarily stopped during stress reversal. Crystals were also noted in fatigue samples fractured at cryogenic temperatures.

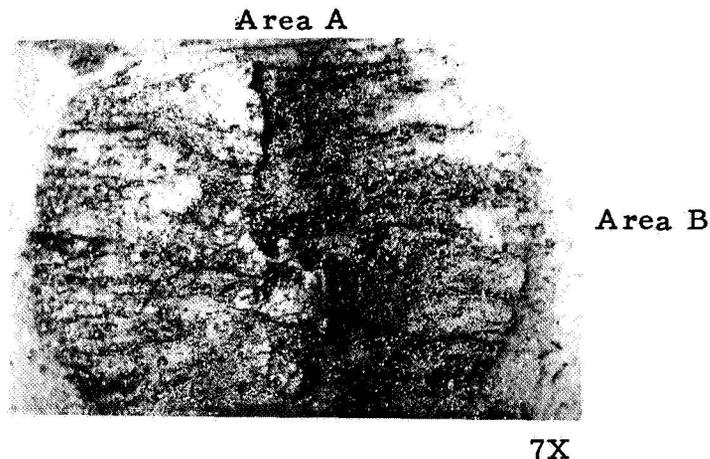
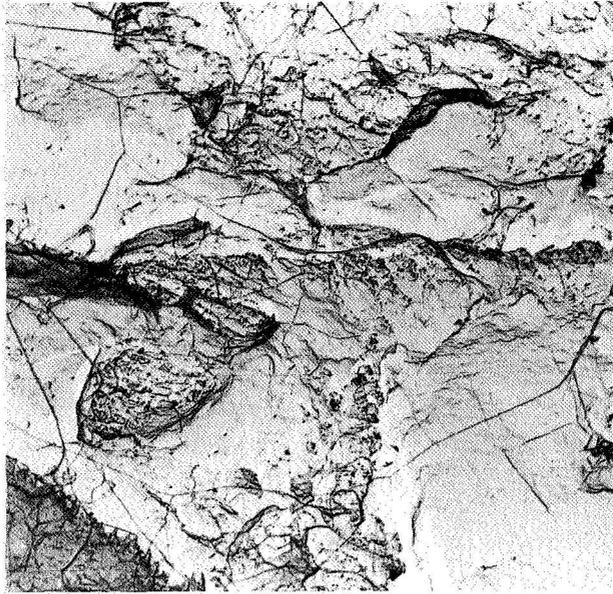
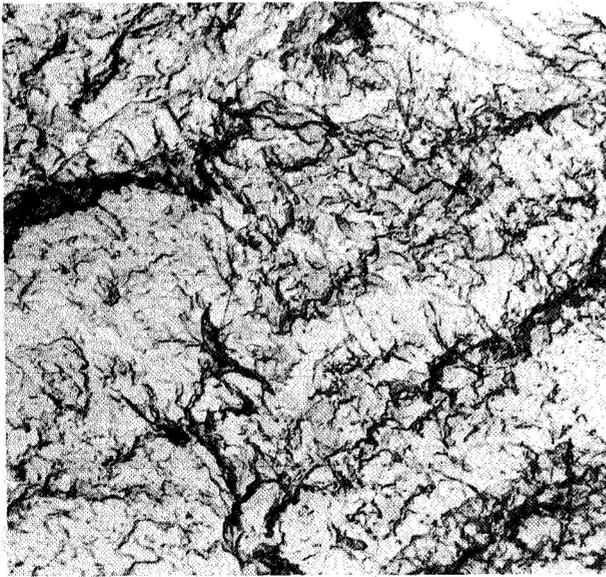
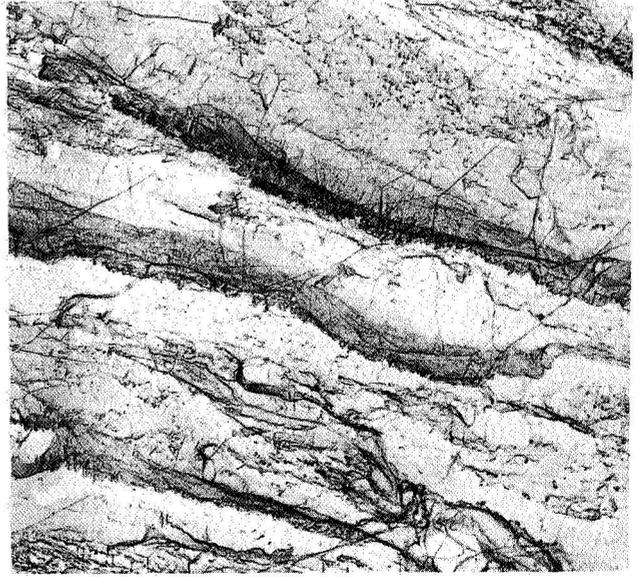
Micrographs of Fractured Surface of PTFE
at Ambient Temperature (Notched Samples) (Sheet 1 of 2)

The fracture had its origin at the root of the notch on either edge and then propagated to the center of the test specimen forming a peak with river-like patterns pointing to the origin.

The fracture was characterized by dimples and tear ridges perpendicular to the notches.

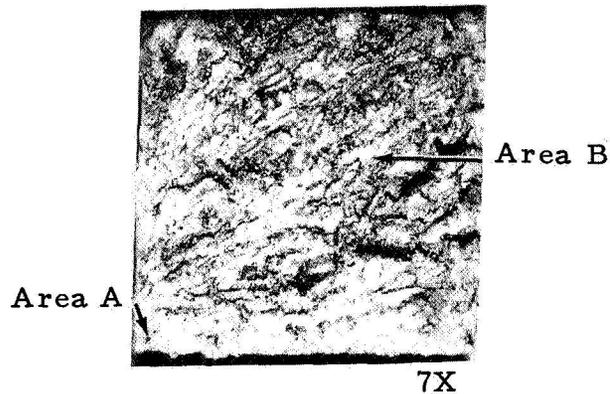
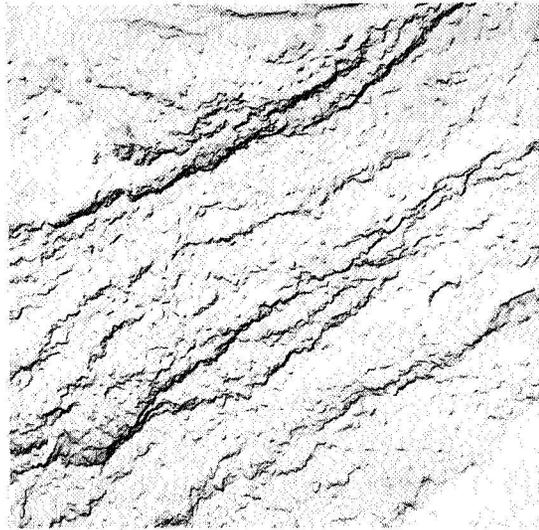
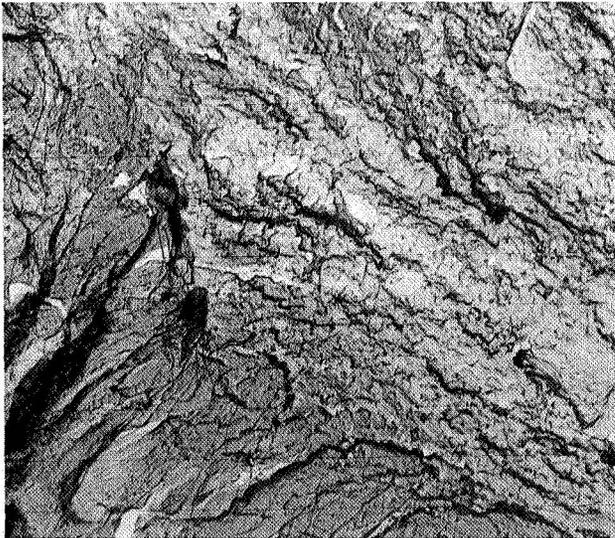
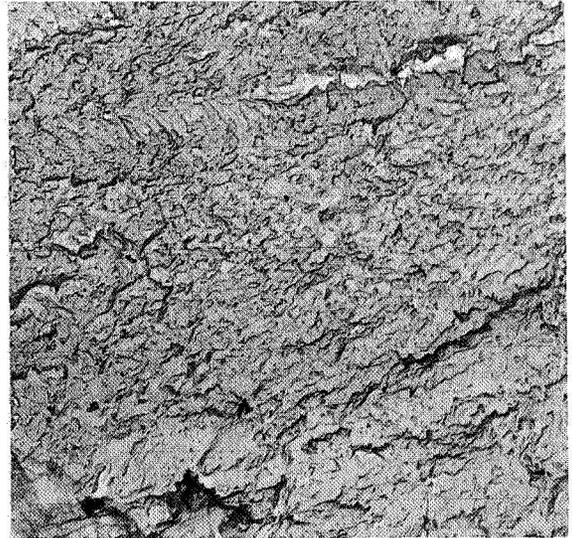
Micrographs of Fractured Surface of PTFE at Ambient Temperature (Unnotched Samples) (Sheet 1 of 2)

The fracture exhibited separation lines pointing to the origin of failure, similar to chevron patterns in metal failures.

The fracture exhibited tear ridges and typical PTFE tension separation patterns similar to dimples in metallic fractures.

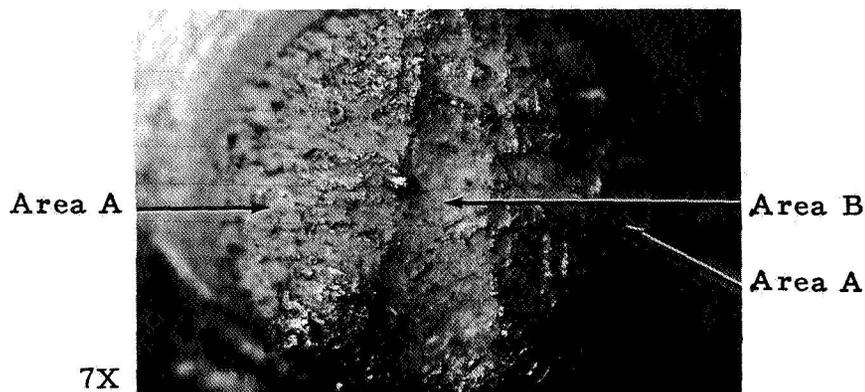
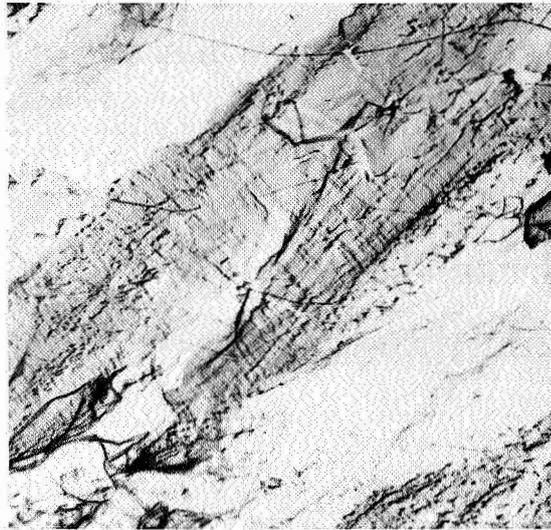
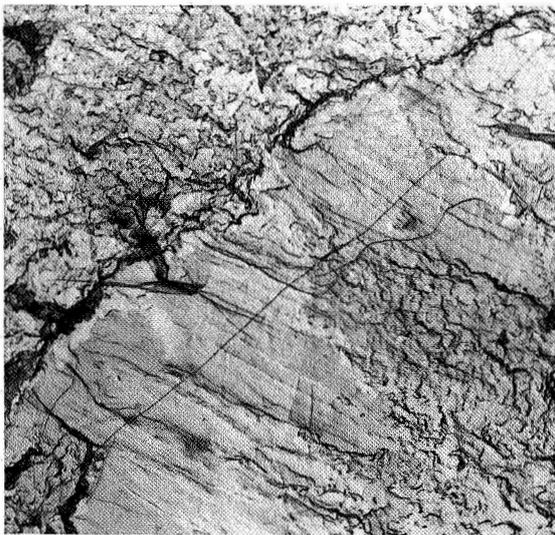
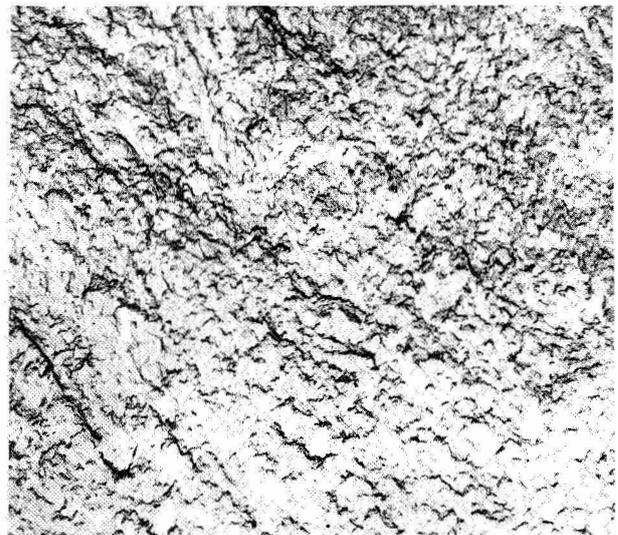
Micrographs of Fractured Surface of PTFE at Ambient Temperature, Low Cycle (Notched Sample) (Sheet 1 of 2)

The fatigue area consisted of a relatively flat zone. Rapid fracture was by tension that formed a valley in the center.

The fatigue striations were well formed but scattered. Rapid fracture was by dimple-like rupture.

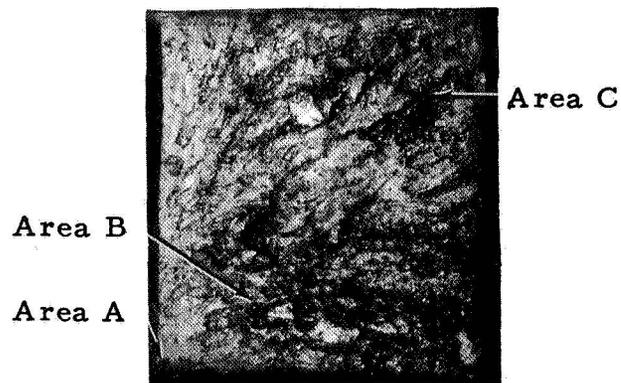
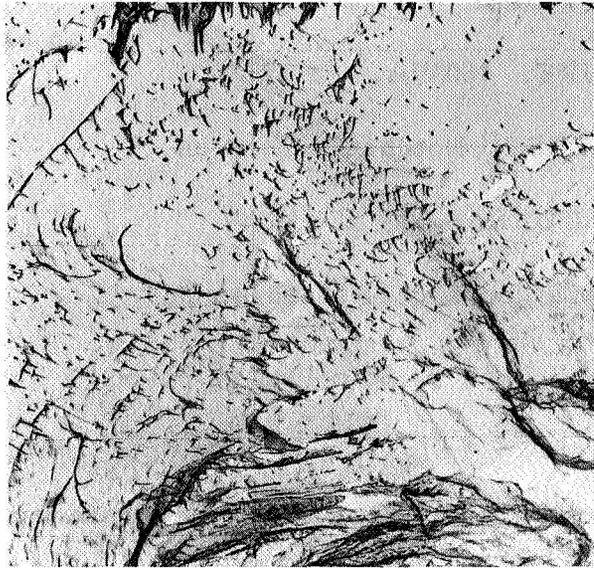
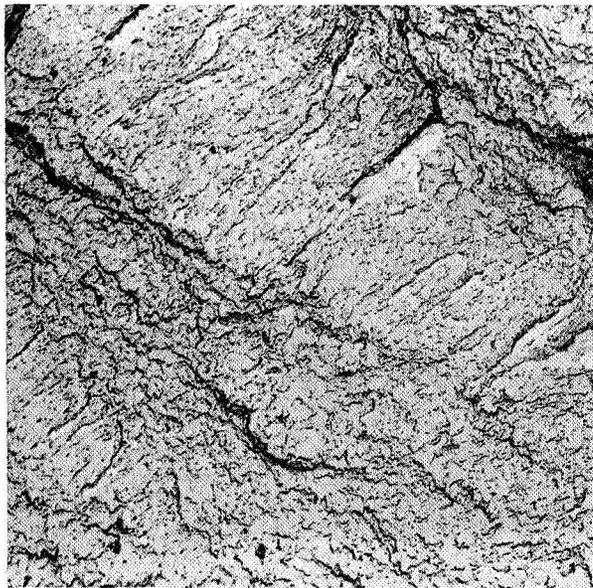
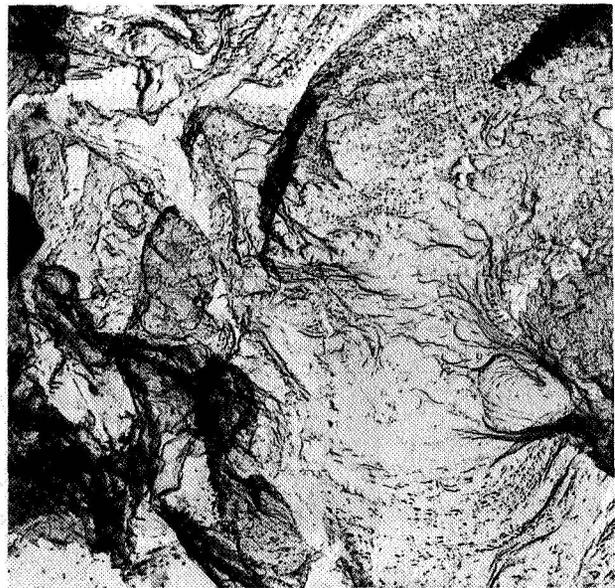
Micrographs of Fractured Surface of PTFE at Ambient Temperature, Low Cycle (Unnotched Sample) (Sheet 1 of 2)

The fracture exhibited separation lines pointing to the origin of fracture very similar to the unnotched tension failure.

The fracture exhibited tear ridges with faint striation near origin of failure, then a twisted dimple-like fracture near fast rupture.

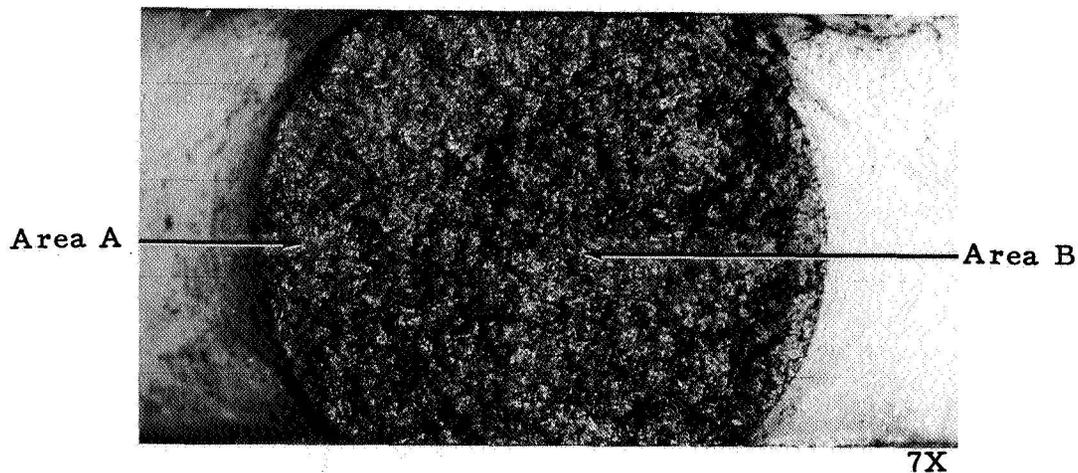
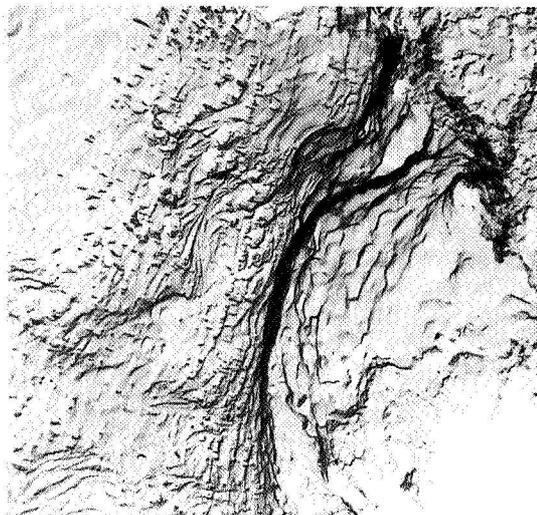
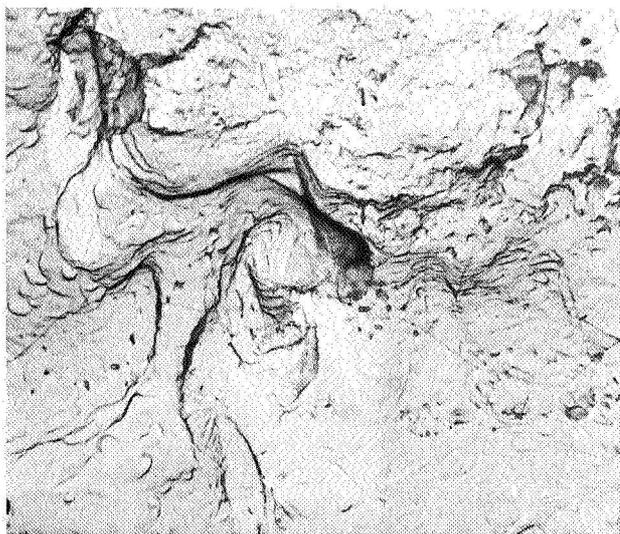
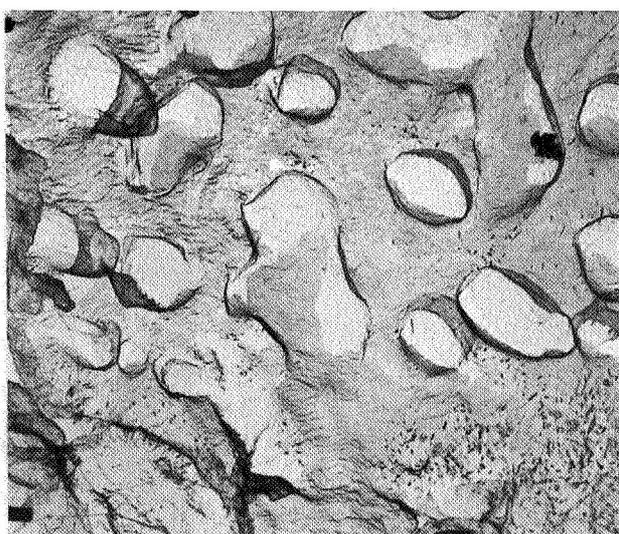
Micrographs of Fractured Surface of PTFE at LN₂
Temperature (Notched Sample, Tensile Failure)
(Sheet 1 of 2)

The fracture exhibited a flat, fine-grain texture.

The fracture exhibited small and large dimple-like structure.
An unusual texture was noted but unexplained.

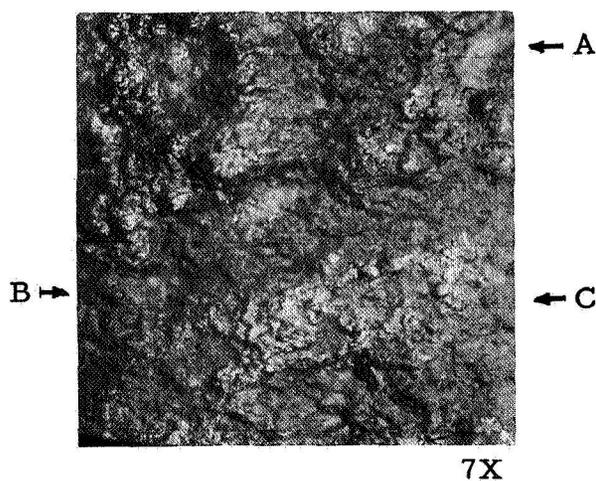
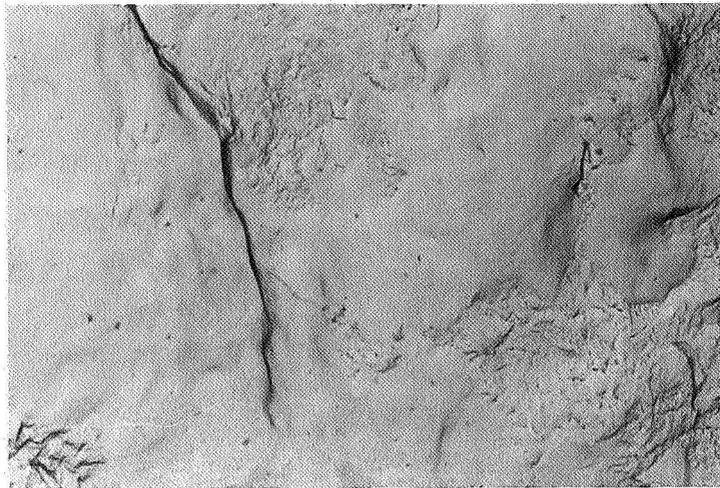
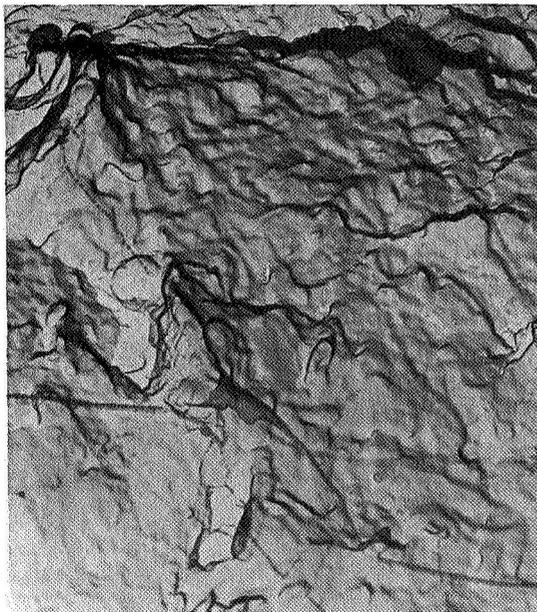
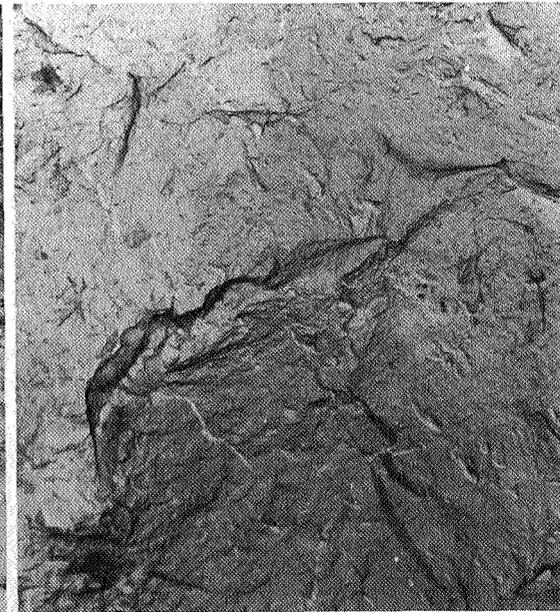
Micrograph of Fractured Surface of PTFE at LN₂ Temperature (Unnotched Sample) (Sheet 1 of 2)²

The fracture face exhibited a flat, smooth topography texture.

The fracture exhibited a flat waxy texture with scattered areas of dimples.

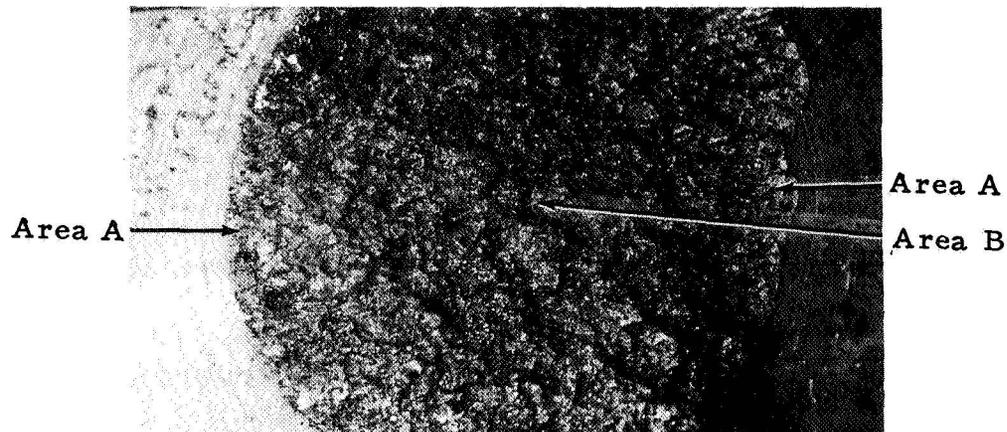
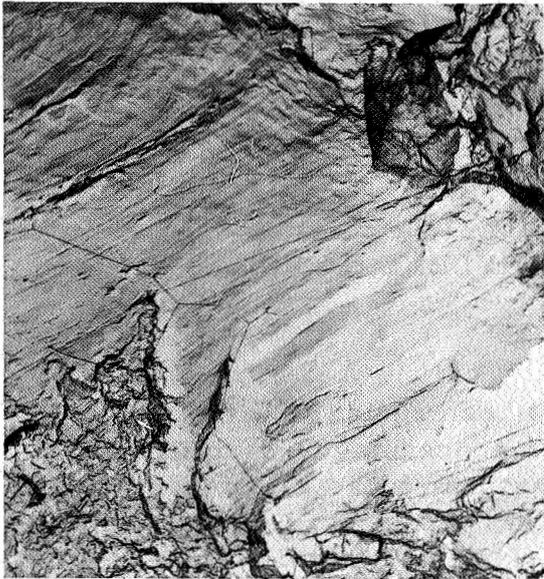
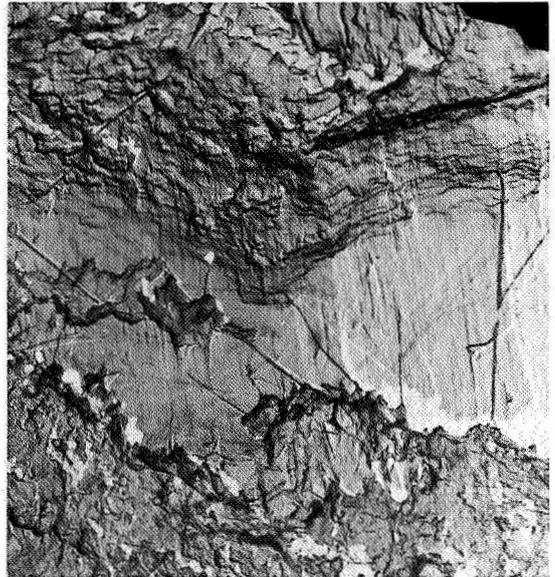
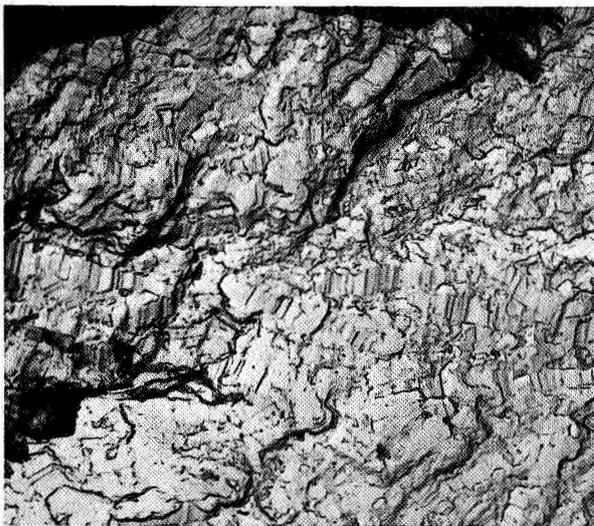
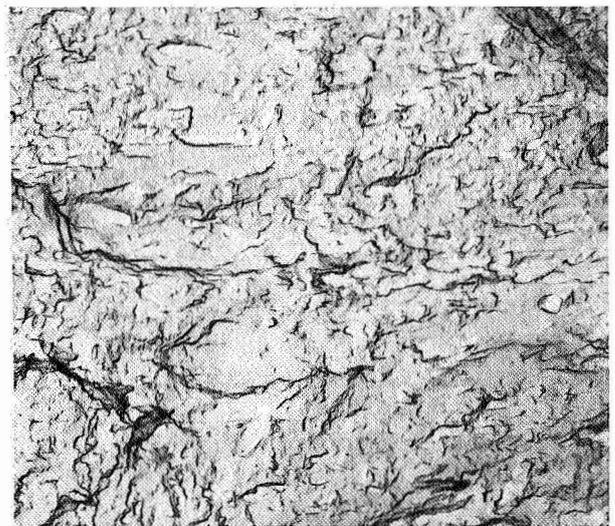
Micrographs of Fractured Surface of PTFE at LN₂
Temperature (Notched Sample, Fatigue Failure) ²
(Sheet 1 of 2)

The fracture exhibited a rough flat surface.

The fracture exhibited typical fatigue striations at the root of each notch with elongated dimple-like structure in the fast fracture area.
