NASA CR-72850

# EVALUATION OF HIGH TEMPERATURE ELECTRICAL MATERIALS AND COMPONENTS

**Westinghouse Electric Corporation  
Aerospace Electrical Division  
Lima, Ohio**

1. Report No. NASA CR-72850	2. Government Accession No.	3. Recipient's Catalog No.	
4. Title and Subtitle Evaluation of High Temperature Electrical Materials and Components.		5. Report Date April 1970

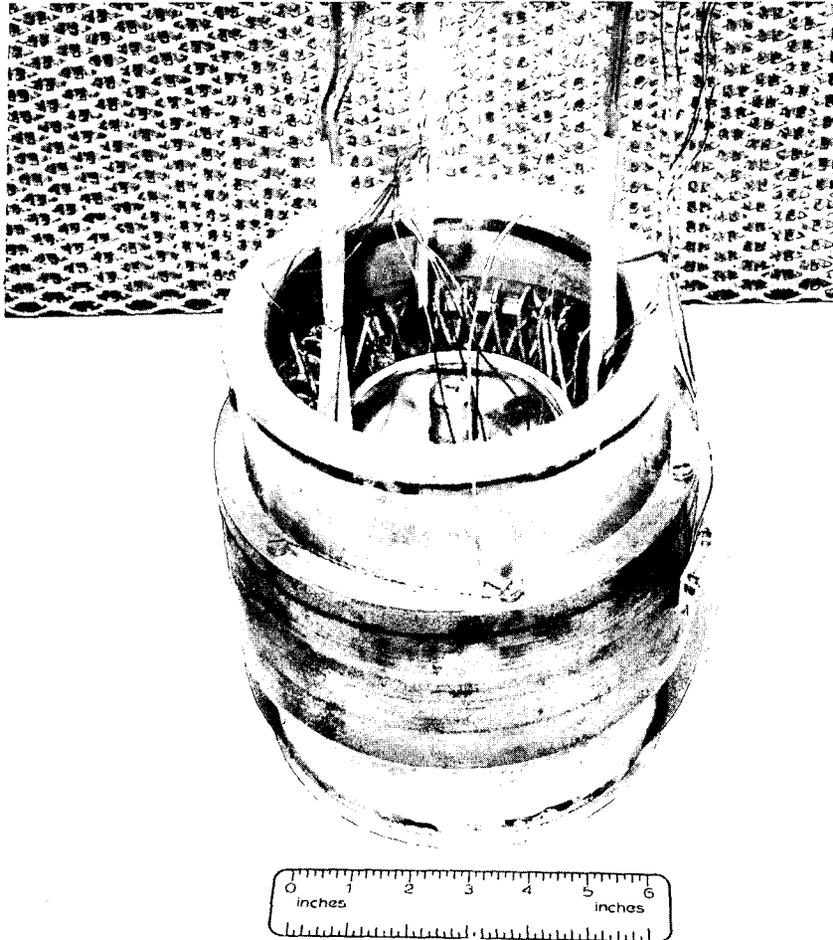
Figure 15. - Photograph of the Stator and Bore Seal Capsule After the 10,000-Hour, 1300° F Ultrahigh Vacuum Endurance Test. Refer to figure 1 and table 1 for location and identification of stator materials.

Visual Examination of the Stator After Removal from the Test Chamber - A visual examination of the stator, performed immediately after removal from the test chamber, revealed some gray discoloration of the insulation materials and a general dulling of the exposed metallic surfaces attributed to deposition of evaporated materials during thermal-vacuum aging. The exposed surfaces of the conductor insulation were gray. Many of the conductor insulation "S" glass fibers on the conductor end turns had been fractured during winding, thereby causing some fraying; but this condition had not progressed further during the aging (see figure 17). The glass fibers were mechanically weak with low interfiber bonding. The adhesion of the wire insulation to the Inconel cladding was also weaker than after firing. The Inconel surface under the insulation was bright and not discolored.

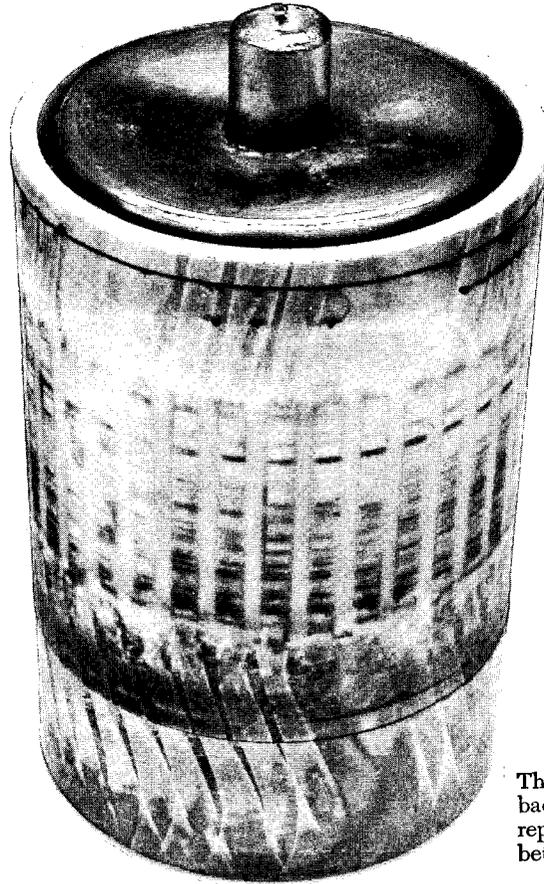
Figure 16. - Photograph of the Bore Seal Capsule and Support Pedestal After the 10,000-Hour Potassium Exposure Test at 1300° F in Vacuum.

Exterior Deposits. - After removal from the stator, the bore seal was visually examined. A deposit with the same pattern as the iron-27% cobalt alloy stator laminations was noted on the beryllia bore seal tube as well as a general darkening of the beryllia surface to a light gray color. Figure 16 shows the bore seal after removal from the stator. A band of dark gray deposits was also seen on each end of the beryllia tube.

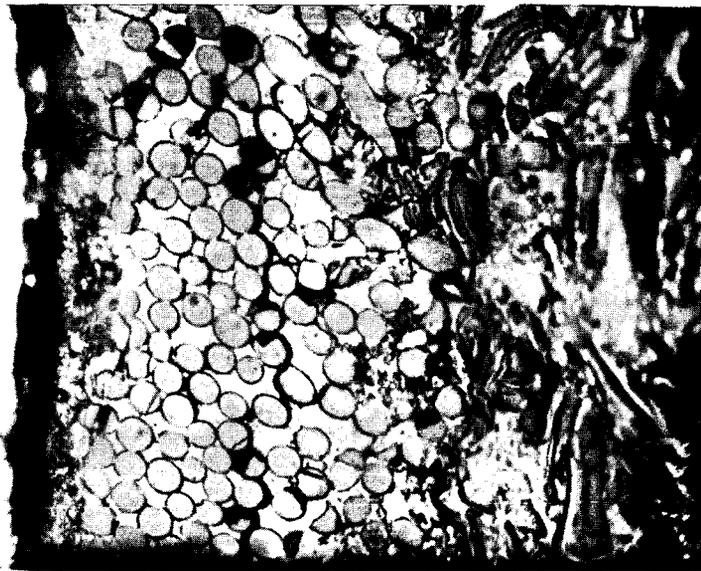
Microscopic Examination of Conductor Insulation. - A transverse section of aged stator Inconel-clad silver conductor with Anadur "S" insulation was prepared for microscopic examination. A photomicrograph of this section is presented in figure 30 accompanied by that of an unaged specimen, figure 31. Examination of the aged specimen showed that the "S" glass fibers remained discrete and were not dissolved to a significant degree by the glass/refractory oxide matrix of the Anadur "S" insulation. The non-uniform appearance of the insulation coating in figure 30 was caused by the mechanical disturbances of sectioning,

Figure 30. - Photomicrograph of Stator Conductor Electrical Insulation After Aging (10,000 Hours at 1300° F Ultrahigh Vacuum). (400X)

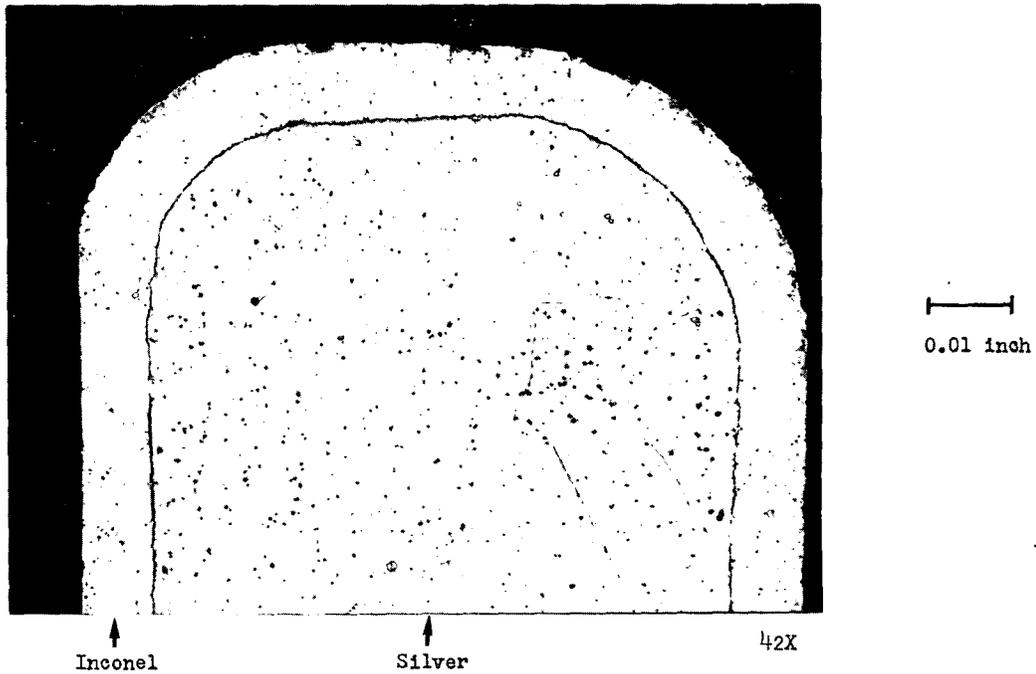
Metallographic Examinations of Inconel-Clad Silver Conductors. - Metallographic examinations were performed on unaged and aged Inconel-clad silver stator conductors from both end turn and slot. Figure 34 is representative of aged conductor from both end turn and slot. No differences were detected between the silver or the Inconel microstructures of the two aged specimens. Figure 35 is a photomicrograph of unaged conductor. A comparison of aged and unaged conductors showed considerably larger grains in the aged Inconel and somewhat larger grains in the aged silver. Grain growth found was considered normal for the aging conditions. There was no evidence of diffusion of silver or chromium in either aged conductor specimen.

Figure 35. - Photomicrograph of Conductor From Stator Slot After 10,000-Hour, 1300° F  $10^{-9}$  Torr Pressure Exposure. (42X)

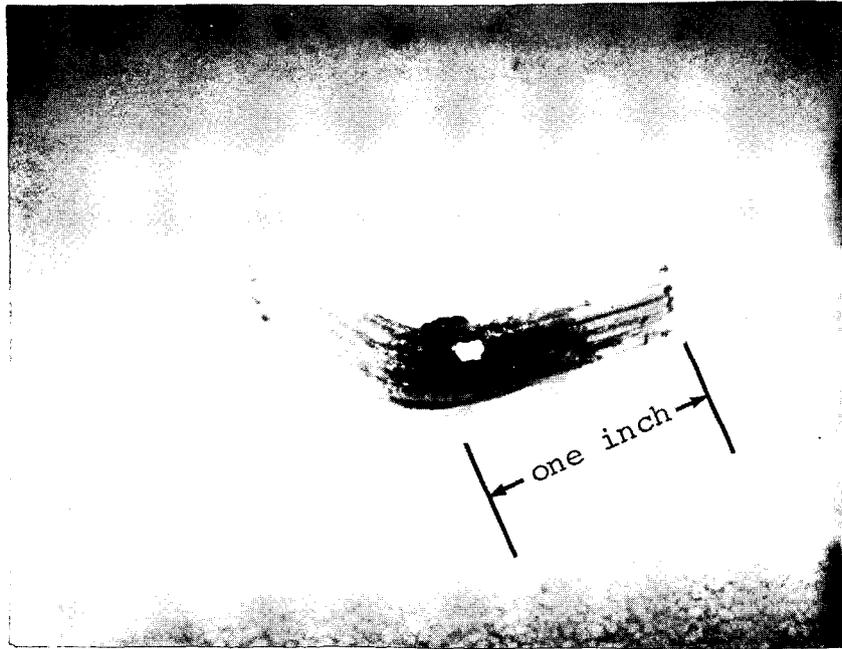
(b) Primary (high voltage) winding failed after 244 hours at test temperature (1300°F hot spot).

Figure 44. - View, After Disassembly, of the Failure Region in the 1300° F Transformer, Primary Winding, Fourth Layer from the Outside.

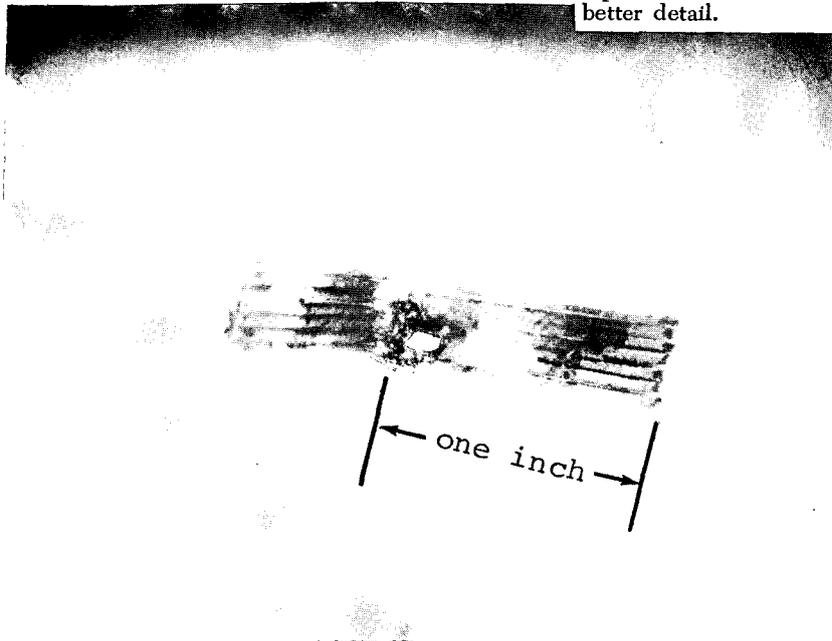
Figure 45. - View, After Disassembly, of the Failure Region in the 1300° F Transformer, Primary Winding, Fifth Layer from the Outside in the Foreground.

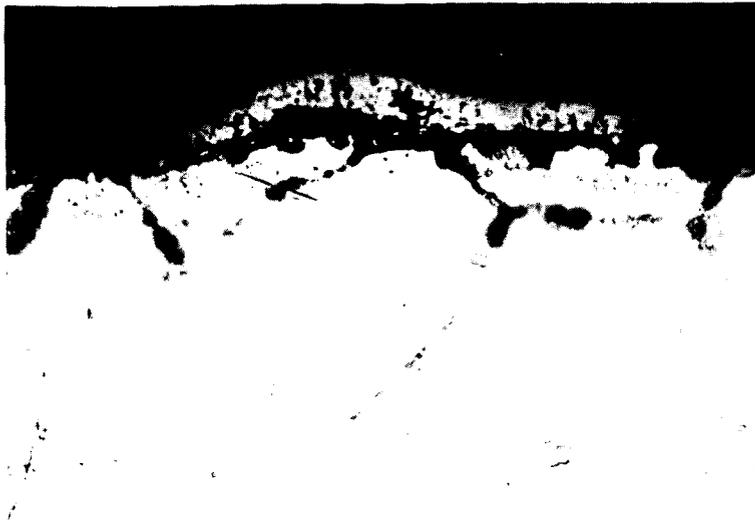
Black Scale on Outside Surface of End Bell

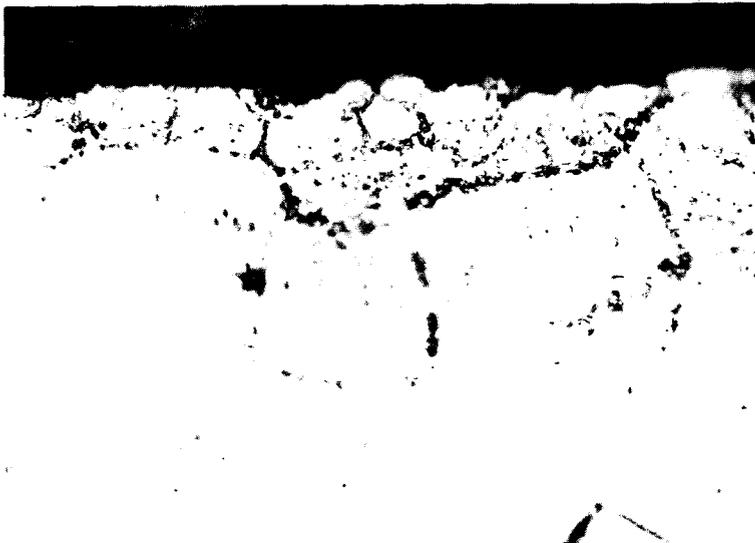
Second Phase Penetration
