NASA CR-159639
R79AEG366

CF6 JET ENGINE PERFORMANCE IMPROVEMENT

NEW FRONT MOUNT

Final Report

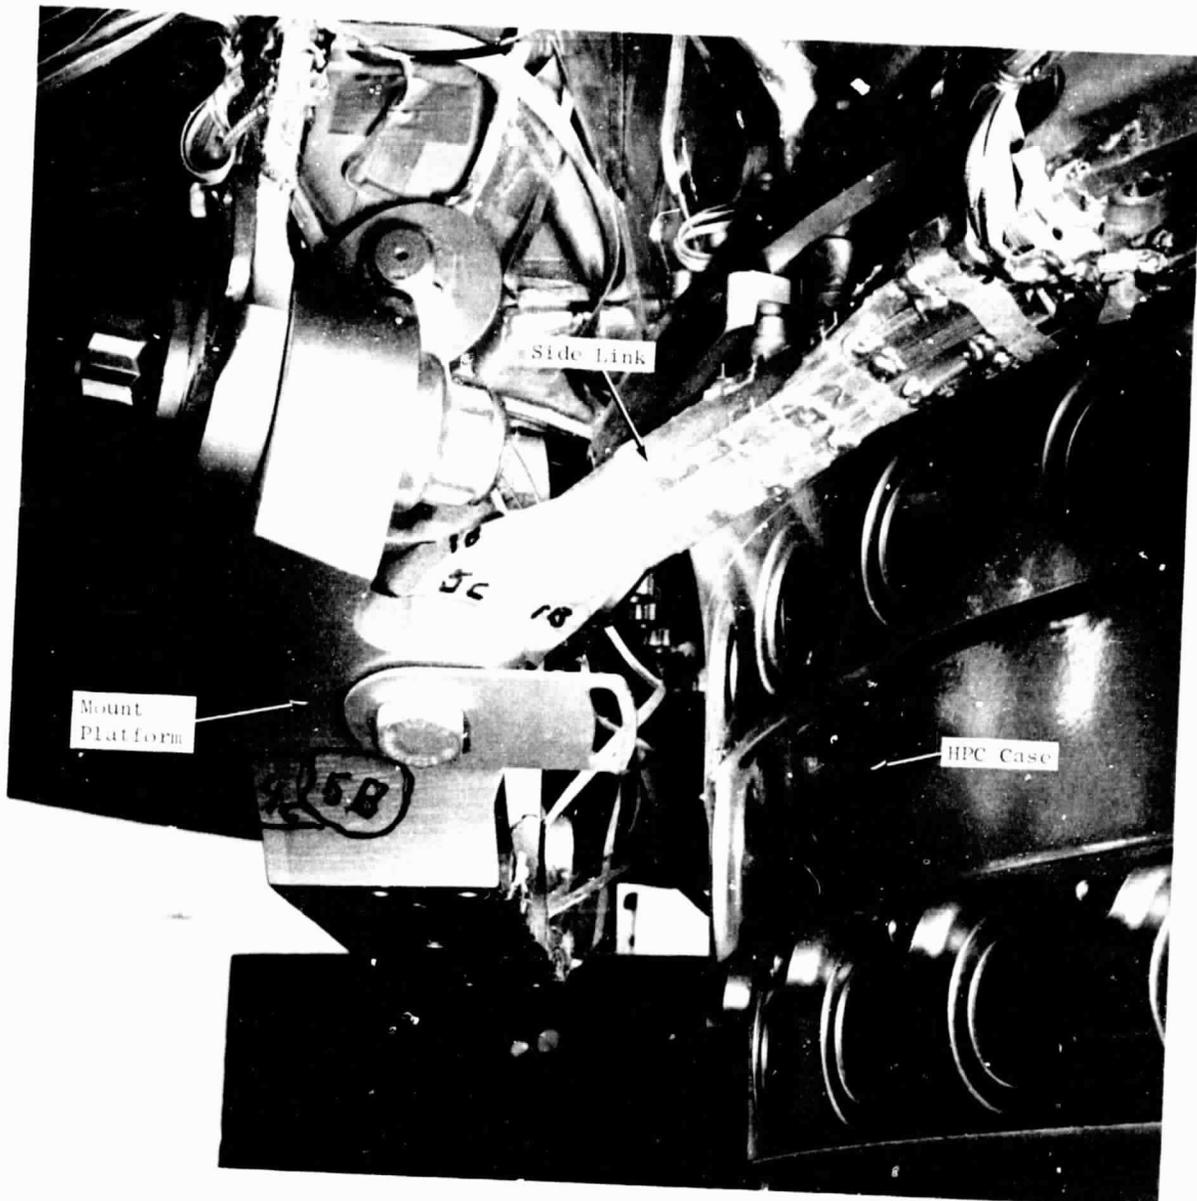
Figure 5.2. Photograph of Stresscoat Map Pattern.

development. Figures 5.2, 5.7, and 5.8 show the pertinent Stresscote cracks for the vertical load. Visual inspection of the side links and mount platform Stresscote crack patterns did not reveal a change in the principal stress direction from preceding tests.

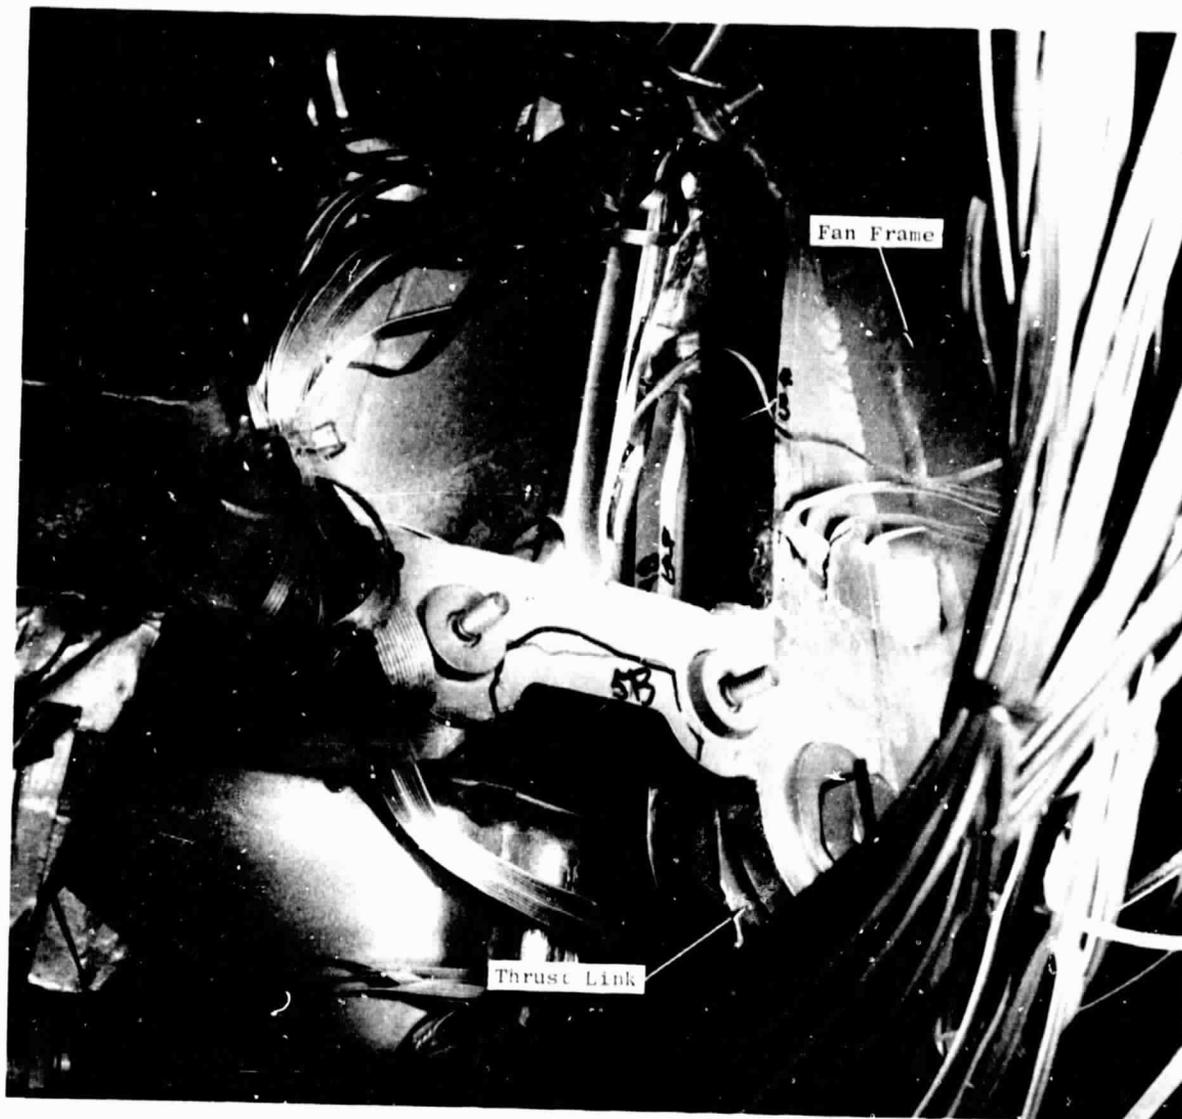
Figure 5.4. Photograph of Stresscoat Map Pattern.

Initial Stresscote cracks in the fan frame clevises in line with the thrust links developed at 88,960 N (20,000 lb) axial load, Figures 5.4 and 5.5. The load was increased to 111,200 N (25,000 lb) and additional stress cracks developed in new areas on the fan frame and mount platform as shown on Figures 5.4 and 5.6, region 5B.

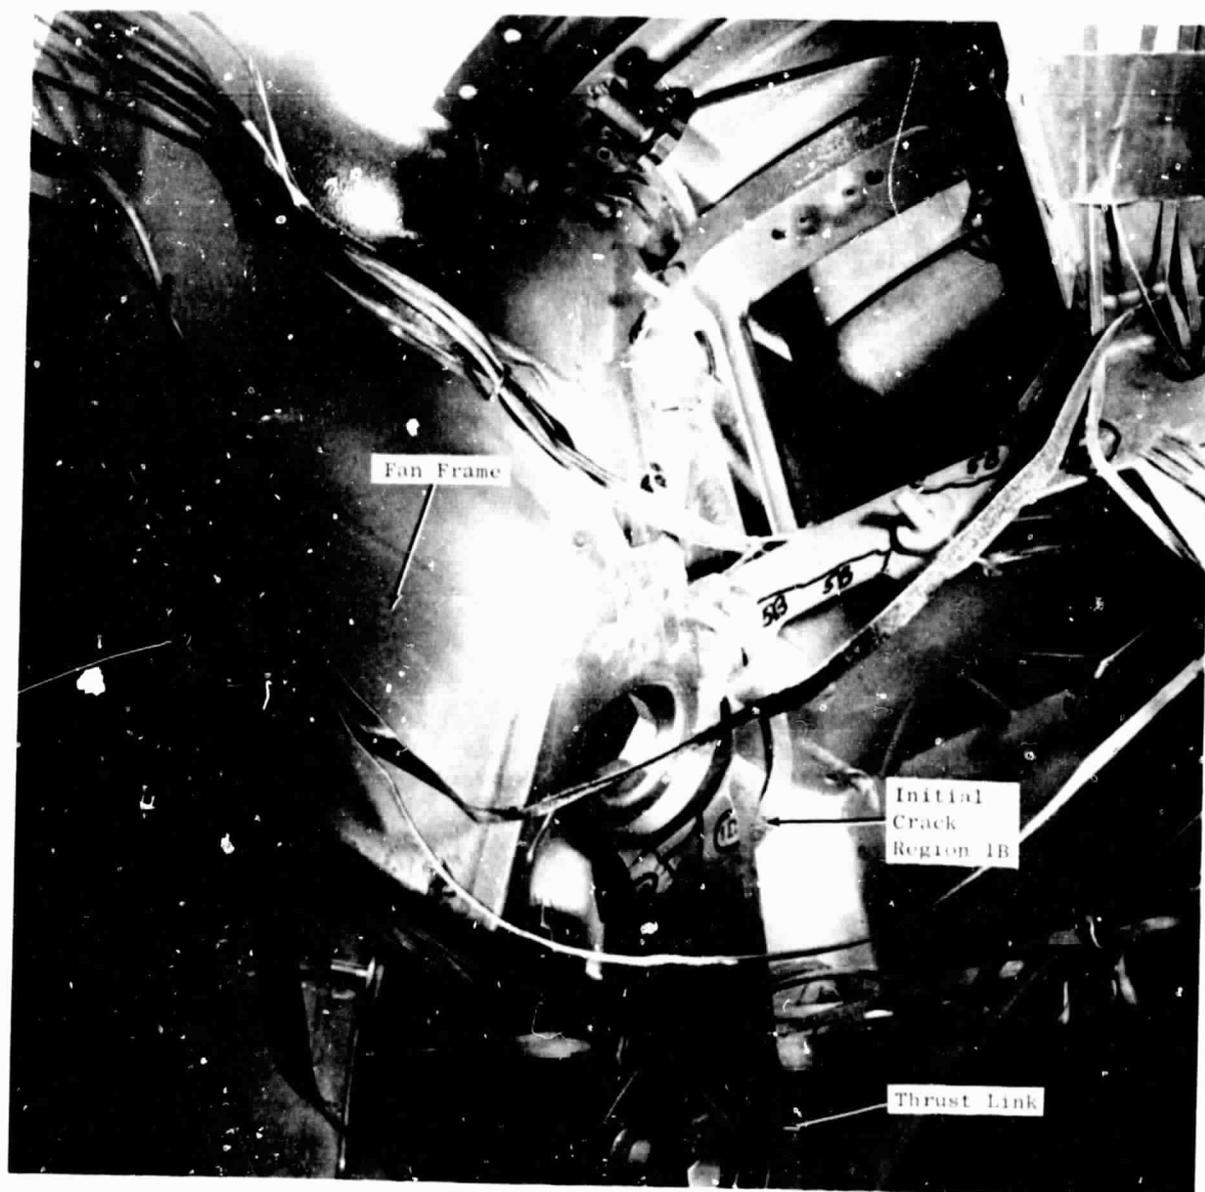
Figure 5.5. Photograph of Stresscoat Map Pattern.

Initial Stresscote cracks developed on the axial thrust link as shown on Figures 5.5 and 5.6, region 1B. Initial crack patterns developed at 66,720 N (15,000 lb) axial load. The thrust links are the primary load-carrying members for the axial load and initial crack formation on these links was anticipated. During this test run suspicious formation of Stresscote cracks developed on the fan frame and side link, region 2B, Figures 5.6 and 5.8. Subsequent investigation of strain gage data showed high strain readings on the fan frame and a side load pickup in the center link. A visual inspection of the test facility detected that the mount facility loading fixture had rotated and made contact with the fan frame clevis at the 12 o'clock location and also with the lock plate on the right side (aft looking forward) thrust link at locations shown in Figure 5.3. It was determined that the rotation was caused because the right side actuator was not vented. After the hydraulic actuator was properly vented, the test facility fixture was reassembled. A checkout of the system was completed and the axial load test was repeated. Stresscote cracks that developed in the side link and fan frame from the test fixture movement are valid for indicating the critical stress areas on the fan frame, side link, and mount platform.

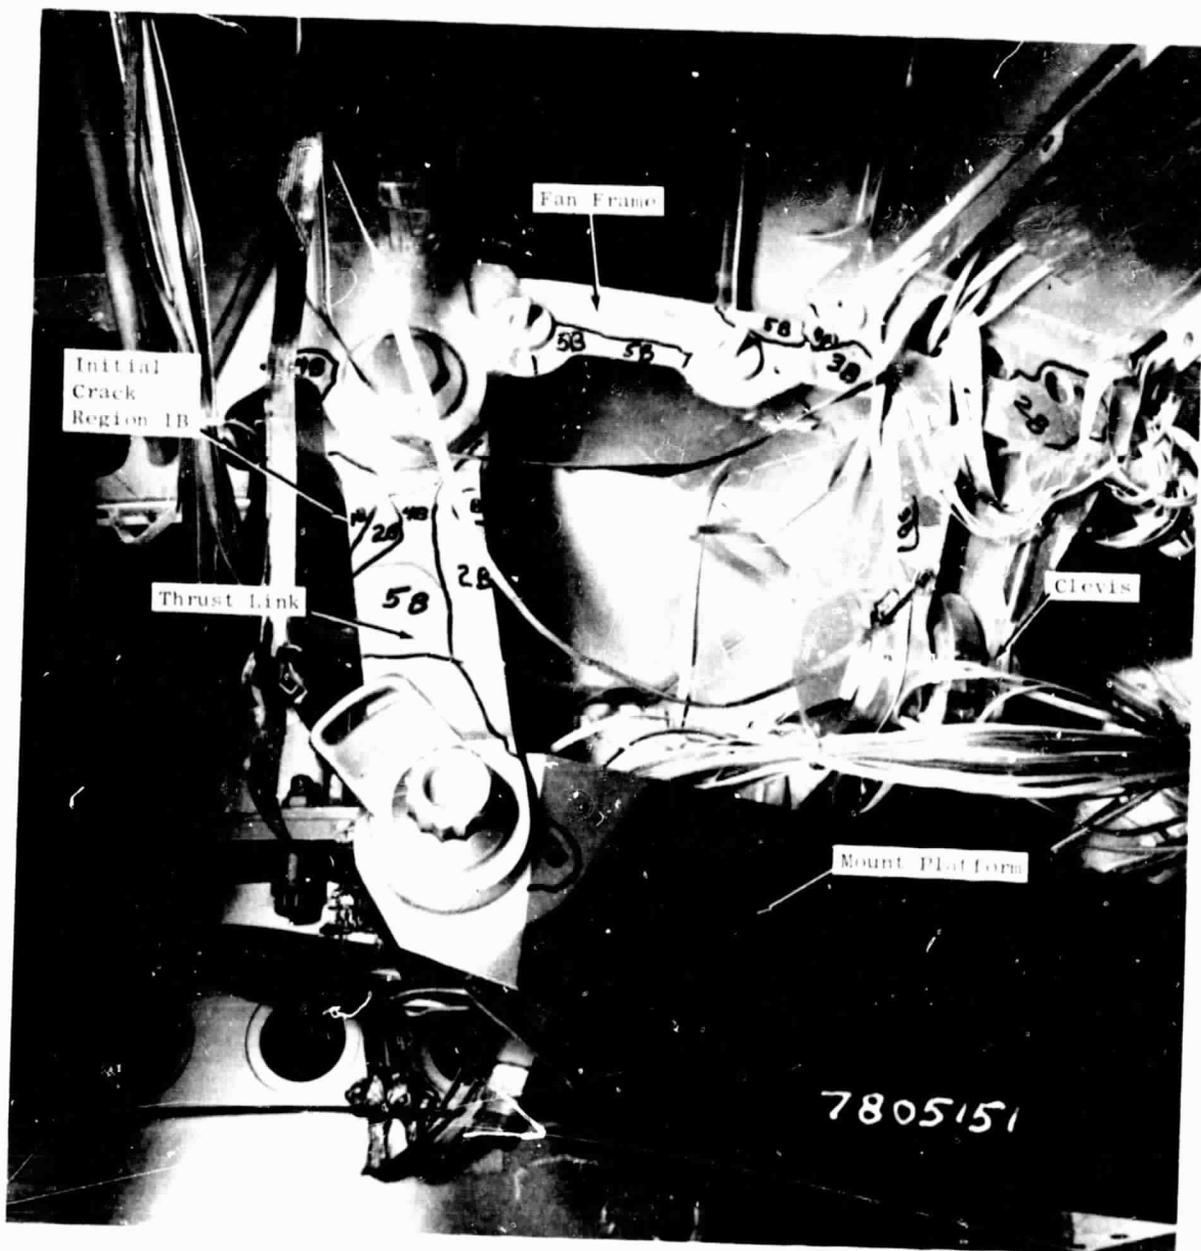
Figure 5.6. Photograph of Stresscoat Map Pattern.

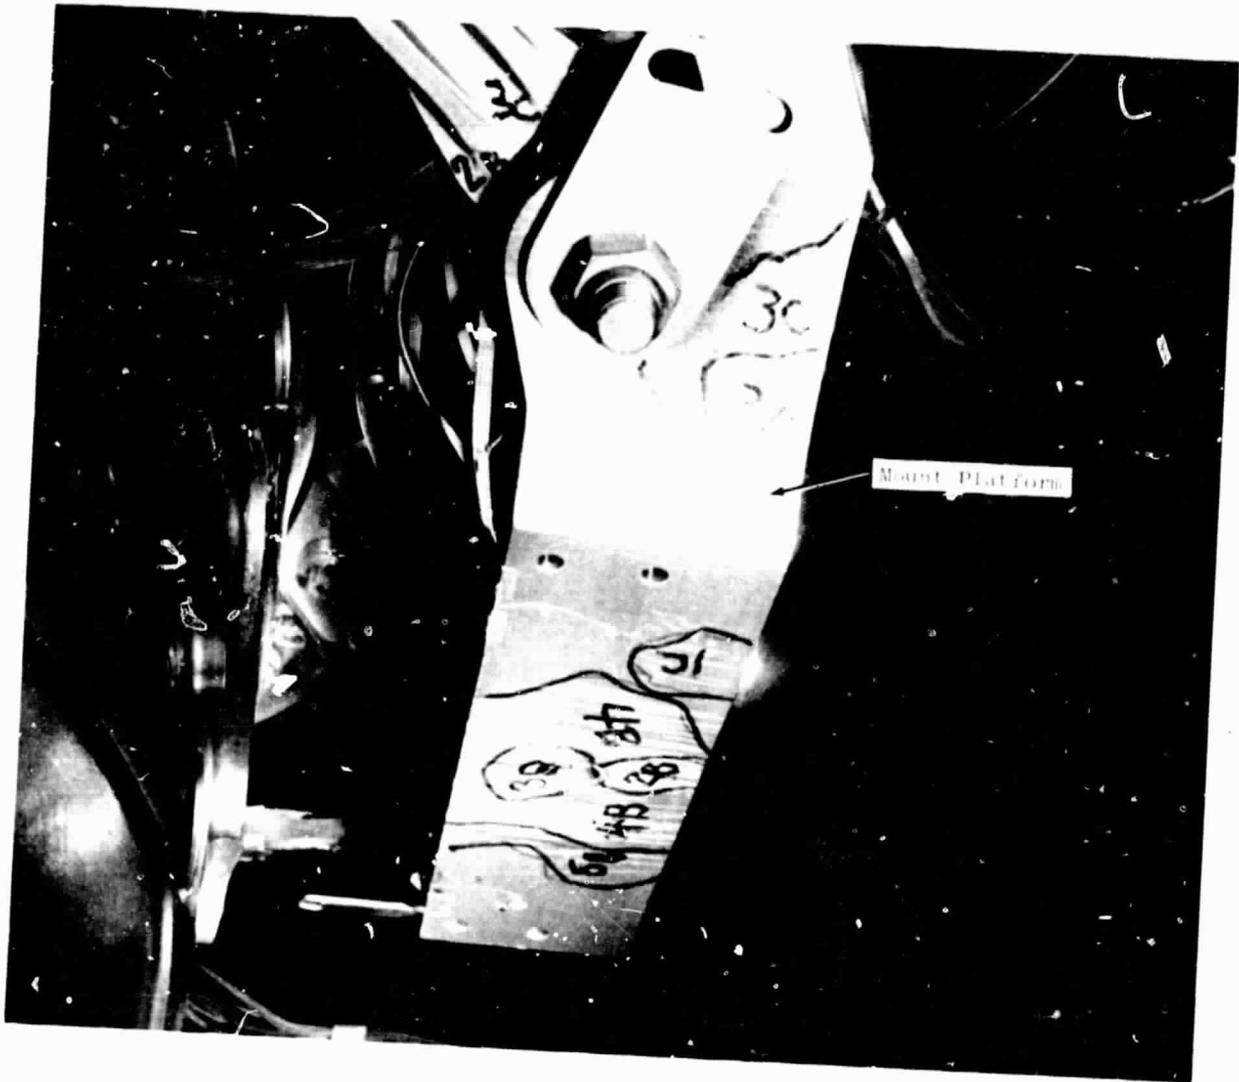
Figure 5.7. Photograph of Stresscoat Map Pattern.

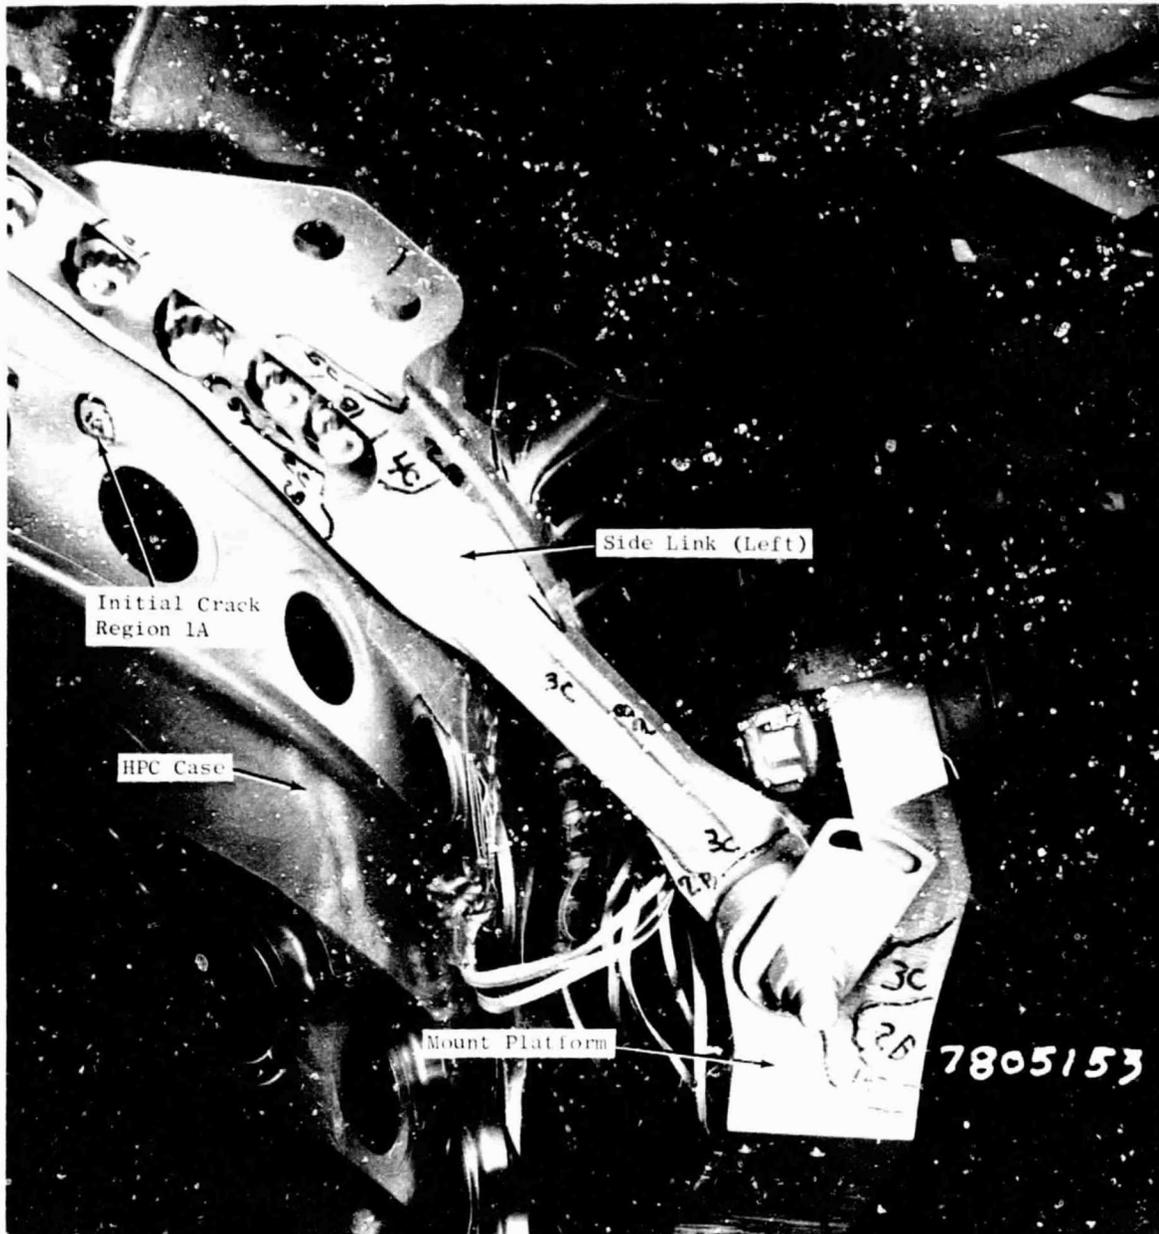
Figure 5.8. Photograph of Stresscoat Map Pattern.

case near the Stage 1 variable vane hole as shown on Figure 5.8, region 1A. A review of the strain gage readings confirmed that the primary load-carrying member for side loads is the center link. Inaccessibility of the center link limited the capability to inspect this component for Stresscote cracks. The absence of Stresscote cracks in other areas indicates a relative low stress condition in members outside the primary load path for a side load condition.

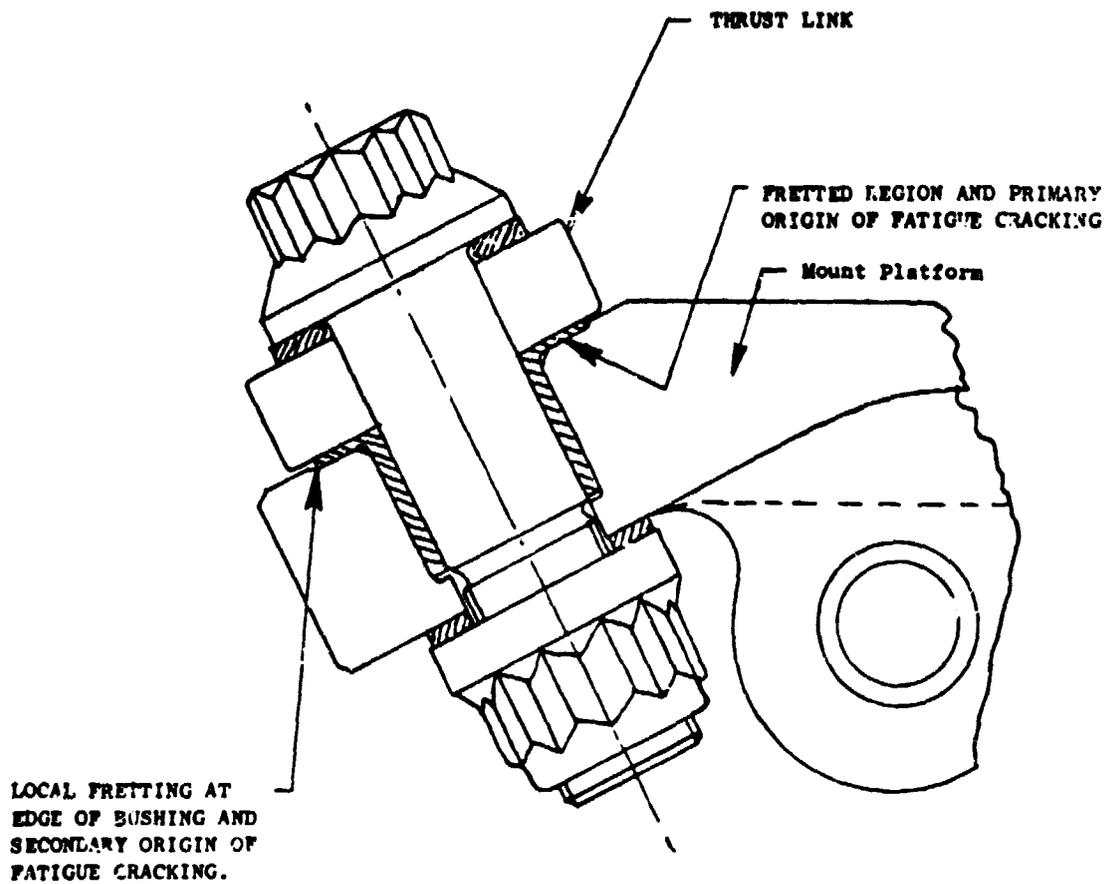
The previously noted cracks in the ball of the left thrust link had not propagated appreciably since first observed after 35,000 cycles. Fretting of the upper interface surface of the mount platform appeared to be unchanged since the previous examination.

Figure 7.2. Cross Section of Left Lug of Mount Platform and Thrust Link Showing Origin of Fatigue Cracks.

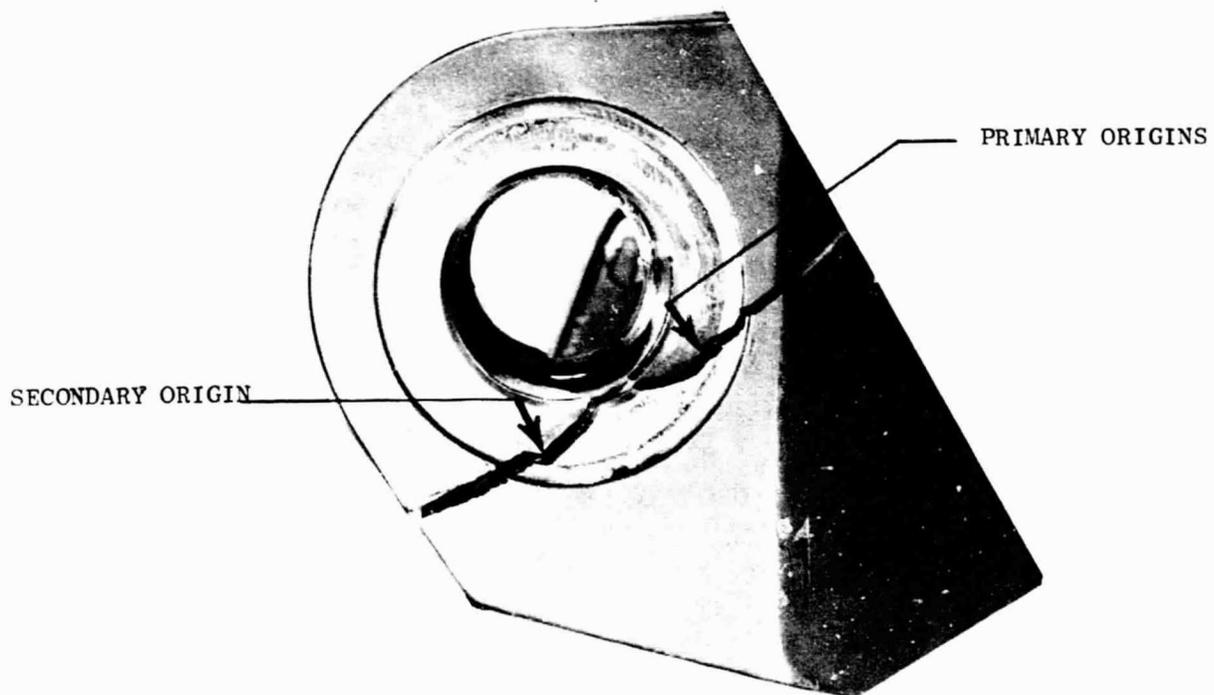
Figure 7.3. Origins of Fatigue Cracking in Left Hand Lug of New Front Mount Platform (Upper Surface) After 47,360 Simulated Flight Cycles, Hole Bushing Removed.
