NASA  
Technical  
Paper  
2087

December 1982

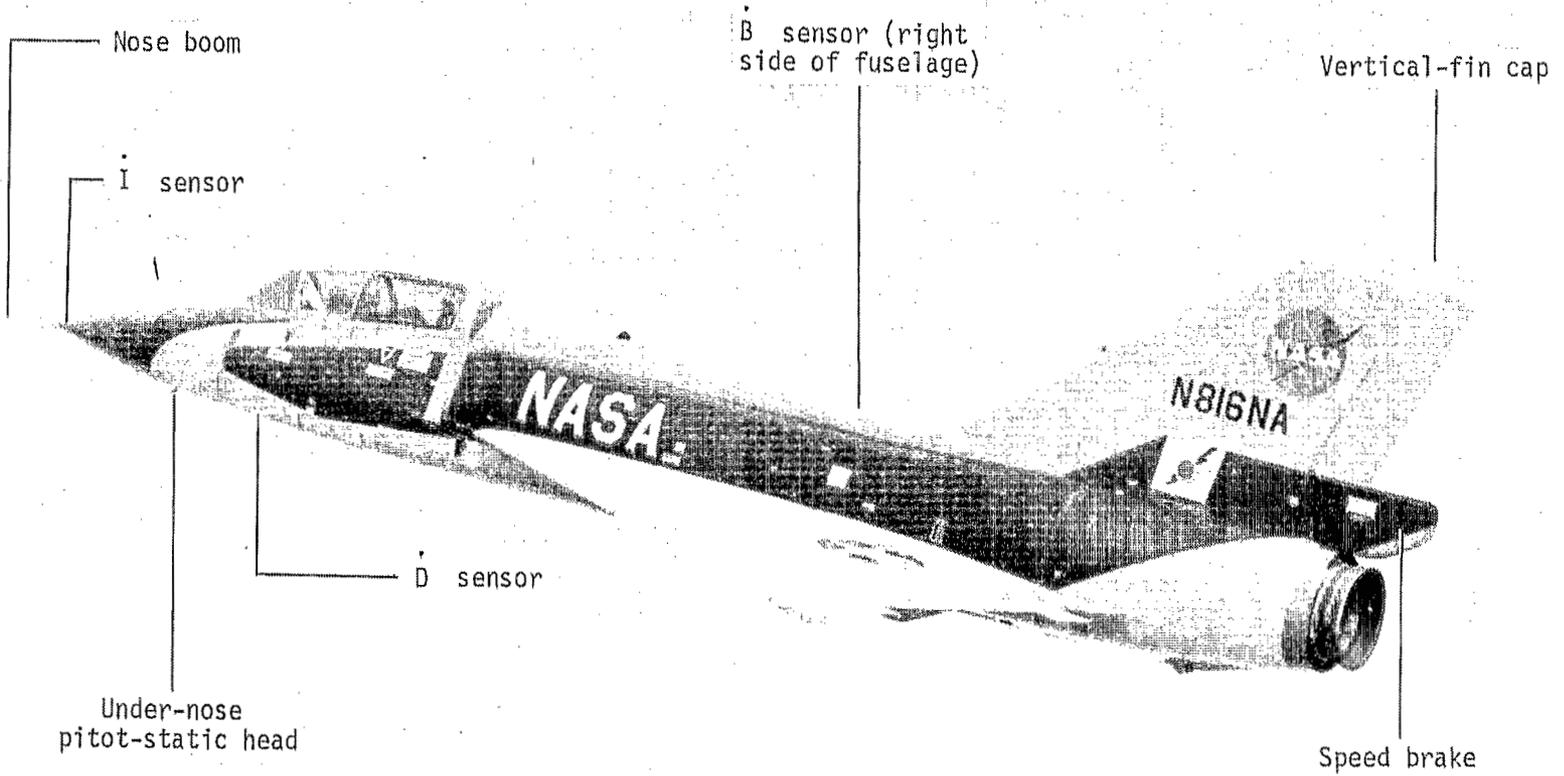
Figure 1.- NASA F-106B research airplane used in Storm Hazards Program.

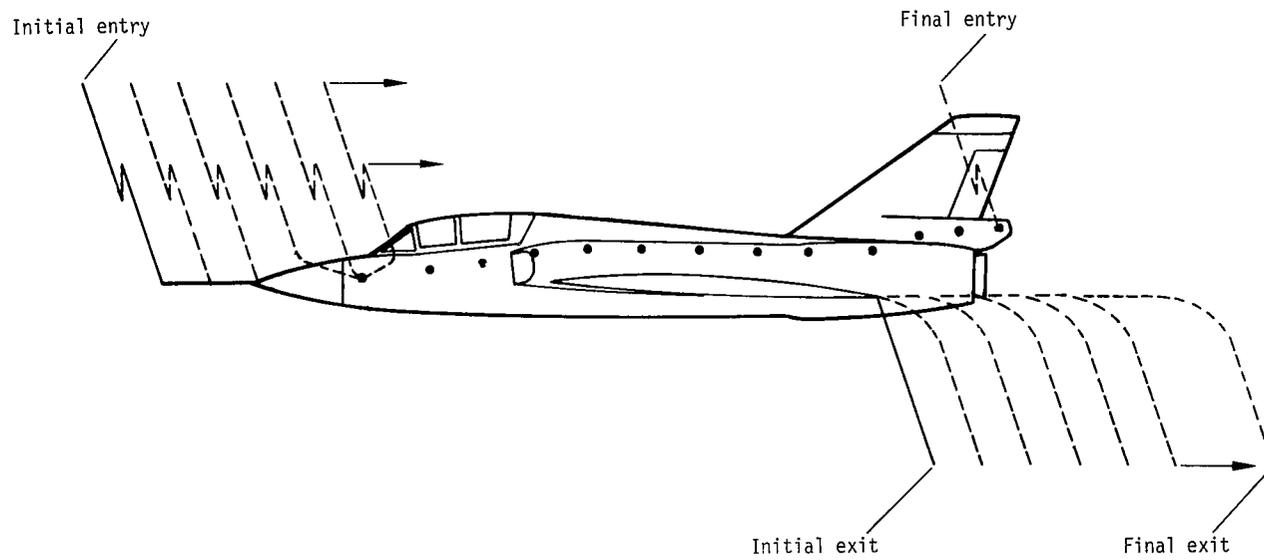
Figure 2.- Typical path of swept-flash attachment points.

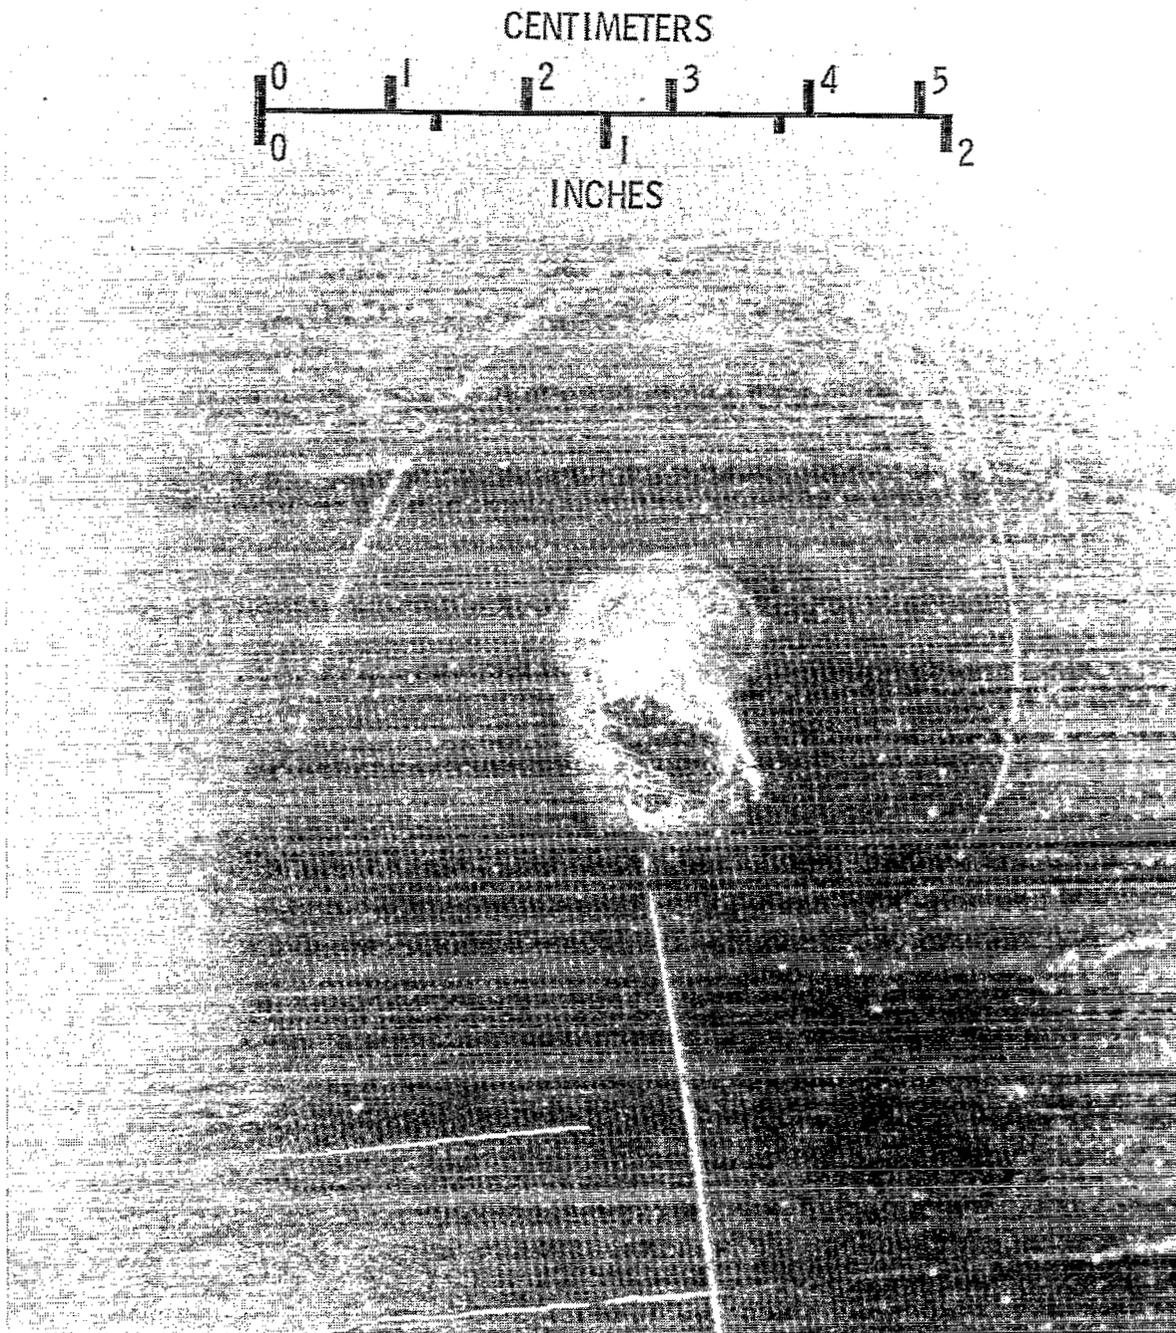
Figure 4.- Lightning damage to F-106B research airplane from strike 1, flight 80-018, June 17, 1980.

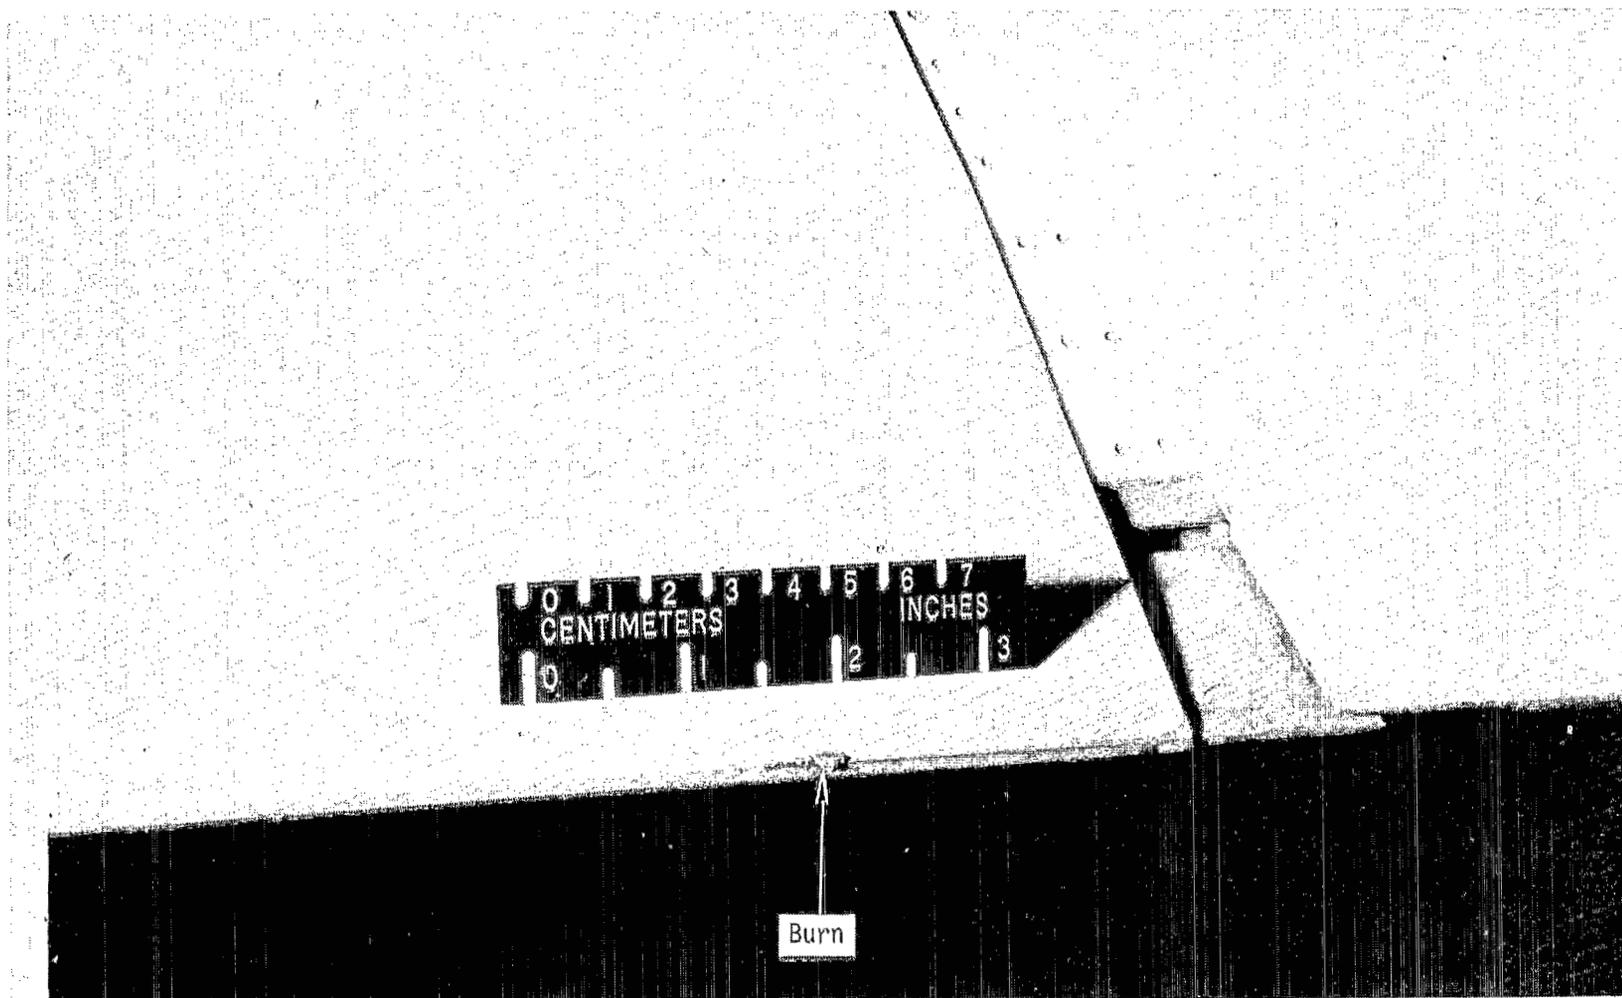
Figure 9.- Lightning damage to F-106B research airplane from strike 2, flight 80-019, June 17, 1980.

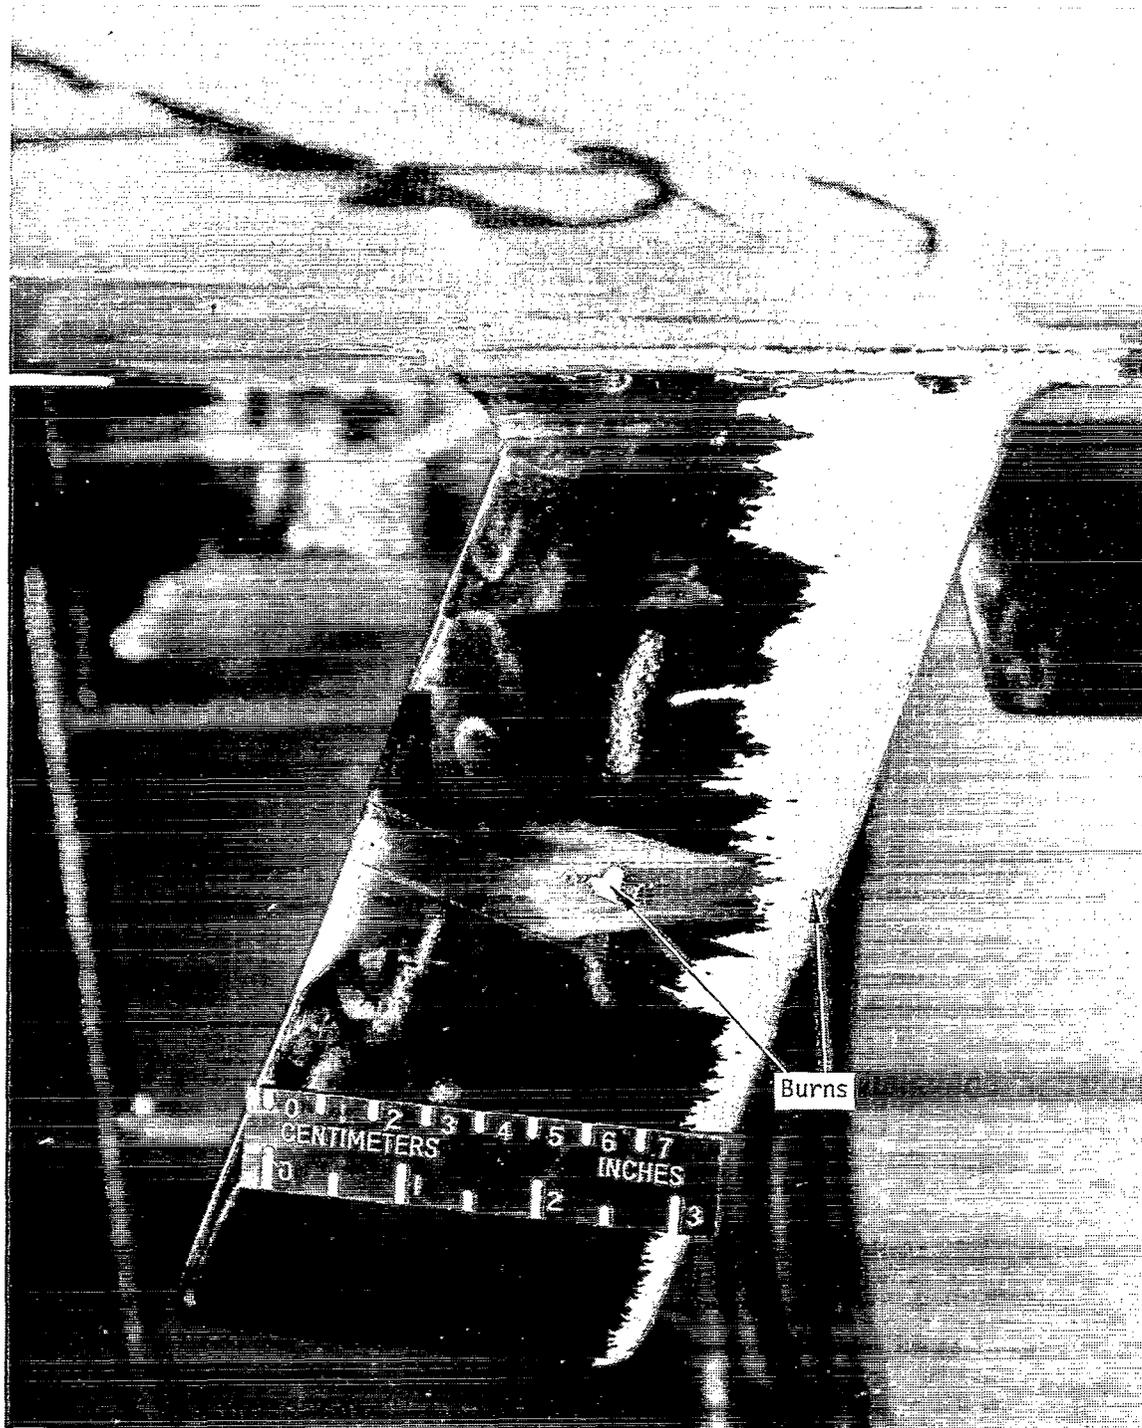
Figure 13.- Lightning damage to F-106B research airplane from strike 3, flight 80-019, June 17, 1980.

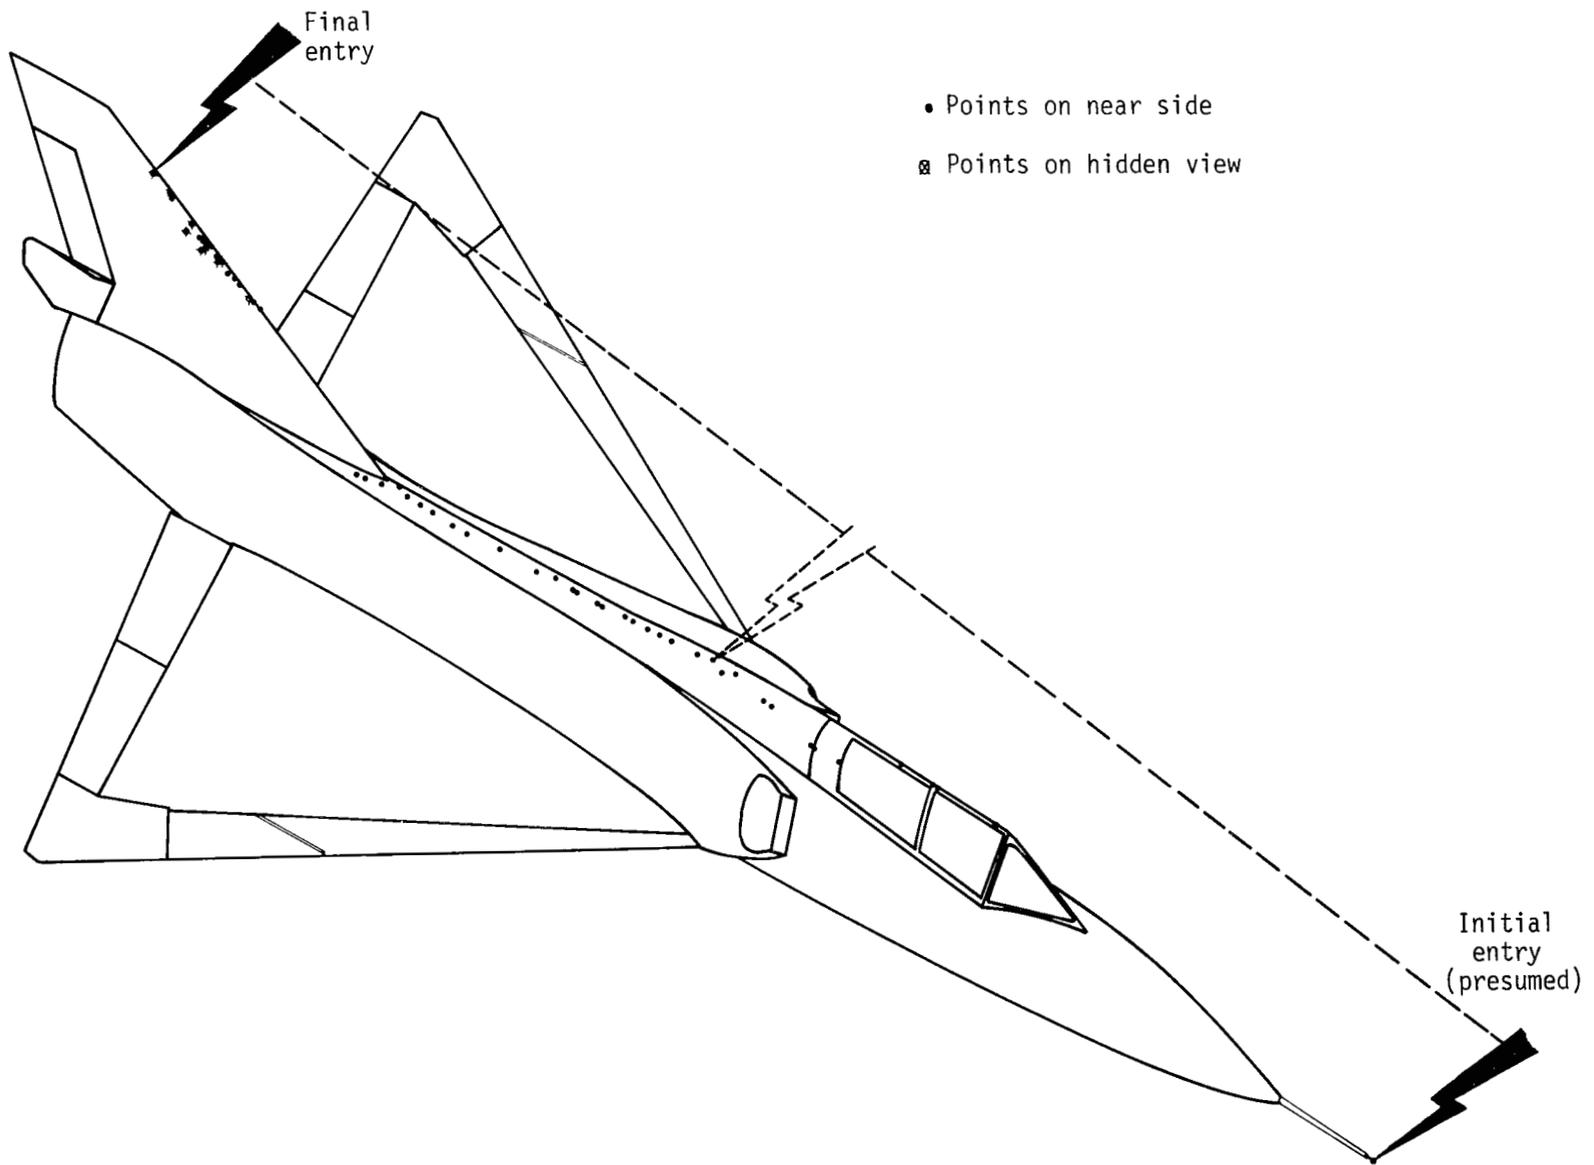
Figure 17.- Lightning attachment points for strike 4, flight 80-029, Aug. 12, 1980.  
(No exit points found.)

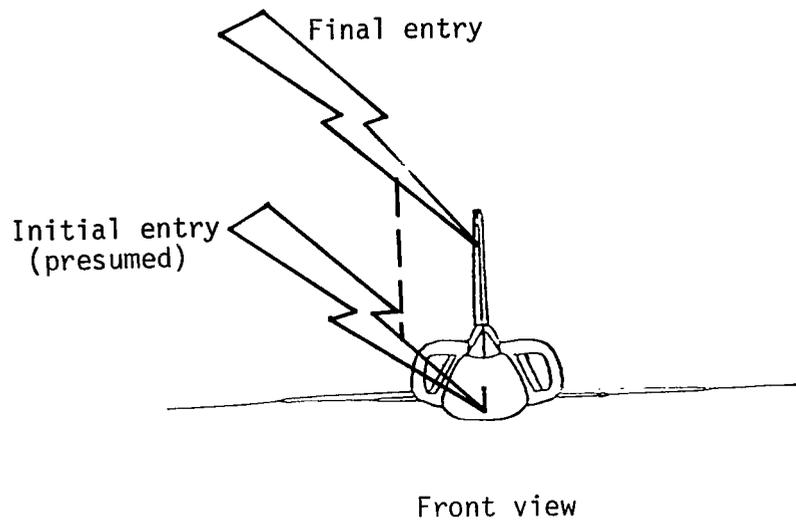
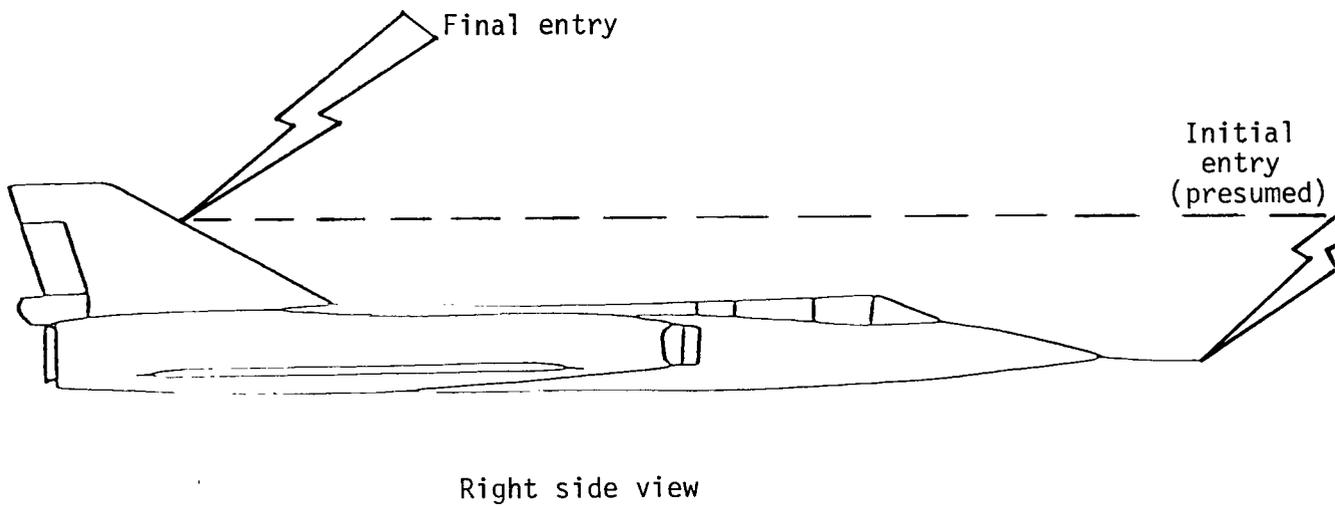
Figure 18.- Lightning strike scenario for strike 4, flight 80-029, Aug. 12, 1980.  
(No exit points found.)

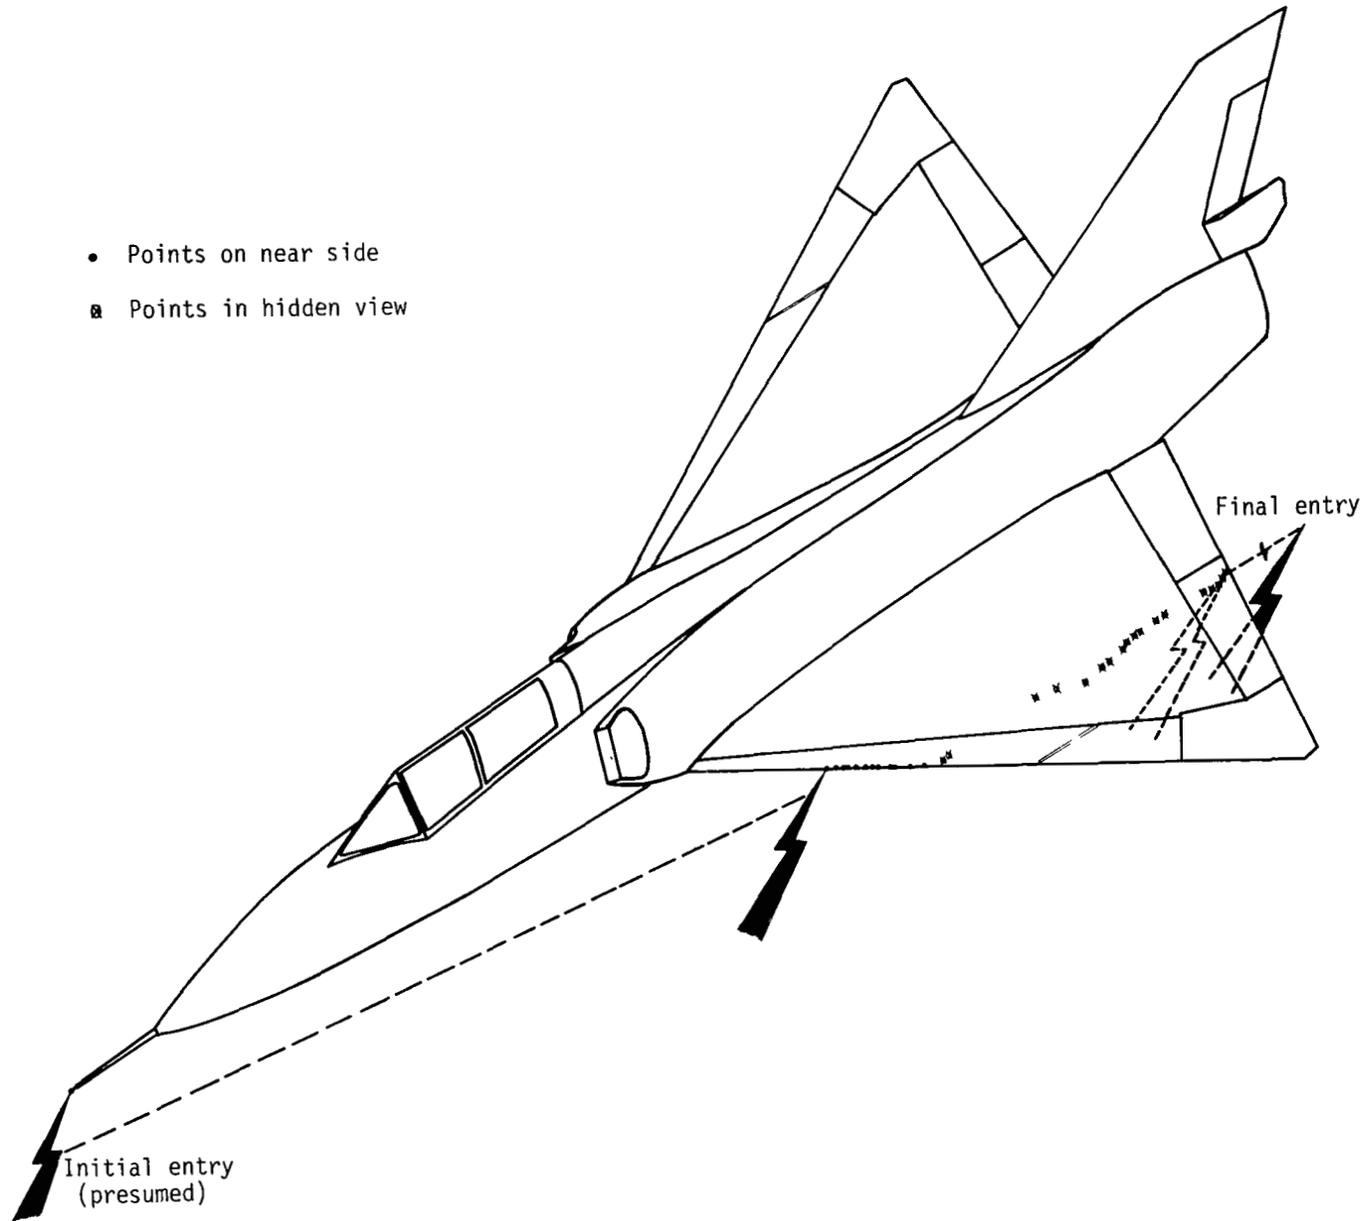
Figure 19.- Lightning attachment points for strike 5, flight 80-036, Sept. 1, 1980.  
(No exit points found.)

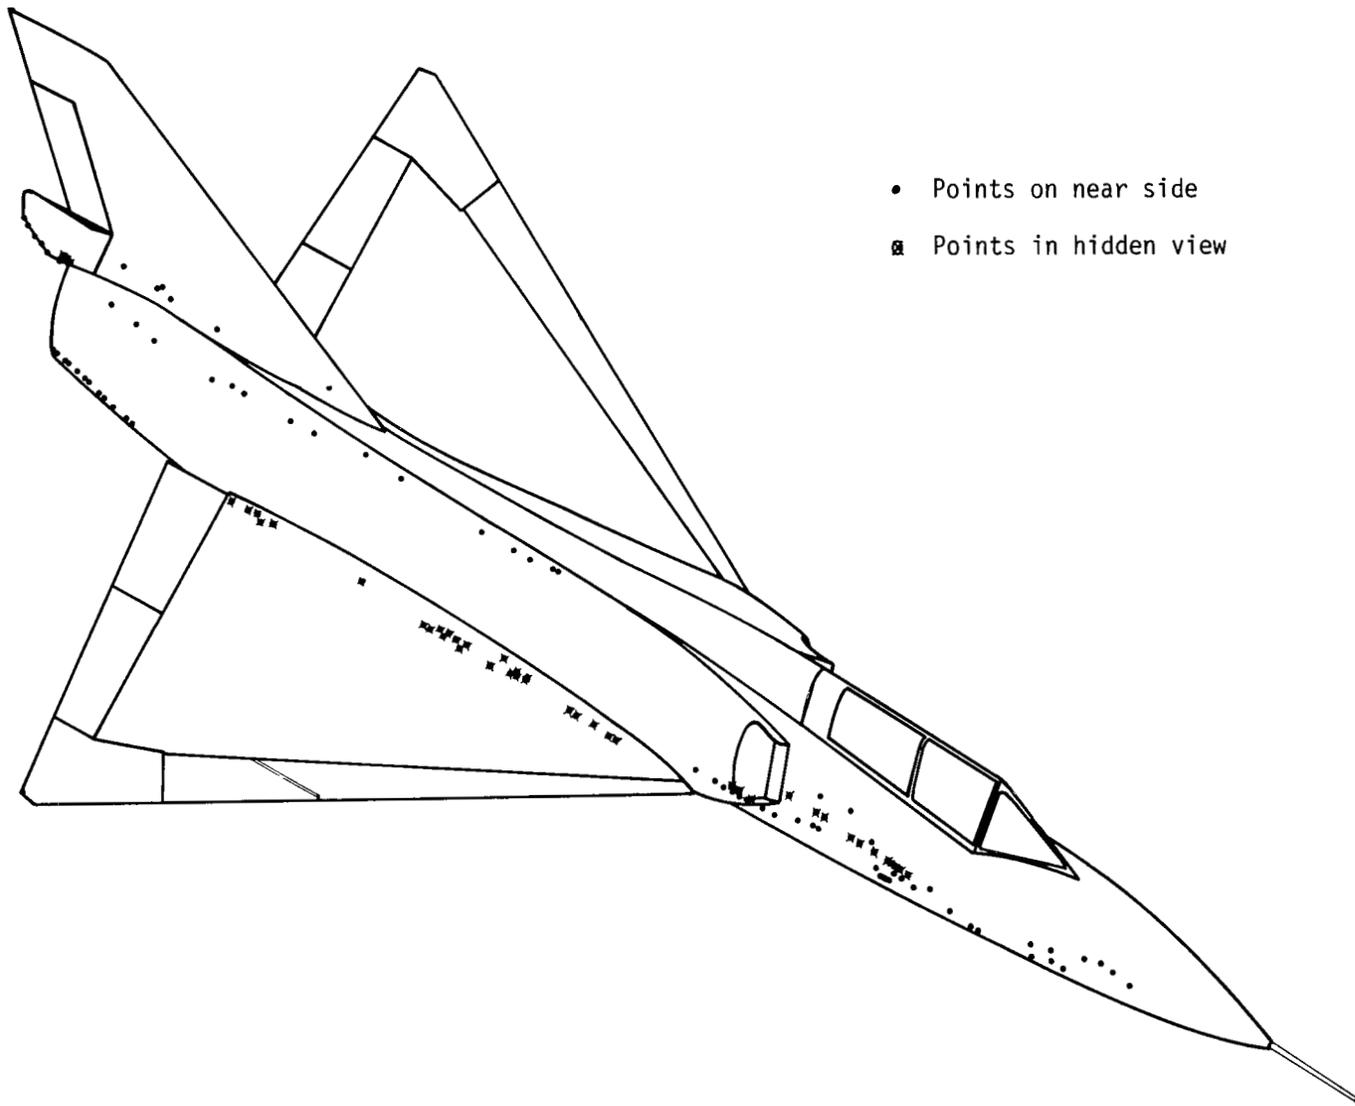
Figure 21.- Lightning attachment points for strikes 6 to 10, flight 80-038,  
Sept. 3, 1980.

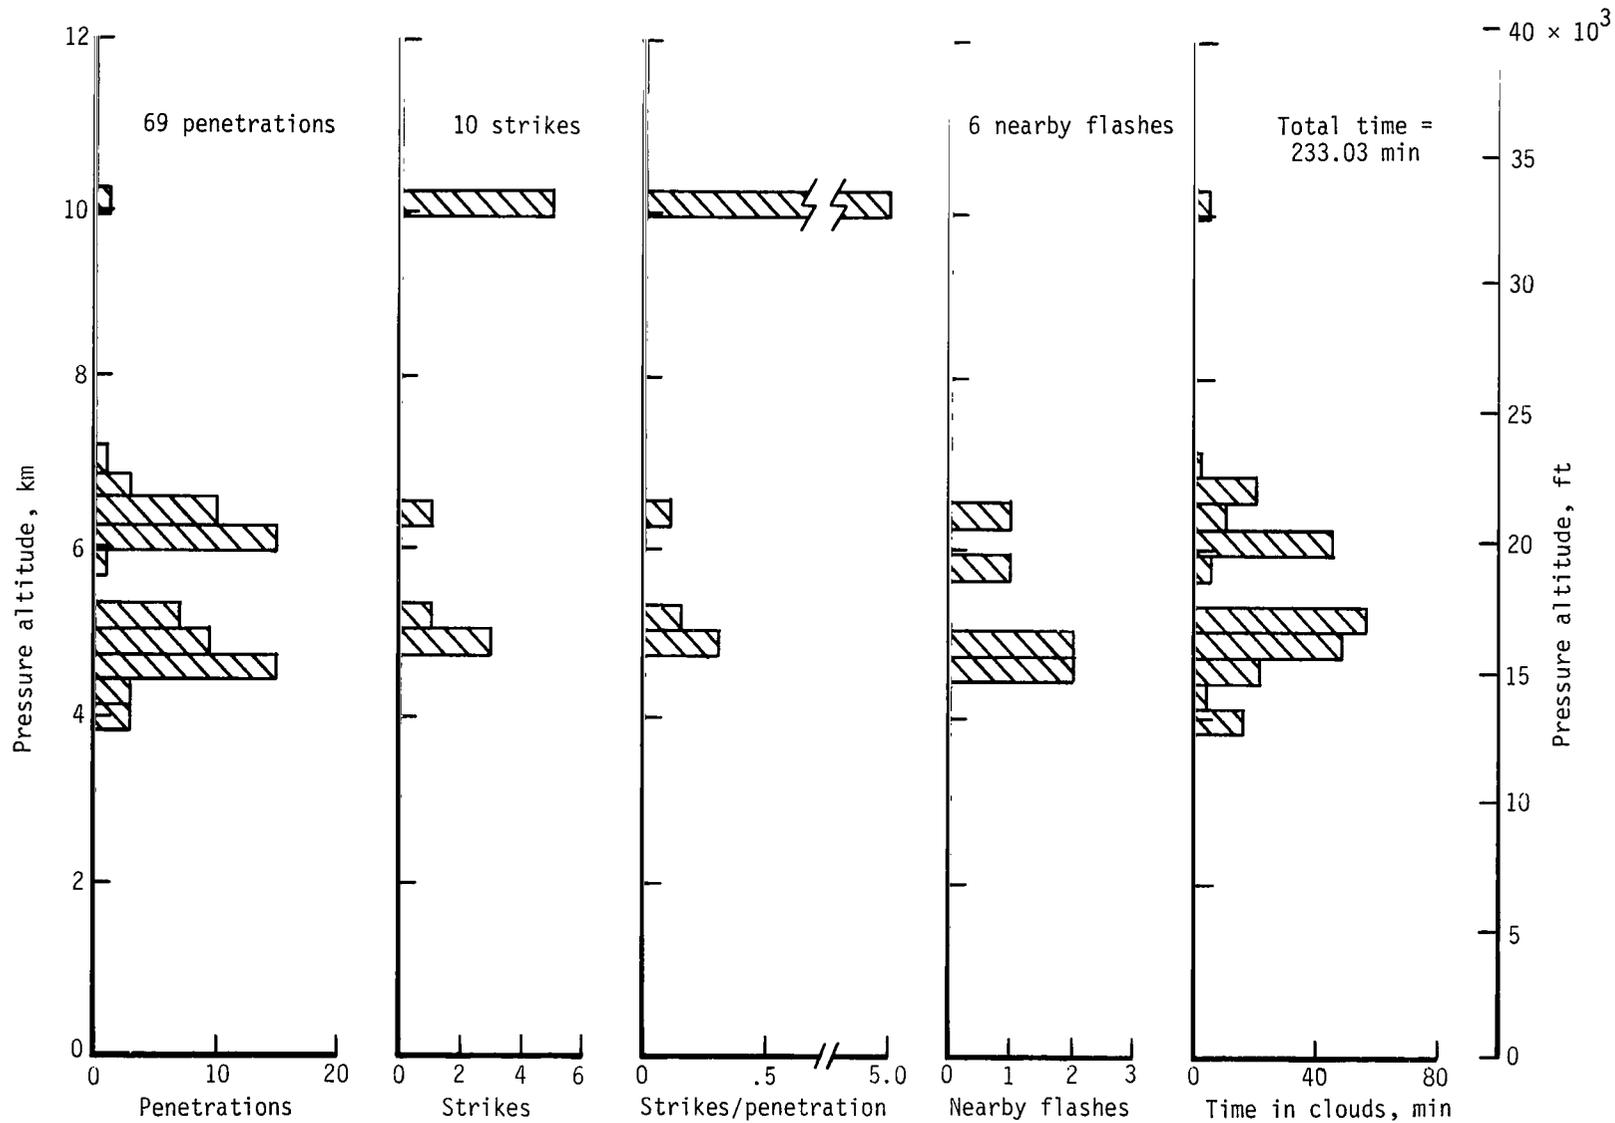
Figure 22.- Thunderstorm penetration and lightning statistics for Storm Hazards '80 Program.

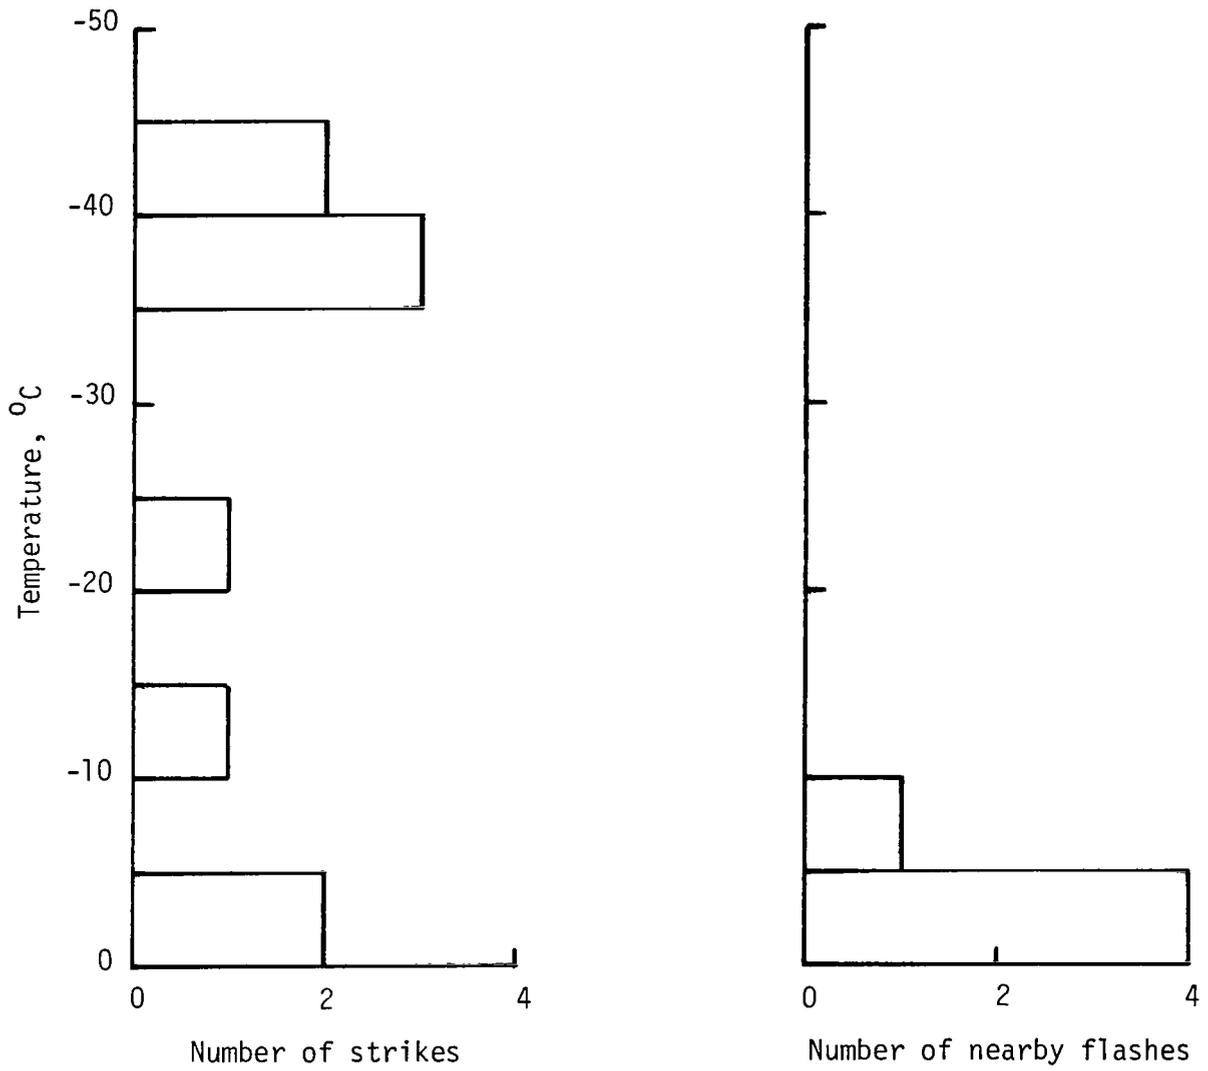
Figure 23.- Ambient temperature at which direct strikes and nearby flashes occurred during Storm Hazards '80 Program. (No temperature for one of each.)

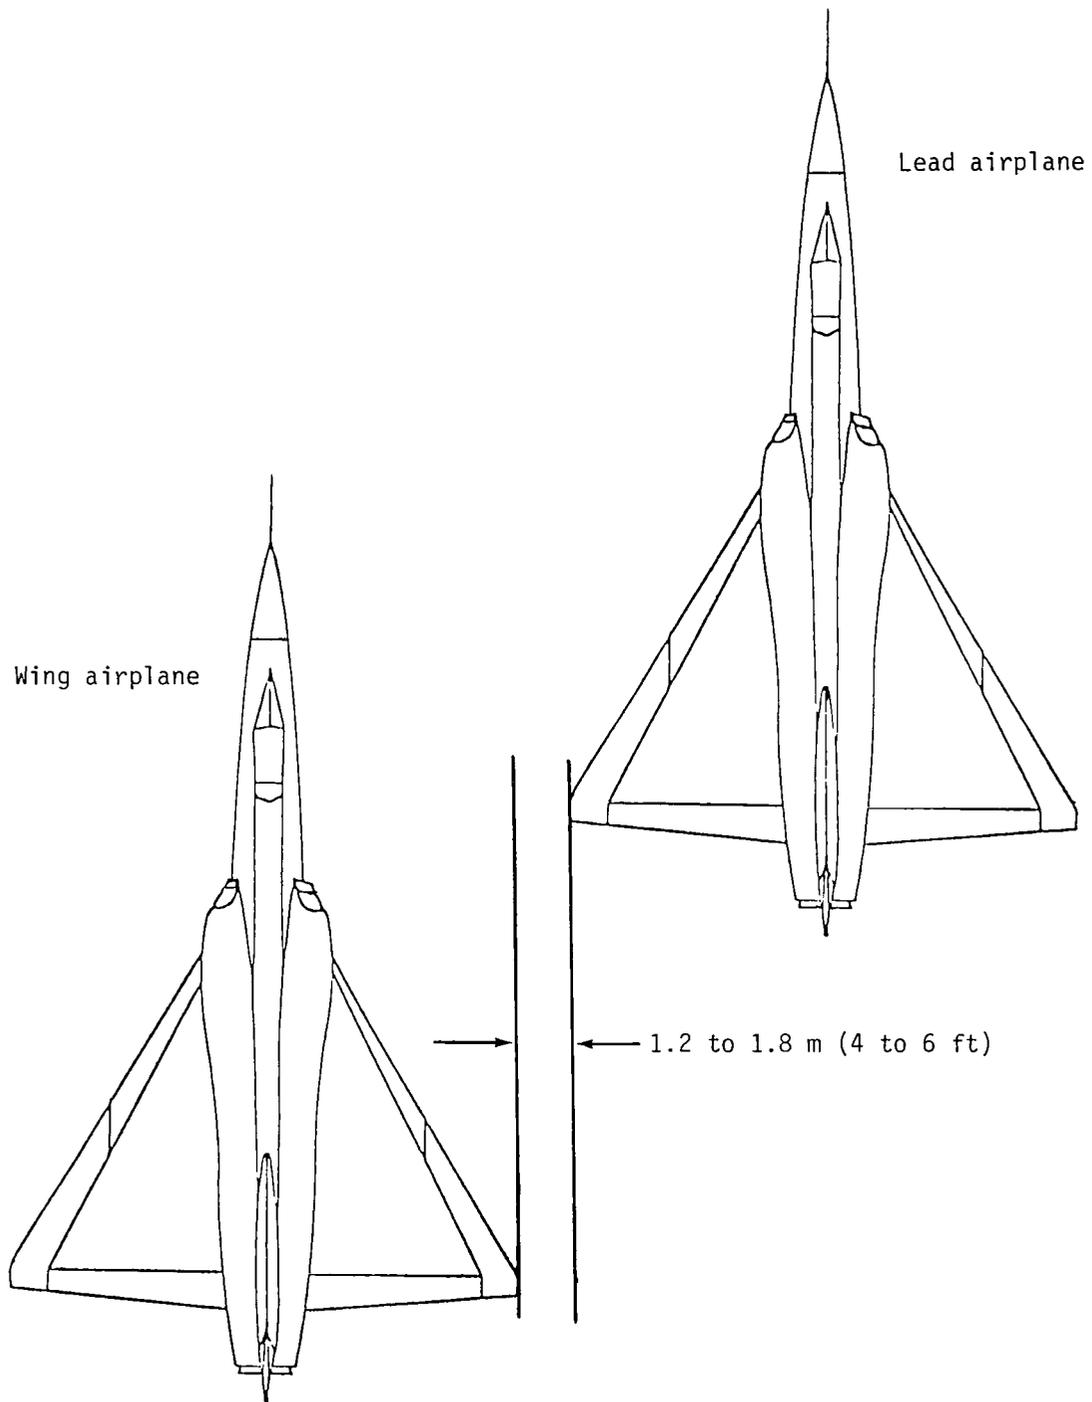
Figure 24.- Plan view showing relative location of two USAF F-106A airplanes at time of first lightning strike to formation.

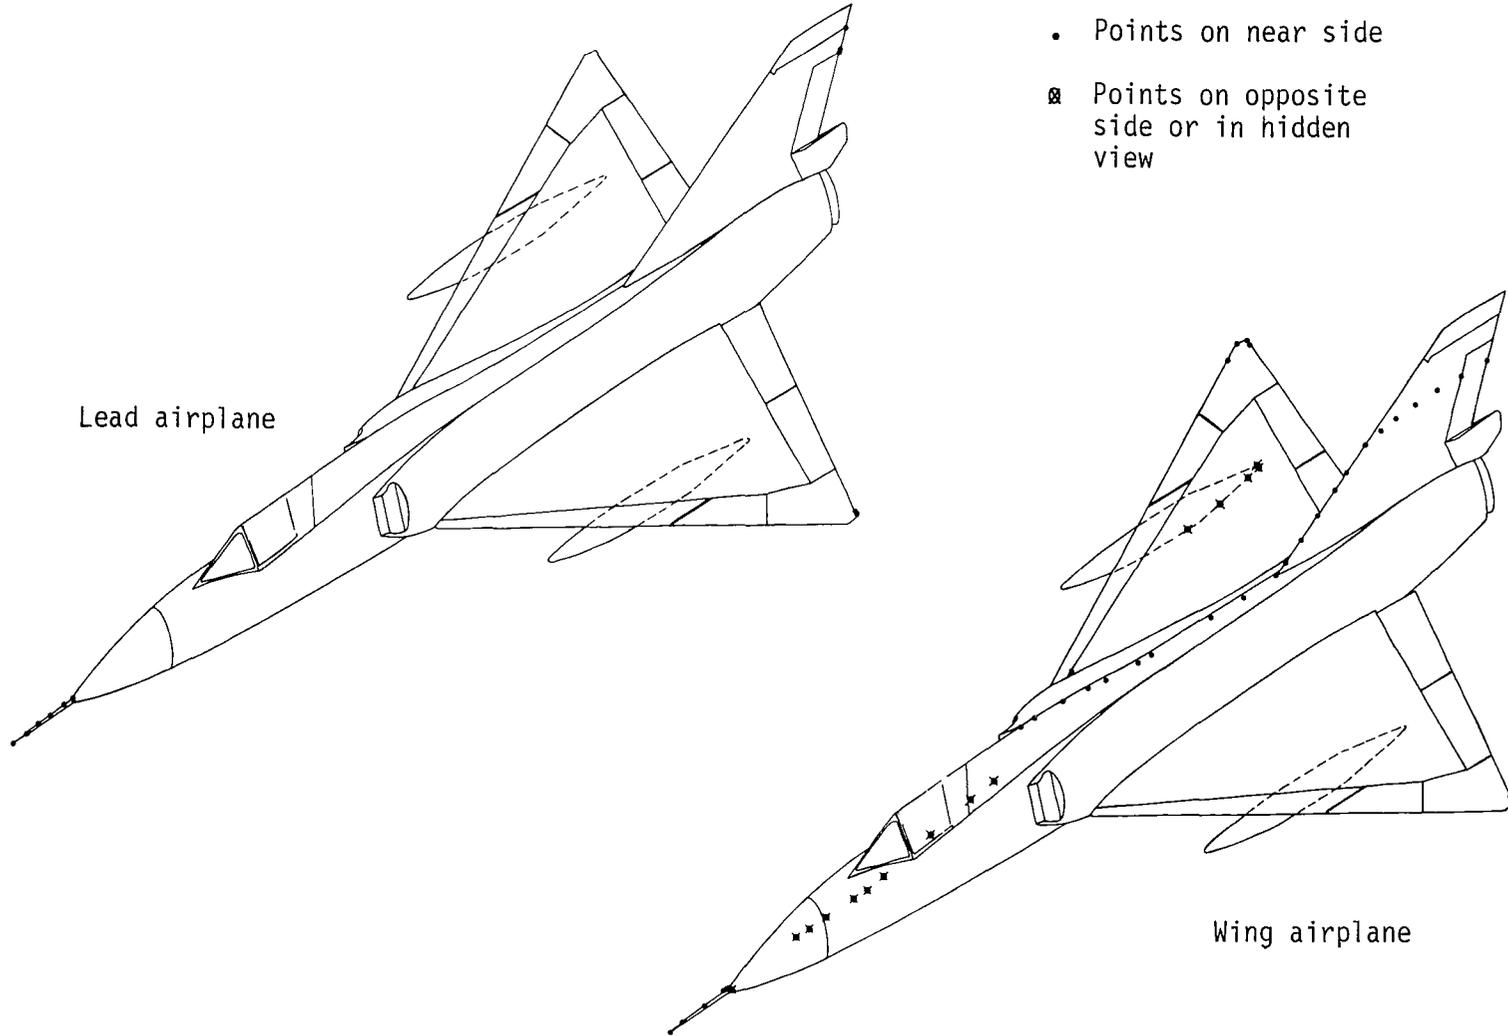
Figure 26.- Lightning attachment points found on two USAF F-106A airplanes following a pair of lightning strikes to the formation.

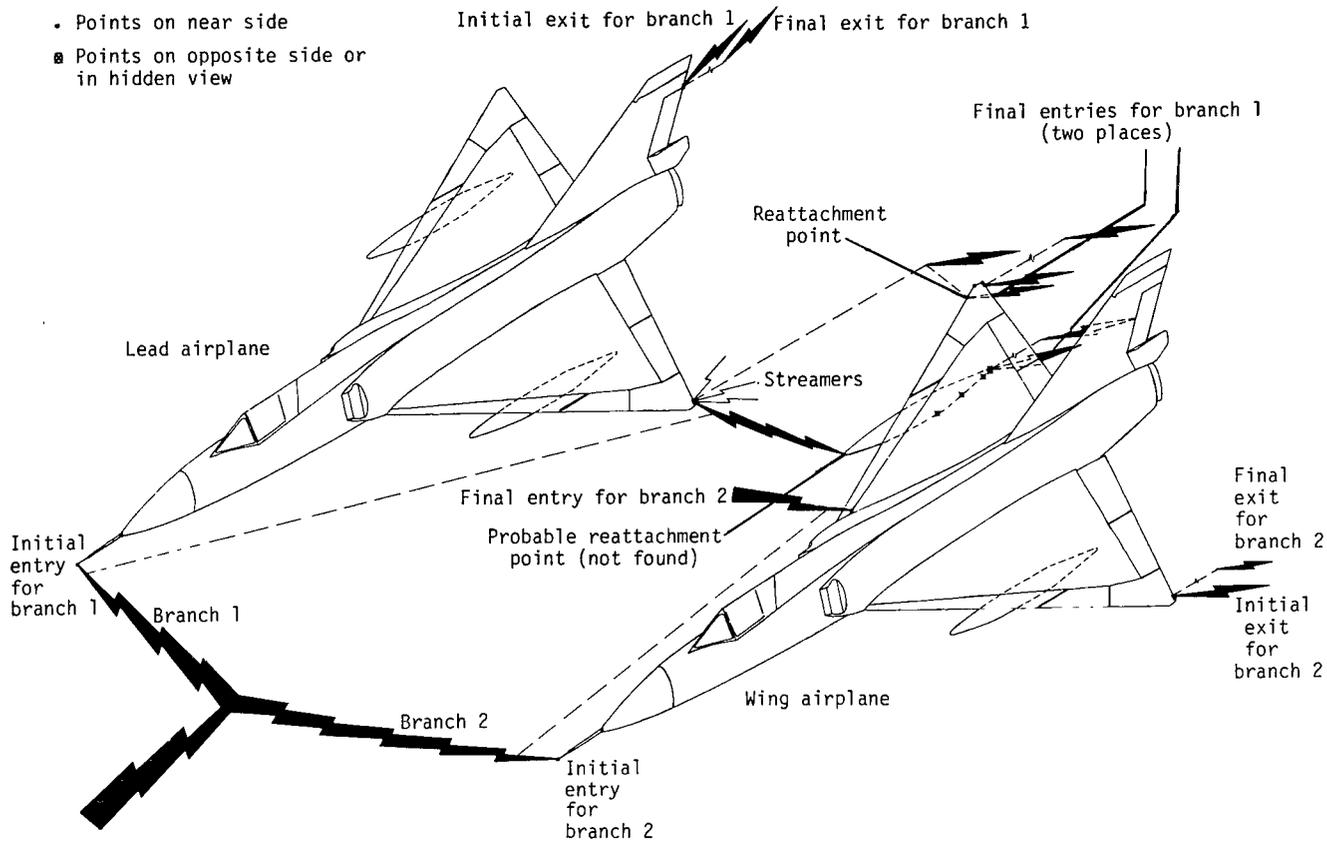
Figure 27.- Lightning strike scenario for first lightning strike to two USAF F-106A airplanes in close formation.

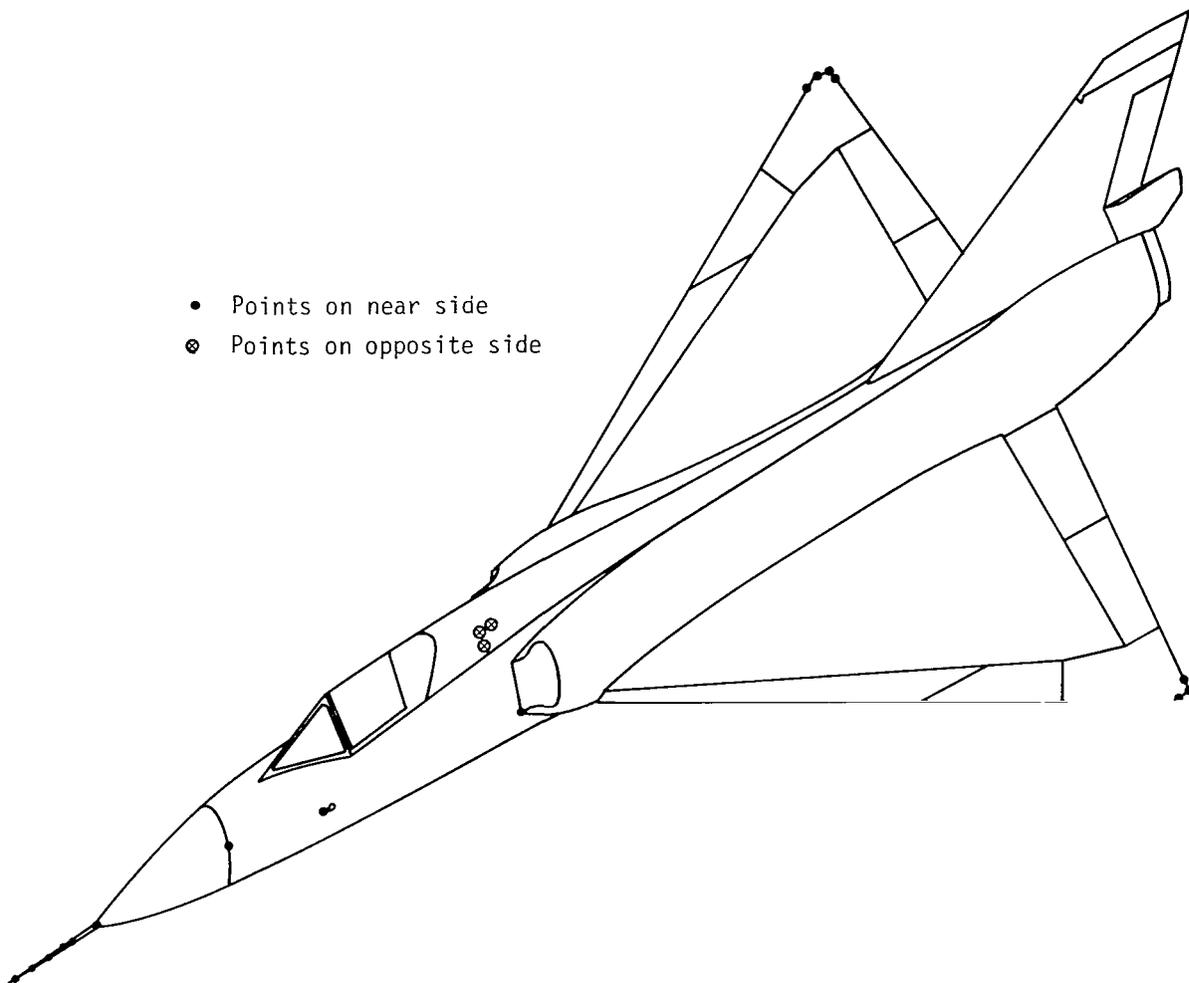
Figure 29.- Lightning attachment points found on USAF F-106A airplane following multiple strikes.

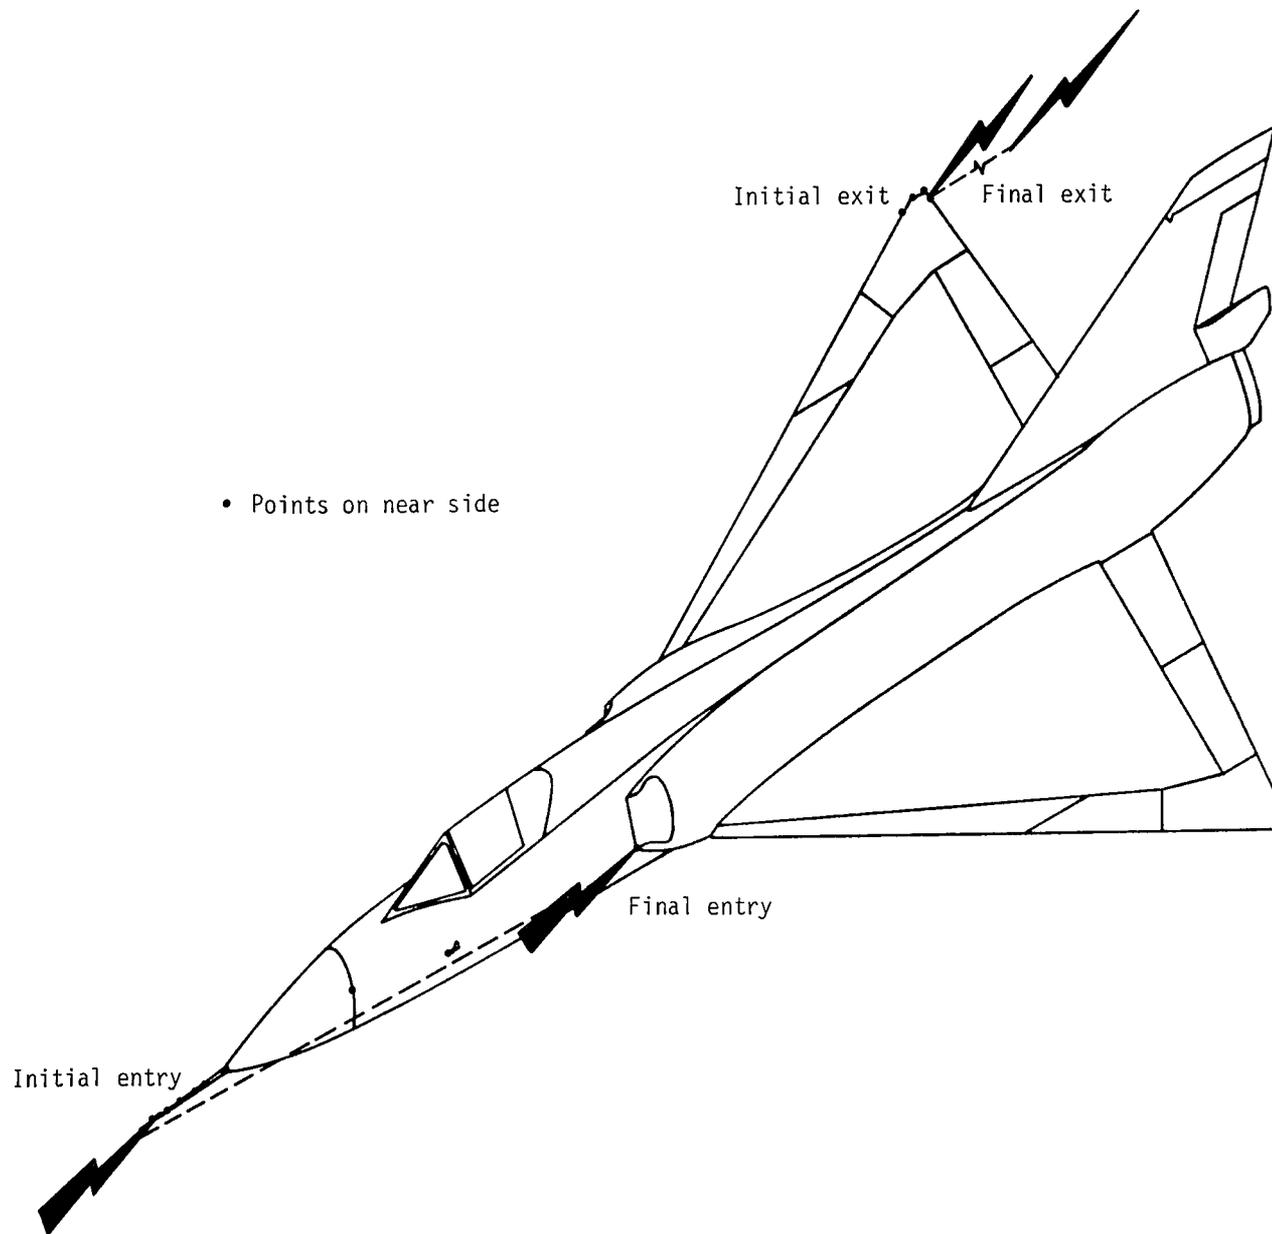
Figure 30.- Lightning attachment points ascribed to first strike of single USAF F-106A airplane.
