NASA  
Technical  
Paper  
2087

December 1982

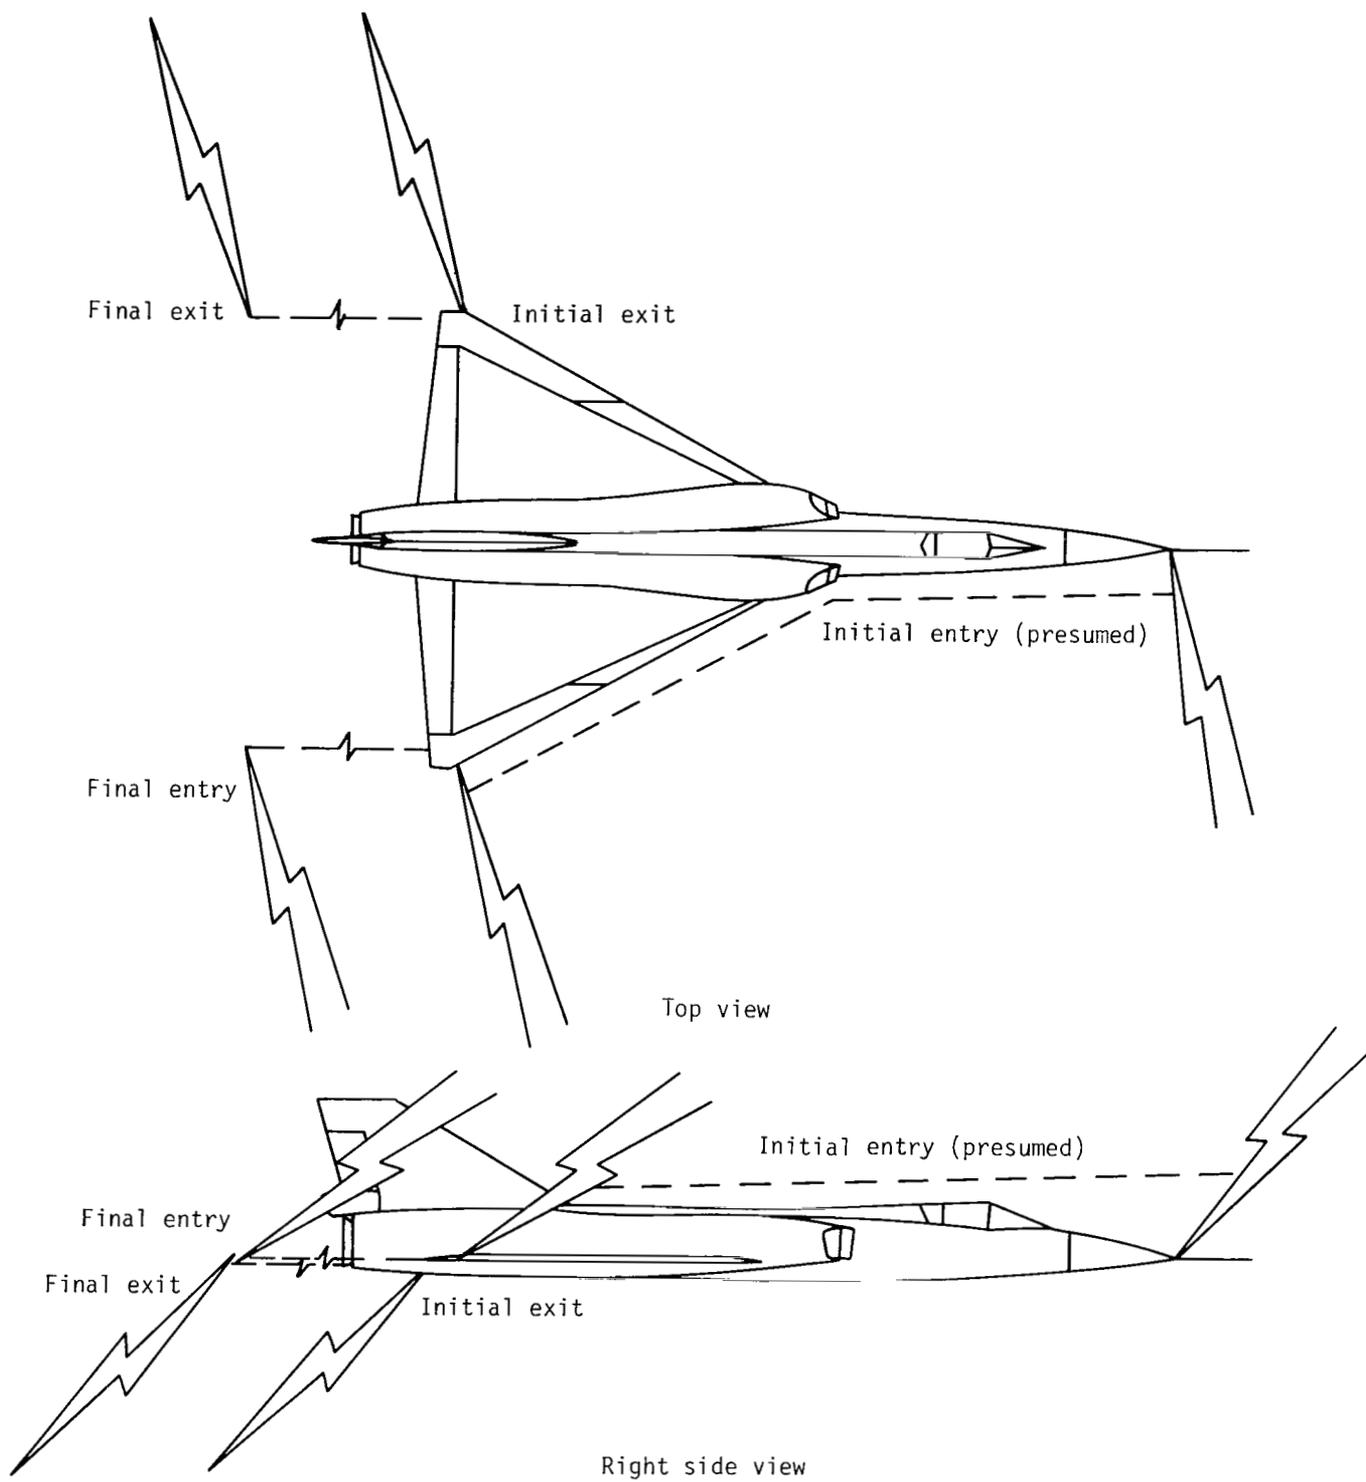
Figure 33.- Lightning strike scenario for second strike to single USAF F-106A airplane.
